RE: Lordstown Construction Recovery
Notice of Violation (NOV)
NOV
Construction & Demolition Debris
Trumbull County
CDDL018743

Subject: Notice of Violation

LORDSTOWN CONSTRUCTION RECOVERY, Village of Lordstown, Trumbull County
Photos Taken: September 15, 2021
By: Jennifer Carlin, DMWM, NEDO

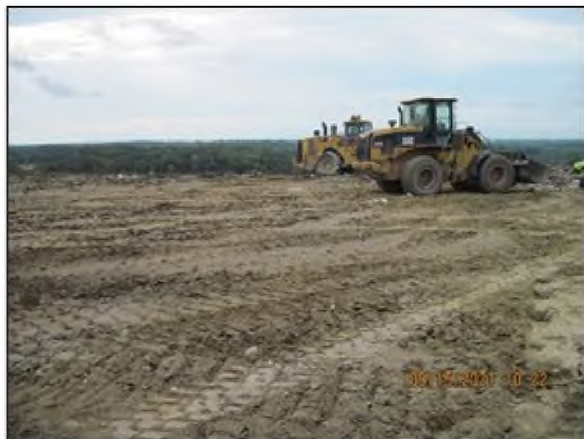
(a) Description: The incoming loads of material were not deposited at a clearly designated and marked unloading zone separate from the working face. The material was not inspected after unloading. Prohibited waste such as solid waste (a.k.a. municipal solid waste [MSW]) was not removed after unloading.

(b) Further information: During the inspection, incoming loads of material were deposited at the working face. There was no physical separation being maintained between the point where the material was unloaded and the working face. (See attached photos #1 and #2 below.) No pickers were present at the unloading area to remove prohibited waste. We inquired about the lack of pickers and were told they were on a break and would return shortly. Once the pickers did arrive, they attempted to pick from the area below the cliff of material; however, it was impossible to do so considering the volume of material, the positioning of the material, and the amount of solid waste present. Prohibited materials were being disposed at the working face. While walking the working face, we noted the presence of a large amount of MSW including such items as pails, pop cans, drink bottles, milk jugs, crates, yard waste, toys, shoes, magazines, books, a CD, a roll of plastic sheeting, a steel canister, a remote control, area rugs, a cassette tape, clothing, a garden hose, tools, many cushions, mattress springs, and large amounts of cloth. (See photos #3 - #10 below.) Even if picking had been attempted, it would have been unsafe to reach. The significant volume of prohibited material was irretrievable from an estimated 25-foot cliff face. (See photos #11 and #12 below.) Solid waste disposal was also observed in areas of waste placement from days prior.

Fig 1 (Left): Unloading zone. The incoming loads of material were not deposited at a designated unloading zone and waste was pushed further into the working face.

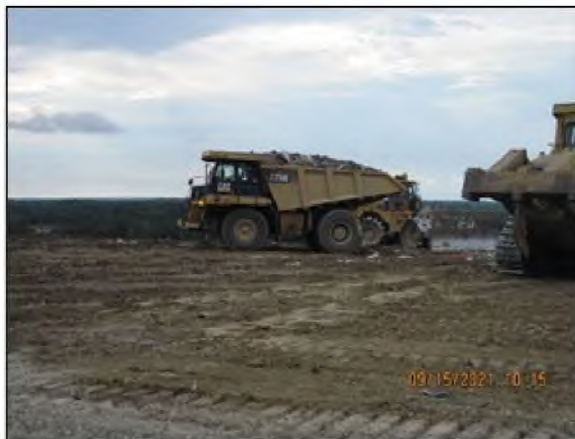
Fig 2 (Right) Unloading zone. The trucks unload directly into the working face.

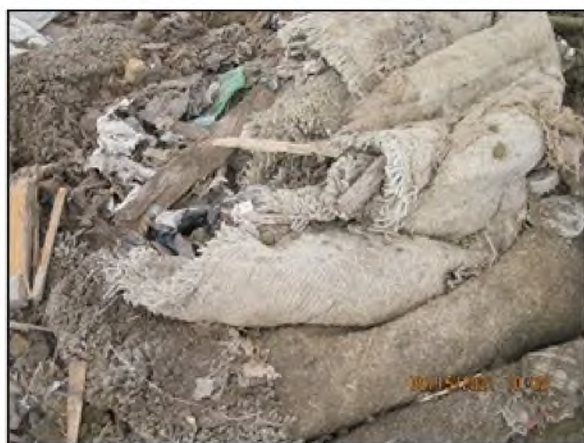
(b) Further information: Prohibited materials were being disposed at the working face. While walking the working face, we noted the presence of a large amount of MSW including such items as pails, pop cans, drink bottles, milk jugs, crates, yard waste, toys, shoes, magazines, books, a CD, a roll of plastic sheeting, a steel canister, a remote control, area rugs, a cassette tape, clothing, a garden hose, tools, many cushions, mattress springs, and large amounts of cloth. In addition, we observed MSW and C&DD protruding from daily cover in a disposal area that you indicated had been used as the working face earlier that week (our inspection took place on Wednesday). We viewed a significant amount of MSW through the inadequate cover in this area, including balls, toys, shoes, mattress springs, cushions, paper, buckets, milk jugs, bottles, etc., and several tires. The owner or operator did not attempt to remove all solid wastes from the material prior to or after the disposal on the working face.

Fig 3 (Left): Prohibited materials disposed at the working face

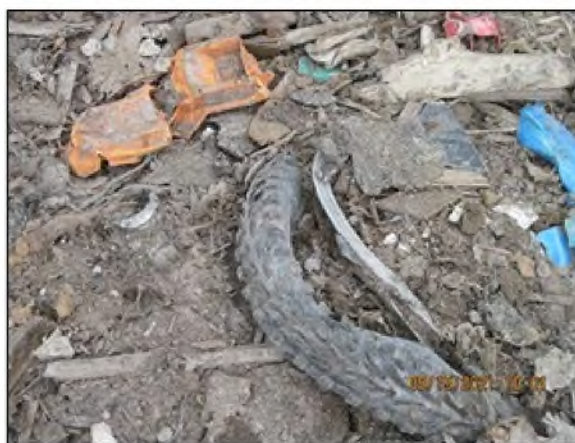
Fig 4 (Right): Prohibited materials disposed at the working face

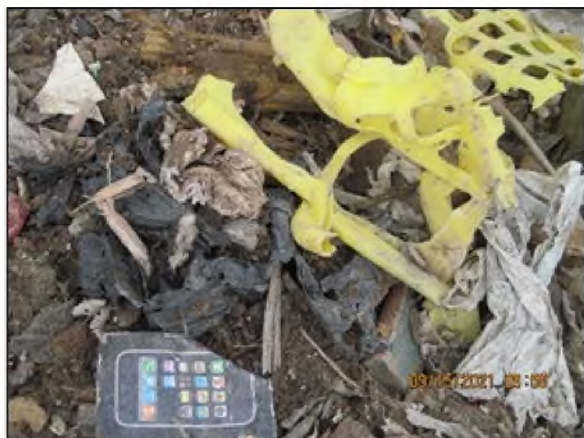
Fig 5 (Left): Prohibited materials disposed at the working face

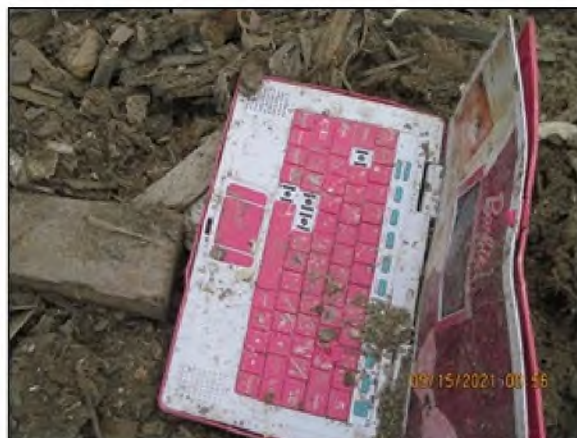
Fig 6 (Right): Prohibited materials disposed at the working face

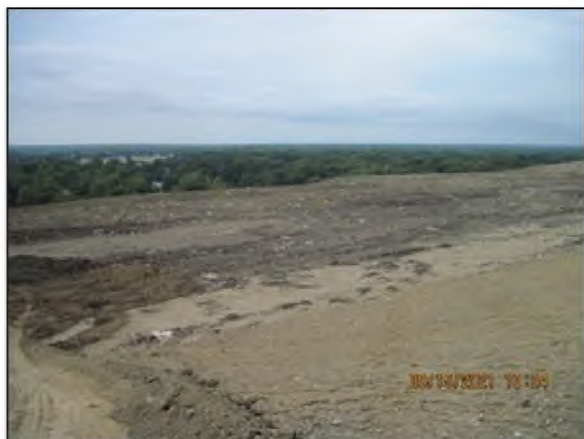
(b) Further information: During our inspection, it was noted that in two areas where debris was placed previously, there was inadequate daily cover. There was exposed debris and waste without the minimum six inches of soil cover.

While we were observing the activity near the working face, we noted an area to the east that had exposed debris and waste. We walked the area and were told that it was the working face for the past Monday and Tuesday (prior to our Wednesday inspection). There was inadequate cover and both MSW and C&DD was exposed. There was a significant amount of MSW present, including balls, shoes, mattress springs, cushions, bottles, etc., and several tires were visible. In addition, an area located to the west of the working face, where the haul road curves down the hill, had exposed debris and inadequate daily cover. (See photos #7 - #10 below.)

Fig 7 (Left) Area to the east of the working face that had inadequate cover and both MSW and C&DD were exposed.

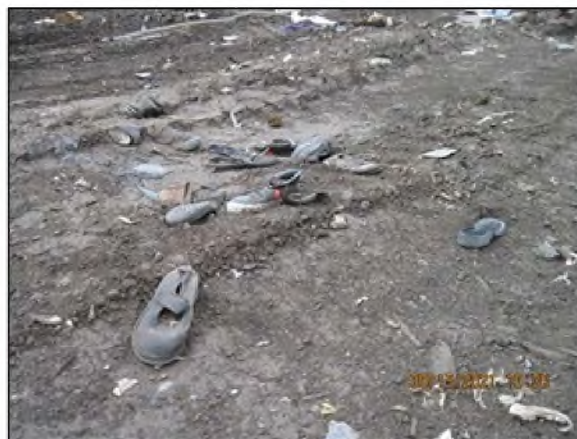
Fig 8 (Right): Area to the east of the working face that had inadequate cover and both MSW and C&DD were exposed.

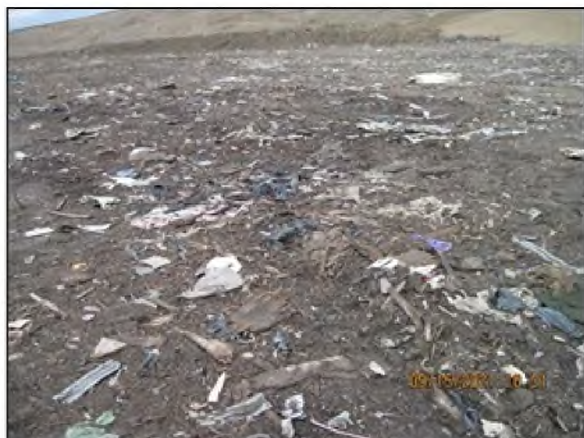
Fig 9 (Left): Area to the east of the working face that had inadequate cover and both MSW and C&DD were exposed.

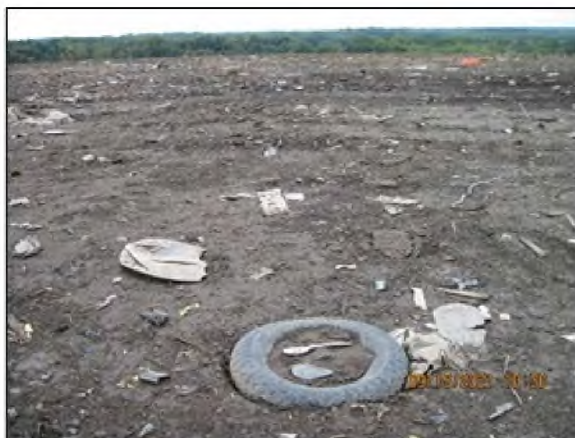
Fig 10 (Right): Area to the east of the working face that had inadequate cover and both MSW and C&DD were exposed.

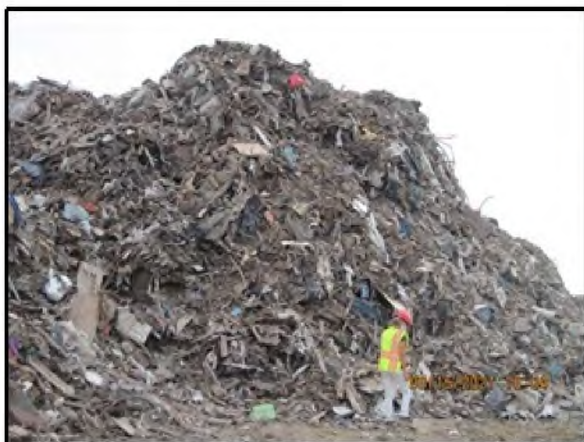
(a) Description: The material was not spread and compacted evenly over the working face and compacted to the smallest practical volume. Significant cliffing was observed in the working face.

(b) Further information: Once the material was unloaded, it was pushed to form a cliff. The cliff of material was approximately 25 feet in height. This cliffed material was not compacted to the smallest practical volume nor spread evenly over the working face. (See photos #11 and #12.)

Fig 11 (Left): Clipping. The uncompact cliff of debris approximately 25 feet in height. Clipping. Debris being pushed back into the working face to form a cliff of debris.

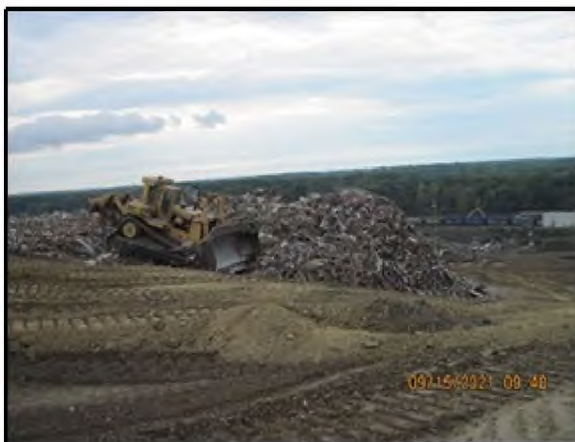
Fig 12 (Right) Clipping. Debris being pushed back into the working face to form a cliff of debris.

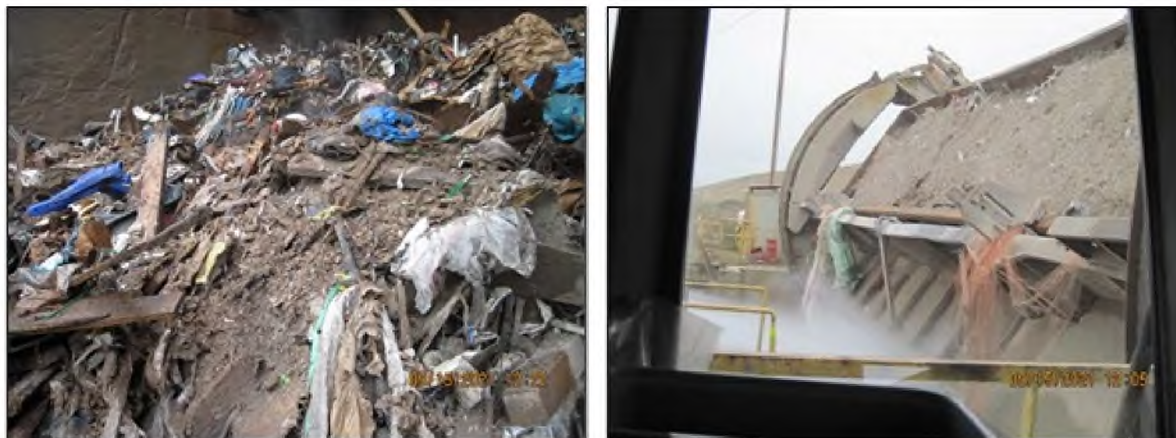
(b) Further information: During our inspection, it was noted that the material that was unloaded at the tipper car and disposed of in the working face was shredded, pulverized, or otherwise rendered to the extent that it was unidentifiable. Much of the material, including what was visible from the top of the rail cars in the tipper area, had an overall uniform appearance and it was not readily identifiable as C&DD. Much of the material had no dimensional components of wood-like material and no void spaces or other common visual signs to readily determine the material came from a structure. This material appeared to have been crushed and processed for volume reduction. (See attached figures #13 - #16 below.)

Fig 13 (Left): Some waste at the tipper car area was not readily identifiable as construction and demolition debris.

Fig 14 (Right): Tipper car being unloaded with pulverized debris.

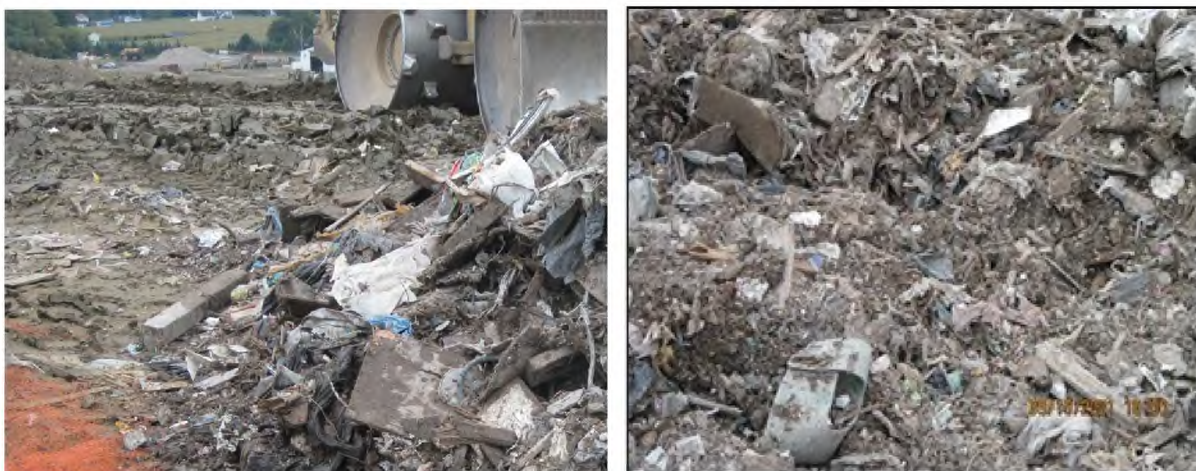
Fig 15 (Left): Waste at the working face was not readily identifiable as construction and demolition debris.

Fig 16 (Right): Waste at the working face was not readily identifiable as construction and demolition debris.

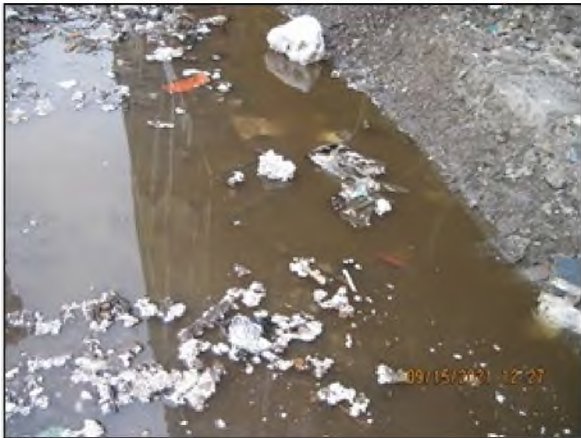
(a) Description: During our inspection, it was observed that leachate is being discharged to Outfall 31N00390004.

day if there is time or at least once a week on Fridays. During precipitation events, the liquid that comes in contact with the waste is considered leachate. As it was raining during our inspection, we witnessed tannin colored leachate forming next to the tracks. There are no engineered leachate collection components at the rail lines. The leachate flows from the rail lines to Sediment Basin 4, where it was observed that waste had entered the pond. (See figures #17 and #18 below.)

Fig 17 (Left): Tannin colored leachate found on the inside of the track after the rain.

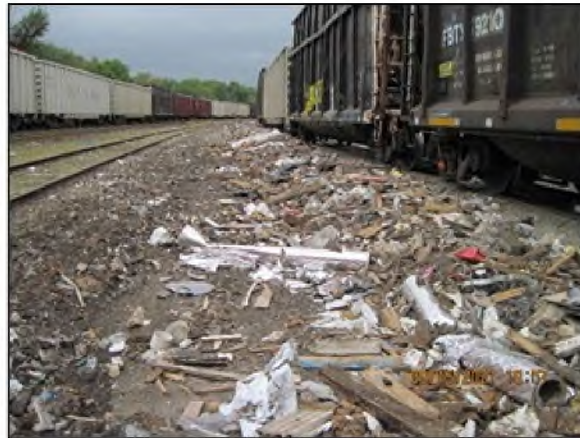
(b) Further information: Large amounts of material and waste had accumulated along the tracks used by the large rail cars. During the removal of material from the rail cars, material spills from the rail cars/grapples to the inside and outside of the tracks. The material and waste on the outside of the tracks were piled as high as three feet. We were informed that the outer rail track area gets cleaned either at the end of the

Fig 18 (Right): Waste along the railroad tracks spilled from the rail cars/grapples along the tracks.
