OH 7800812
TIER I Sites

CONCORD CARE CENTER OF HARTFORD
3090 FIVE POINTS - HARTFORD RD.
FAULDER, OHIO 44118
330-637-7906

ORIGINAL BUILDING BUILT
1950
LEAD MAPPING

OH7800812
 TIER 1

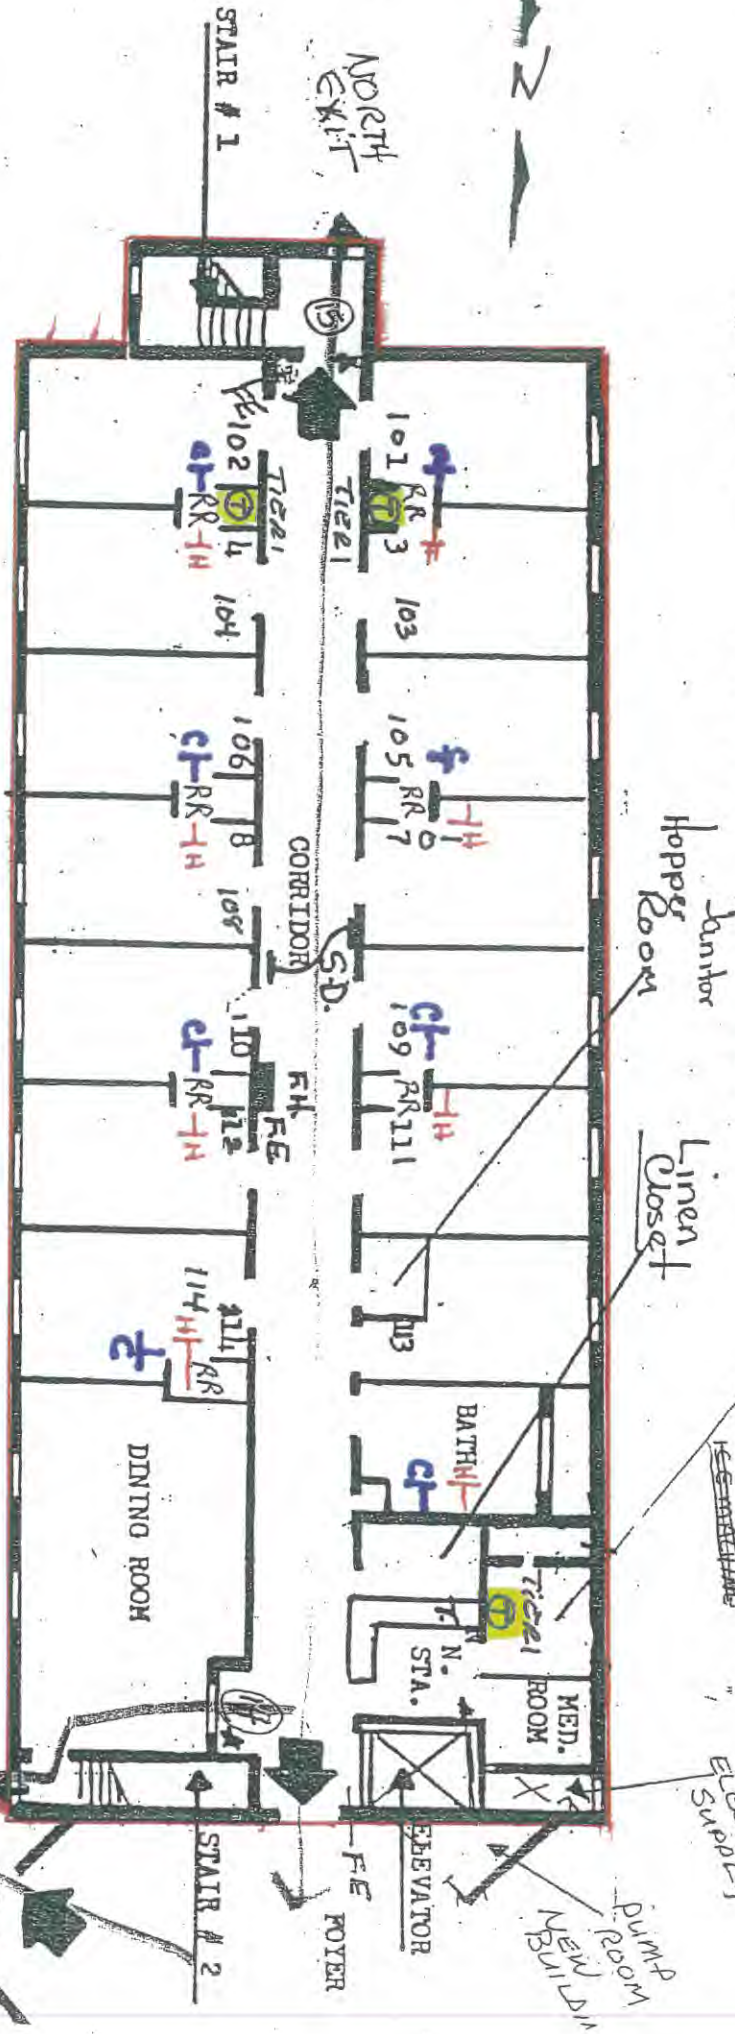
FIRST FLOOR PLAN

NOTE: IN 2014-2015 ALL EXISTING FIXTURES AND LINES WERE REPLACED WITH LEAD FREE FIXTURES.

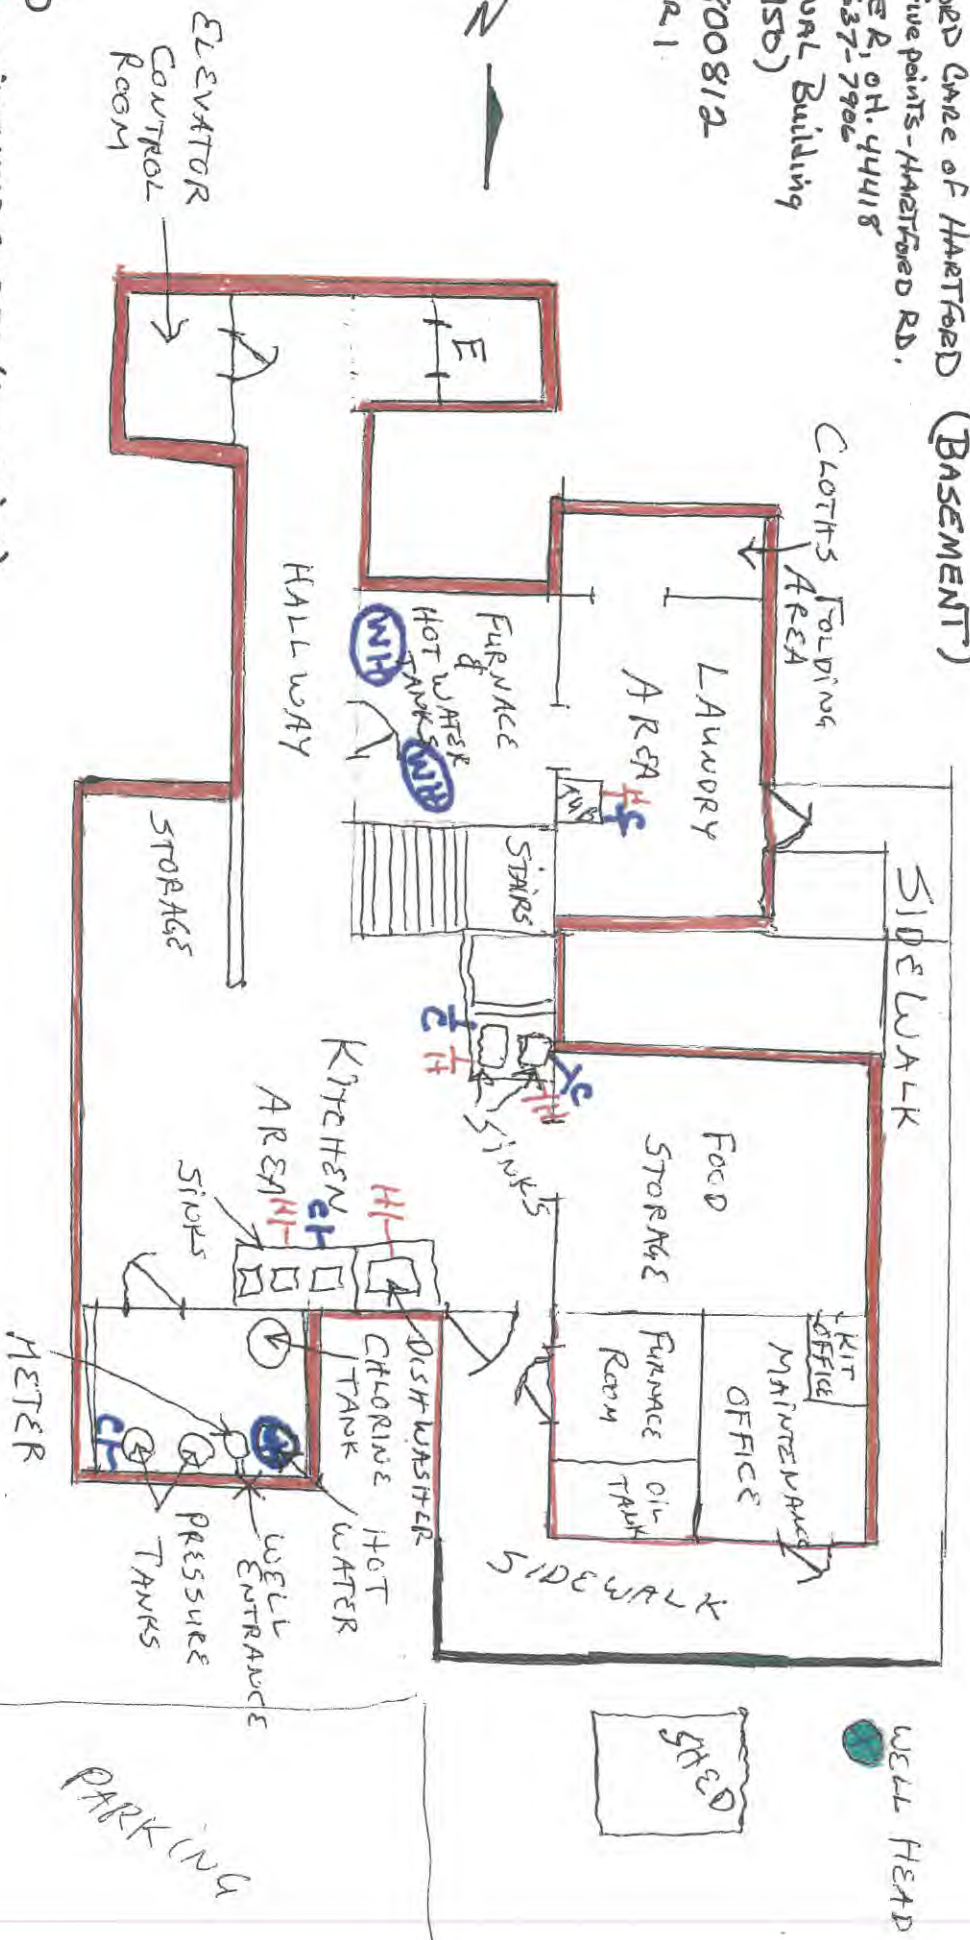
CONDORD CARE OF HAATFORD (BASEMENT)

NOTE: IN 2014-2015 ALL EXISTING FIXTURES AND LINES WERE REPLACED WITH LEAD FREE FIXTURES.

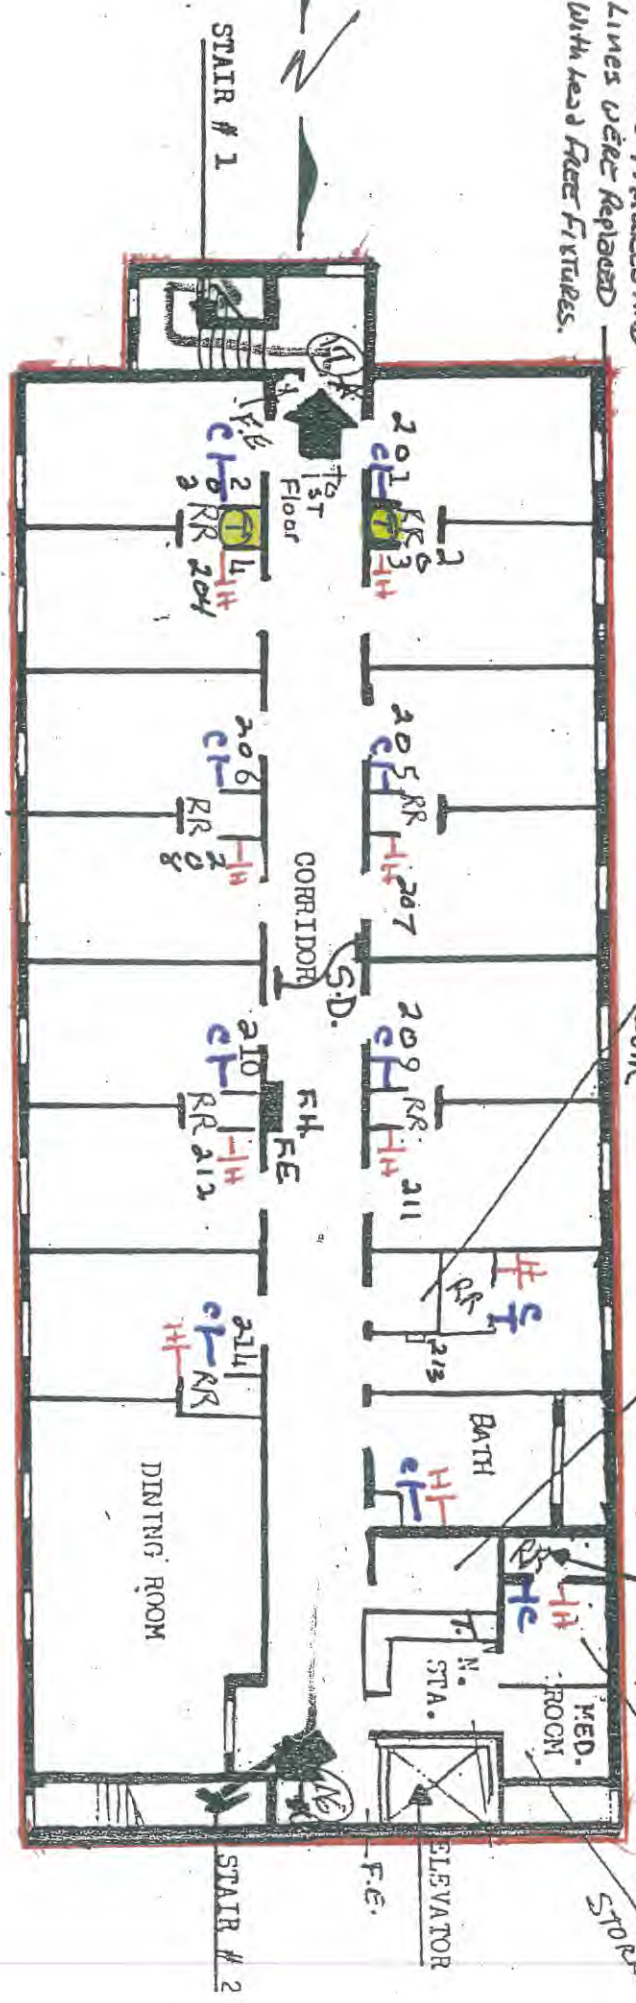
SECOND FLOOR PLAN

NOTE: IN 2014-2015 ALL
EXISTING FIXTURES AND
LINES WERE REPLACED
WITH LEAD FREE FIXTURES.
