LEAD MAPPING Program  
- LOUISVILLE M/H/P  
CANTON, OHIO 44705

OH7602512

Entity: Louisville MHP Nick BROD, OWNER  
Doc Type: Report  
Doc Subtype: \_\_\_\_\_  
Program: DDAGW LOUISVILLE M/H/P  
County: Stark 4519 LOUISVILLE ST. N.E. 330-456-293  
Secondary ID: OH7602512 CANTON, OHIO 44705

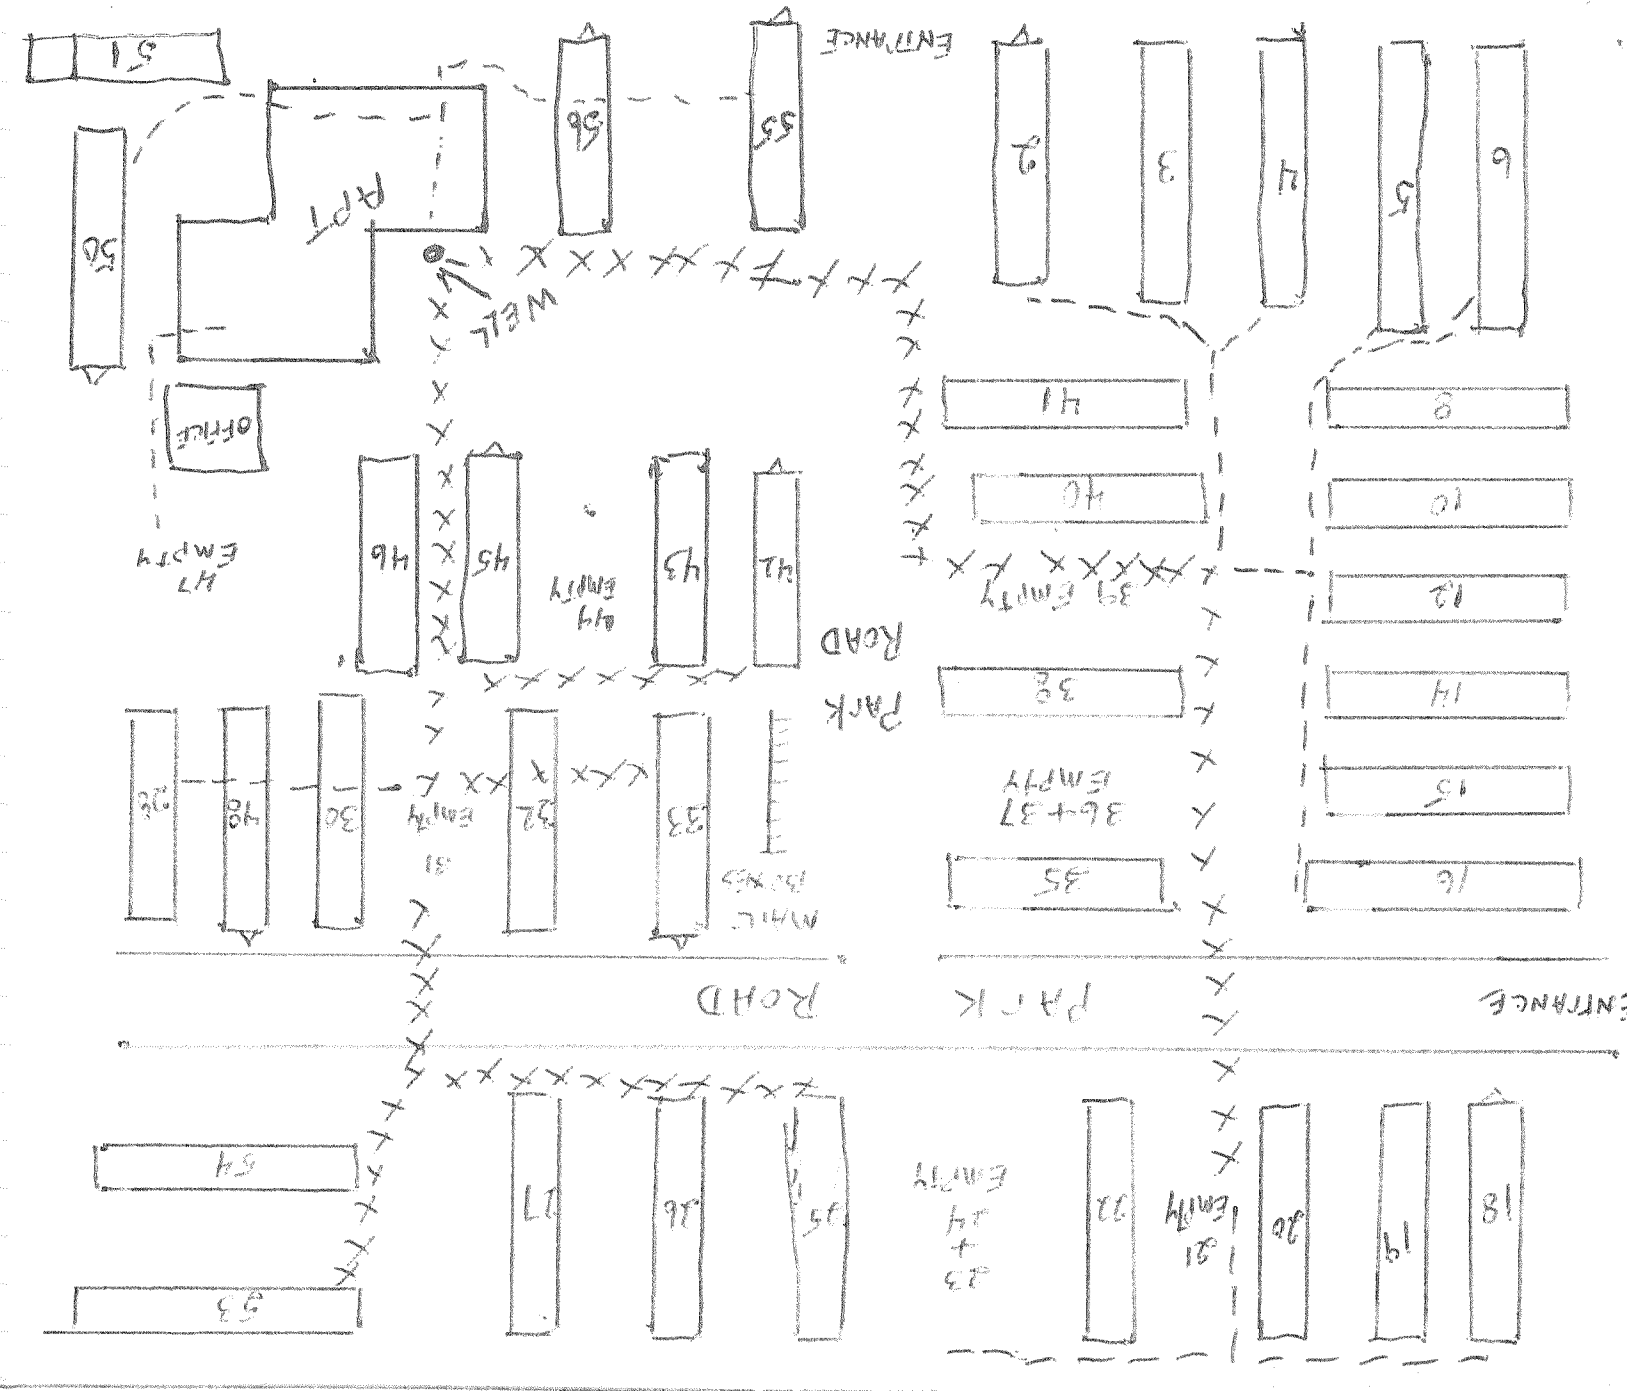
- 6 X INDICATES GALVANIZED SERVICE LINES.
- INDICATES PLASTIC SERVICE LINES.

2. Lots 5, 19, 53, 28, 33, 41, 51 contain mobile homes, but are abandoned, they are not hooked up to the service.
3. The apartment building has some GALVANIZED LINES IN THE BASEMENT. ALL 3 APARTMENTS HAVE BEEN CONVERTED TO PLASTIC.
4. A FEW mobile homes still have a combination of GALVANIZED & COPPER "FLARED", but the vast majority have been replumbed in plastic.
