Hardin Houston Lead and Copper Distribution Mapping Project

Hardin Houston Local Schools
5300 Houston rd.
Houston, OH 45333

(937) 295-3010 pws id: OH7542312

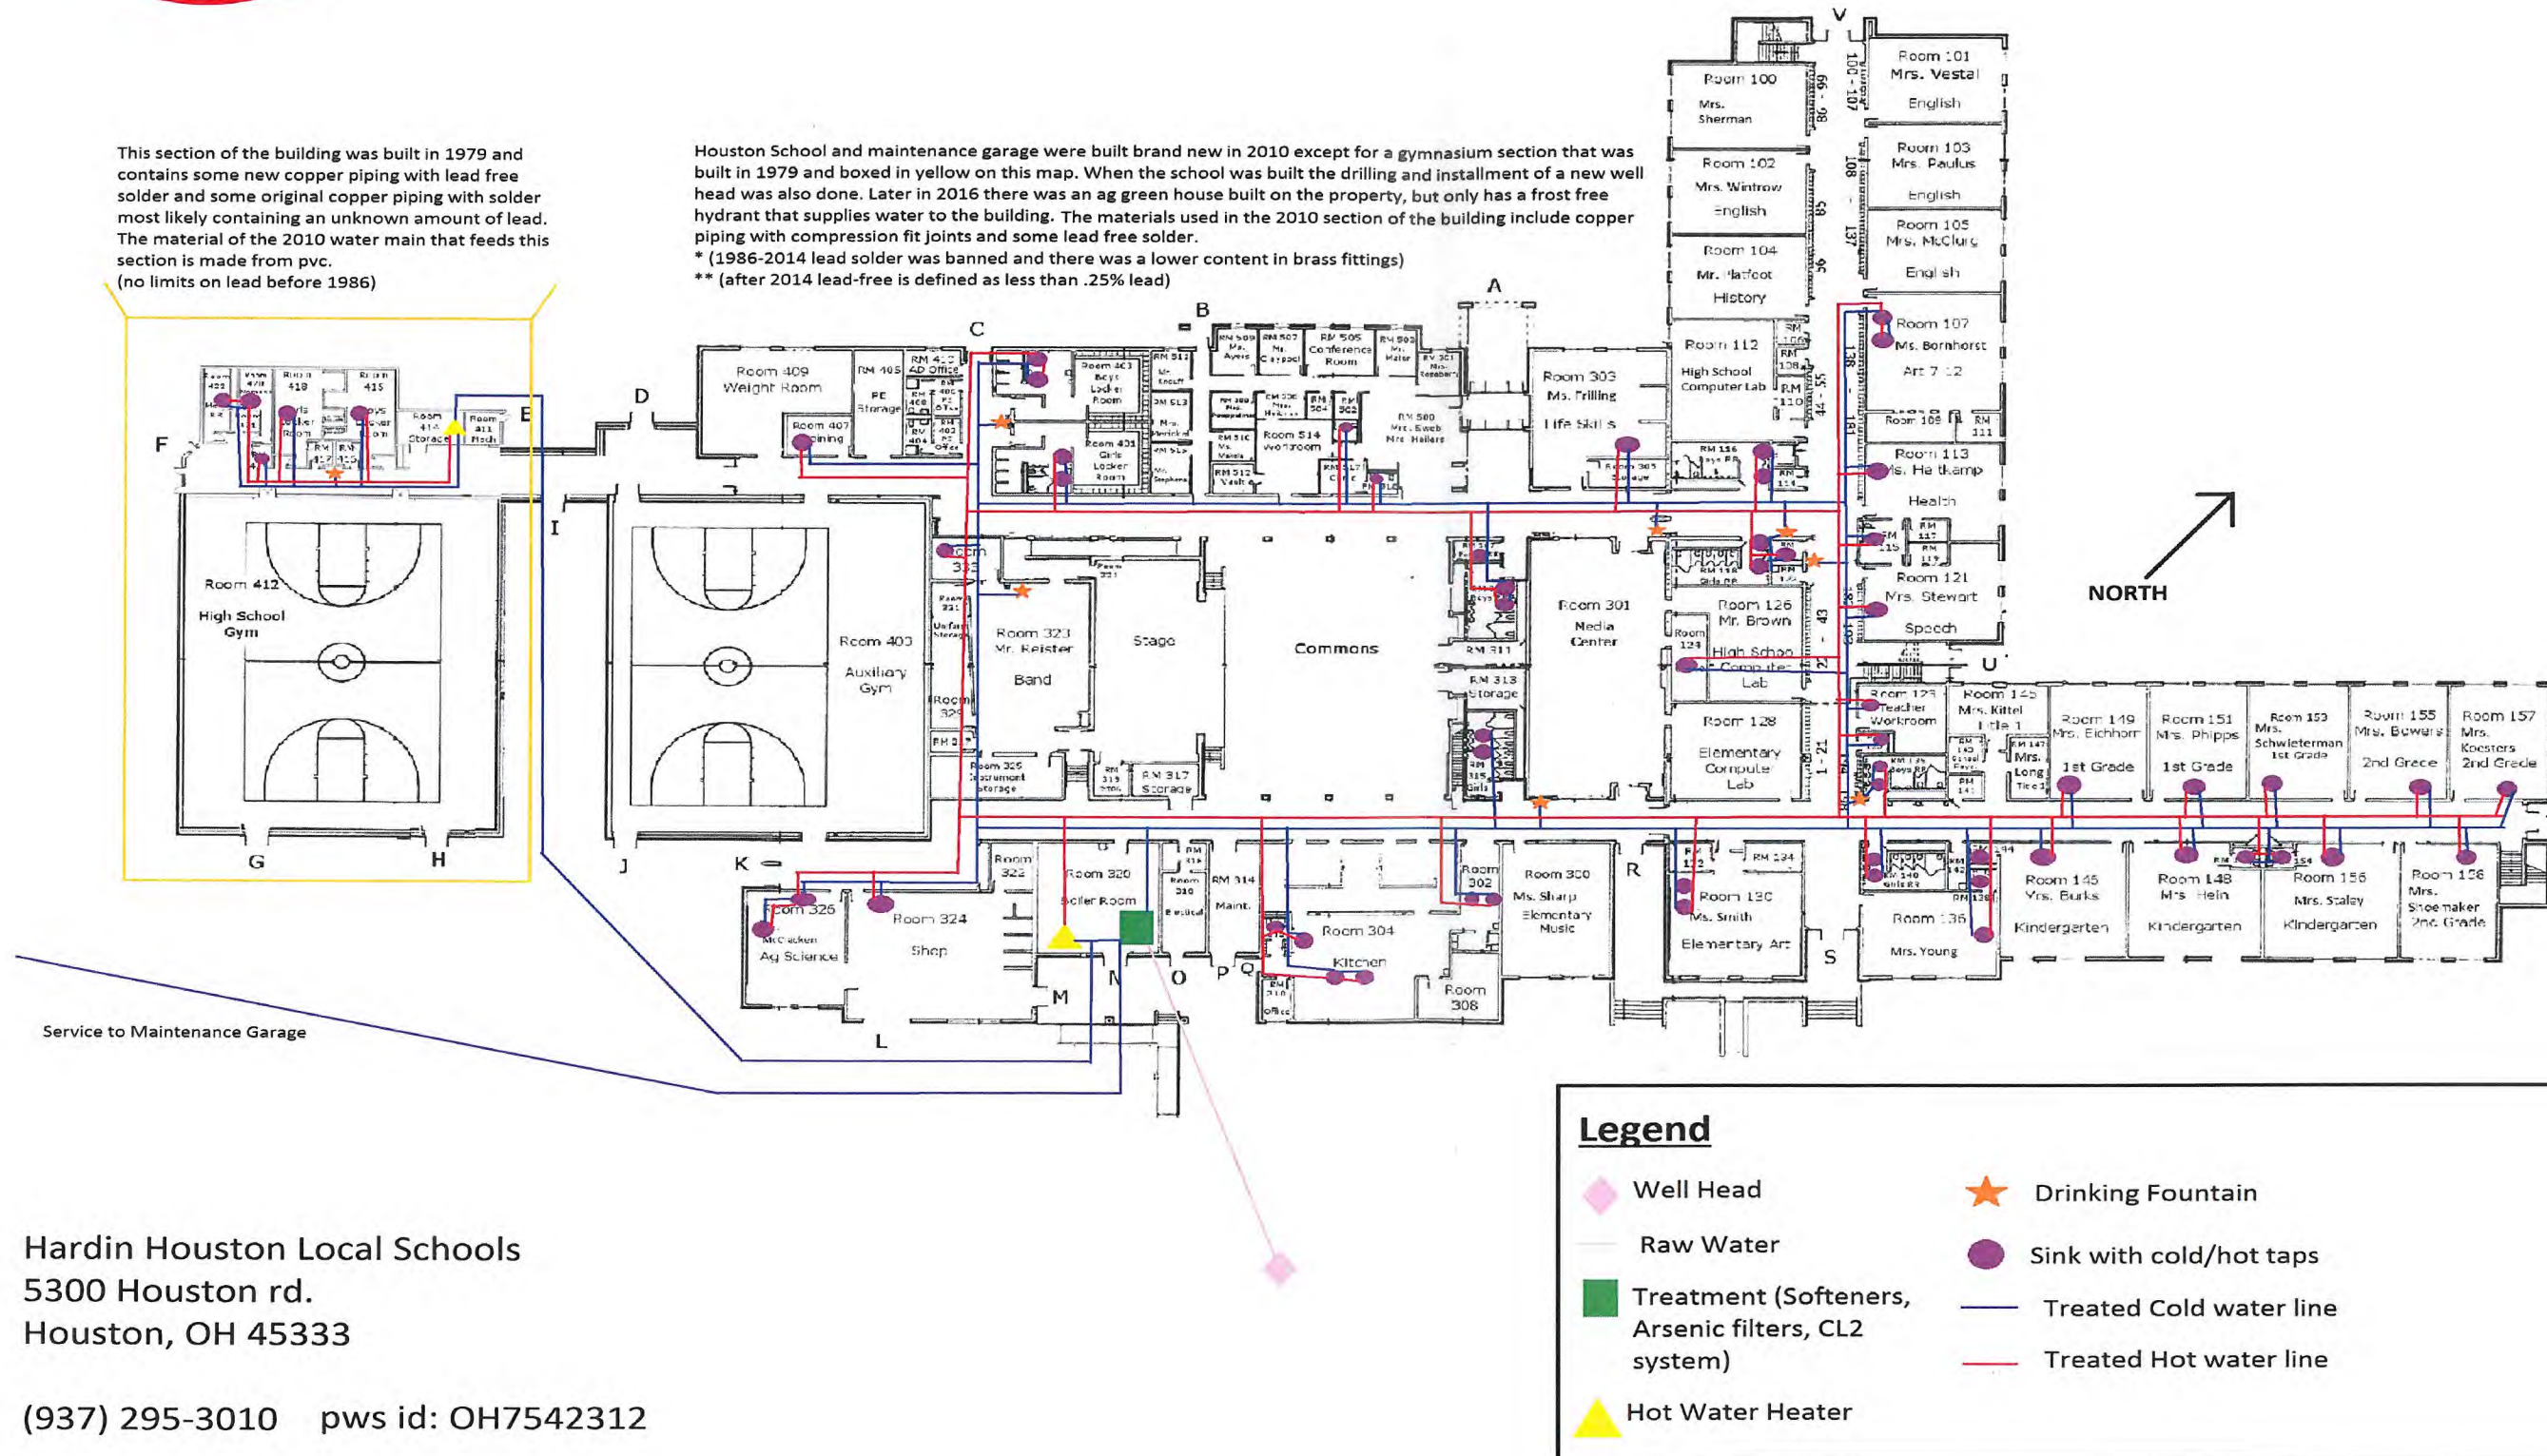
This section of the building was built in 1979 and contains some new copper piping with lead free solder and some original copper piping with solder most likely containing an unknown amount of lead. The material of the 2010 water main that feeds this section is made from pvc.
(no limits on lead before 1986)

Houston School and maintenance garage were built brand new in 2010 except for a gymnasium section that was built in 1979 and boxed in yellow on this map. When the school was built the drilling and installment of a new well head was also done. Later in 2016 there was an ag green house built on the property, but only has a frost free hydrant that supplies water to the building. The materials used in the 2010 section of the building include copper piping with compression fit joints and some lead free solder.
* (1986-2014 lead solder was banned and there was a lower content in brass fittings)
** (after 2014 lead-free is defined as less than .25% lead)

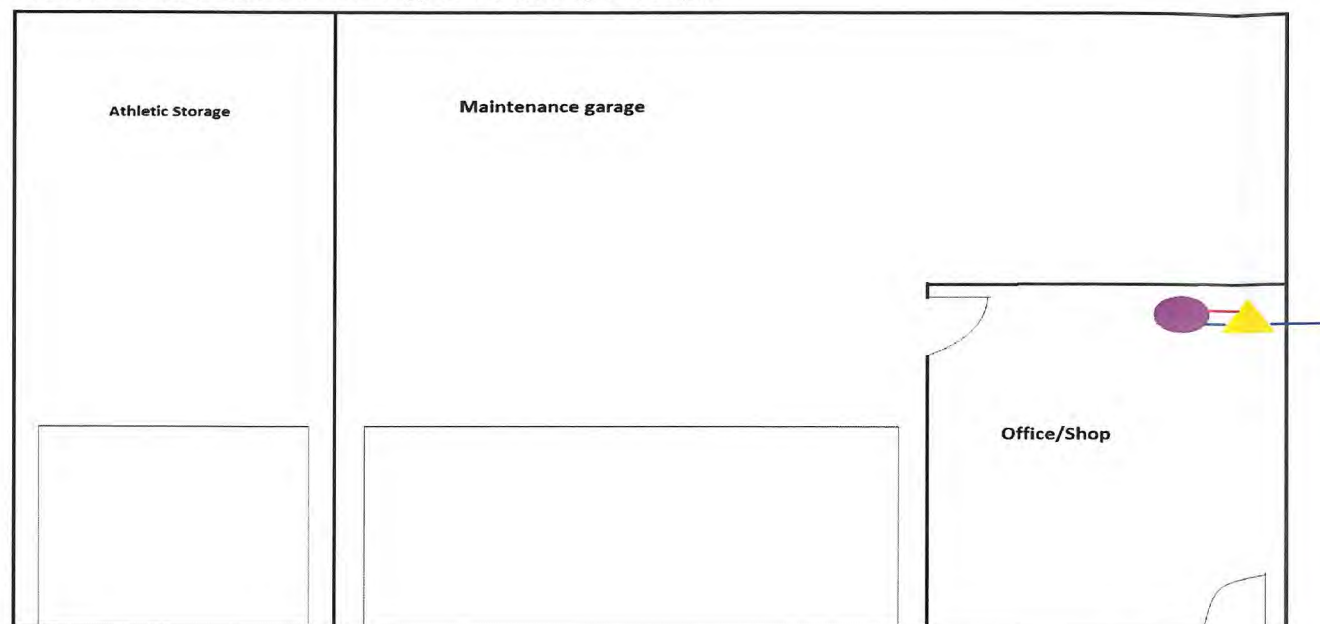
Hardin Houston lead and copper distribution mapping project (maintenance garage)

The maintenance garage was built in 2010. (same year as main school building)
It contains all copper piping materials with compression fit joints and some lead free solder.
The material of the water main that supplies the building is rolled pvc.

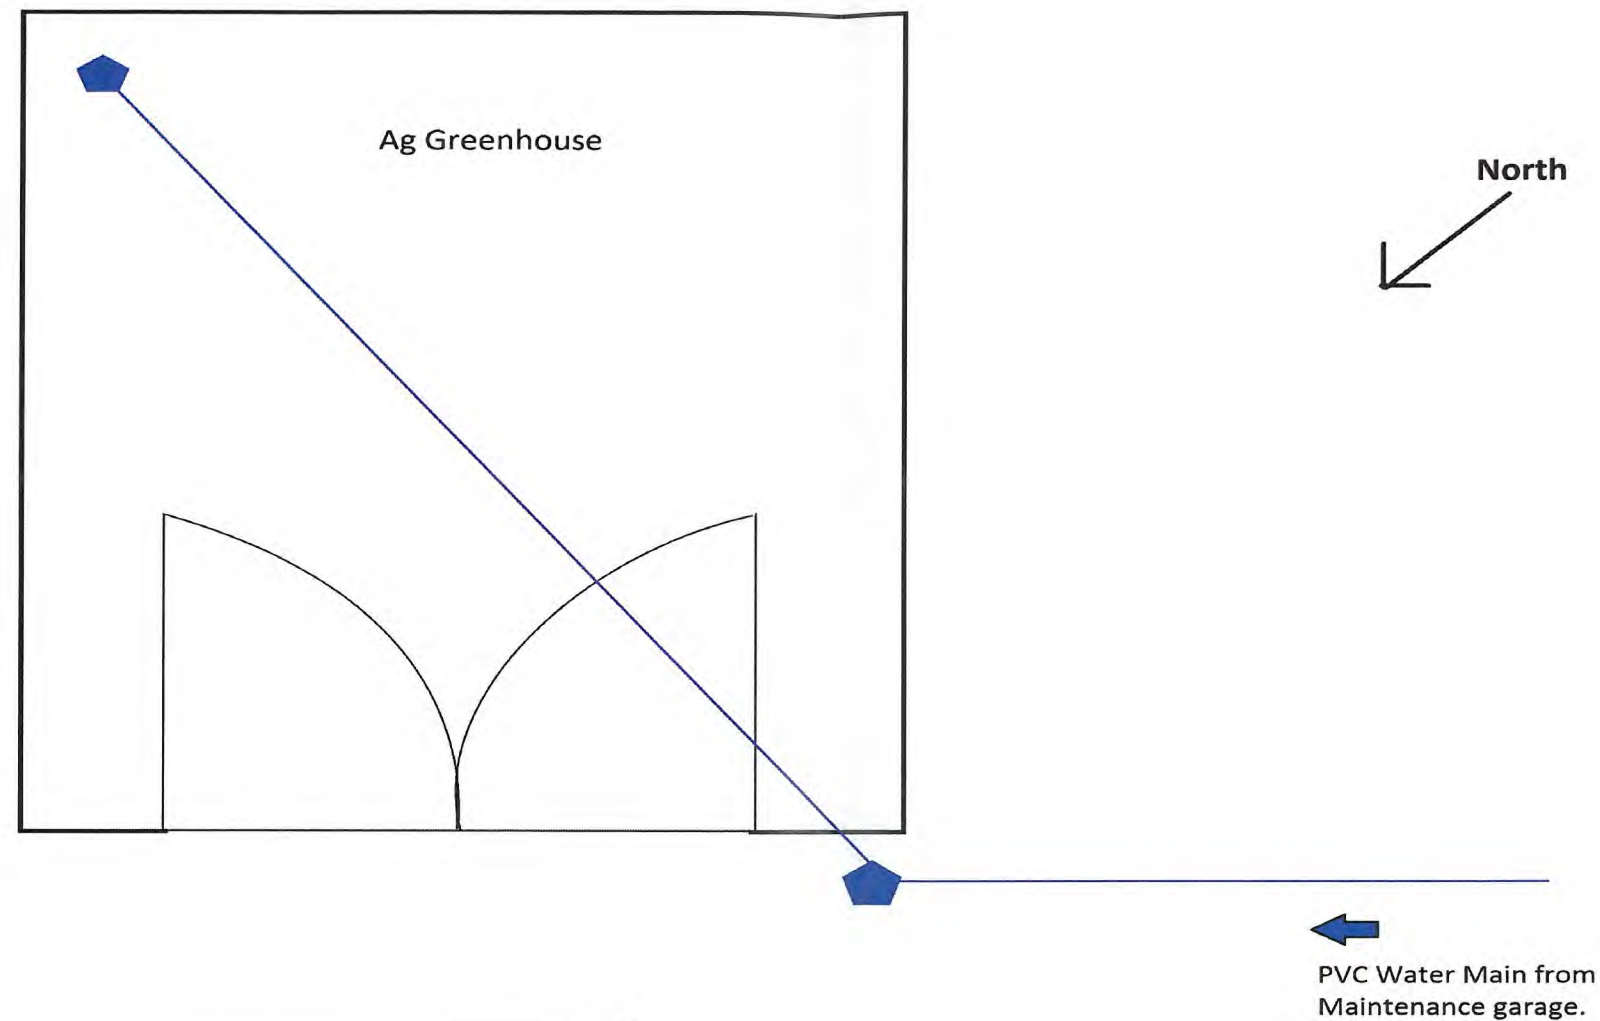
Hardin Houston Lead and Copper Distribution Mapping Project. (Ag Greenhouse)

Ag greenhouse built in 2016. The building only contains two frost free hydrants supplied by a rolled pvc water main.
