Austin Powder Company

**RE: Austin Powder Company
Lead & Copper Mapping Requirements**

Austin Powder Company
430 Powder Plant Road
McArthur, Ohio 45651
(740) 596-5286
Main Plant System
PWSID OH8230412
Buildings with Hose Connections

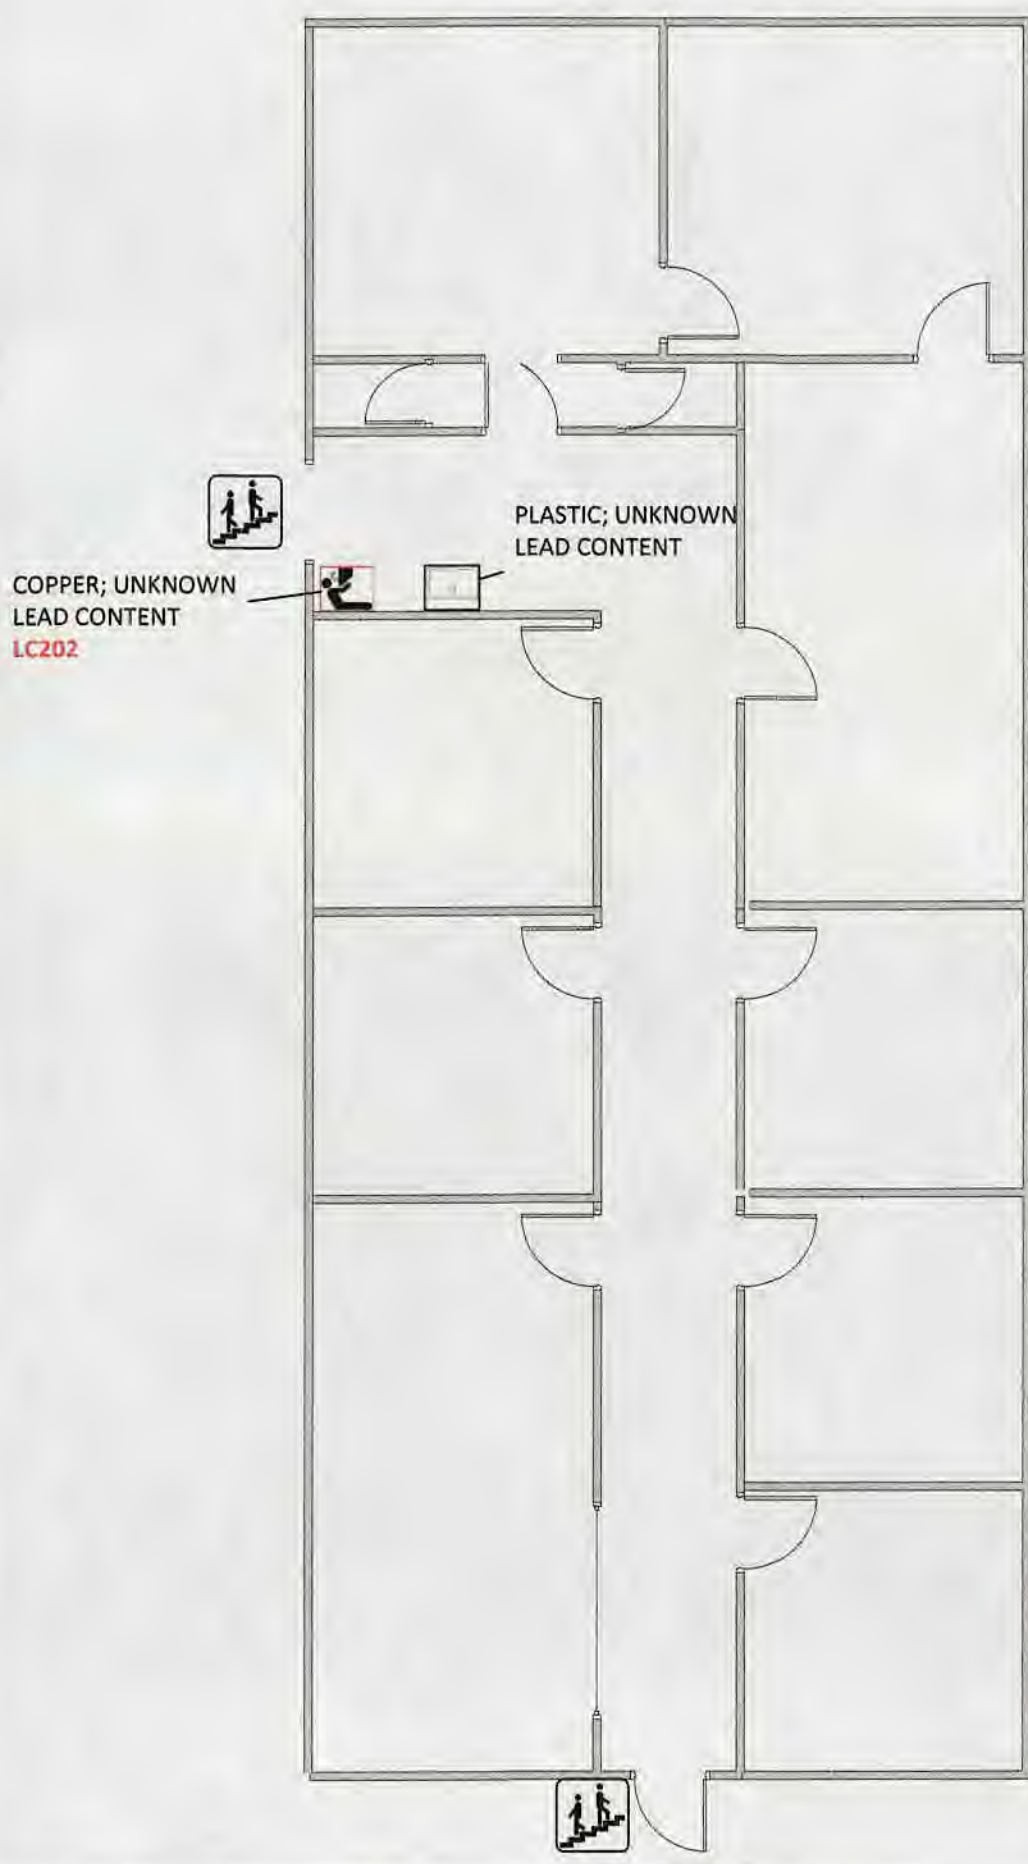
Office (Top Floor)
OH8230412
430 Powder Plant Road
McArthur, Ohio 45651
(740) 596-5286

The Office Building was constructed in 1975. The building was built prior to 1986 when there was no limit on lead. Assume high risk; greater than 8% lead.

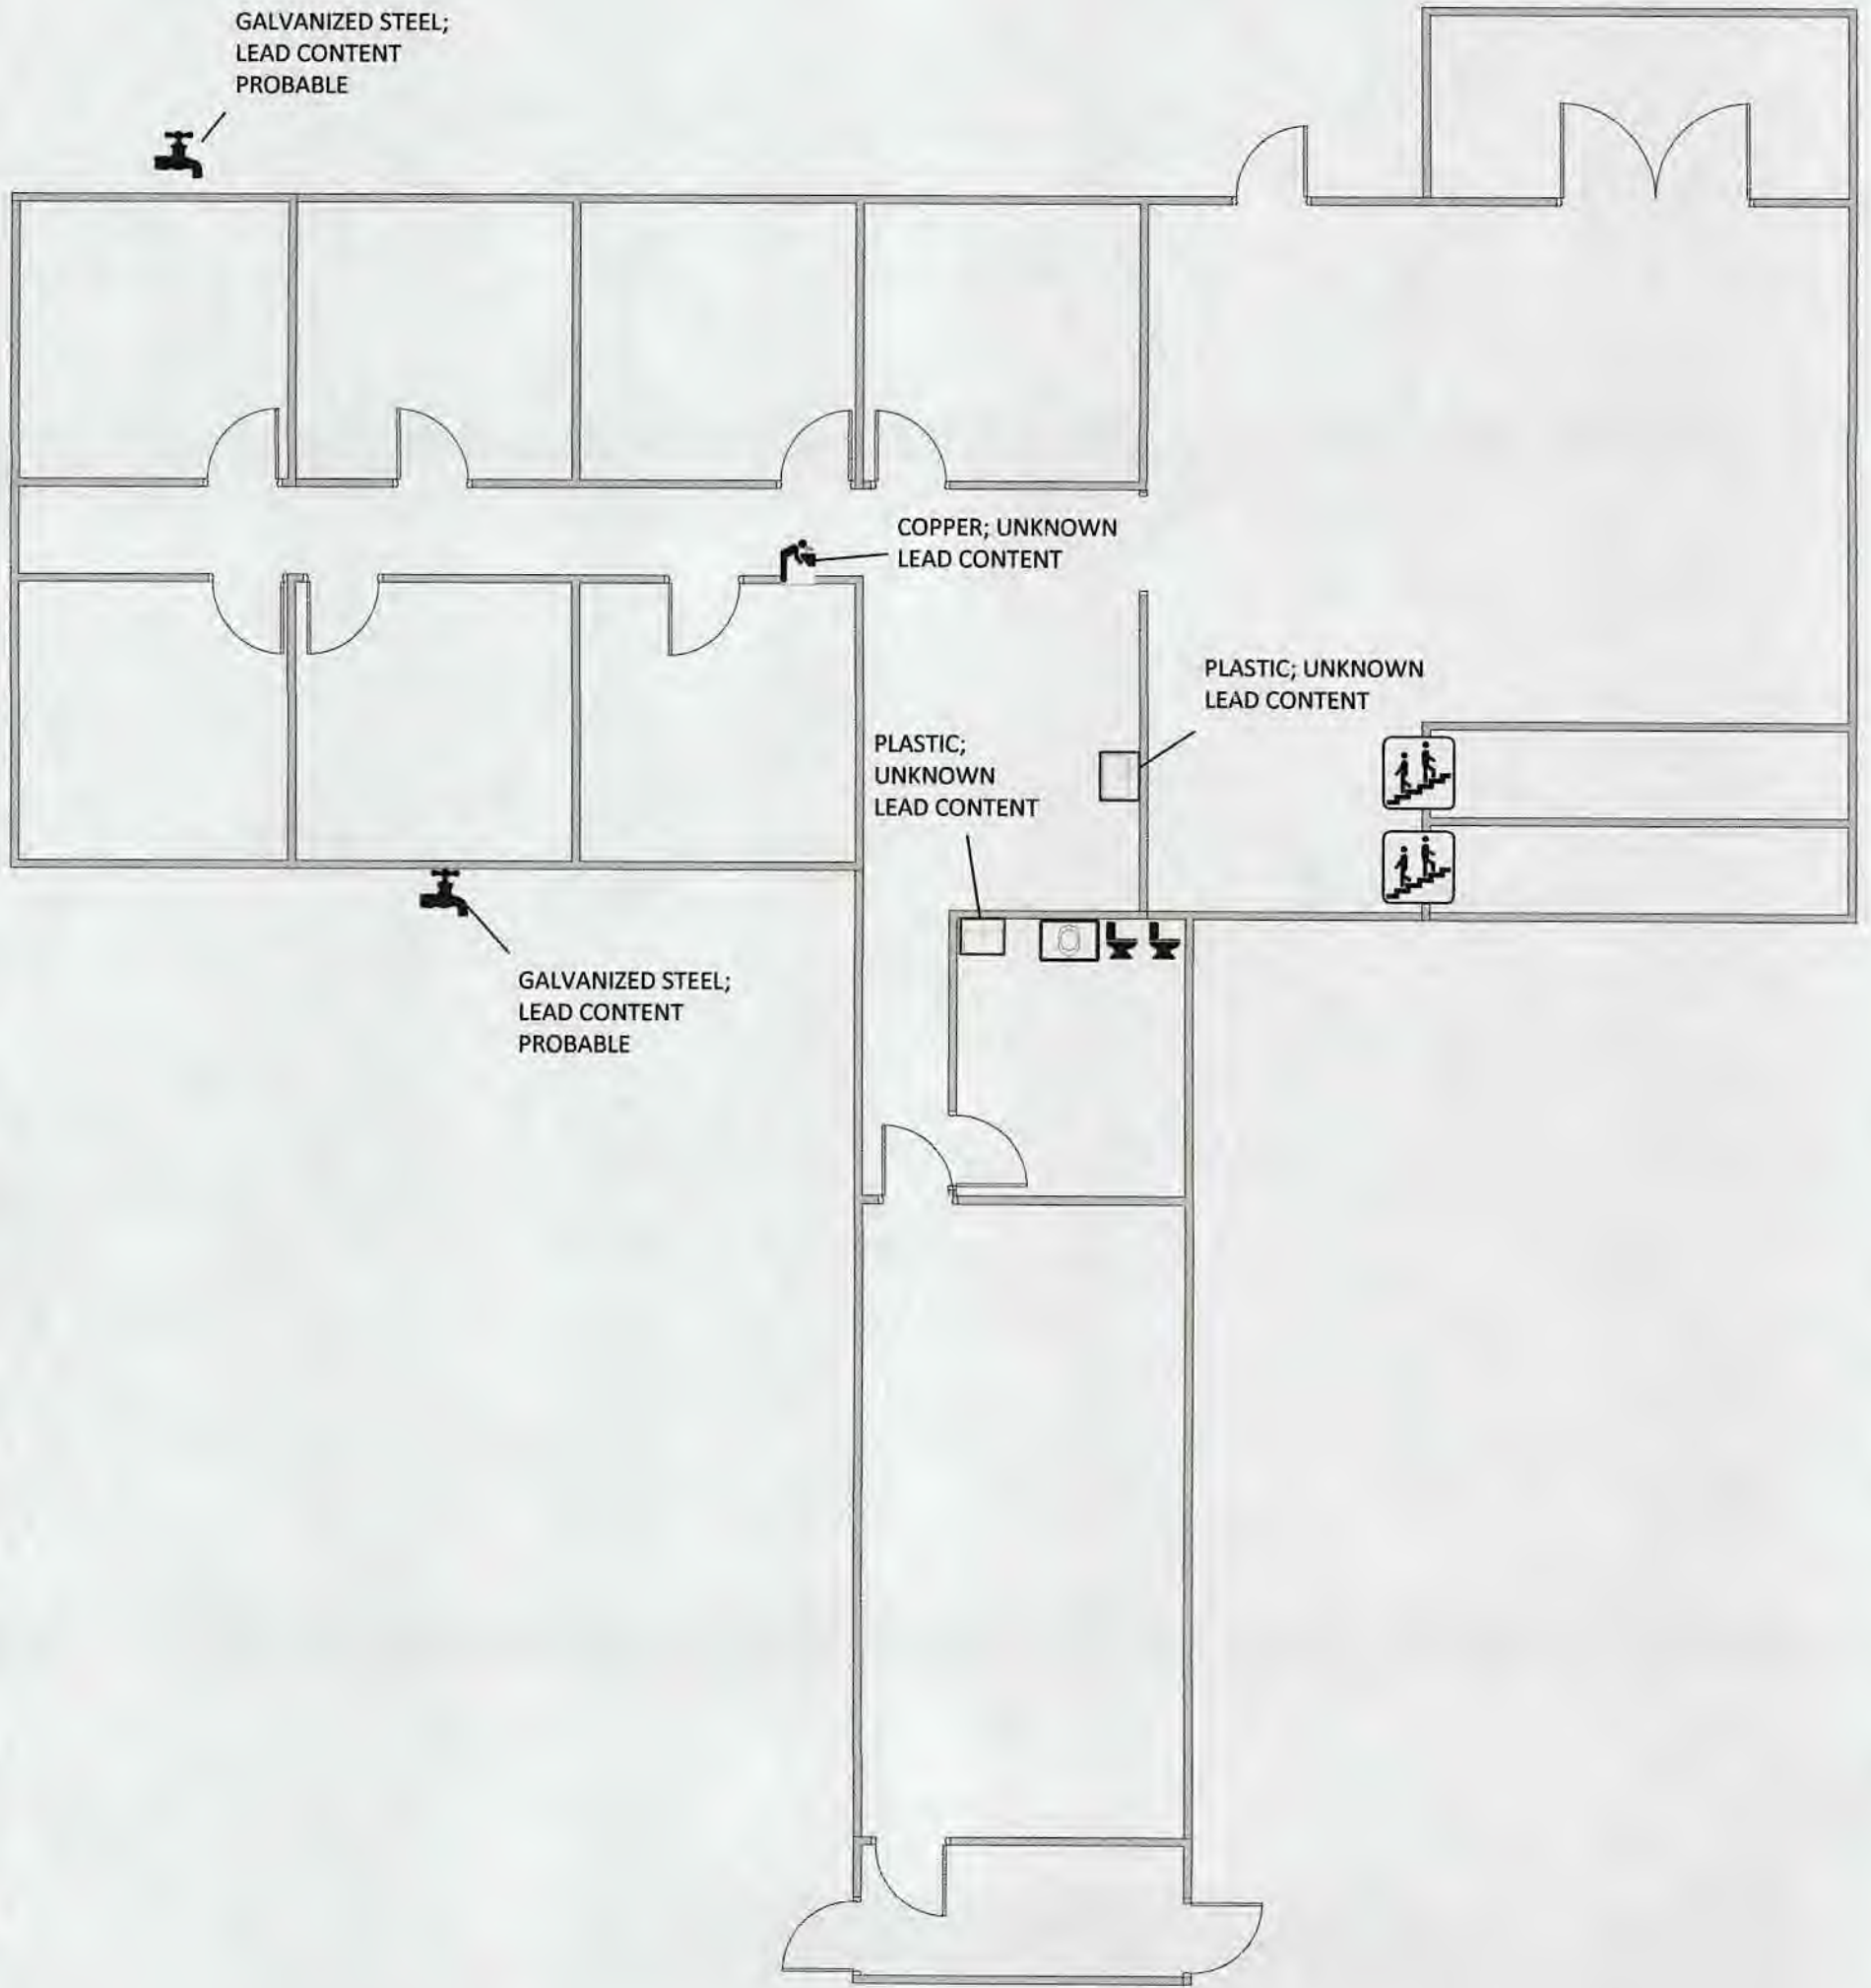
Office (Second Floor)
OH8230412
430 Powder Plant Road
McArthur, Ohio 45651
(740) 596-5286

The Office Building was constructed in 1975. The building was built prior to 1986 when there was no limit on lead. Assume high risk; greater than 8% lead.

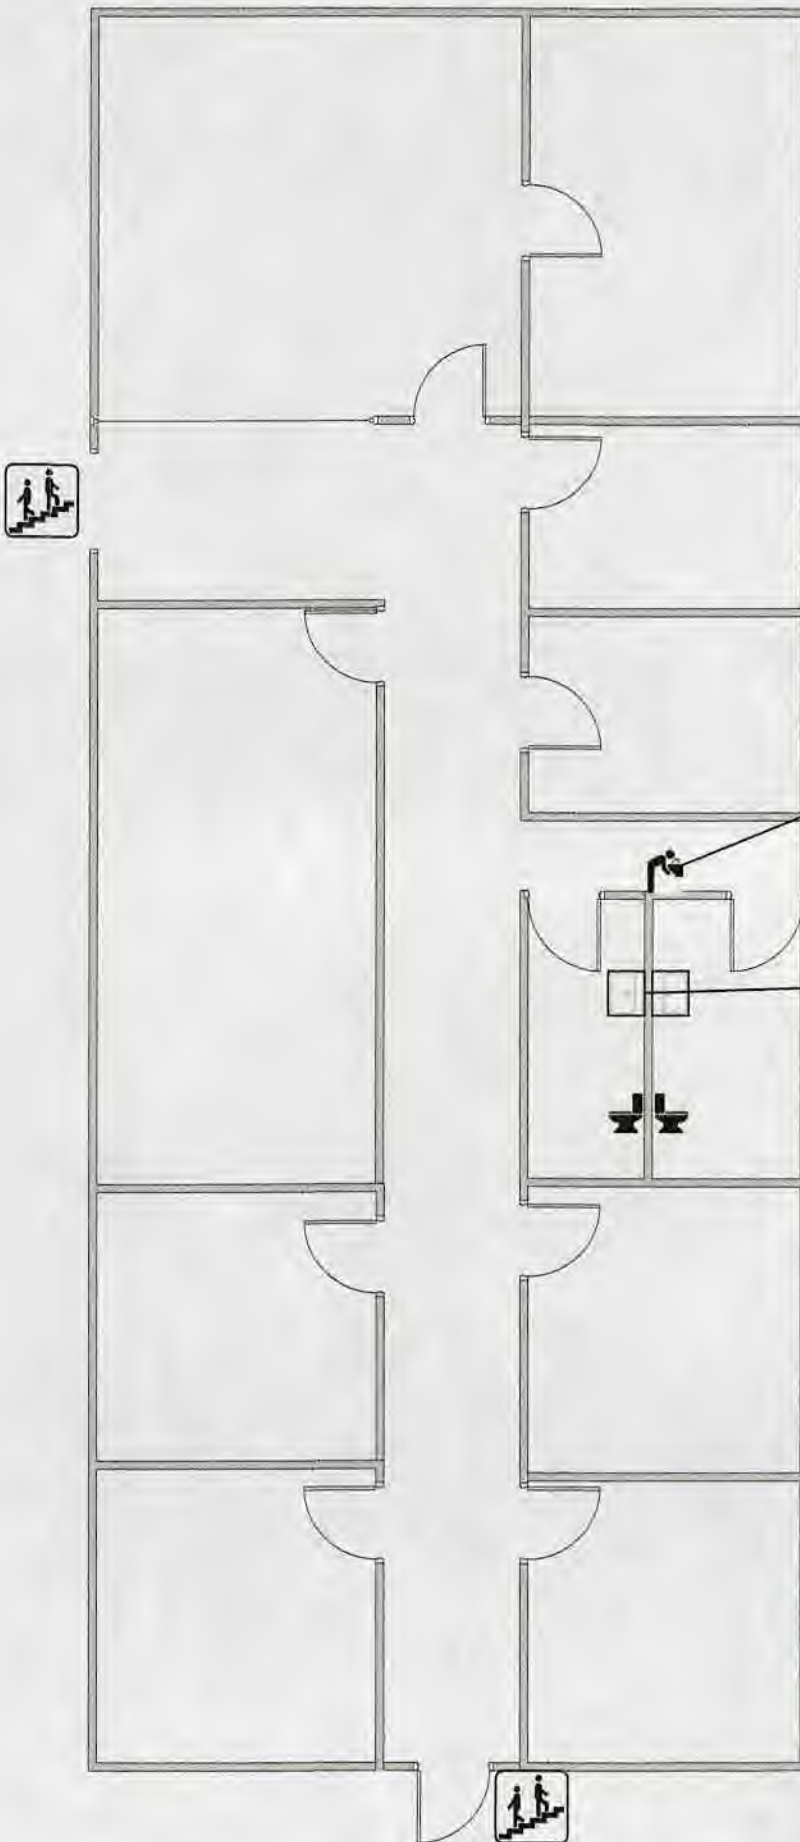
Office (Bottom Floor)

COPPER; UNKNOWN
LEAD CONTENT

PLASTIC; UNKNOWN
LEAD CONTENT

The Office Building was constructed in 1975. The building was built prior to 1986 when there was no limit on lead. **Assume high risk; greater than 8% lead.**

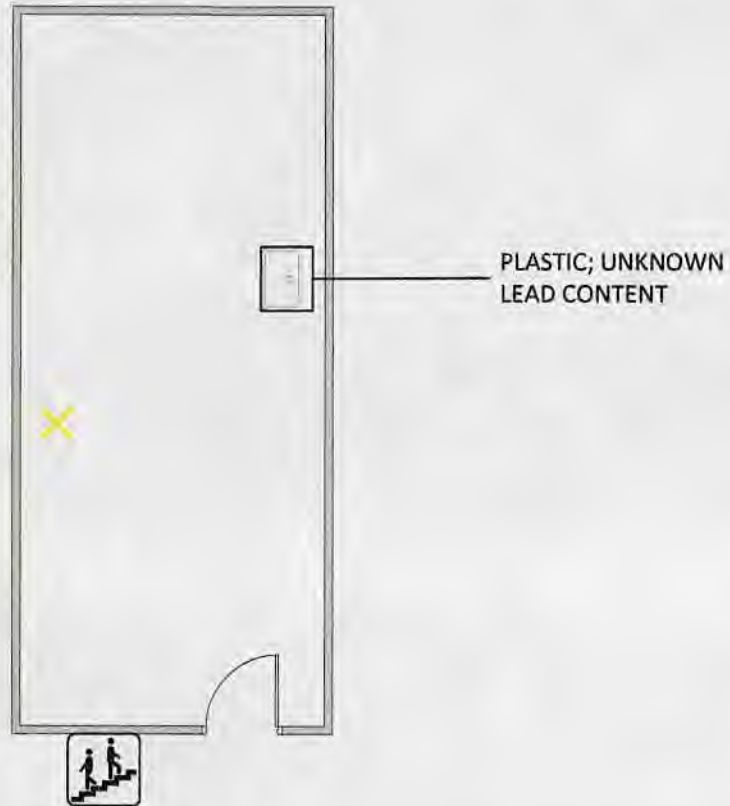
Office (Basement)
OH8230412
430 Powder Plant Road
McArthur, Ohio 45651
(740) 596-5286

The Office Building was constructed in 1975. The building was built prior to 1986 when there was no limit on lead. **Assume high risk; greater than 8% lead.**

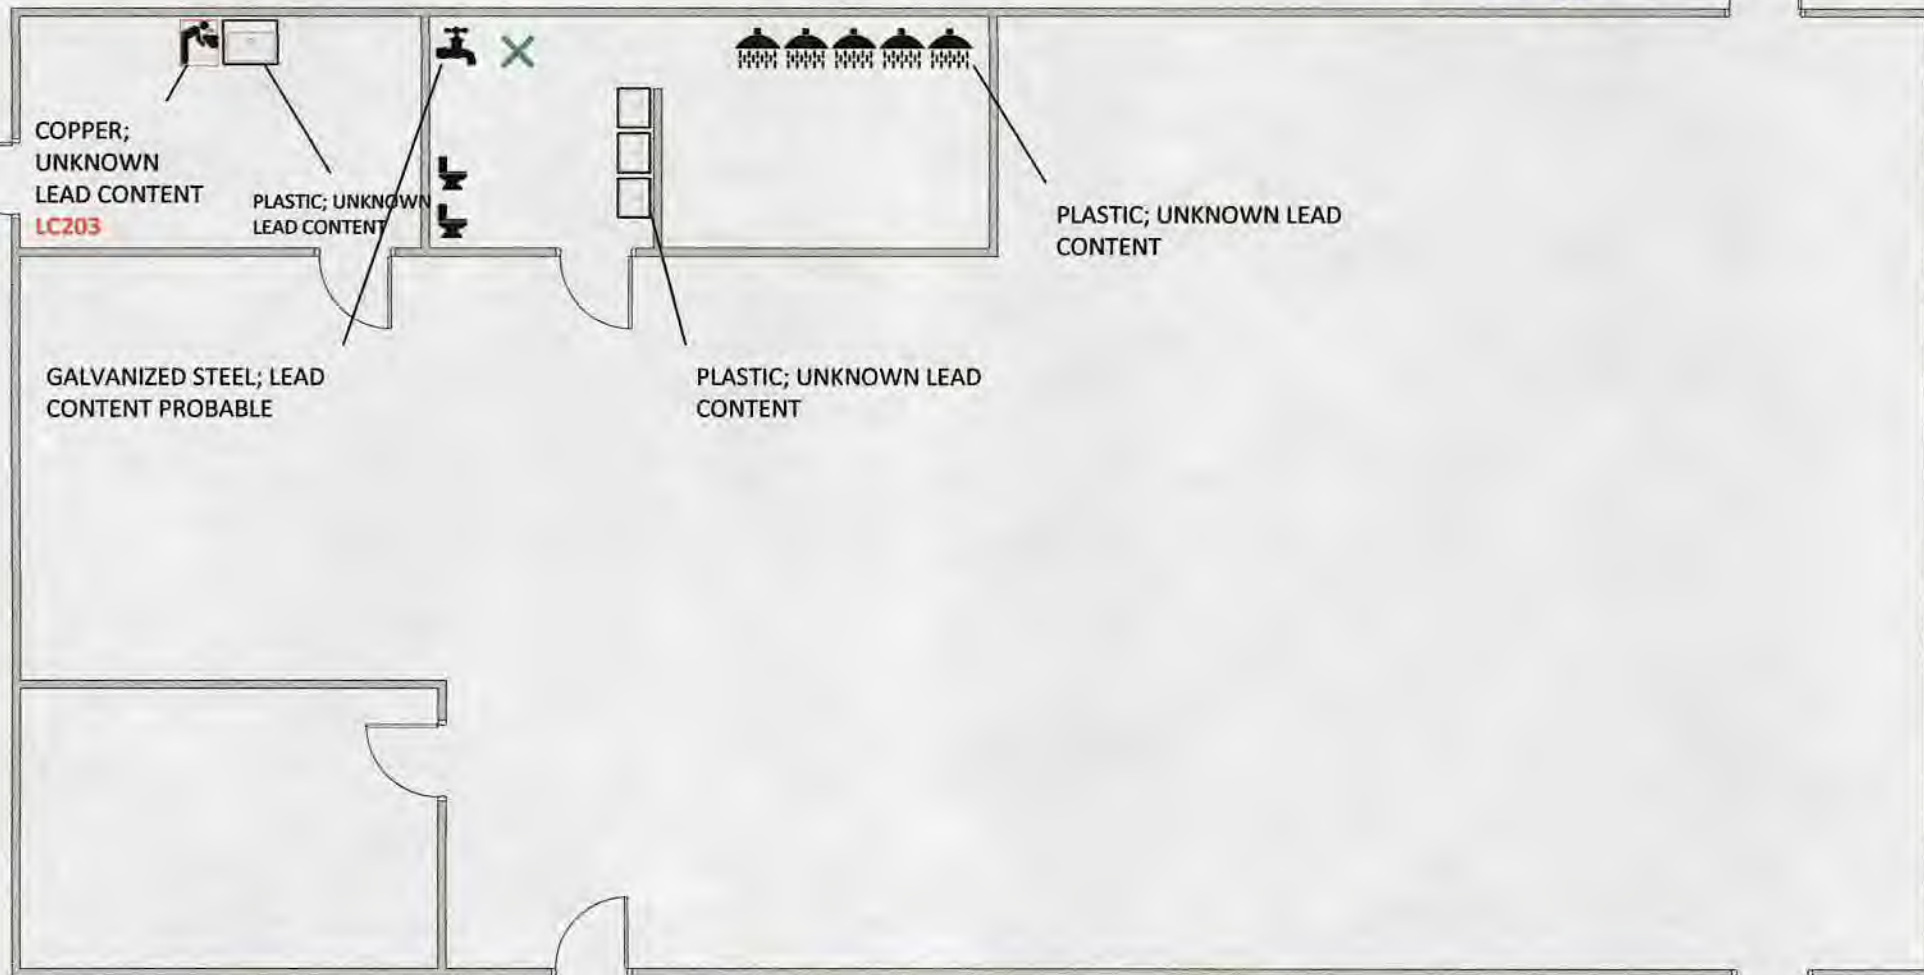
The Maintenance Breakroom was constructed in 1969. This was built prior to 1986 when there was no limit on lead. Assume high risk; greater than 8% lead.

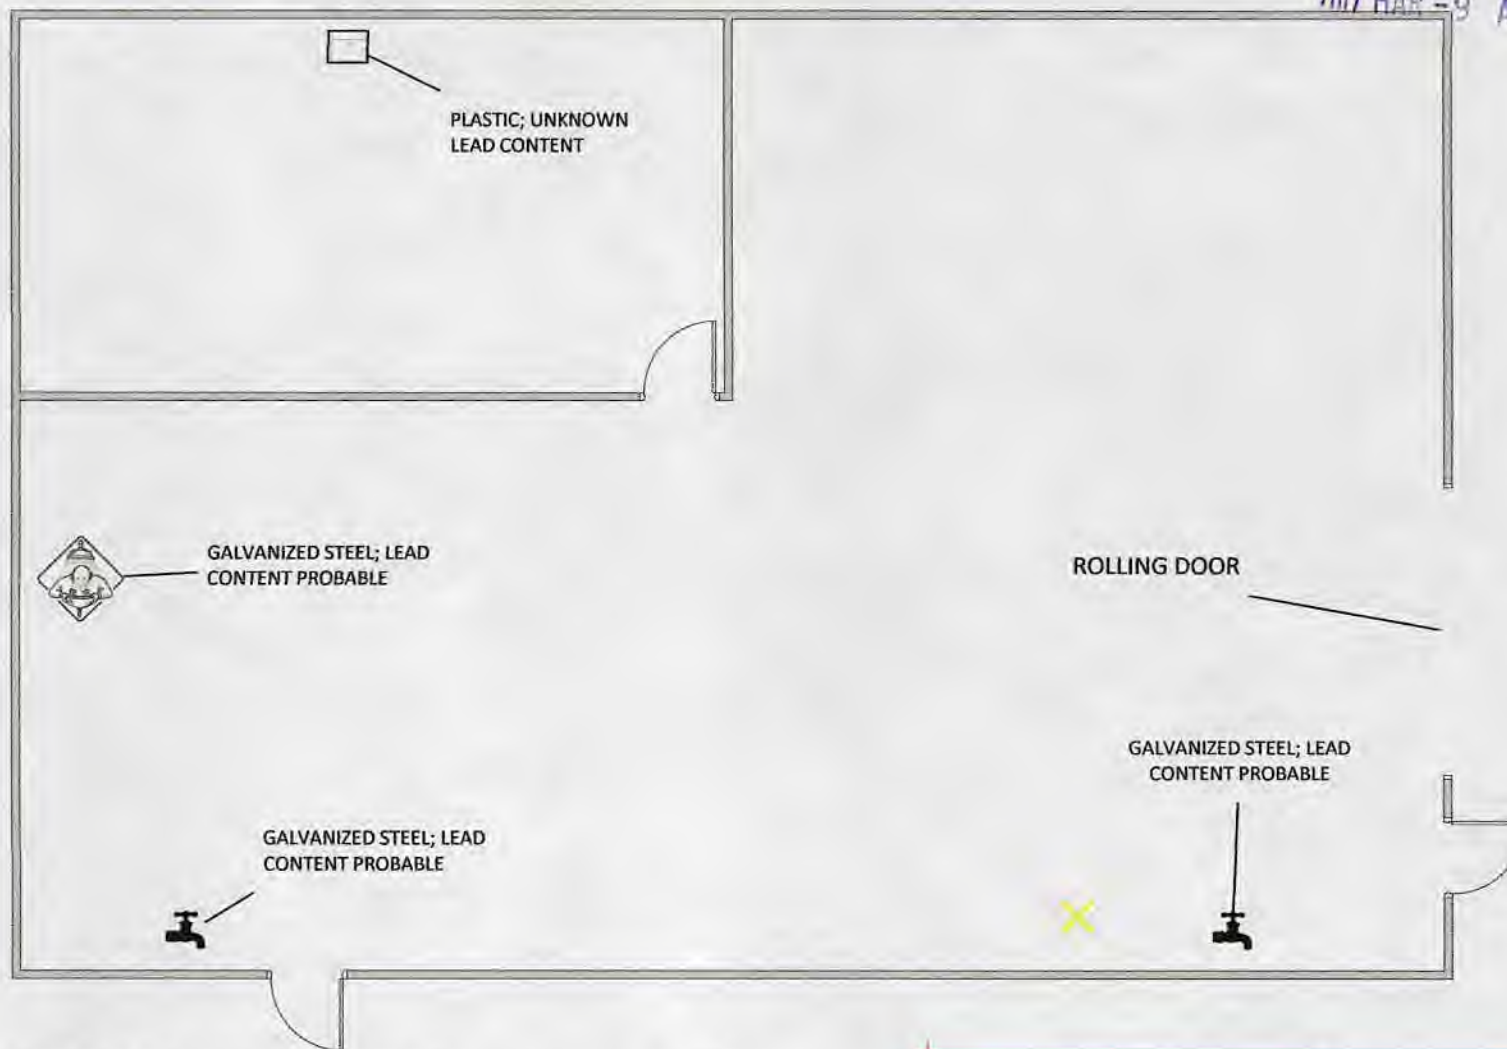
Emulsion R&D
OH8230412
430 Powder Plant Road
McArthur, Ohio 45651
(740) 596-5286

The Emulsion R&D building was constructed in 1969. This was built prior to 1986 when there was no limit on lead. **Assume high risk; greater than 8% lead.**

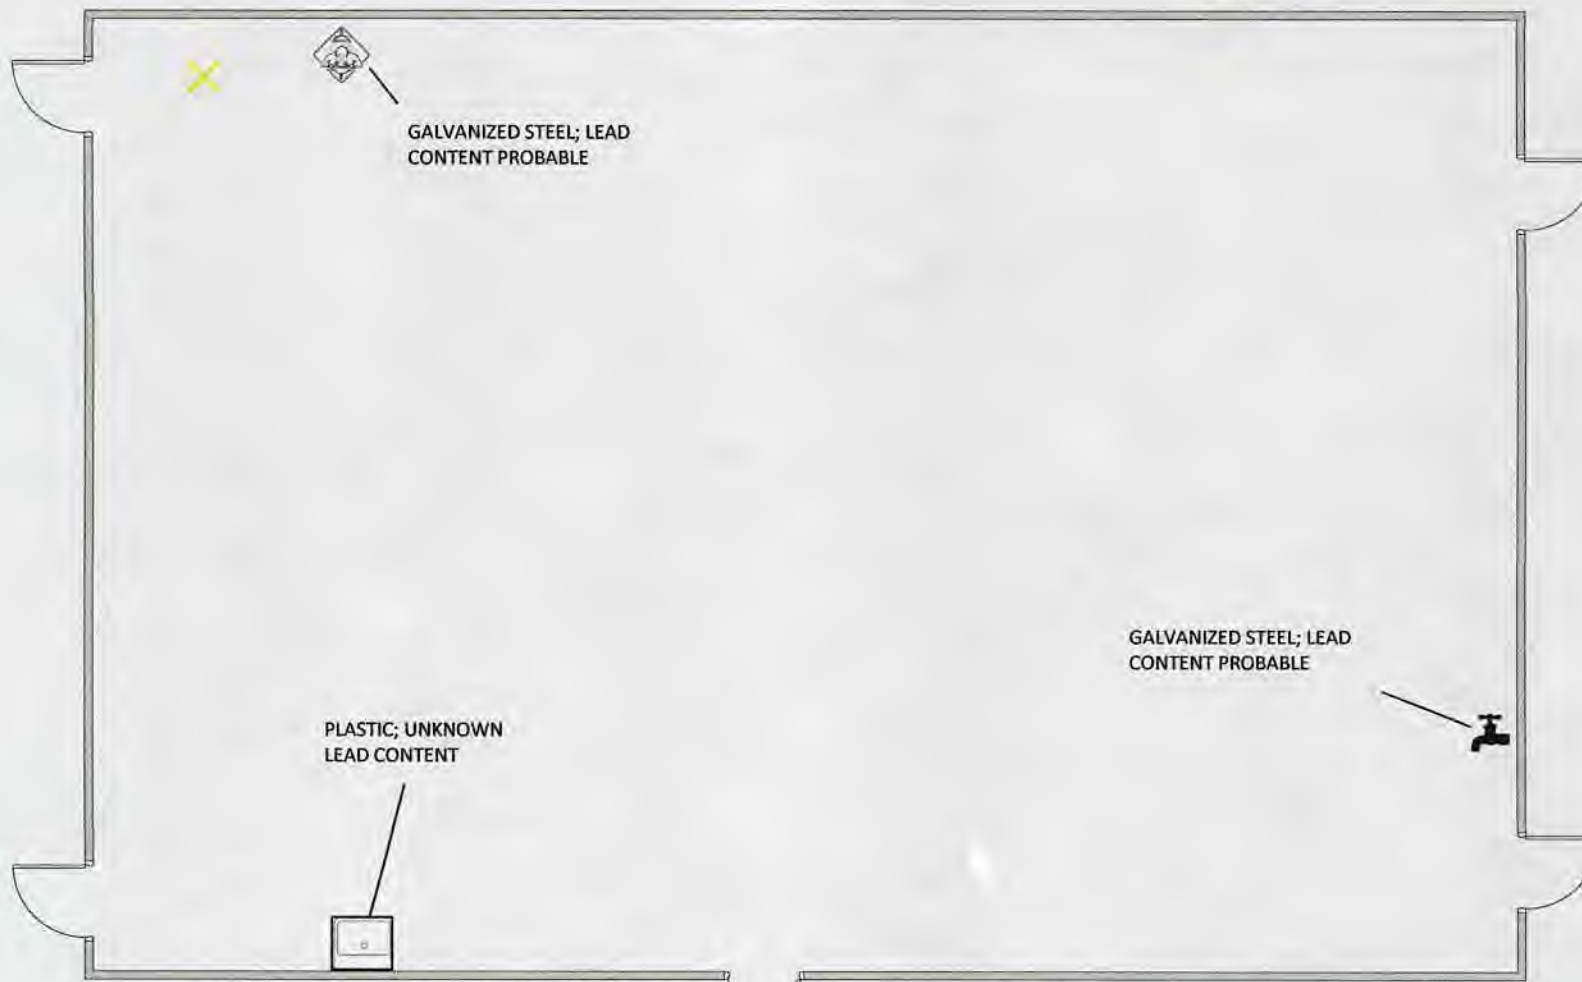
Mix Plant
OH8230412
430 Powder Plant Road
McArthur, Ohio 45651
(740) 596-5286

The Mix Plant was constructed in 1970. This building was built prior to 1986 when there was no limit on lead. **Assume high risk; greater than 8% lead.**

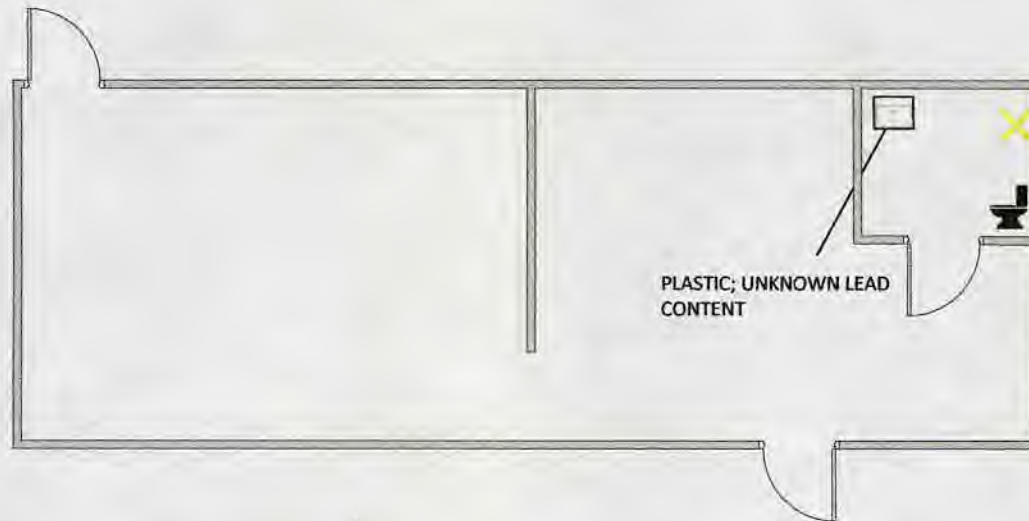
The Fuse Line Maintenance Shop was constructed in 1969. This building was built prior to 1986 when there was no limit on lead. **Assume high risk; greater than 8% lead.**

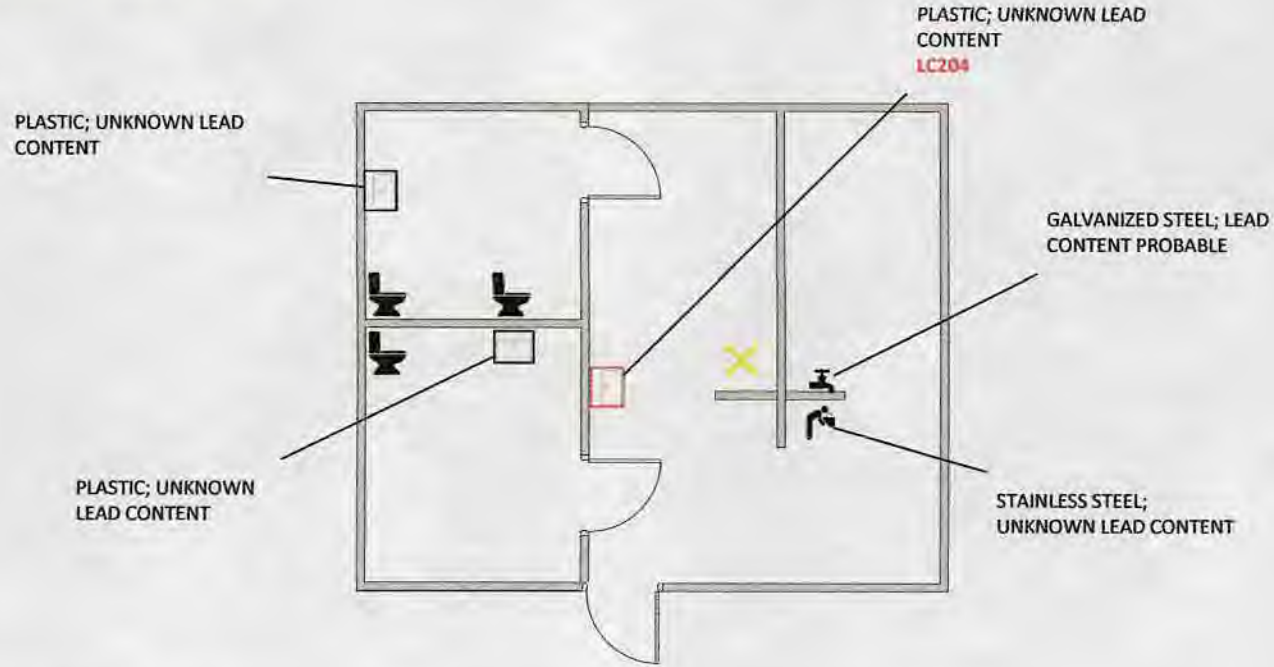
FUSE LINE BREAKROOM

The Fuse Line Breakroom was constructed in 1963. This building was built prior to 1986 when there was no limit on lead. **Assume high risk; greater than 8% lead.**

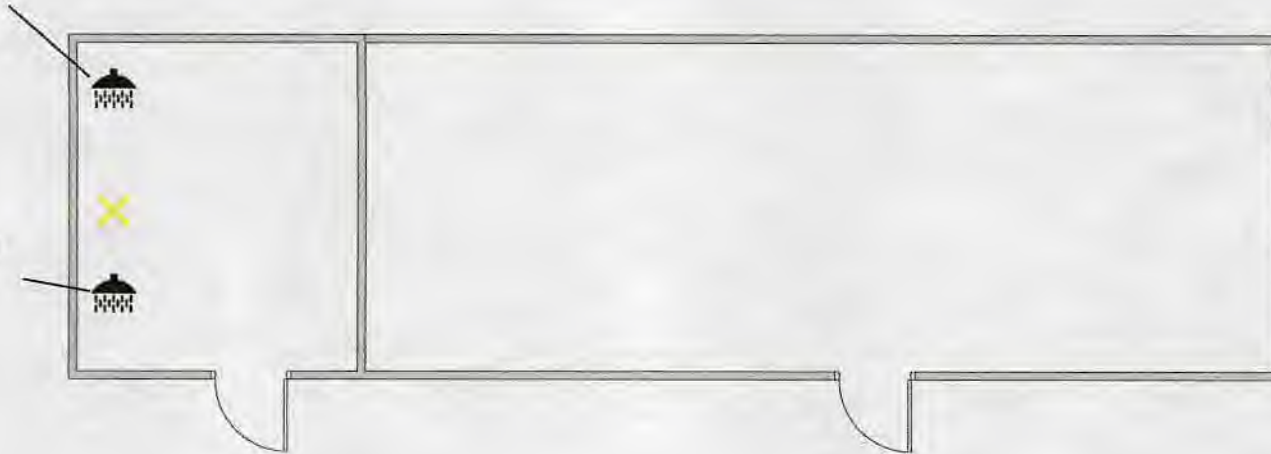
Fuse Line Trailer
OH8230412
430 Powder Plant Road
McArthur, Ohio 45651
(740) 596-5286

PLASTIC; UNKNOWN
LEAD CONTENT

The Fuse Line Trailer was constructed in 1979. This building was built prior to 1986 when there was no limit on lead. **Assume high risk; greater than 8% lead.**

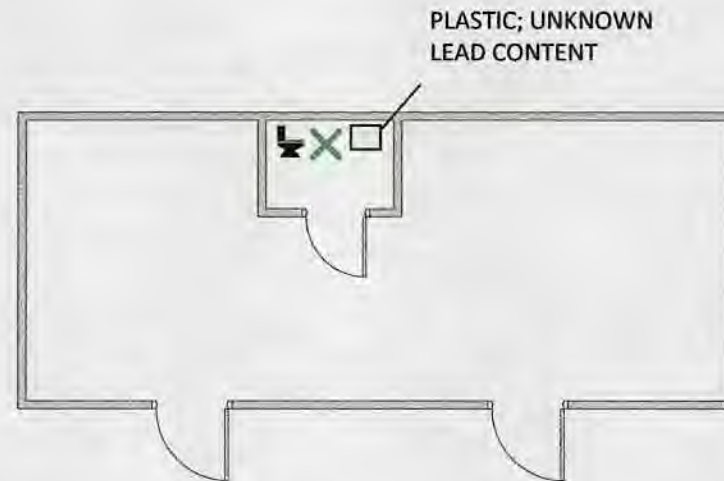
Truck Driver Breakroom
OH8230412
430 Powder Plant Road
McArthur, Ohio 45651
(740) 596-5286

The Trucker Breakroom was constructed in 2012. This building was built during the 1986-2014 regulatory period when lead solder was banned and there was a lower content of lead in brass. **Assume low risk; less than 0.25% lead by weight.**

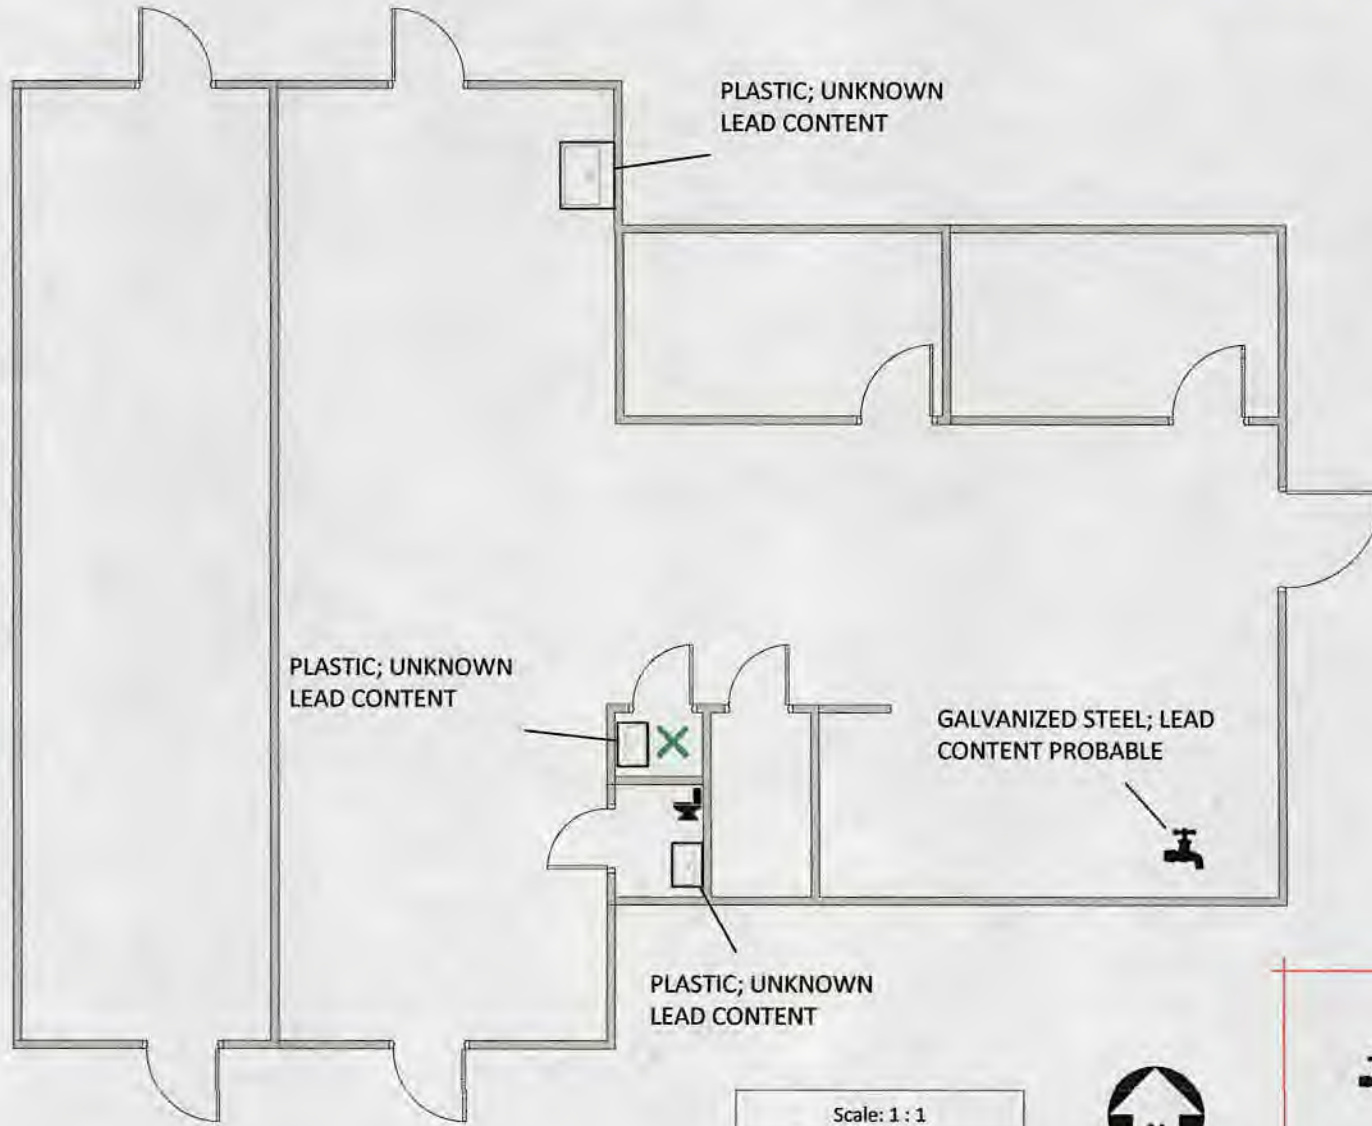
Gate House
OH8230412
430 Powder Plant Road
McArthur, Ohio 45651
(740) 596-5286

The Gate House was constructed in 2008. This building was built during the 1986-2014 regulatory period when lead solder was banned and there was a lower content of lead in brass. **Assume low risk; less than 0.25% lead by weight.**

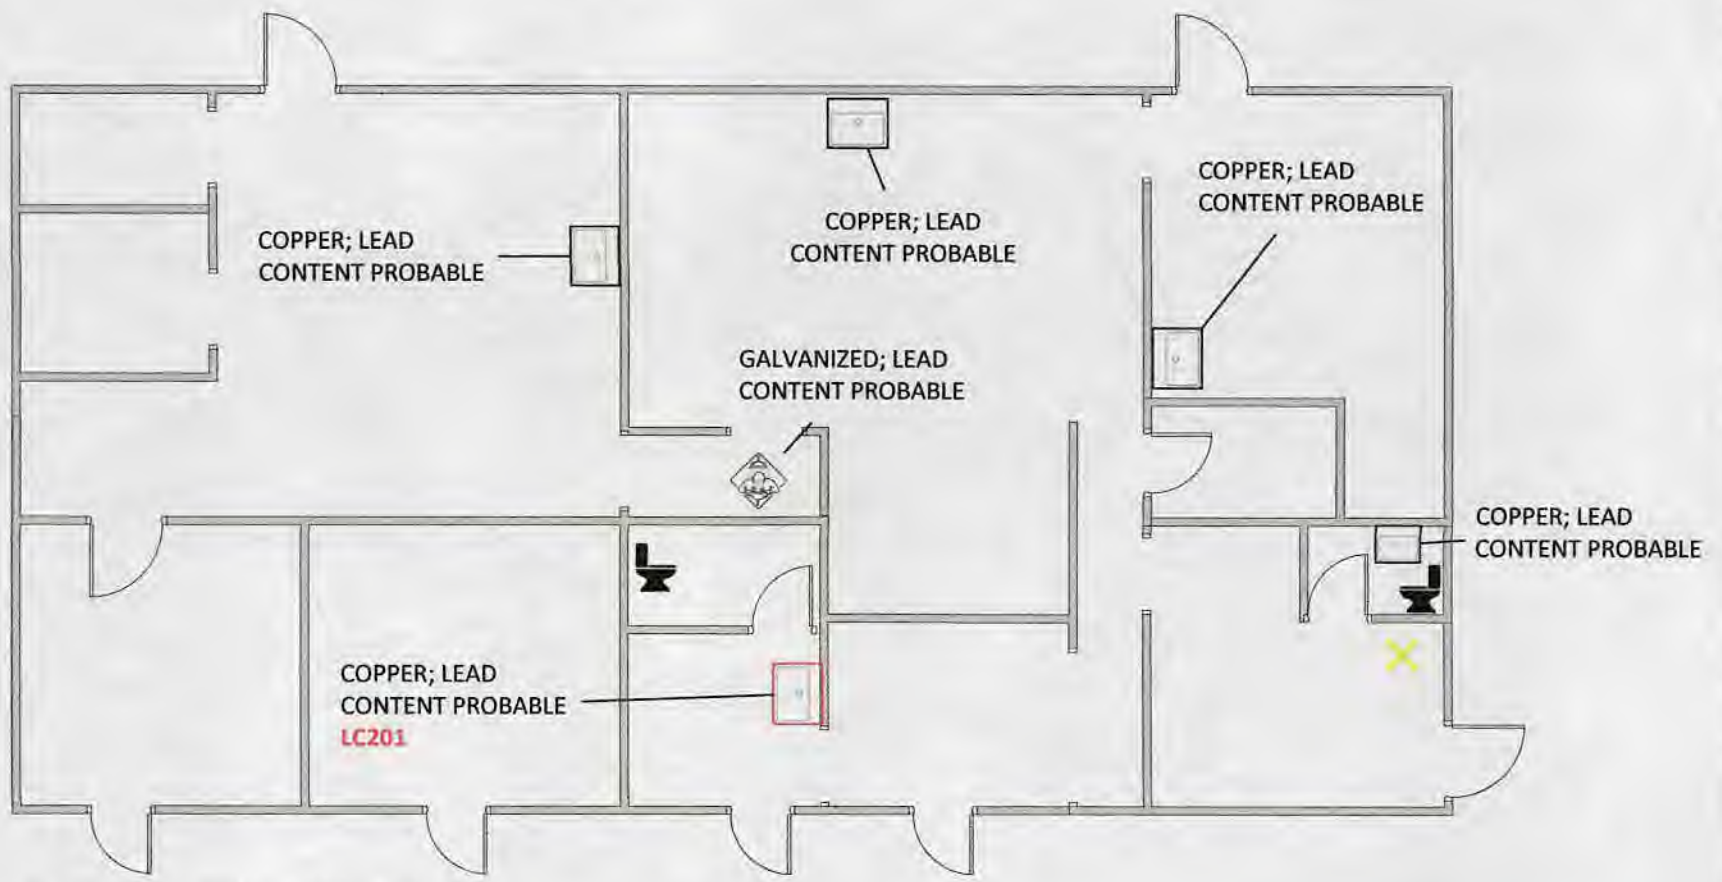
**Laboratory
OH8230412**
430 Powder Plant Road
McArthur, Ohio 45651
(740) 596-5286

The Laboratory was constructed in 1975. This building was built prior to 1986 when there was no limit on lead. **Assume high risk; greater than 8% lead.**

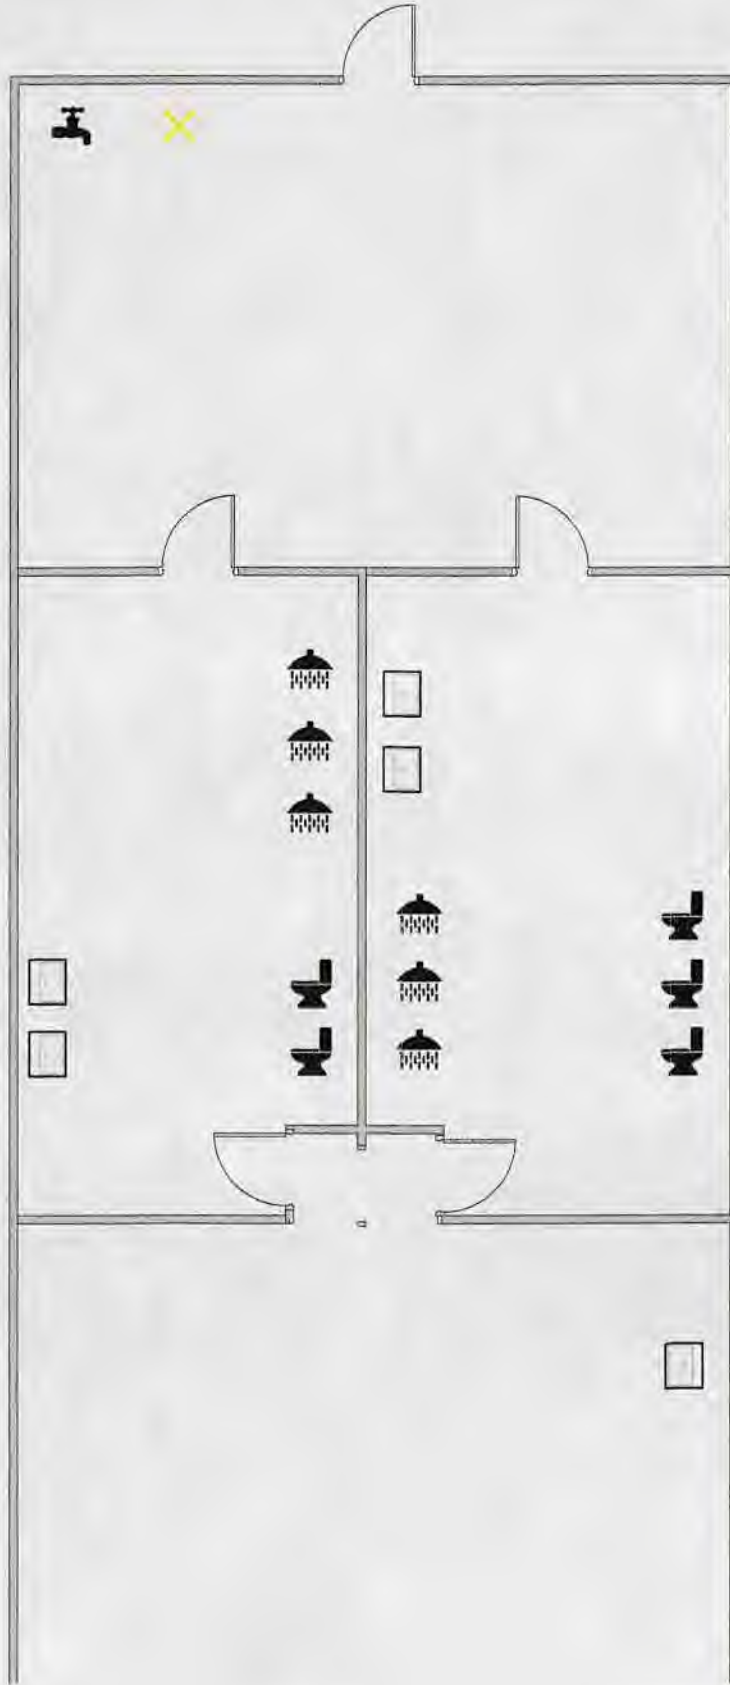
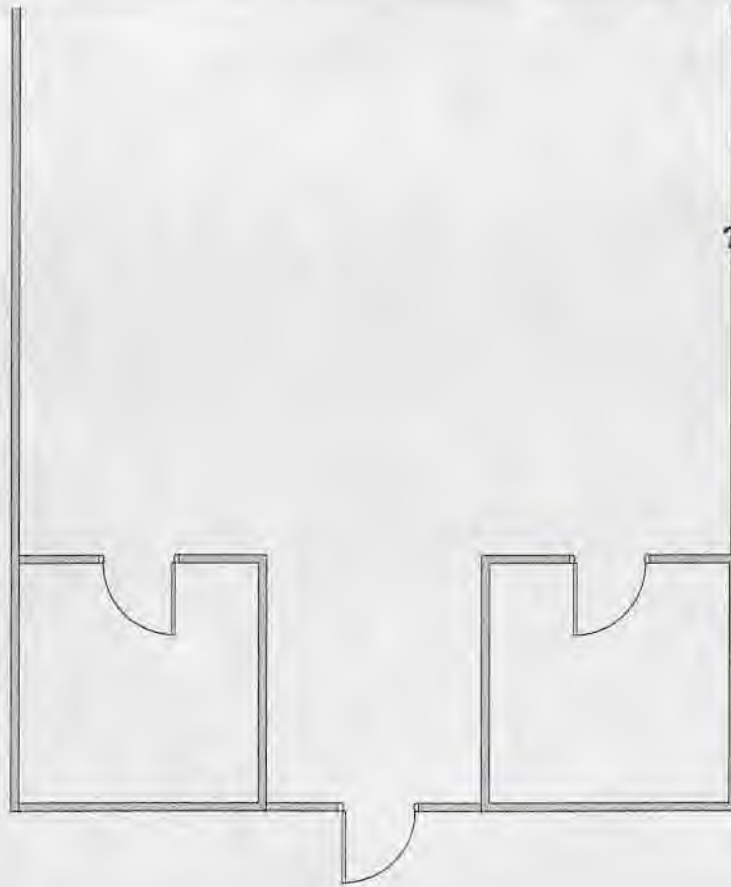
PETN Breakroom
OH8230412
430 Powder Plant Road
McArthur, Ohio 45651
(740) 596-5286

The PETN Breakroom was constructed in 1972. This building was built prior to 1986 when there was no limit on lead, however, the building was renovated in 2016, and all existing water lines were replaced with plastic lines. **Assume low risk; less than 0.25% lead by weight.**

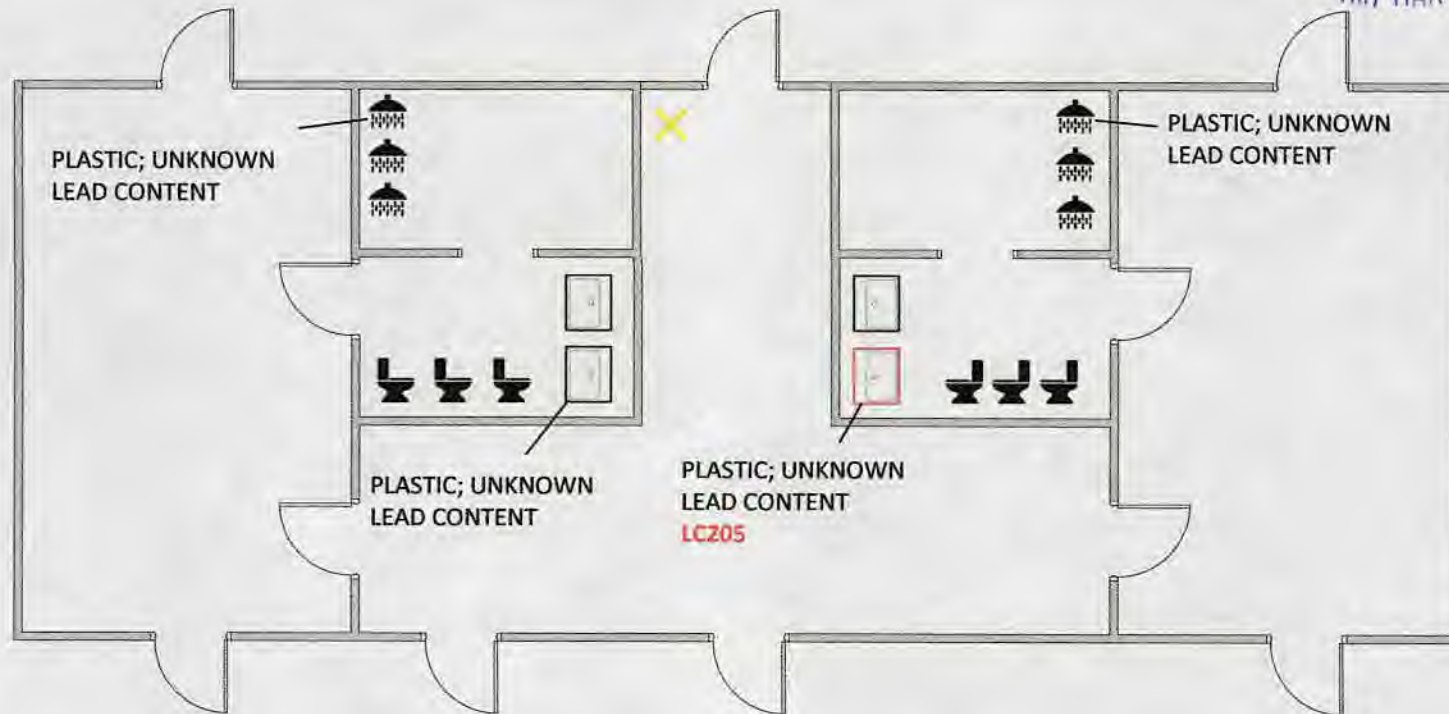
The Old Booster Line Change House was constructed in 1976. This building was built prior to 1986 when there was no limit on lead. **Assume high risk; greater than 8% lead by weight.**
