Austin Powder Company

**RE: Austin Powder Company
Lead & Copper Mapping Requirements**

Austin Powder Company
430 Powder Plant Road
McArthur, Ohio 45651
(740) 596-5286
Main Plant System
PWSID OH8230412
Buildings with Hose Connections

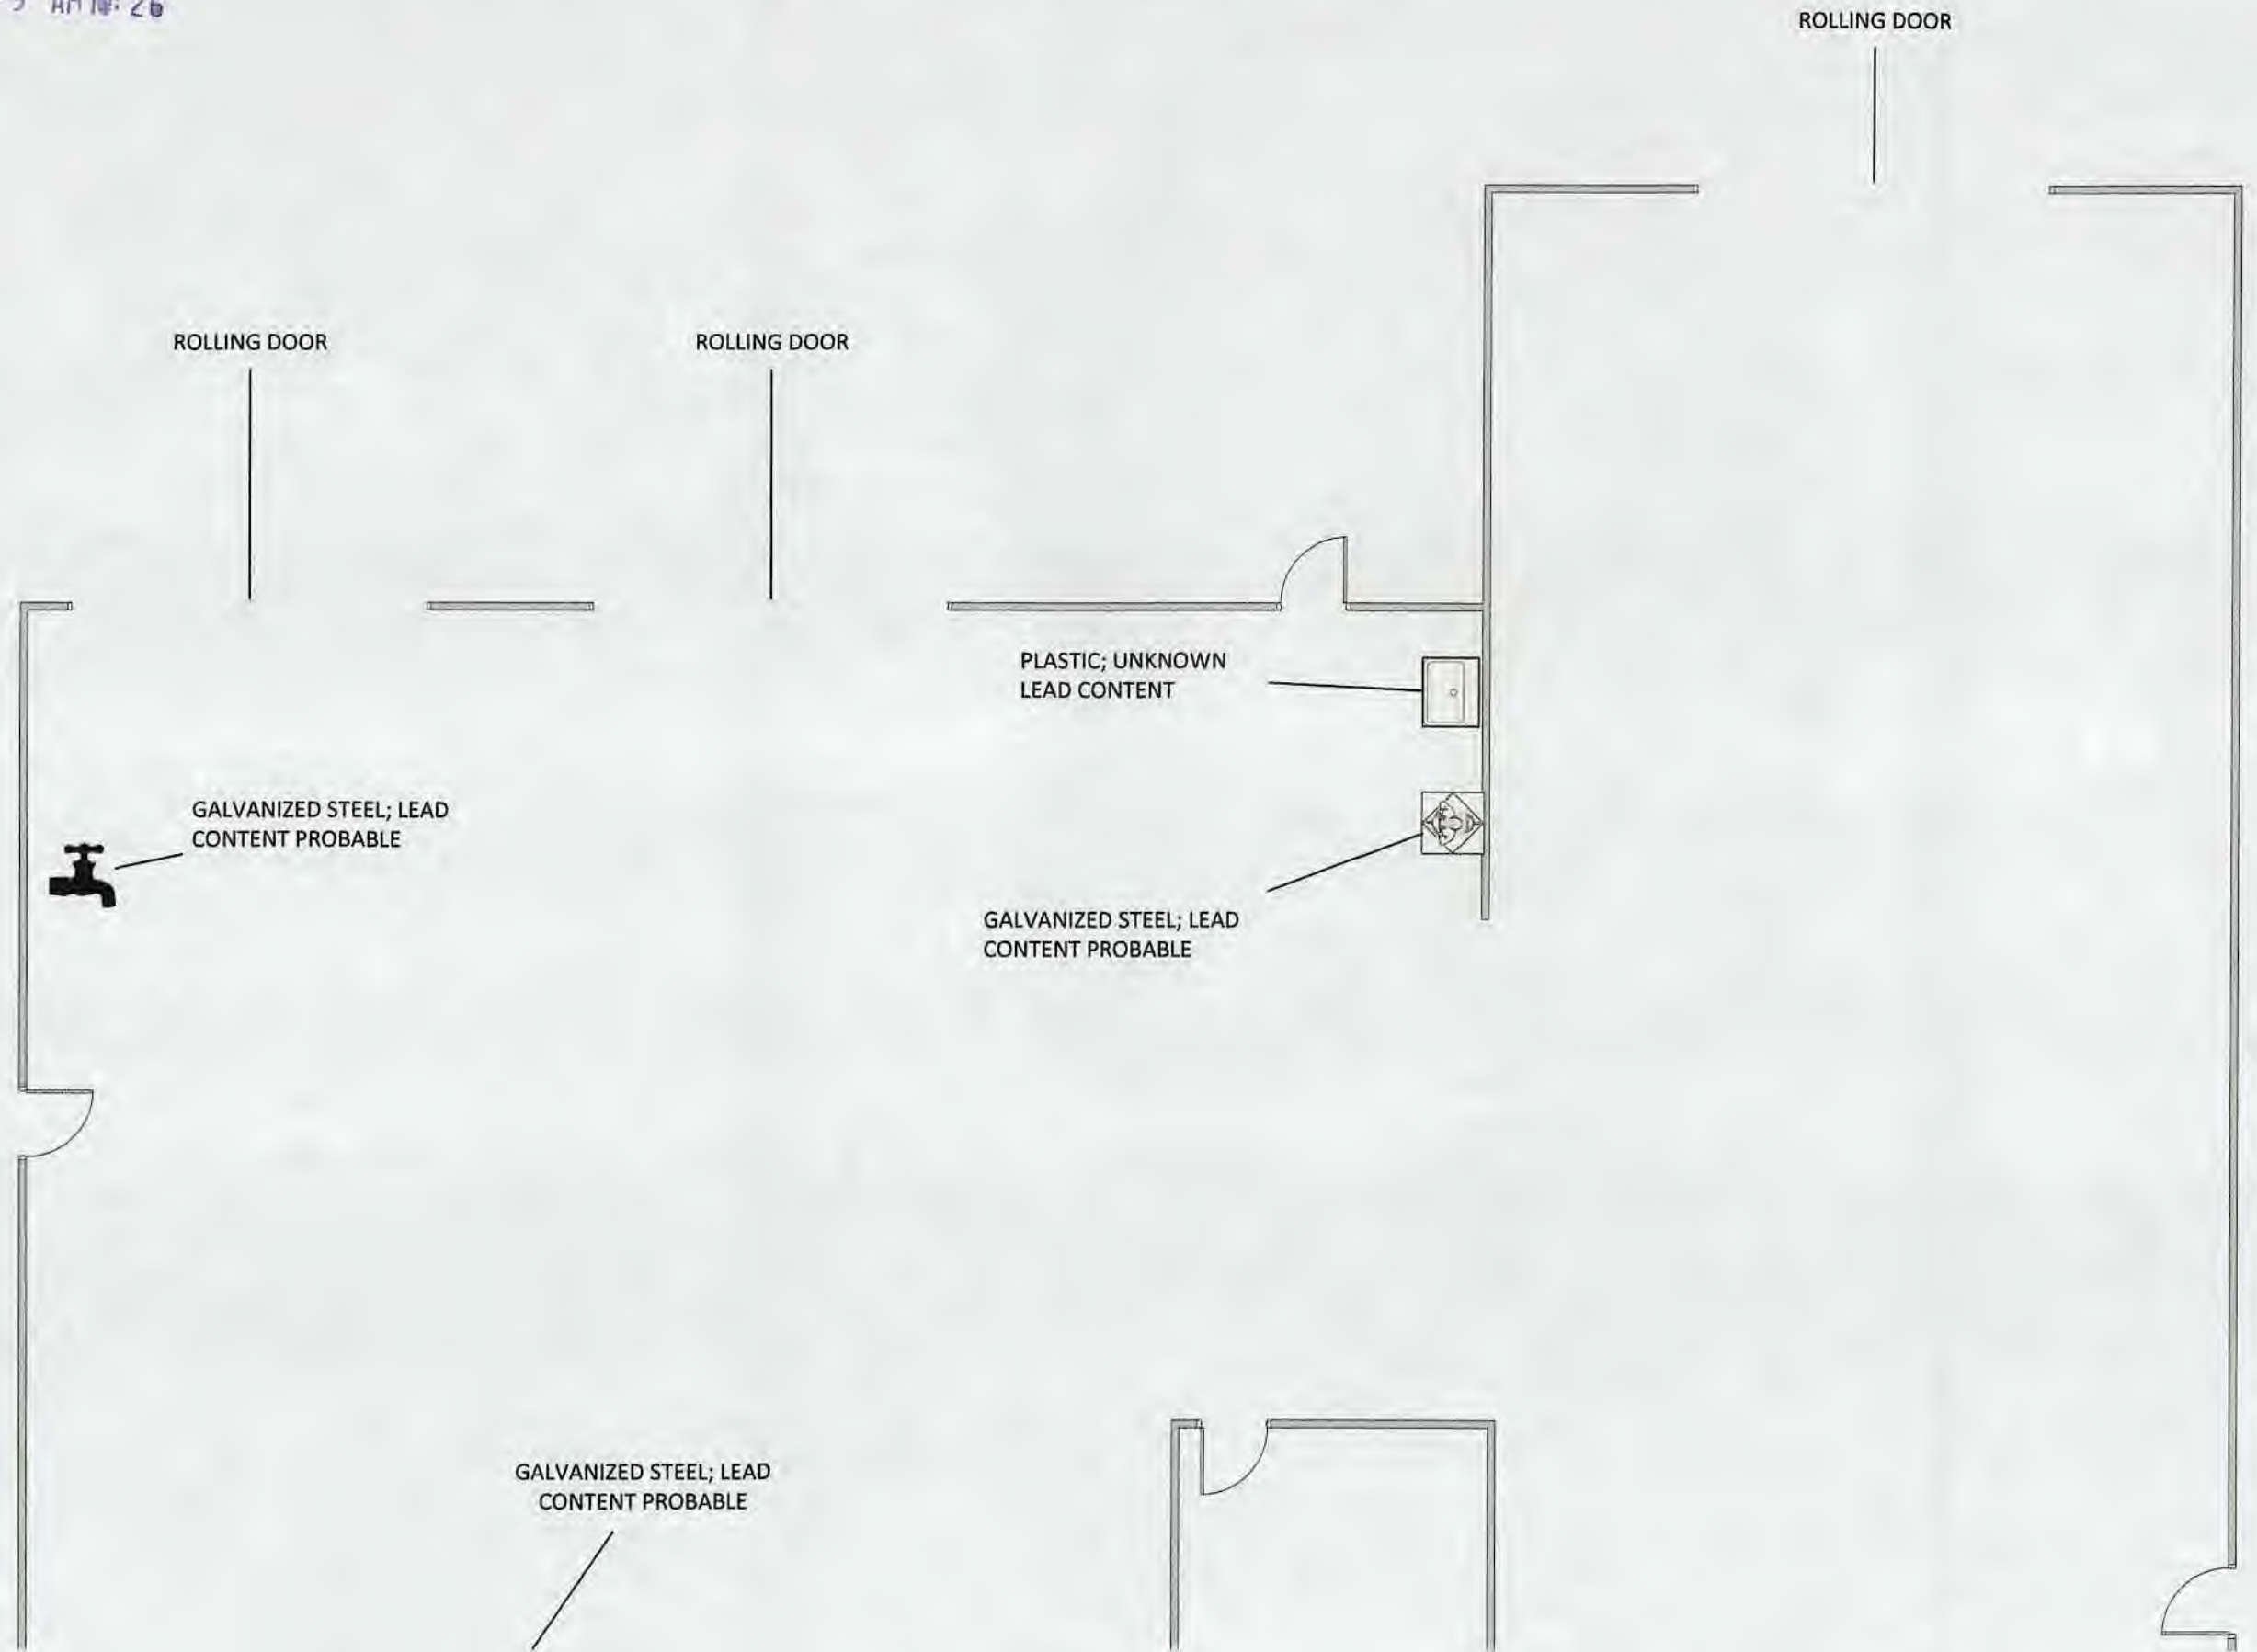
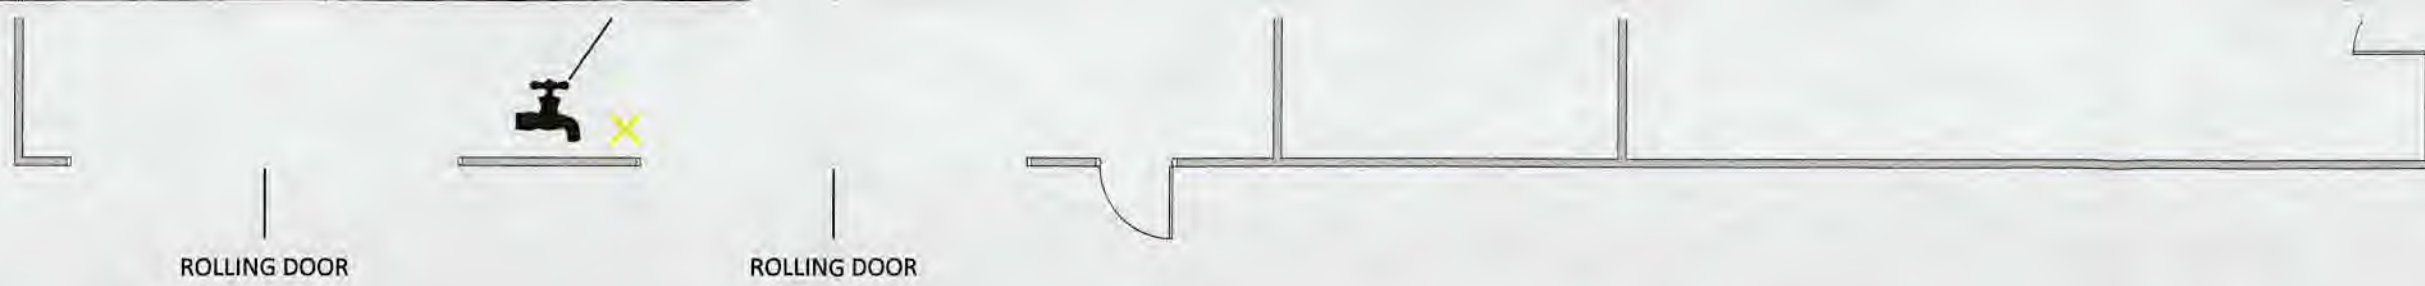
Garage
OH8230412
430 Powder Plant Road
McArthur, Ohio 45651
(740) 596-5286

GALVANIZED STEEL; LEAD
CONTENT PROBABLE

PLASTIC; UNKNOWN
LEAD CONTENT

The Garage was constructed in 1976. This building was built prior to 1986 when there was no limit on lead. **Assume high risk; greater than 8% lead.**
