LANCASTER COUNTRY CLUB FIRST FLOOR

LANCASTER COUNTRY CLUB

Lancaster Country Club Clubhouse

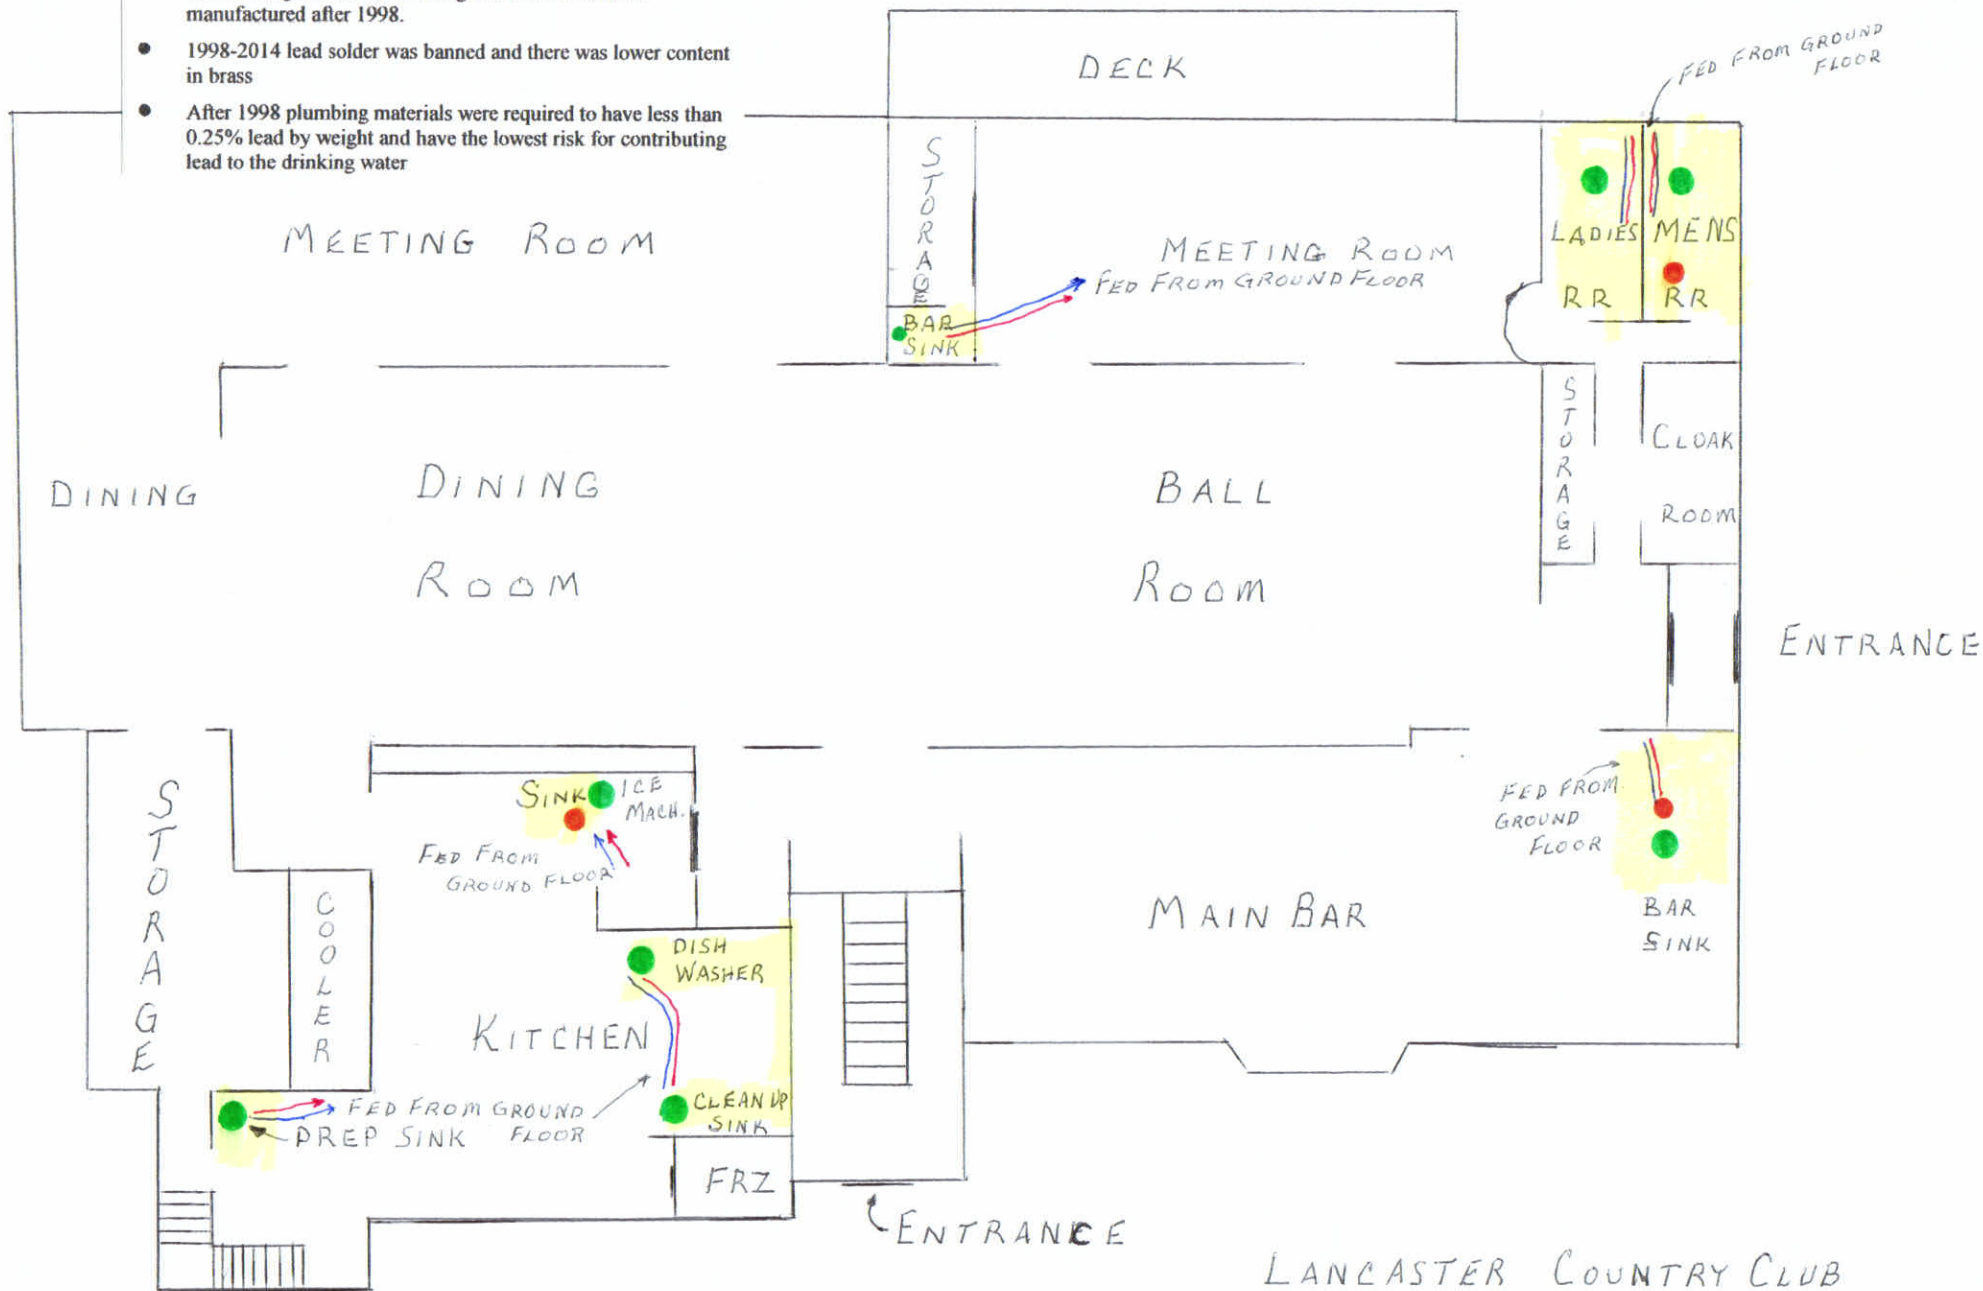
BUILT: 1910 MAJOR RENNOVATION: 1955 & 1985

- POTENTIAL SOLDER BEFORE 1998
- PIPING END POINT
- SAMPLE SITE

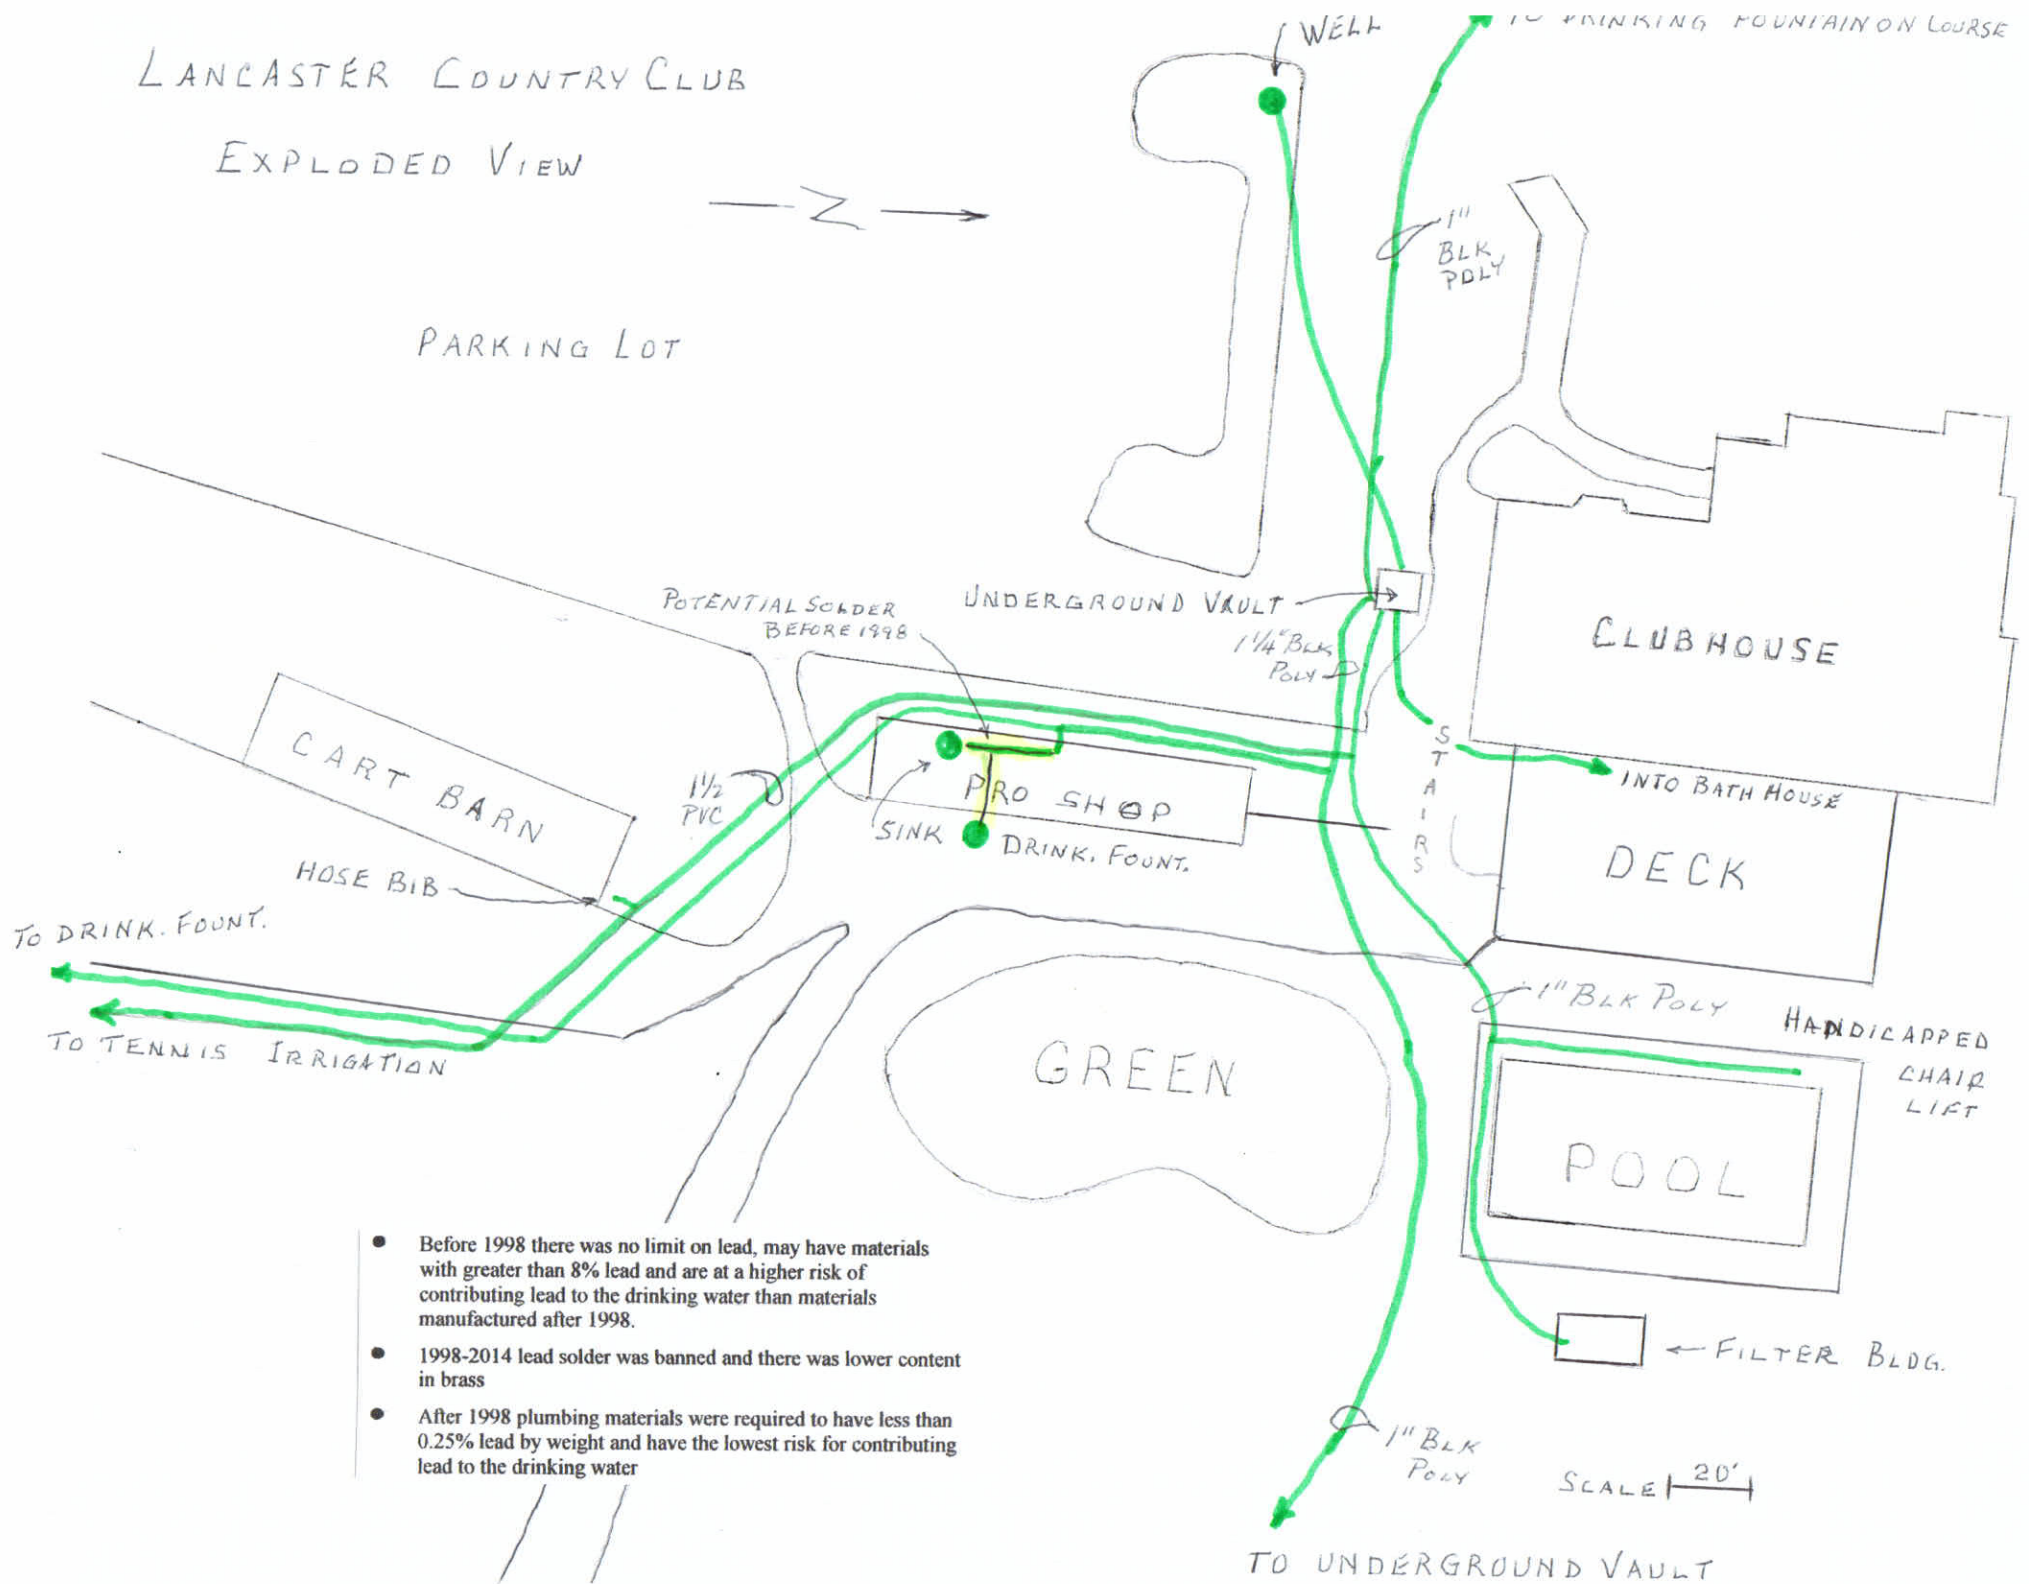
BATH HOUSE SITUATED UNDER THE DECK

BUILT 1999

POTENTIAL SOLDER BEFORE 1998

1" COPPER

A one inch copper line runs from the vault to the Bath House. This line was installed to the Old Bath House when the swimming pool was installed in 1955. That Bath House was demolished in late 1998 and a new Bath House put in service in 1999. The copper supply line was used and connected to a manifold from which polybutylene pipe supply all the plumbing needs.

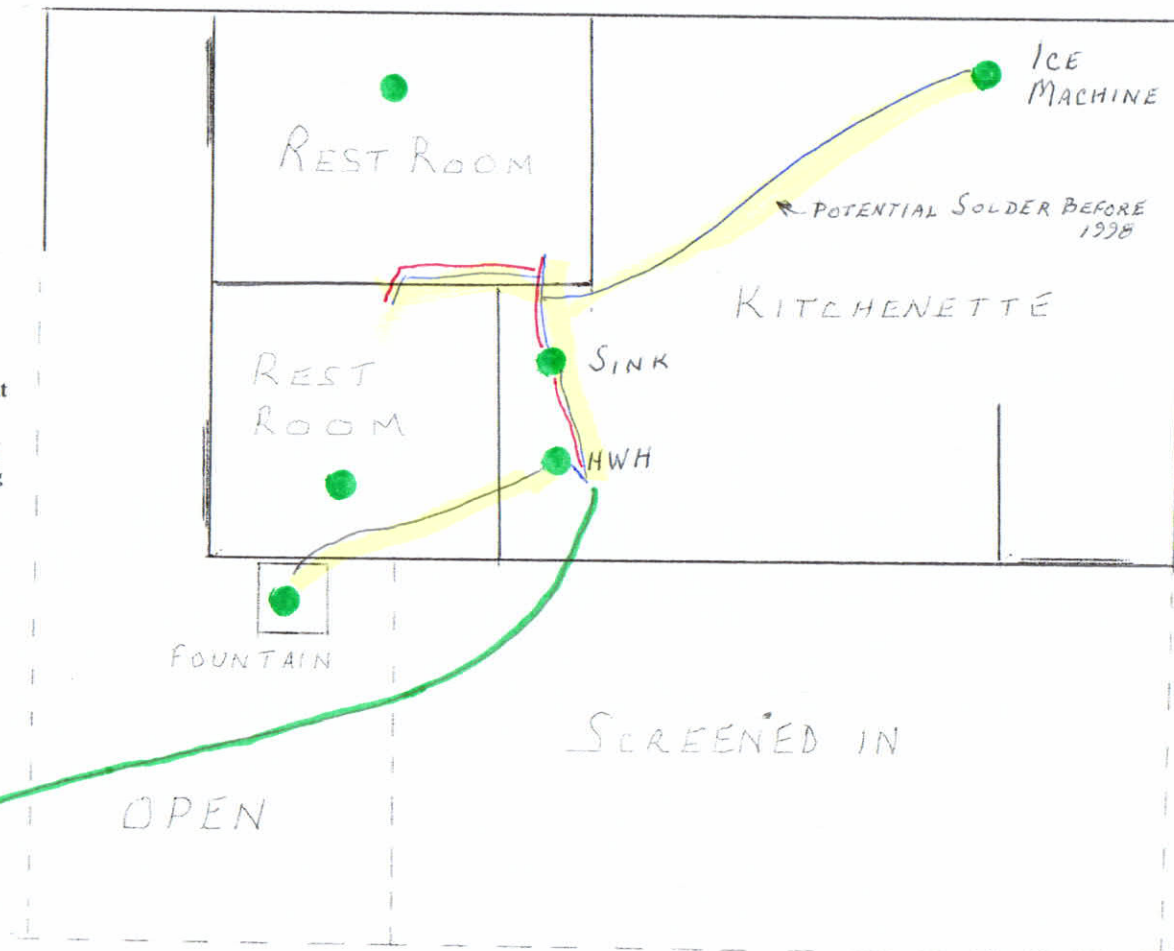
HALF WAY HOUSE
BUILT: 1983

FROM
VAULT
SEE EXPLODED VIEWS

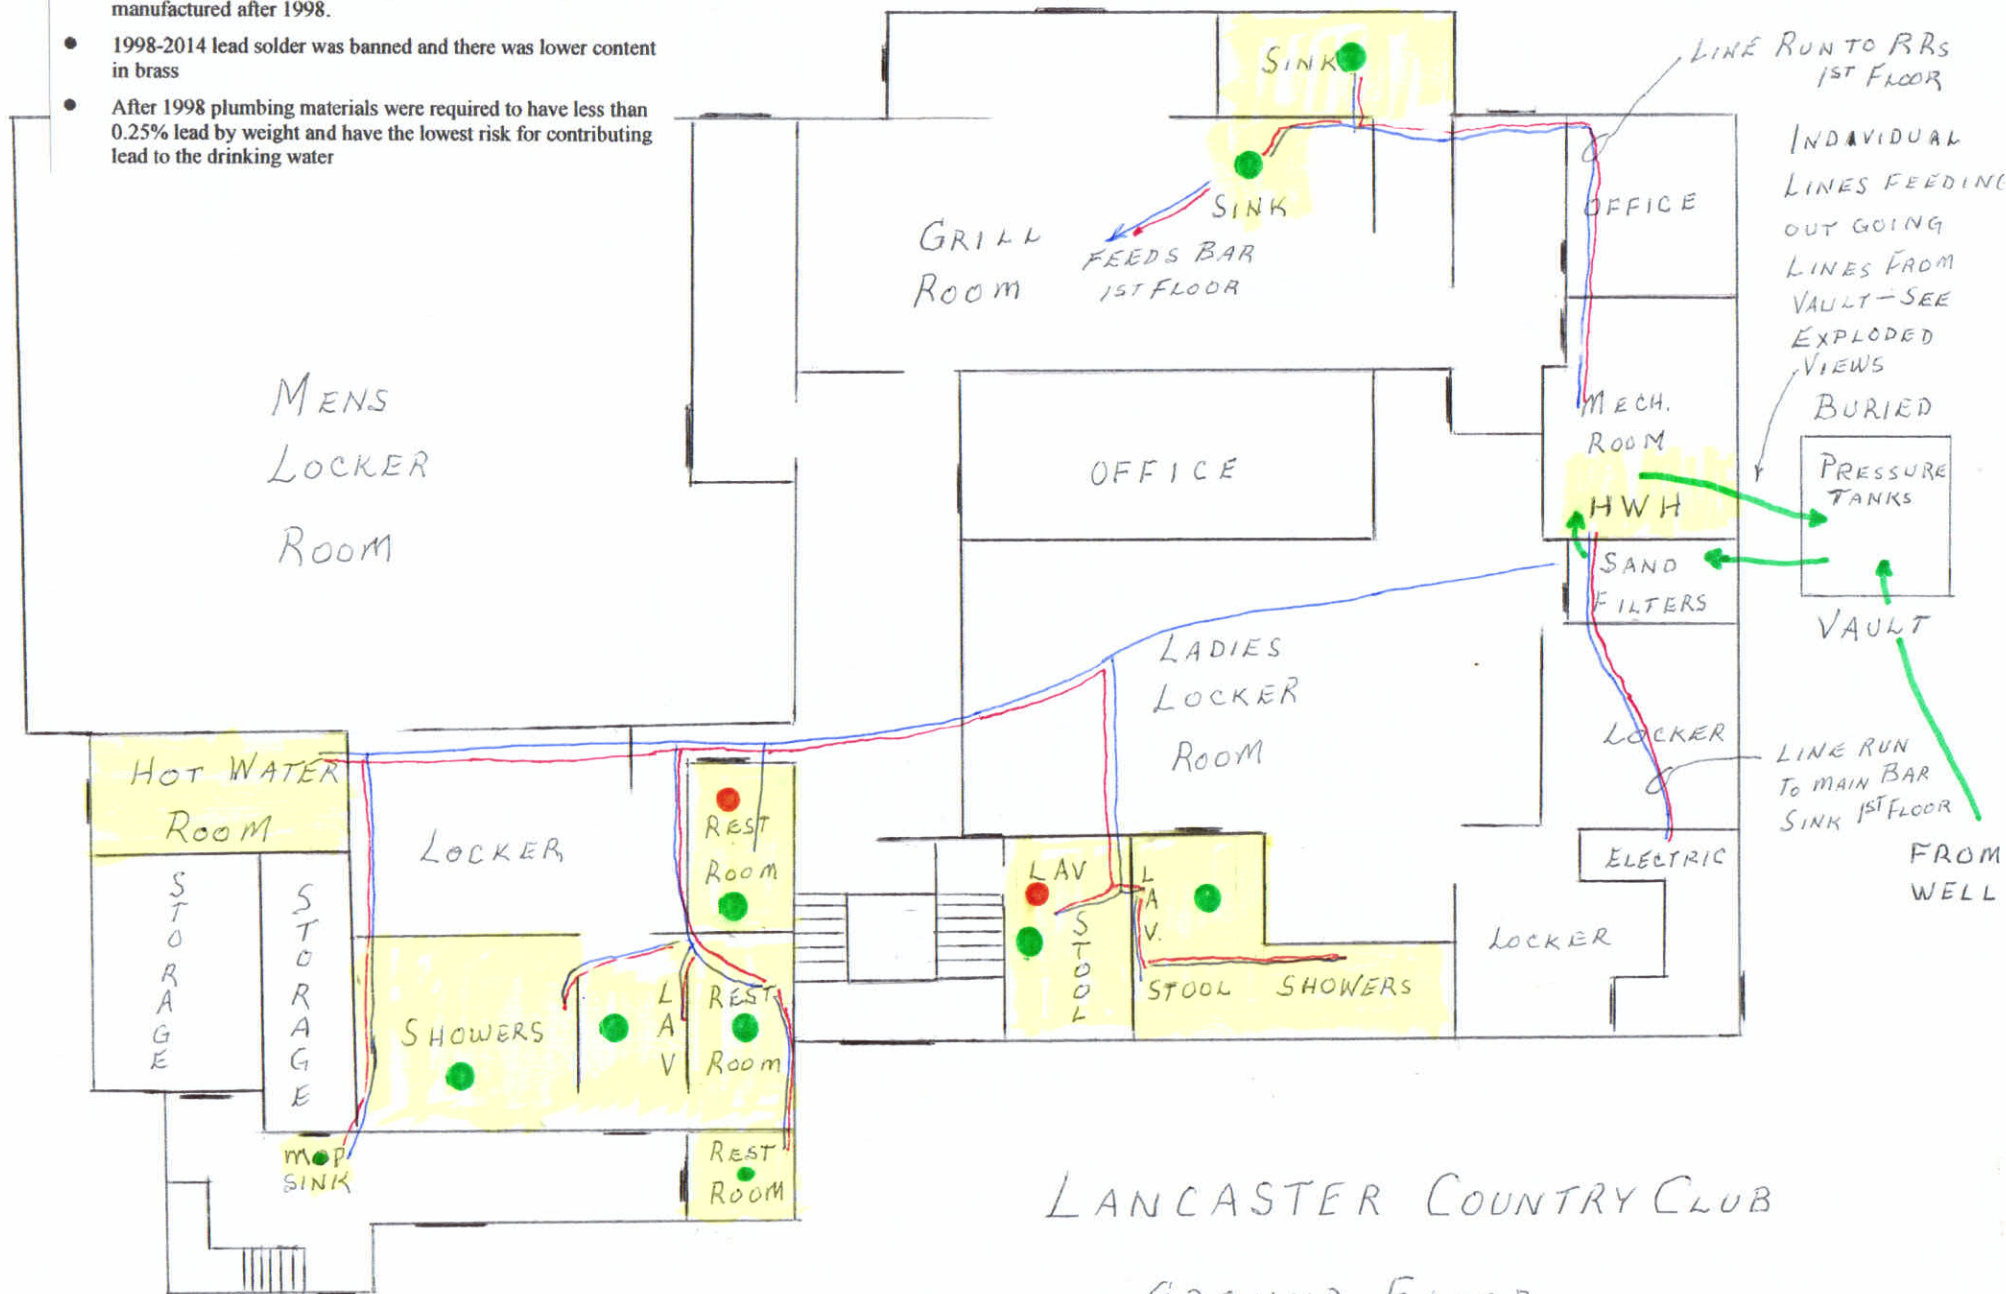
GROUND FLOOR

BUILT: 1910 MAJOR RENNOVATION: 1955 & 1985

- POTENTIAL SOLDER BEFORE 1998
- PIPING END SITE
- SAMPLE SITE
