**PINEVIEW ESTATES MHP  
PUBLIC WATER SYSTEM # OH5702212**

DESCRIPTION OF REVISION
NO. DATE	
DESIGNED BY: JZ	SEAL
DRAWN BY: SJS	
REVIEWED BY: SJS	
FINAL REVIEW BY: JSJ	
PINEVIEW PINES WATER SYSTEM MIAMISBURG, MONTGOMERY COUNTY, OHIO <b>SITE DISTRIBUTION SYSTEM</b>	
<b>JONES WARNER CONSULTANTS, INC.</b> CONSULTING ENGINEERS 8401 CLAUDE THOMAS ROAD, SUITE 51 FRANKLIN, OHIO 45005 PH: 937-704-9868 FAX: 937-704-9949 EMAIL: jwc@joneswarner.com VISIT US AT: JONESWARNER.COM	
DATE:	03/02/2017
PROJECT NO.:	16-048
SCALE:	1"=80'
SHEET NO.:	C 1.01

**Pineview Pines Water System Narrative  
for  
Lead, Solder & Fixtures**

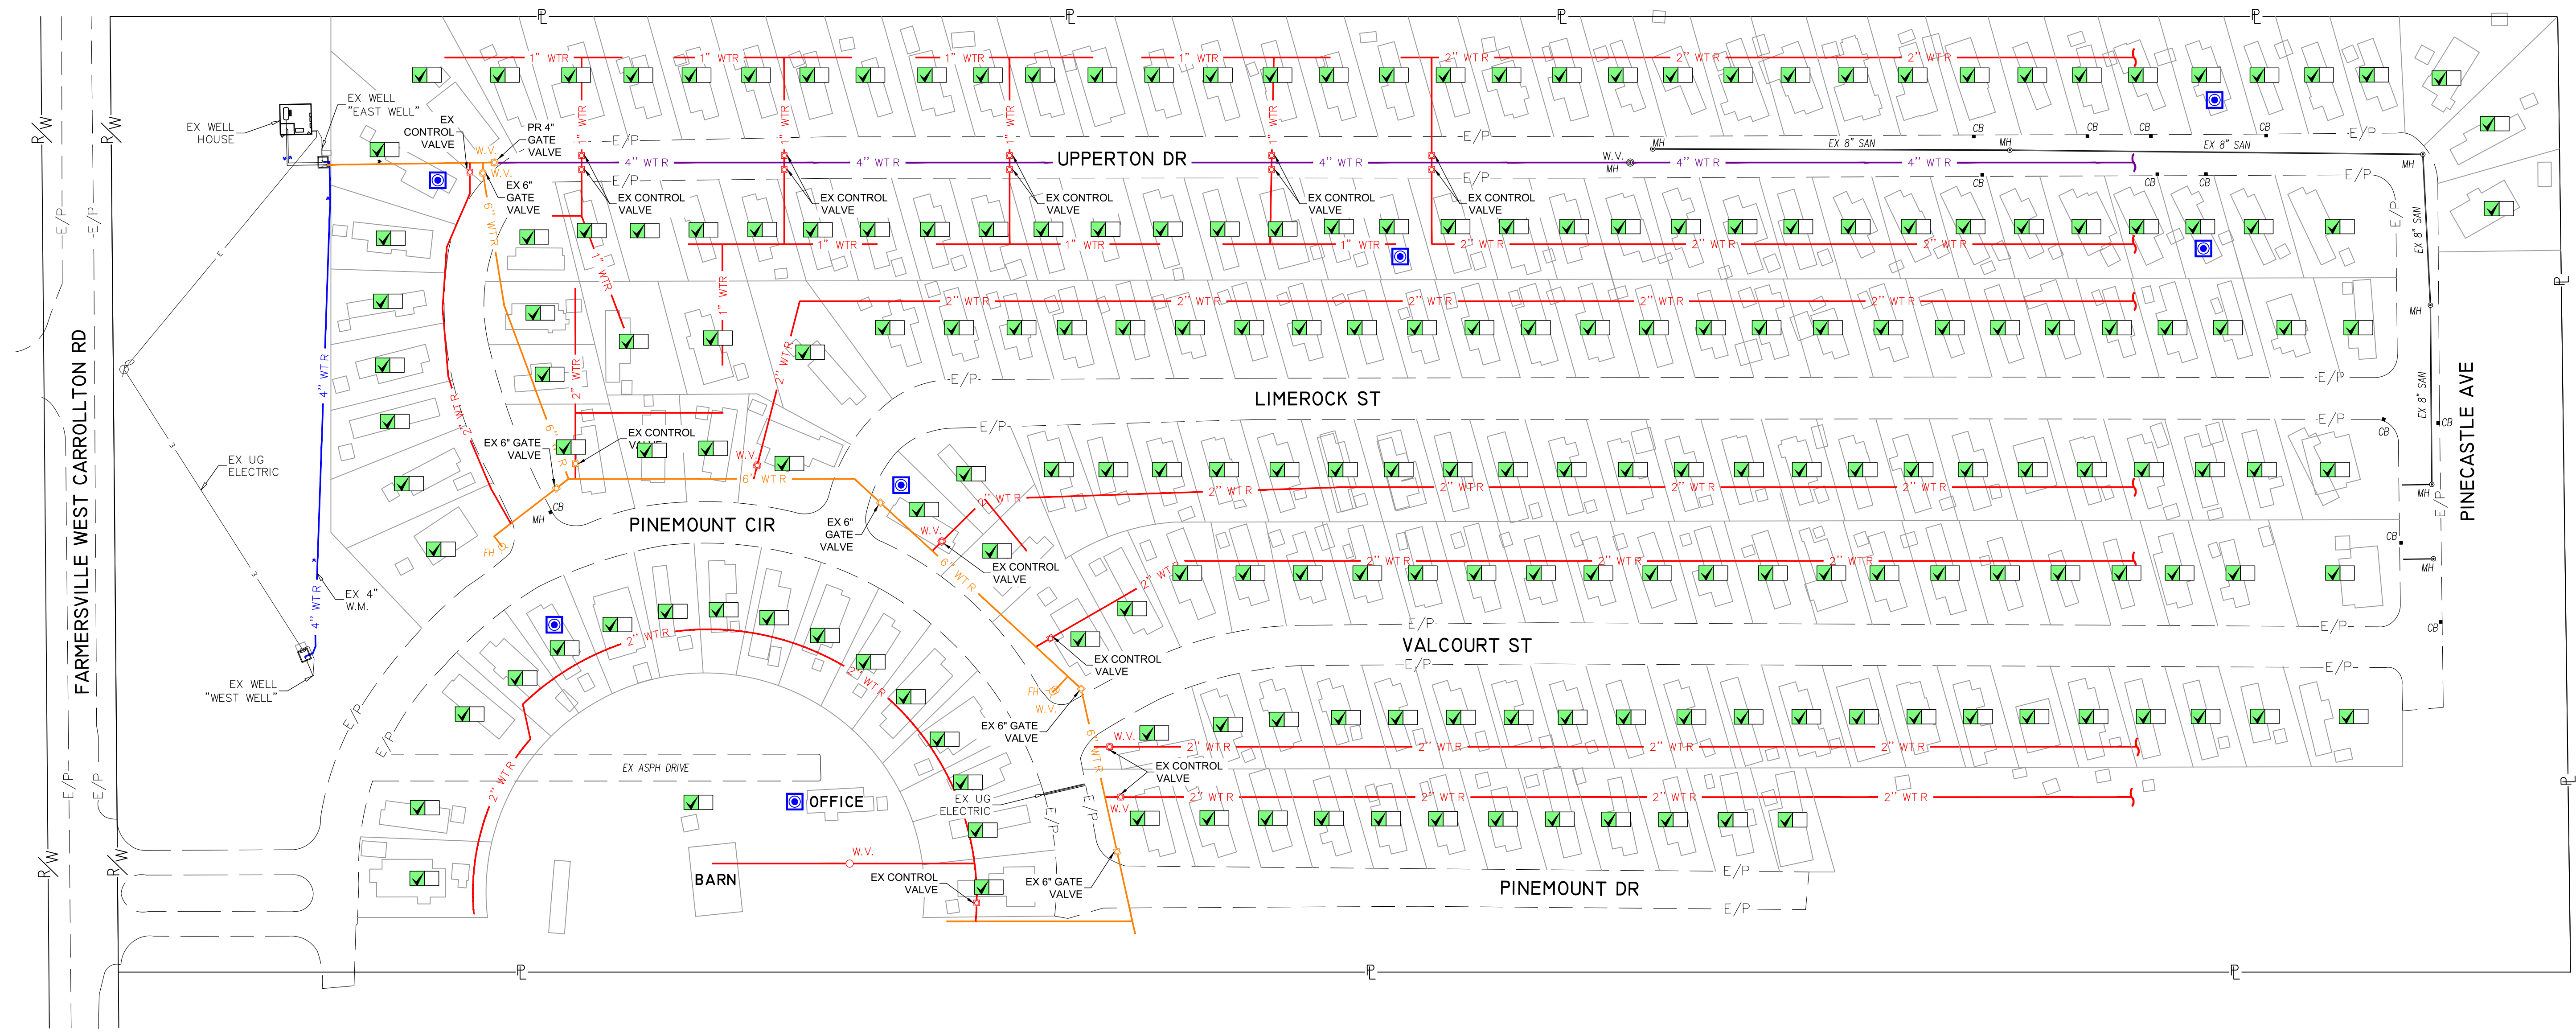
The map depicts four categories of water mains. Category 1 is comprised of Ductile Iron Pipe and PVC C-900 with compression joint gaskets. Category 2 is comprised of Schedule 40 PVC with glued joints. Category 3 is comprised of SDR 21 PVC with gasketed joints. Category 4 is comprised of SDR 21 PVC with glued joints. Each category is depicted with an identifier color as indicated in the Table on the Map.

All water mains are depicted on the map. Some of these lines are new within the system and the remainder which are older, are all comprised of either ductile iron pipe or PVC pipe. Based on our knowledge of these mains, we are confident that the water mains indicated above contain no lead joints or lead appurtenances.

To the best of our knowledge, all service lines connected to the mains in Pineview Pines are all constructed of plastic, galvanized steel, or copper.

It is also important to note we are not aware of any historical lead issues at Pineview Pines MHP. Testing of the source water could be performed to identify if lead is present at the source. For these reasons, while we do not anticipate lead in the services, we are classifying all service branched as UNKNOWN.
