NEW MIAMI VILLAGE PWS  
PUBLIC WATER SYSTEM #OH0902112

VILLAGE OF MORROW, OHIO WATER DISTRIBUTION		VILLAGE OF NEW MIAMI LEAD MAPPING PROJECT		DESIGNED BY: S/S		DESCRIPTION OF REVISION	
DATE: 03/08/2017		PROJECT NO.: 4014-2017		DRAWN BY: S/S		1	
SCALE: 1" = 300'		SHEET NO.: 1		REVIEWED BY: UZ		2	
				FINAL REVIEW TSC		3	
						4	
						5	
						6	
						7	
						8	
						9	
						10	
						11	
						12	
						13	
						14	
						15	
						16	
						17	
						18	
						19	
						20	
						21	
						22	
						23	
						24	
						25	
						26	
						27	
						28	
						29	
						30	
						31	
						32	
						33	
						34	
						35	
						36	
						37	
						38	
						39	
						40	
						41	
						42	
						43	
						44	
						45	
						46	
						47	
						48	
						49	
						50	
						51	
						52	
						53	
						54	
						55	
						56	
						57	
						58	
						59	
						60	
						61	
						62	
						63	
						64	
						65	
						66	
						67	
						68	
						69	
						70	
						71	
						72	
						73	
						74	
						75

## **Village of New Miami Water System Narrative for Lead, Solder & Fixtures**

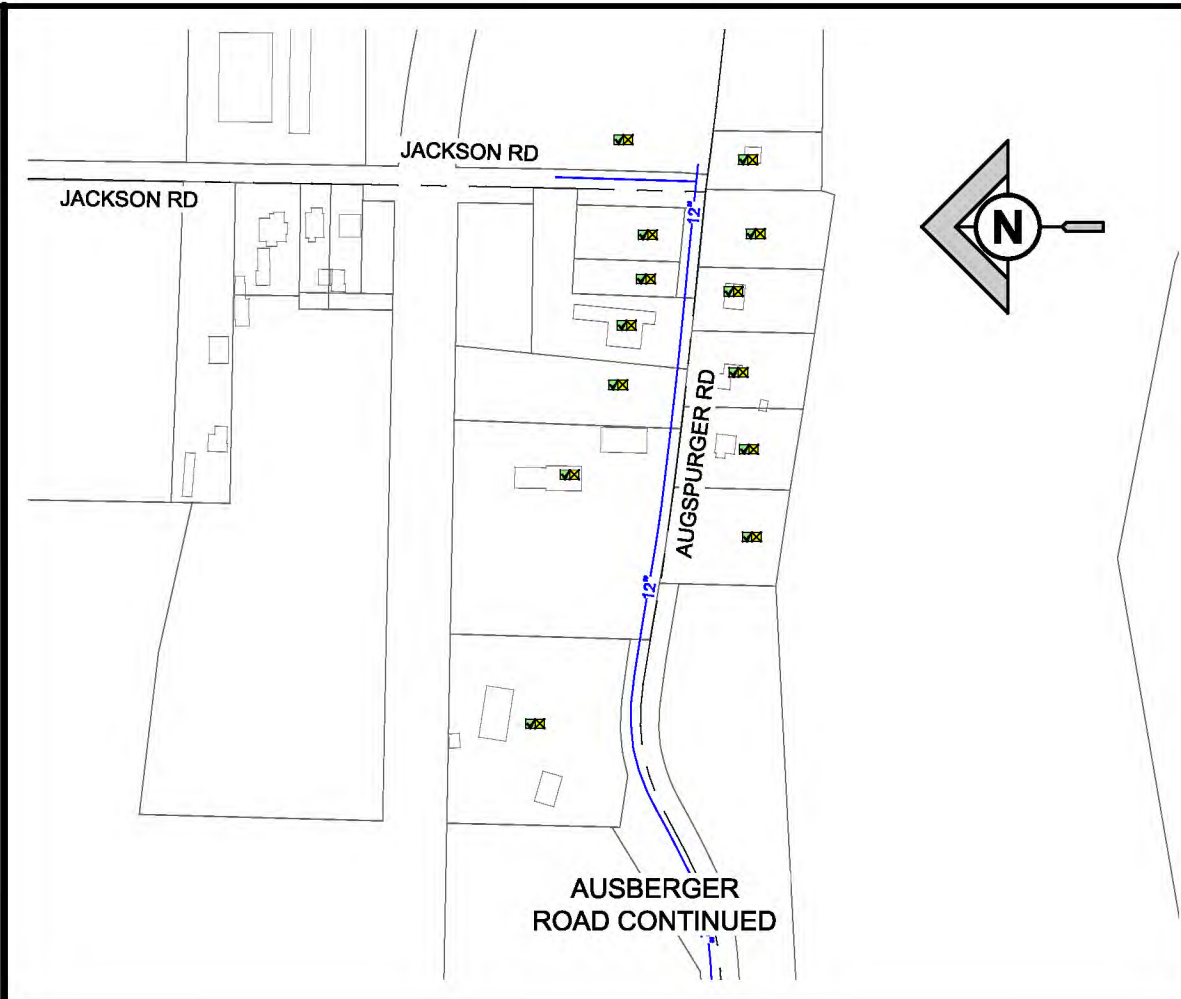
Category 1 water mains are depicted on the map. These are made of cast iron and the joints of these mains and taps are packed with oakum and lead. Because of the potential of lead being present at sleeves, joints and/or near service lines for properties tapping into cast iron mains, we feel that that these mains are likely to contain lead regardless of the service line material.

Category 2 water mains are also depicted on the map. These are newer lines within the village and are comprised of either ductile iron pipe or plastic (C900) pipe. Water mains constructed from these materials use rubber/mechanical joints in construction; therefore, the public side does not contain leaded joints. All properties served by Category 2 mains have been marked as not likely to contain lead on the public side. Based on our knowledge of these mains, we are confident that the mains and taps contain no lead. Also, due to the time frame of installation, we are confident that the service taps and service lines are continuous copper or plastic and contain no lead from the tap to the meter pit. ( public side)

To the best of our knowledge, service lines connected to Category 1 and Category 2 water mains may still contain lead on the private side. On the public side, we are confident that there are no lead service lines, but we cannot be completely sure that they are free of lead solder or fixtures. Additionally, these properties have outside meter pits, which have been inspected and verified by the Village of New Miami employees to not have lead service lines on the public side. Over the years as lead service lines were discovered during water meter replacement and water main repairs, the lead service lines were removed and replaced with copper or galvanized pipe. In 2003 about 75% of the water meters in the village were replaced. During late 2013 and 2014 100% of the water meters were replaced with radio read meters. No lead service lines were found by the installers in 2003 and 2014. We have a high level of confidence that no lead service lines on the public side exist. As previously mentioned with regards to the private side, based on the age of the homes, we assume that there is a potential for lead, lead solder and flux.

exist. Piping on the public side of the connection has been identified as likely to contain lead, regardless of the material used in the installation of individual service lines.

Like service lines connected to Category 1 water mains, services connected to Category 2 mains consist of copper and galvanized pipes. Most of the buildings served by Category 2 mains were constructed before 2015; therefore, the private side of the connection has been marked as likely to contain lead regardless of the material used to manufacture the service line unless specific records on file indicate otherwise
