Lead Service Line and Fixture
Mapping Project
For Mount Saint John

System Name: Mount Saint John
Nontransient Noncommunity PWS
PWS ID: OH2900112
Address: 4435 E. Patterson Rd.
Beavercreek, Ohio 45430

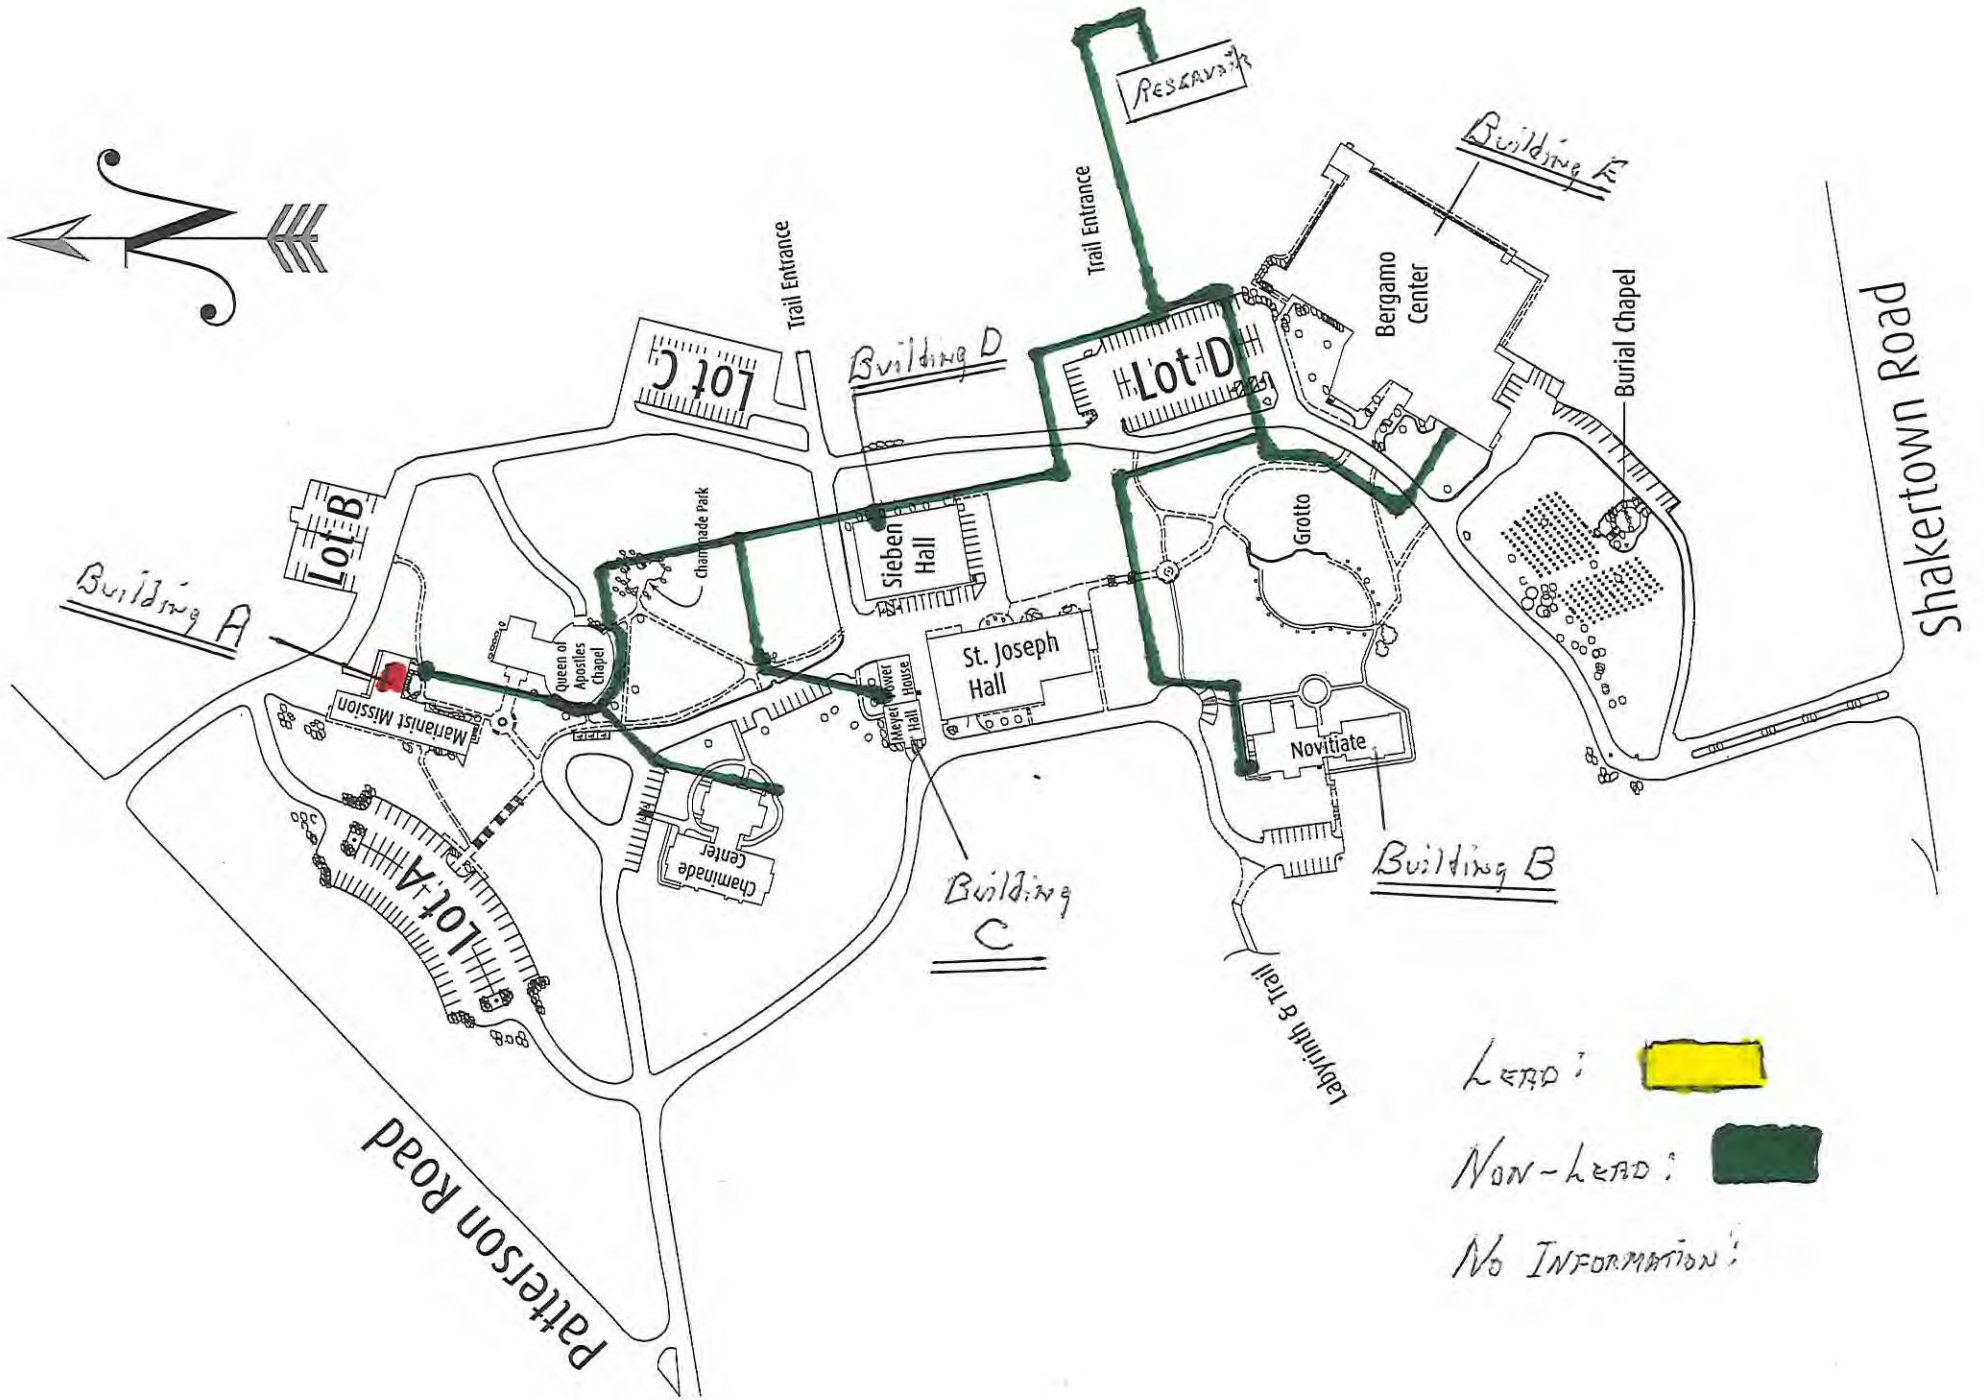
LEAD:

NON-LEAD:

NO INFORMATION:

General Description of System: The property has two wells which feed a reservoir on the top of a hill behind Bergamo Center. We only use one pump at a time, the other is a backup. The distribution system which feeds the property from the reservoir is gravity feed. All of the lines feeding the property are other materials other than lead. We do not have any lead service lines on the property.

All service lines were tested with a magnet and scratched and no lead was found in the service lines.

Recommendation: Bergamo Center fixtures will be looking at replacing the fixtures in the near future. All the other buildings will be monitored in the next lead sampling in 2018.
