**Bethel, Ohio**

**Water System Evaluation Analysis and Recommendation Report**

**FINAL REPORT**

**Brandstetter Carroll Inc.**

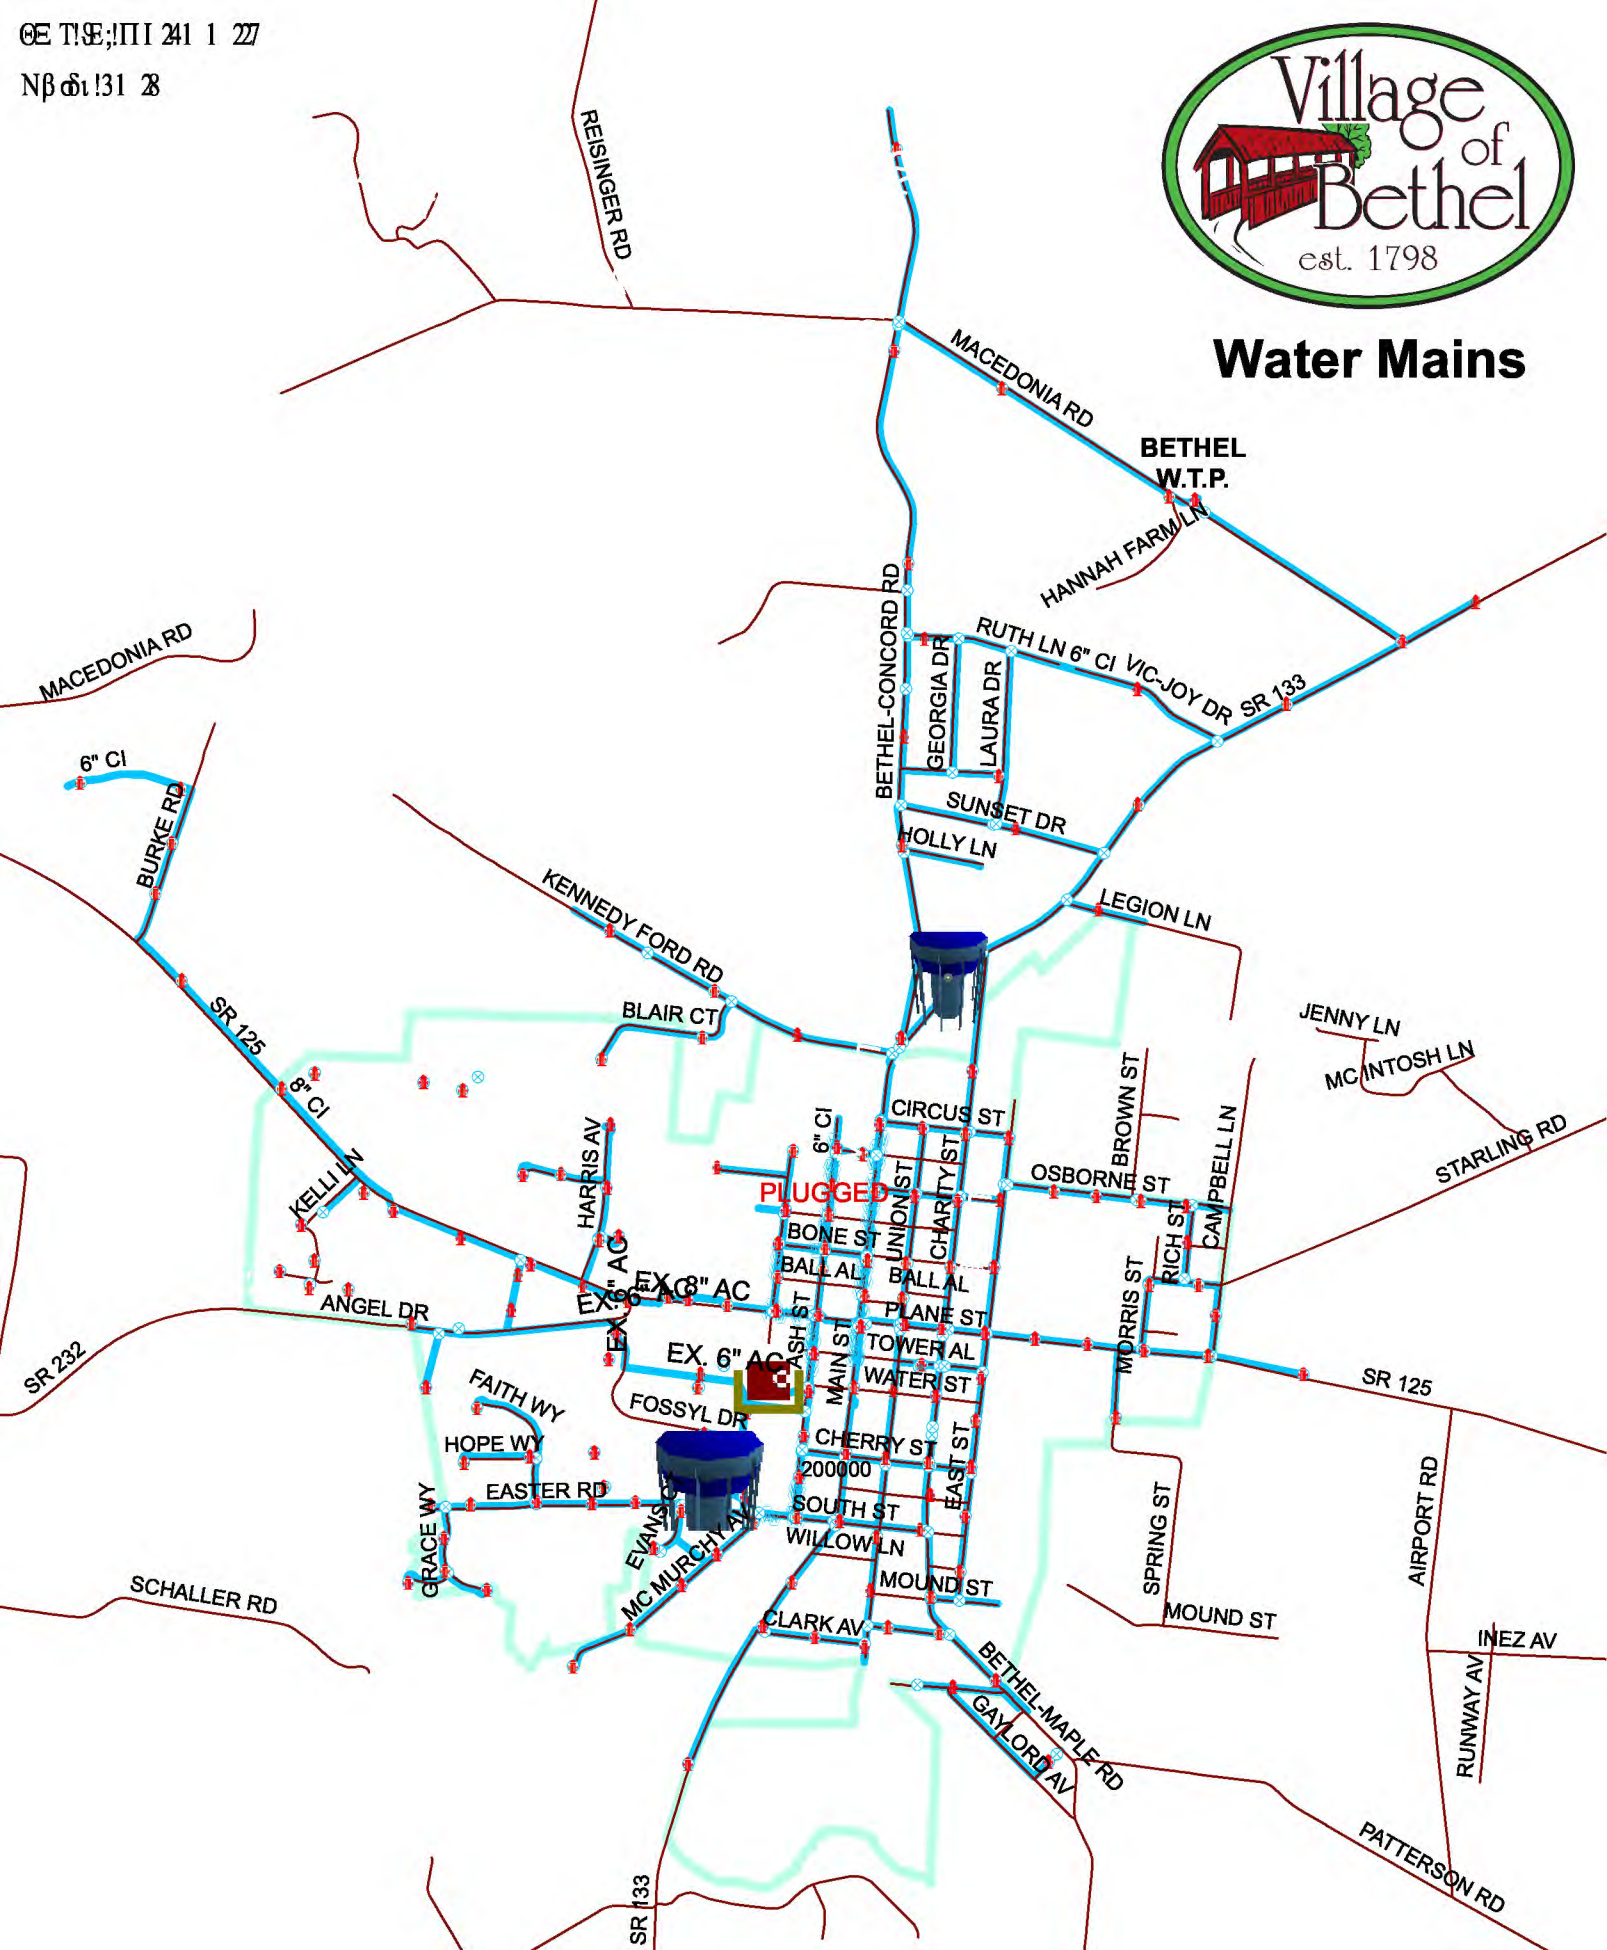
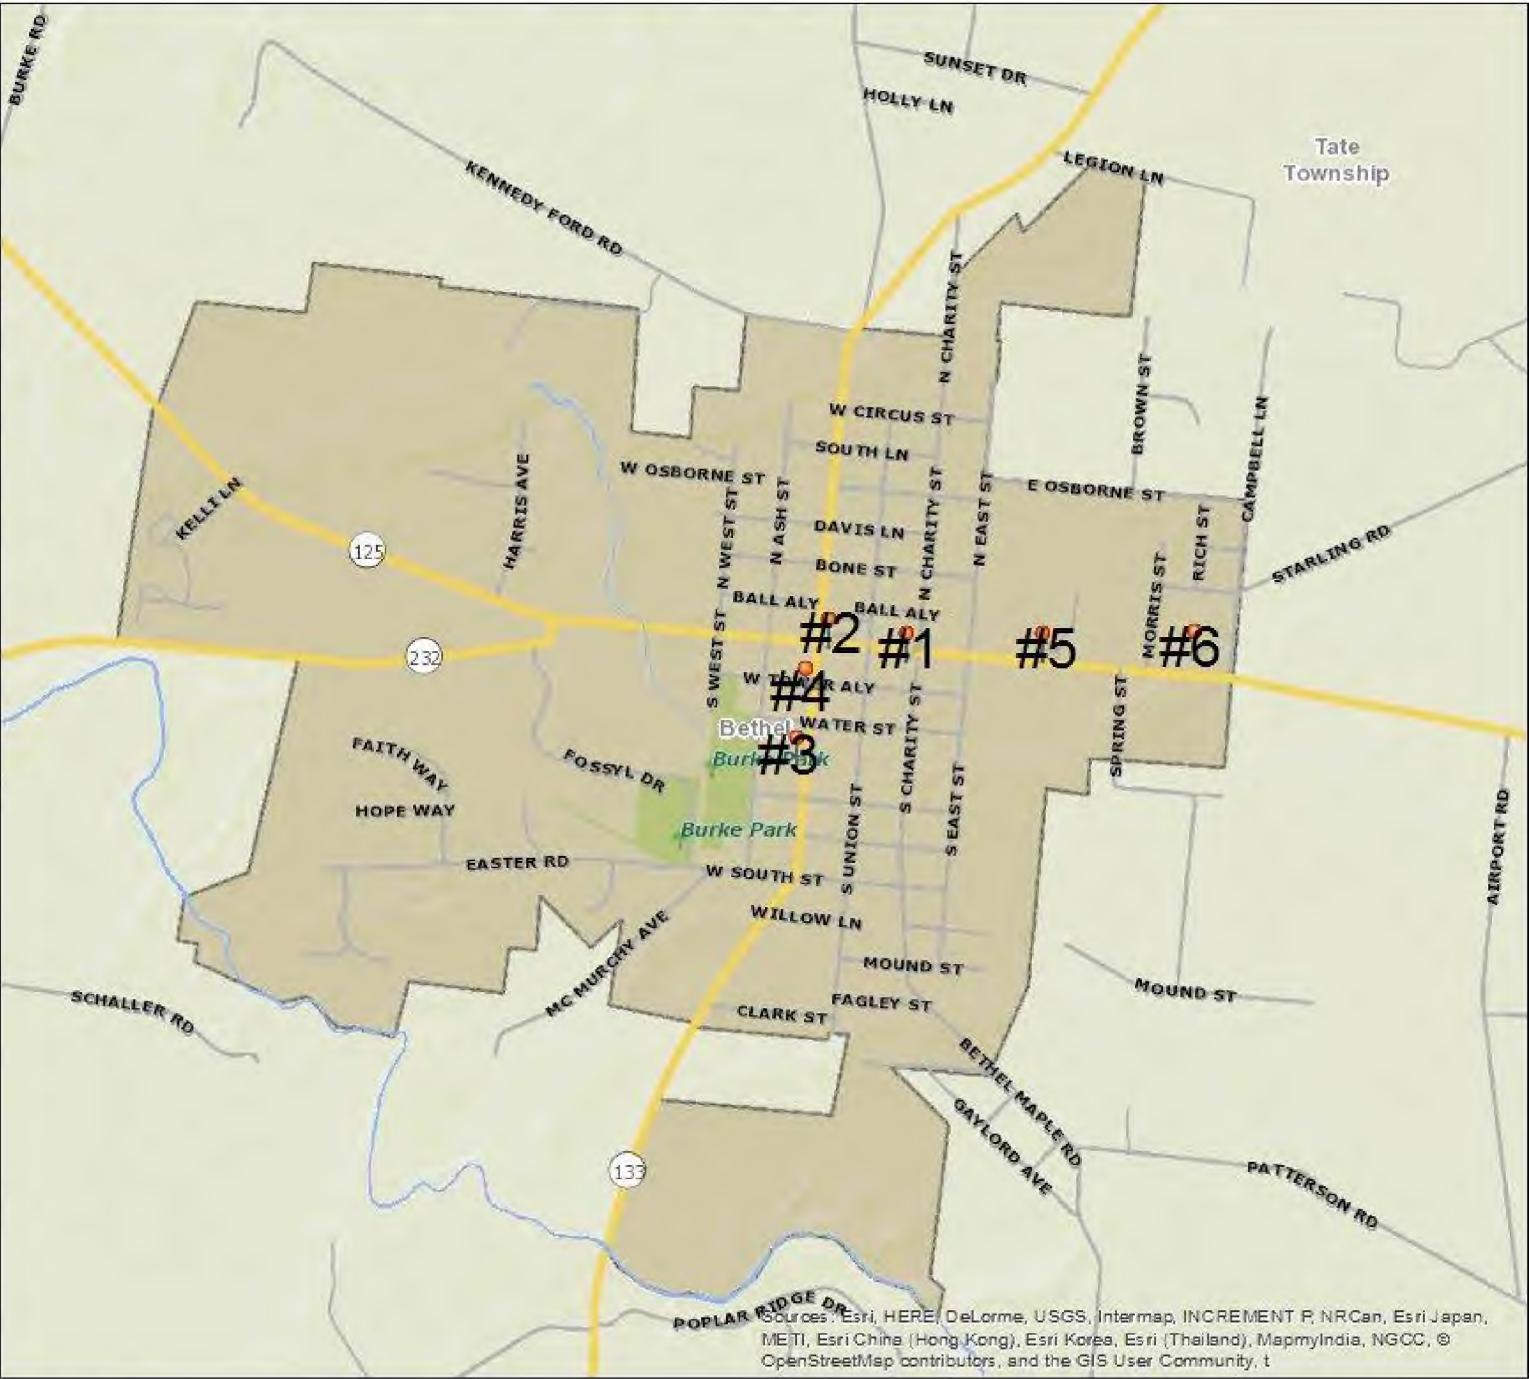
# Village of Bethel Lead Survey Locations

- #1 101 W Plane Street
- #2 235 W Plane Street
- #3 231 S Main Street
- #4 137 S Main Street
- #5 245 E Plane Street
- #6 330 E Plane Street

This survey was conducted in February 2017 on the six oldest properties in the Village of Bethel. None were found to have lead service lines. No lead service lines are known to exist in the Village of Bethel.
