RE: McDonalds Restaurant - Hanley  
Report  
Lead Mapping  
Drinking Water Program  
Richland County  
PWS ID: OH7046312

# HANLEY Rd Mc DONALD'S

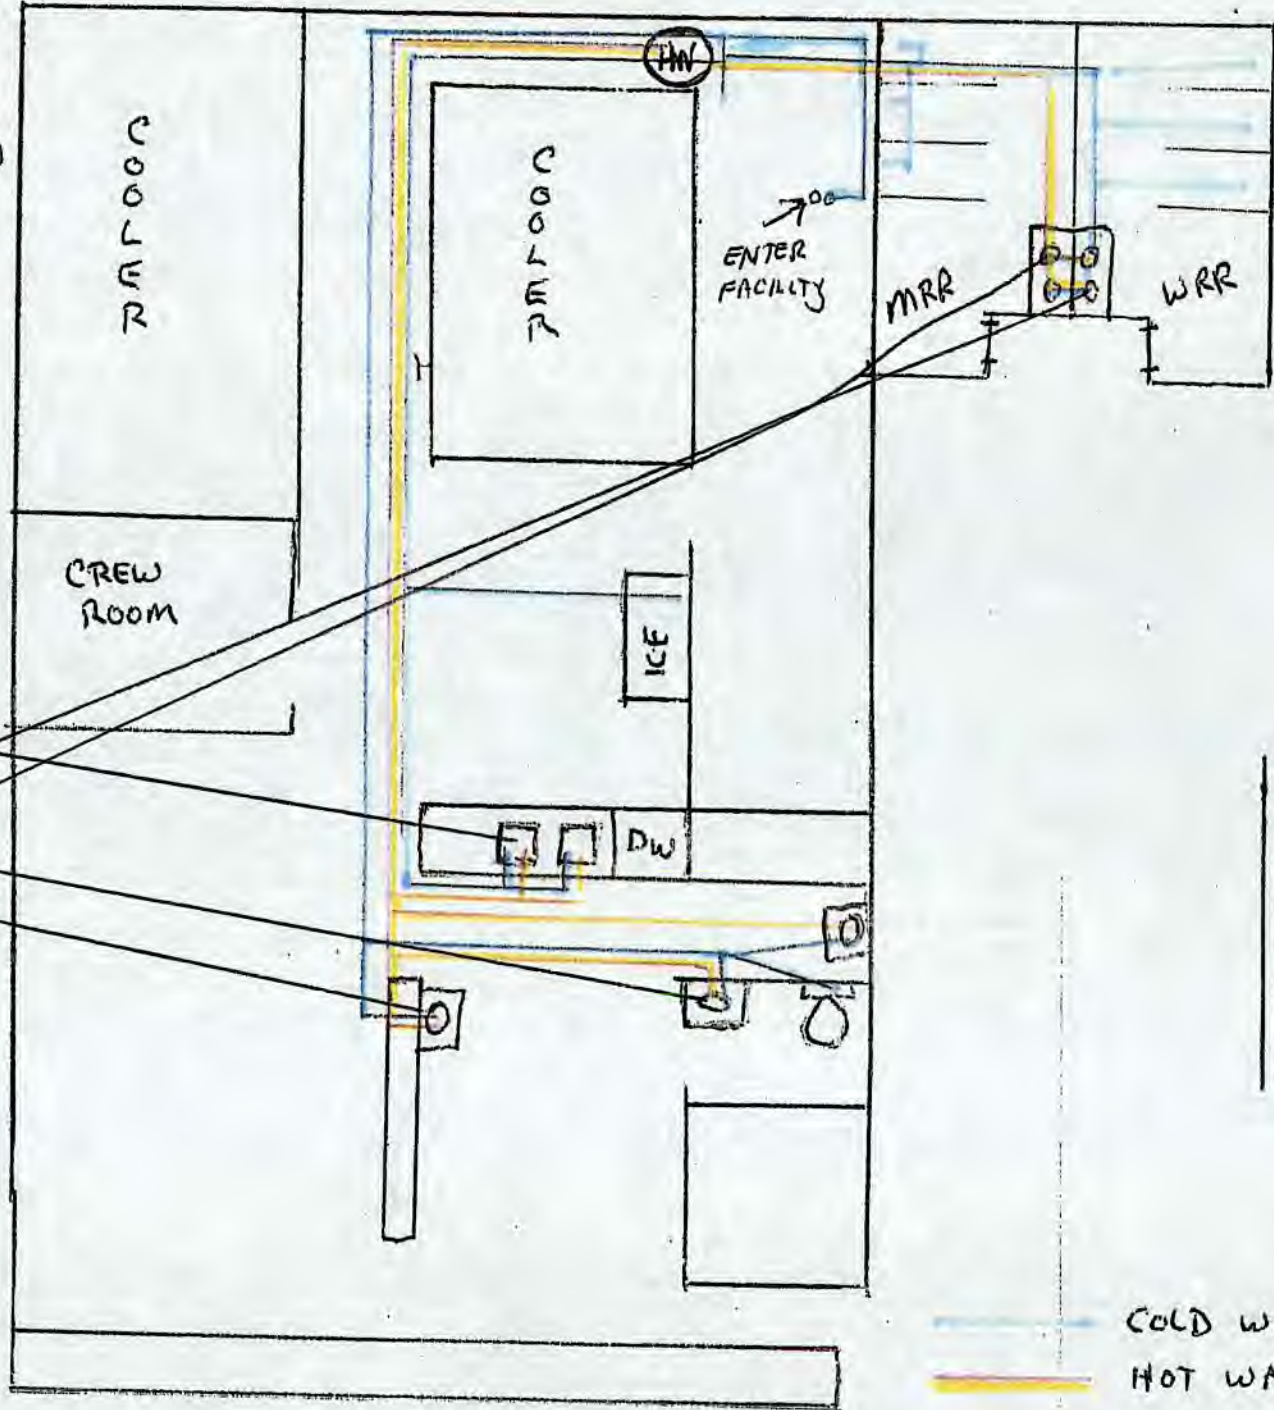
Here is the map for McDonalds Bellville and Hanley Road. Some of the hot water has soldered joints but was in long before the decision was made to reduce lead solder. We have had no lead show up in the water for either McDonalds. We take five samples from all the sinks in the resauarnt and have no lead show up.

PWSID 7046312  
 25 HANLEY Rd MAPSFIELD OH  
 LINES: PLAS, CU  
 HOT WATER HAS LEADED  
 SOLDER  
 SOLDERED JOINT CONTAIN  
 LEAD  
 FIXTURES MIGHT CONTAIN  
 LEAD

HANLEY Plumbing  
 1980
