Water Line Overview, Layer Site 1 EPA Well

Well Site to Water Room

Trillum Farms, Layer 1
11995 Croton Rd
Croton, OH 43013

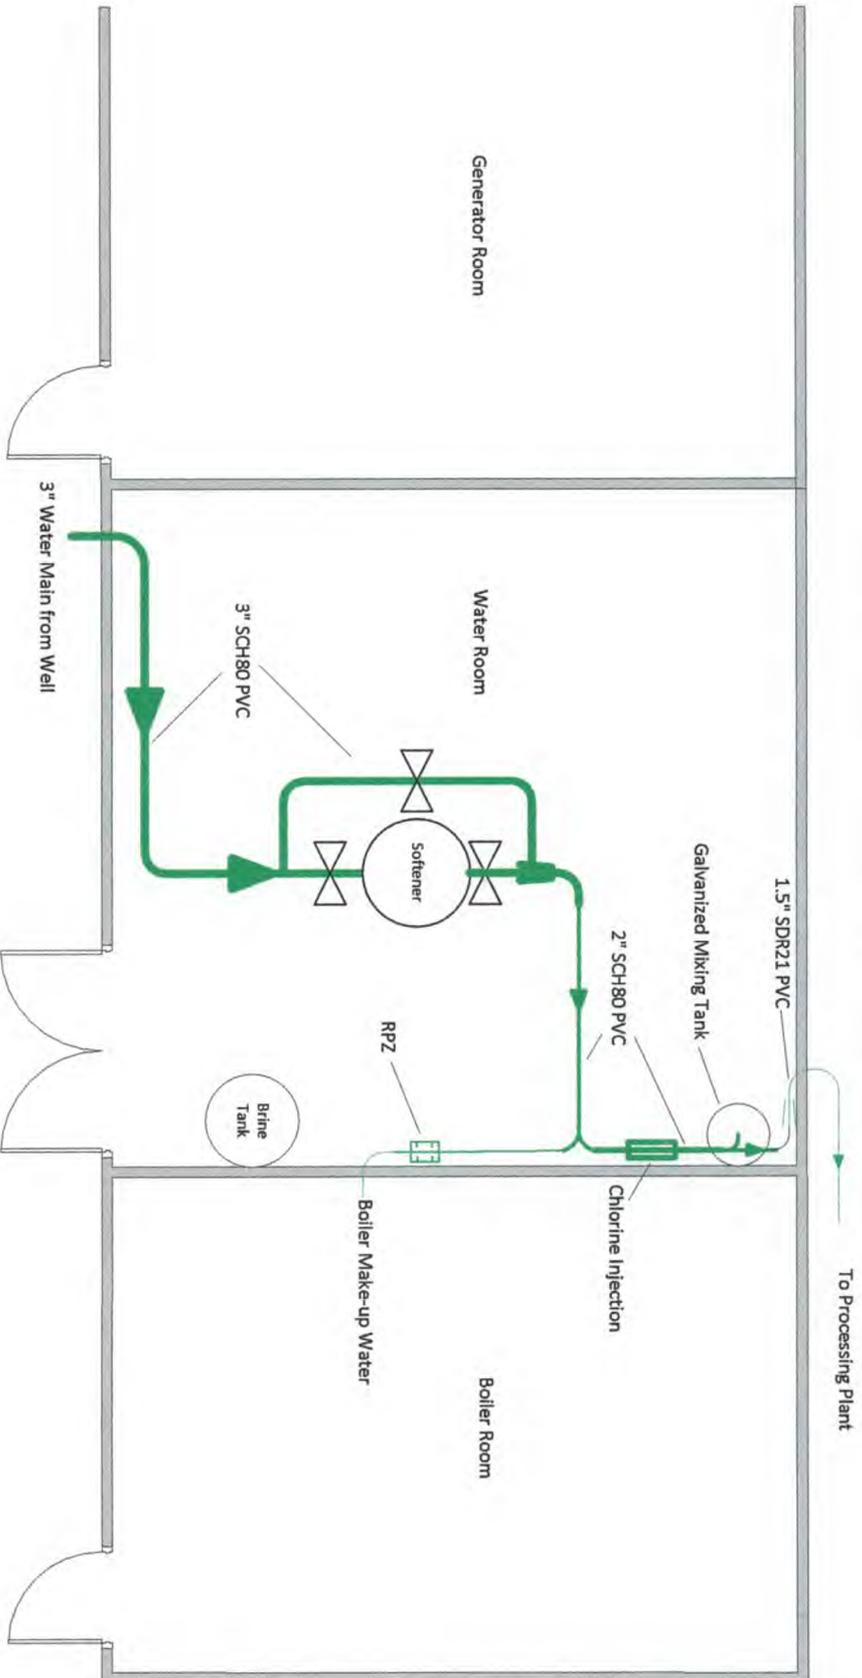
*** No Copper/Lead pipe or fittings in this water room**

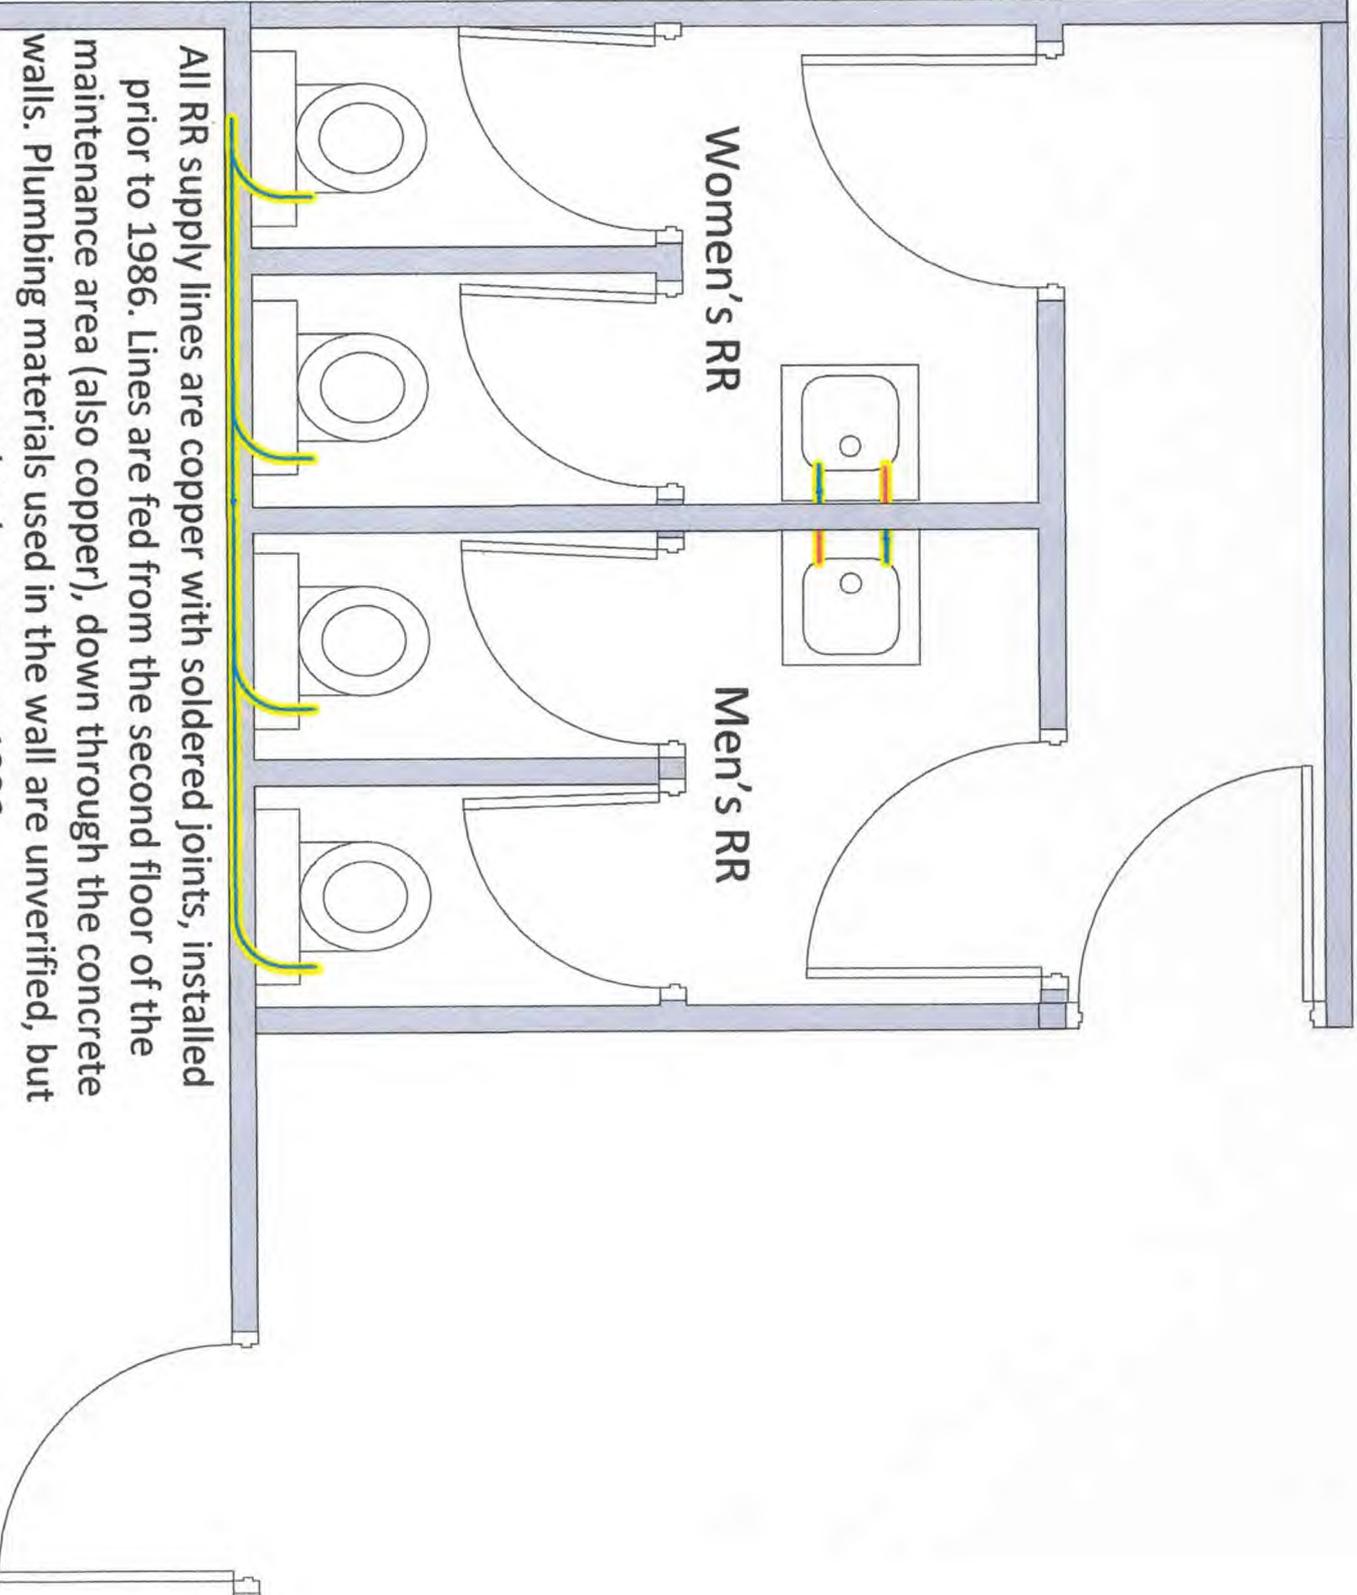
All RR supply lines are copper with soldered joints, installed prior to 1986. Lines are fed from the second floor of the maintenance area (also copper), down through the concrete walls. Plumbing materials used in the wall are unverified, but assumed to be copper <1986.

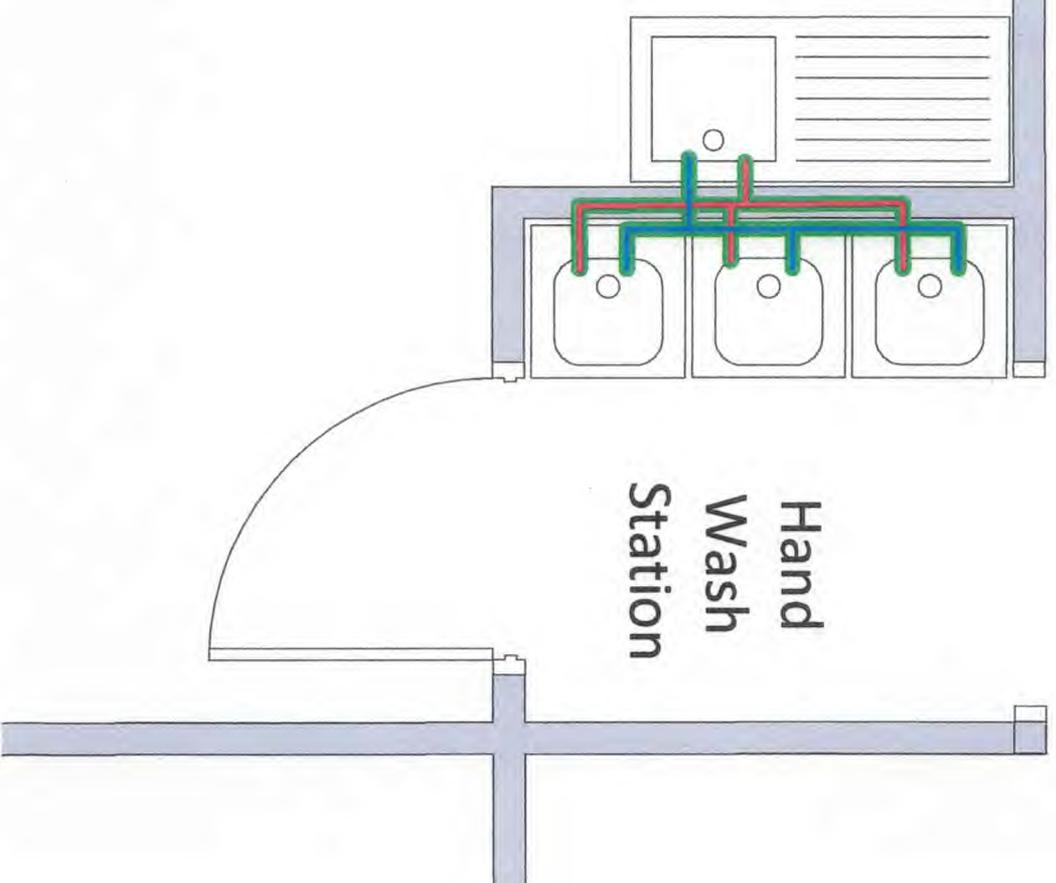
Hand Wash and Break Room sinks supply lines are CPVC/PEX. Lines are fed from the second floor of the maintenance area (also copper), down through the concrete walls. Plumbing materials used in the wall are unverified, but assumed to be copper <1986.
