RE: ALLEN EAST COMMUNITY
CENTER

Report
Drinking Water Program
Allen County
PWS ID: OH0235412

LEAD SERVICE MAP

Allen East Community Center
9520 Harrod Rd. - Harrod, OH 45850 - (419) 648-9271

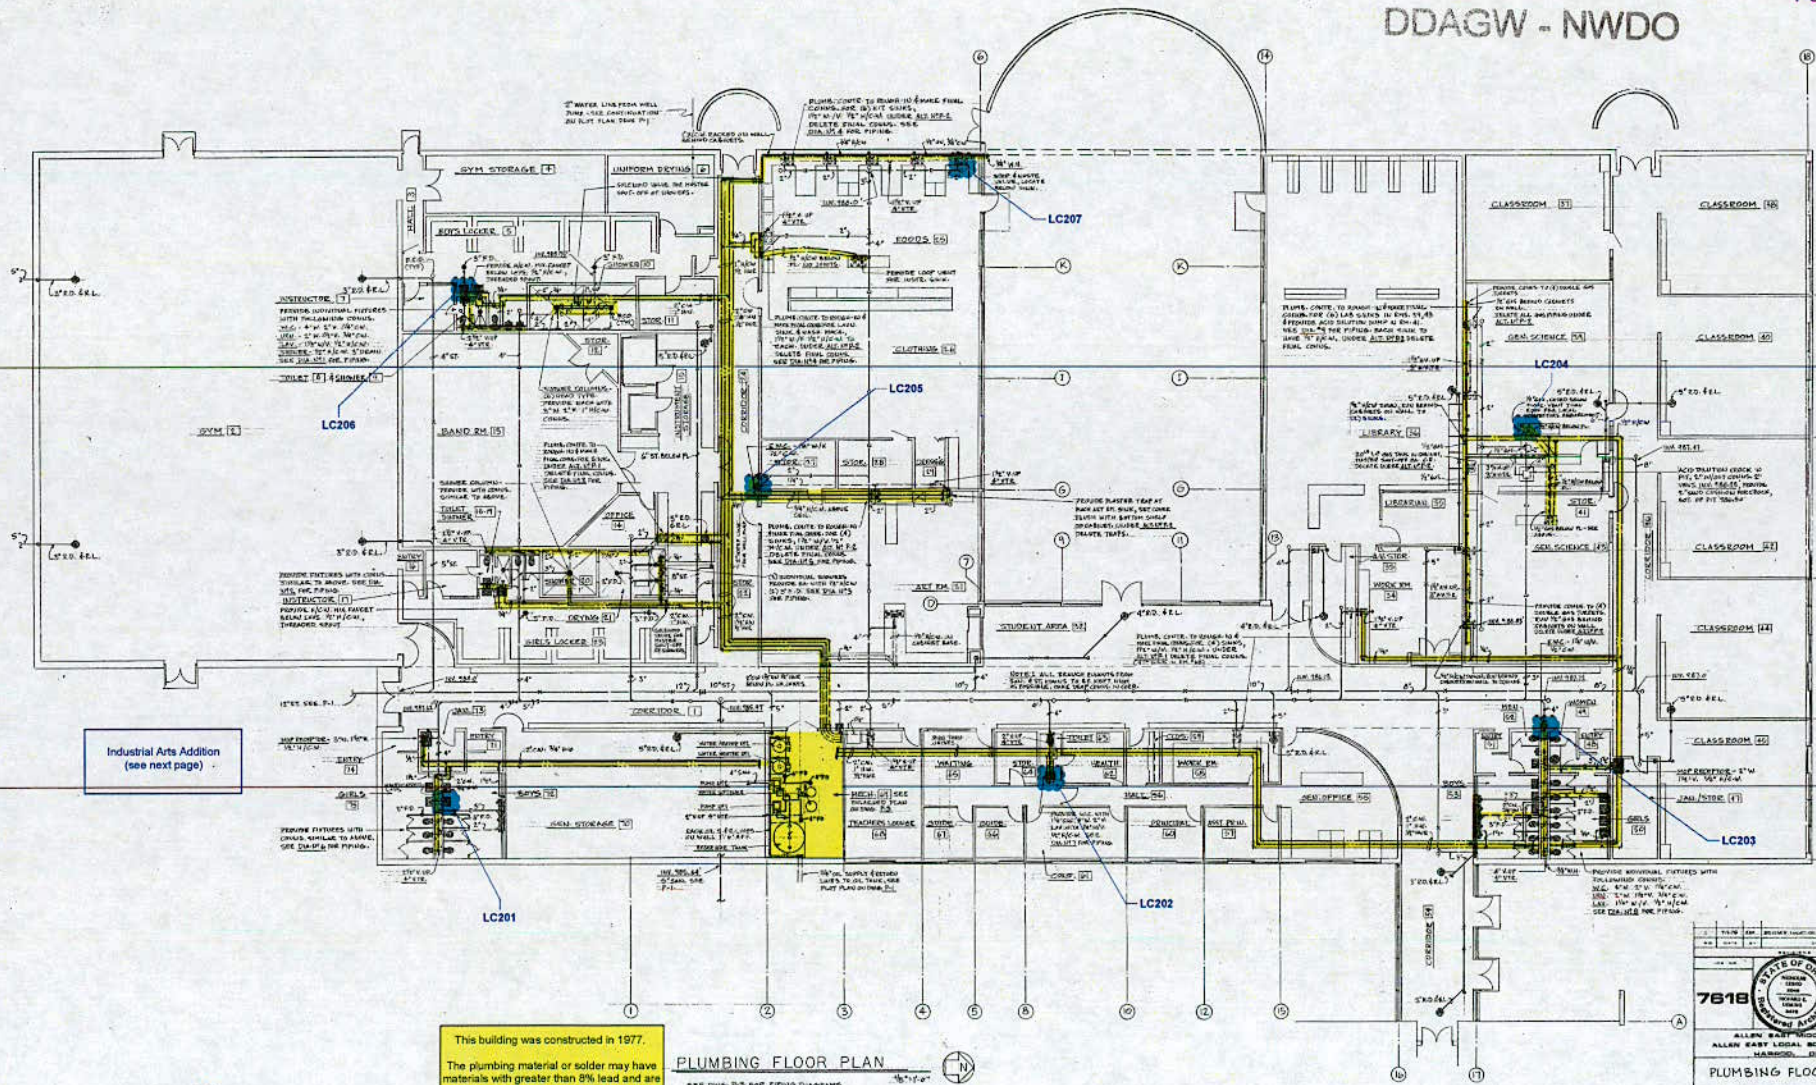
This building was constructed in 1977.
The plumbing material or solder may have materials with greater than 8% lead and are at a higher risk of contributing lead to the drinking water than materials manufactured after 1998.

Lead & Copper Sample Site

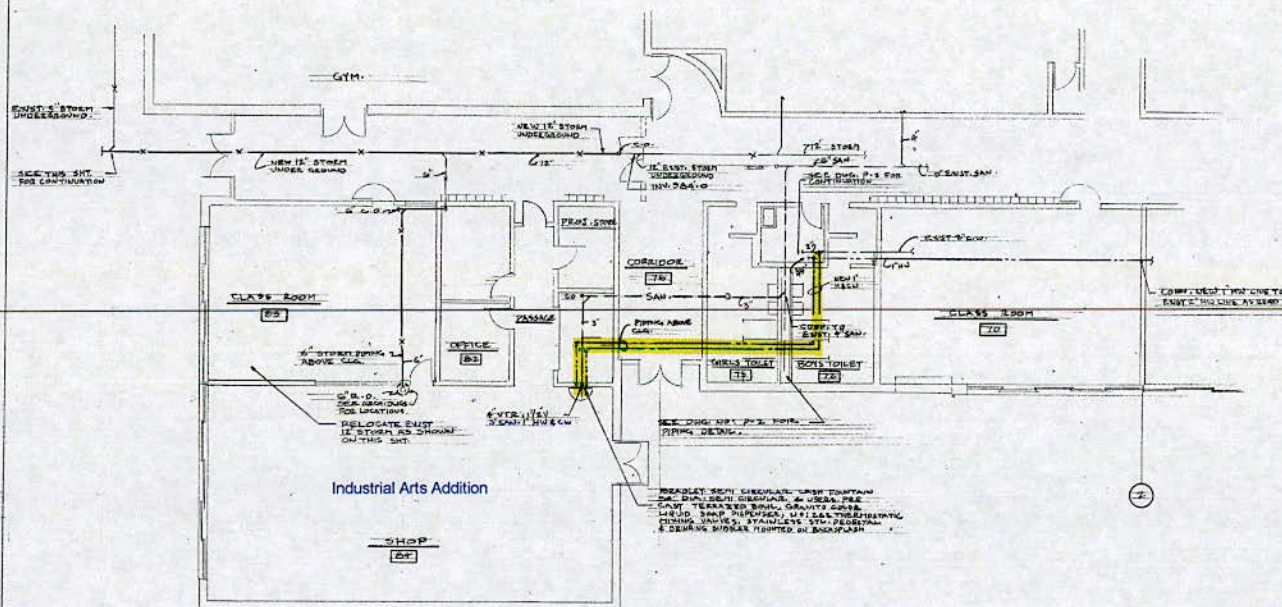
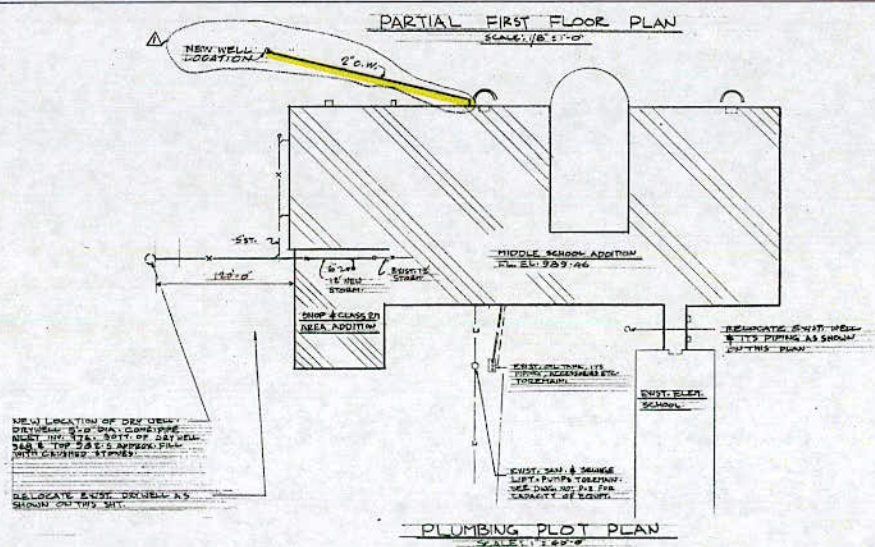
SHEET NO.
SUPP.
P. 4

This building was constructed in 1977.

The plumbing material or solder may have materials with greater than 8% lead and are at a higher risk of contributing lead to the drinking water than materials manufactured after 1998.

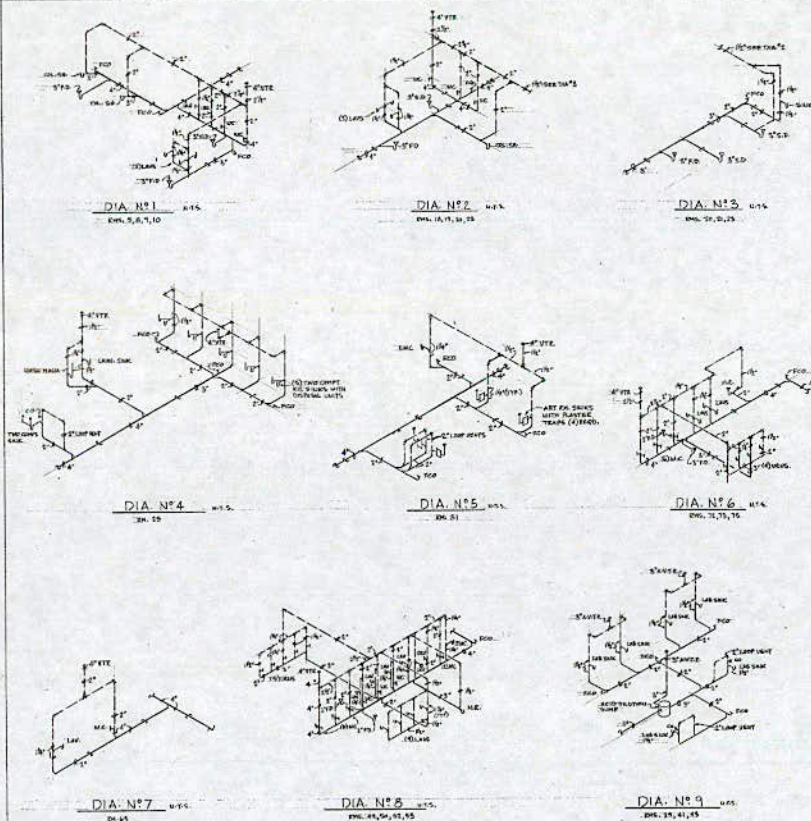
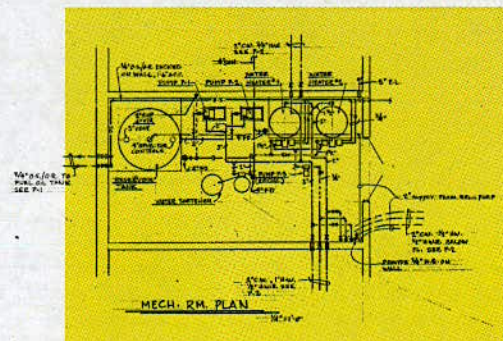
7518	REV	REVISION (NUMBER OF REV., DATE, AND BY WHOM)
7518	1	1
7518		
ALLAN EAST LOCAL SCHOOL DISTRICT HARRISBURG, OHIO		
PLUMBING DIAGRAMS		
DRAWN BY: LEUNG ASSOCIATES INC. ARCHITECTS 1000 EAST 10TH STREET A.D.G. FEB. 12, 1977		
P.3		5

This building was constructed in 1977.
The plumbing material or solder may have materials with greater than 8% lead and are at a higher risk of contributing lead to the drinking water than materials manufactured after 1998.
