RE: GRAYMONT DOLIME (OH)
Report
Drinking Water Program
Ottawa County
PWS ID: OH6254112

GRAYMONT DOLIME (OH) INC

21880 West State Route 163, PO Box 158, Genoa, Ottawa County, Ohio
PWS #OH6254112

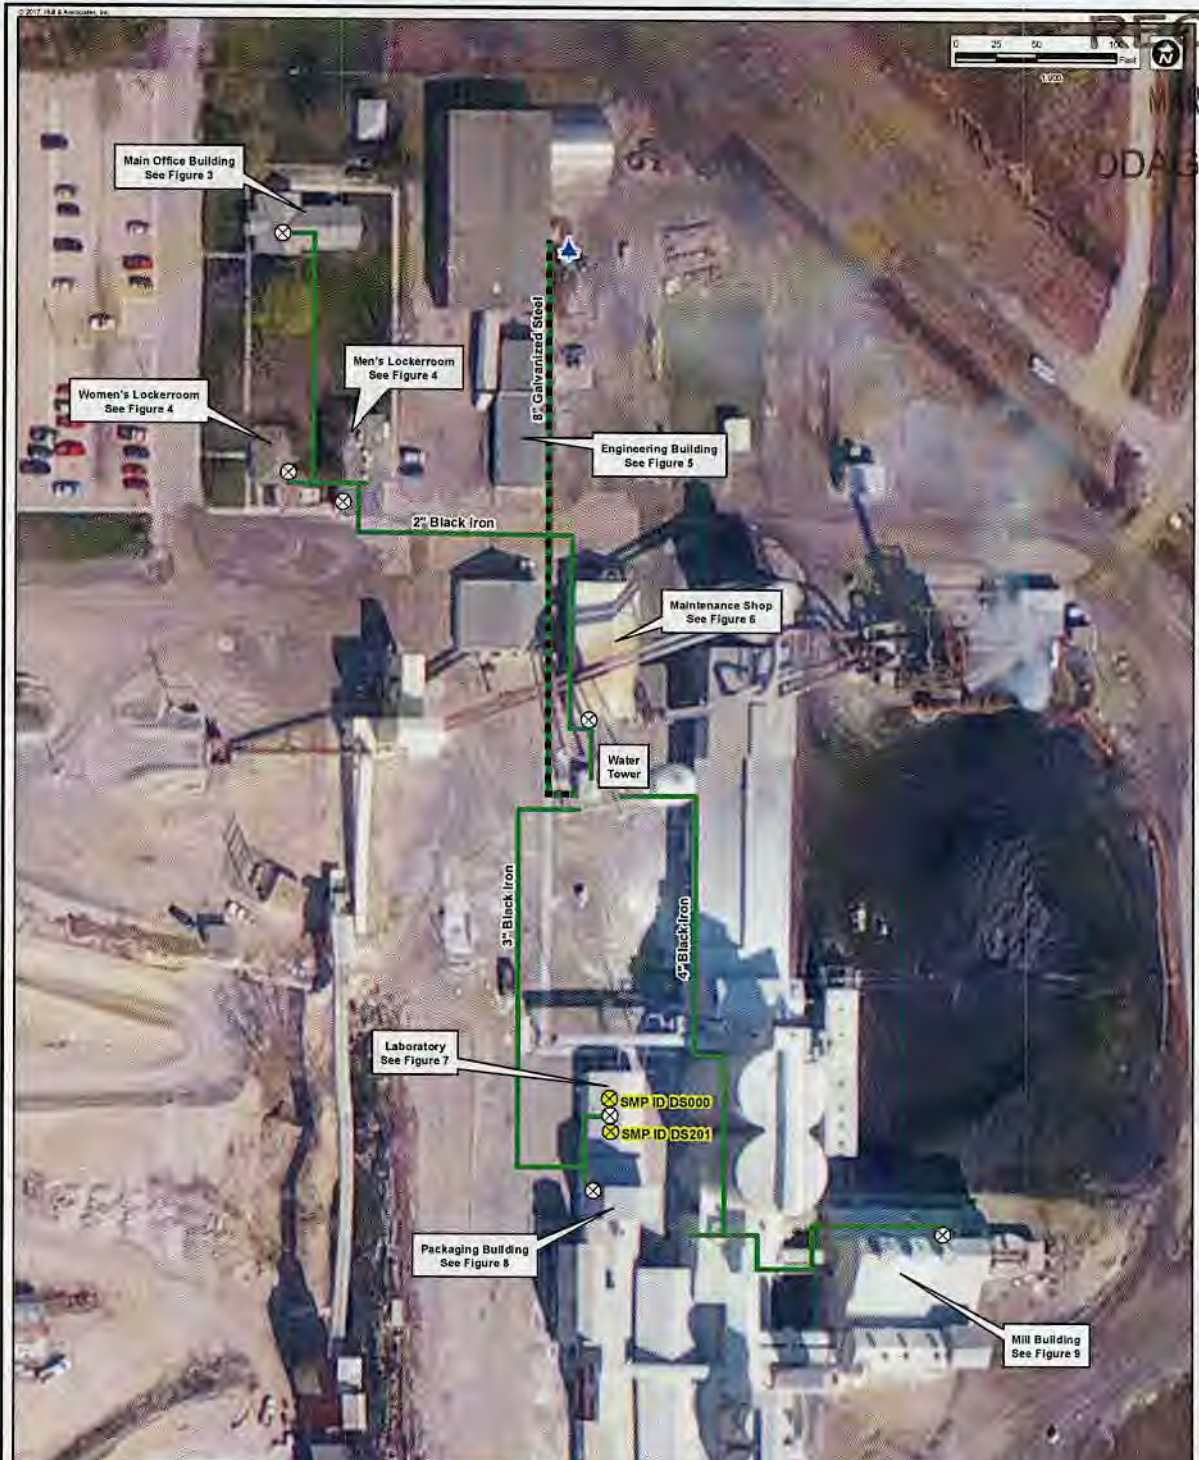
March 2017
 Water Supply Mapping
 Gaymont Doline Facility
Facility Layout
 21880 West State Route 163
 Genoa, Ottawa County, Ohio
 Figure
2

4) Based on information from facility personnel, the distribution piping is constructed of black iron with screwed or bolted joints/fittings. This black iron pipe was visually observed in some locations throughout the facility.

5) Most of the building construction occurred in the 1940s and 1950s, with the exception of the main office and engineering buildings, that were constructed in the 1980s.

6) No drinking fountains were observed in any of the facility buildings. Drinking water is provided in bottled water coolers throughout the facility.
 7) The aerial photo was acquired through the ESRI Imagery web service. Aerial photography dated 2015.

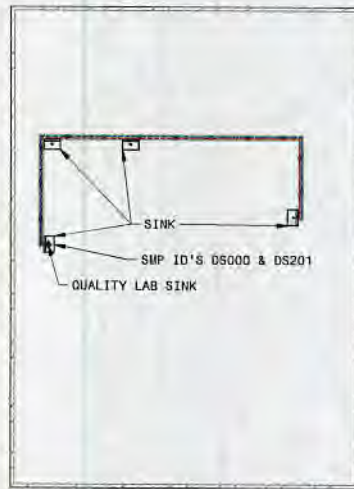
WATER SUPPLY MAPPING
GRANDVIEW OILFIELD FACILITY
FIGURE 7
LABORATORY

1. NO WATER FOUNTAINS OBSERVED WITHIN THE BUILDING.
2. BLACK IRON, GALVANIZED STEEL AND COPPER PIPING WAS OBSERVED DURING THE SITE INSPECTION.
3. EXACT LOCATION OF WATER SERVICE LINE TO BUILDING IS NOT KNOWN.

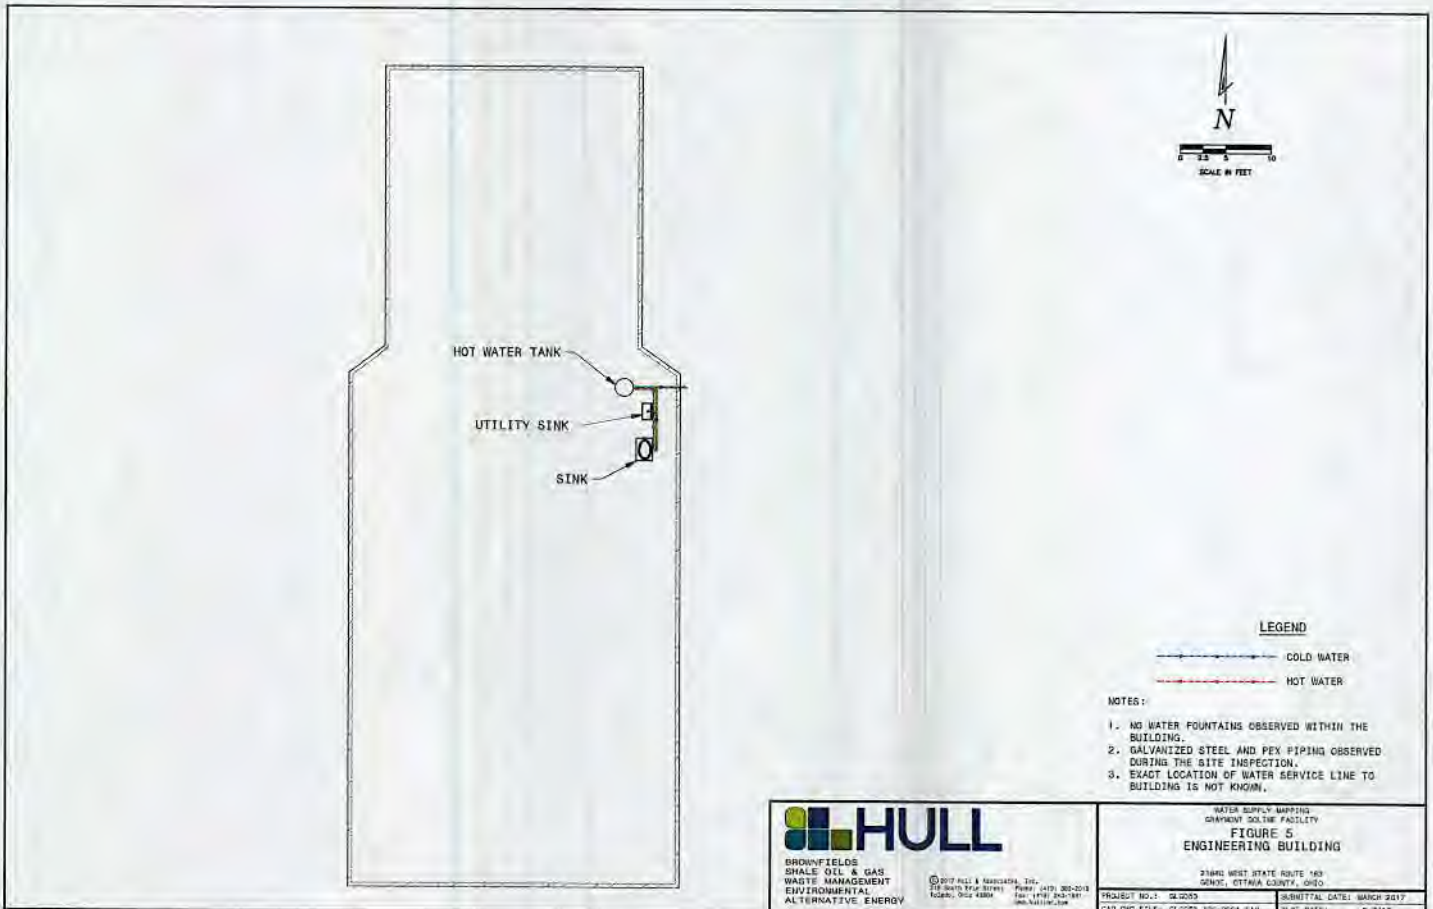
WATER SUPPLY MAPPING
CHRYSLER SOLAR FACILITY
**FIGURE 5
ENGINEERING BUILDING**
21800 WEST STATE ROUTE 149
GENEO, OHIO 43024, OHIO

1. NO WATER FOUNTAINS OBSERVED WITHIN THE BUILDING.
2. GALVANIZED STEEL AND PEV PIPING OBSERVED DURING THE SITE INSPECTION.
3. EXACT LOCATION OF WATER SERVICE LINE TO BUILDING IS NOT KNOWN.
