PWS Name ASHANTON DAYCARE

PWS ID OH7136514

REVIEW CHECKLIST FOR 6109.121(F) LCR MAPPING

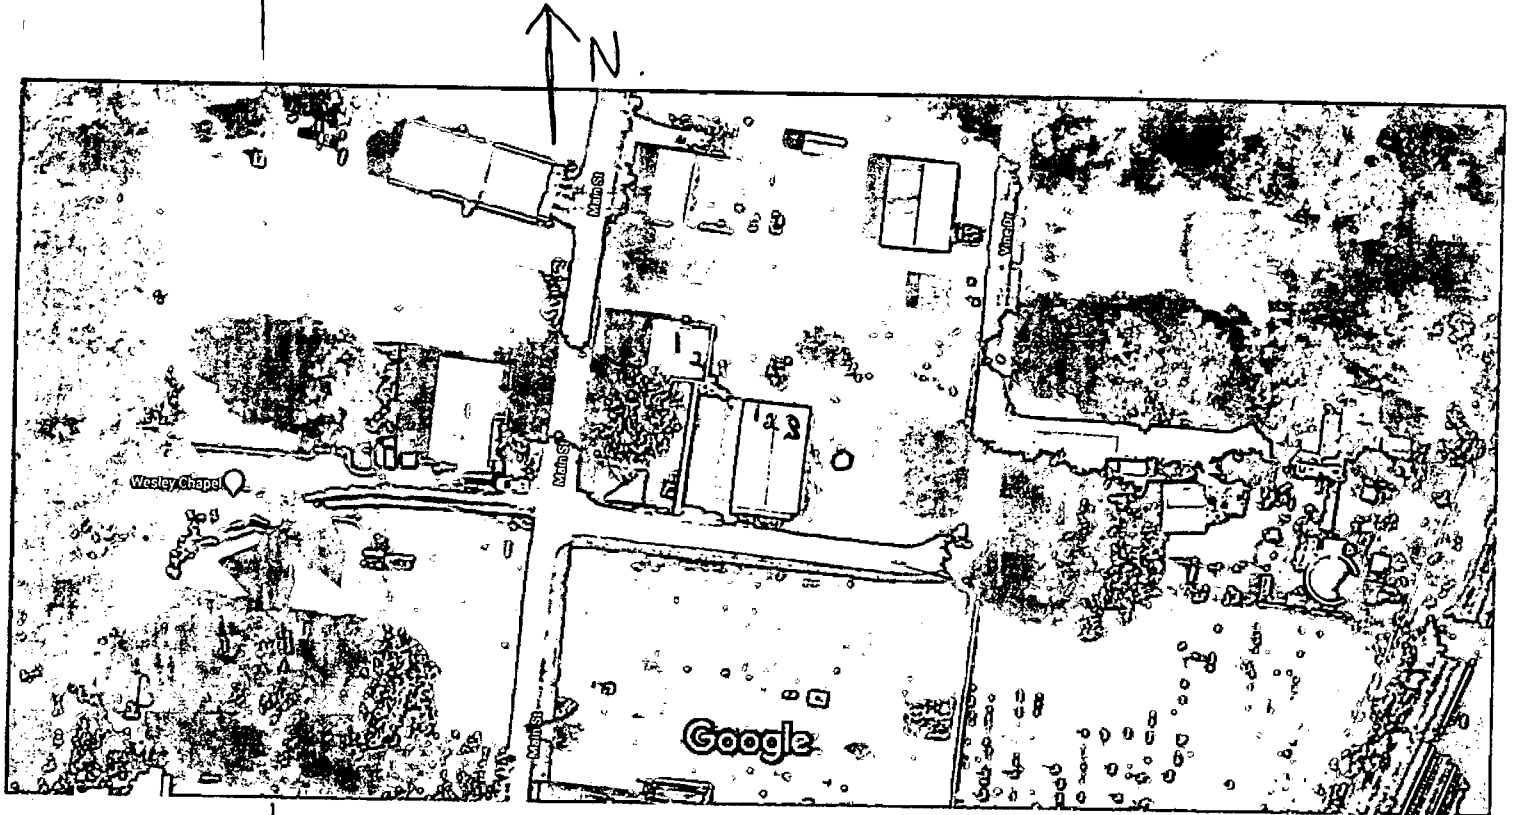
Legend = PVC/Plastic

Comments: CUSTOMER SAID POLE BUILDING WAS BUILT IN 1989 AN ONLY PVC
WATER LINES WERE USED.

HOUSE WAS BUILT IN 1923. BETWEEN 1986/1987 ALL PLUMBING WAS REPAIRED
WITH PVC
