Re: Lordstown Battery Cell Plant Permit - Intermediate Application and Support 401 Wetlands Trumbull County DSW401206639

Application for Section 401 Water Quality Certification

C. Brief Project Description/Purpose: Const	struct a mass-production battery cell manu	ufacturing facility for future electric vehicles
D. Construction Timeframe (Provide "start	t and end dates): April 2020	January 2022
		rr-The-Fact" permit application? YES NO the unauthorized impacts on waters of the state:

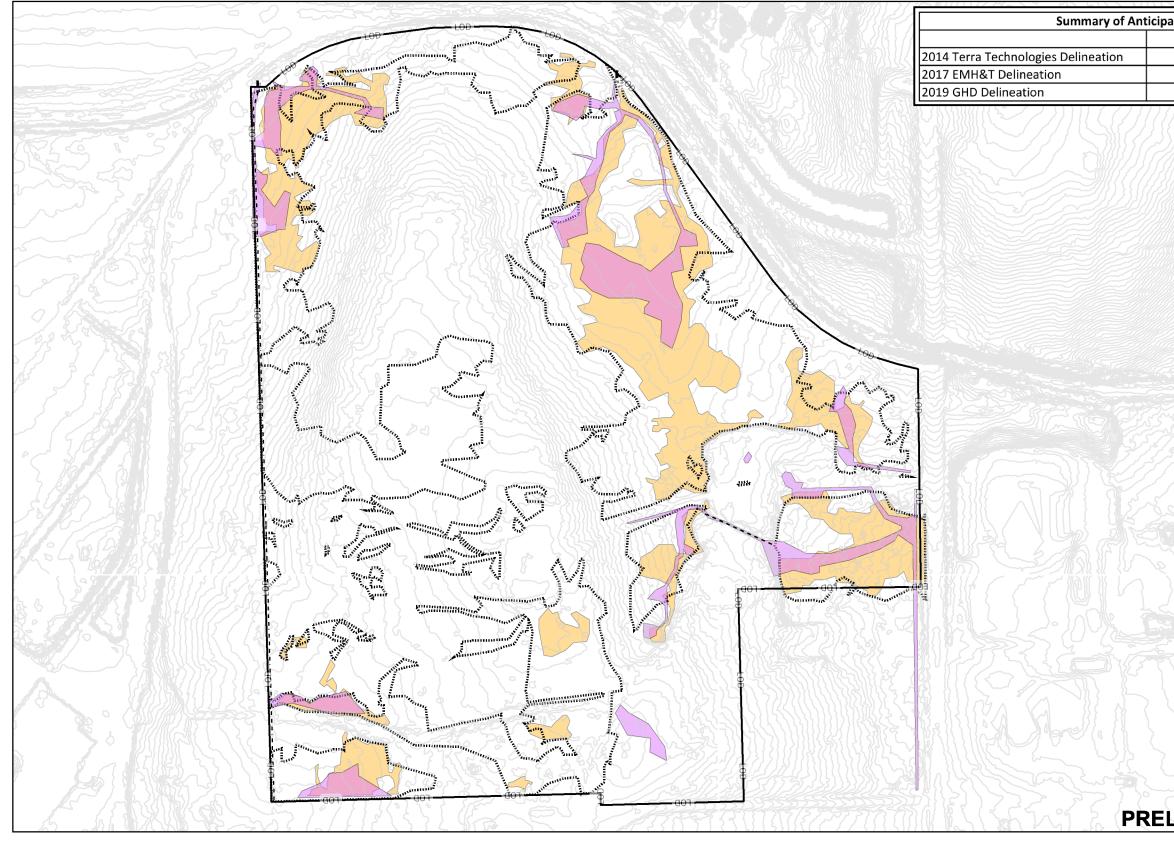
PROJECT MAGELLAN WETLAND DELINEATIONS 2014 - 2017 - 2019 GENERAL MOTORS, LLC CITY OF LORDSTOWN, TRUMBULL COUNTY, OH

The site was historically agricultural. Farming ceased in the 1970's and 1980's. Wetlands on the NorthPoint site were delineated on September 30, 2014 and October 1, 2014 by Terra Technologies, a consulting firm based in Leawood, Kansas. Investigators from Terra Technologies observed ten (10) wetlands on the site totaling 8.81 acres and three (3) stream segment totaling 2,597 linear feet on-site. The delineation was submitted to the USACE in October 2014 (Figure 3).

In April 2017, EMH&T and the USACE conducted a joint site visit to observe the current site conditions. During that site visit, it appeared that wetlands on the site either had expanded outside their original boundaries or were larger than originally delineated. Some other areas on the site appeared to be holding water in uplands due to severe rutting caused by equipment used during the 2015 clearing activity. According to the EMH&T 2017 report, it was agreed that these upland areas holding water would not be considered wetlands at the time of the Corps April 2017 site visit. On May 22, 2017 through May 24, 2017, EMH&T conducted a delineation of the NorthPoint property. All wetland boundaries were flagged and surveyed using a handheld GPS unit. Delineation datasheets were completed for all delineated wetlands. EMH&T observed that the boundaries of most wetlands had expanded in size since the 2014 Terra Technologies delineation was completed and several additional wetlands were identified and delineated. EMH&T identified 24.56 acres of wetlands on-site, and 0.21 acre of wetland in the right-of-way of Tod Ave SW, and three (3) stream segments totaling 3,040 linear feet on-site. The Corps issued a preliminary jurisdictional determination (LRP 2014-1077) on December 20, 2017 based on EHM&T's 2017 wetland delineation (Figure 3).

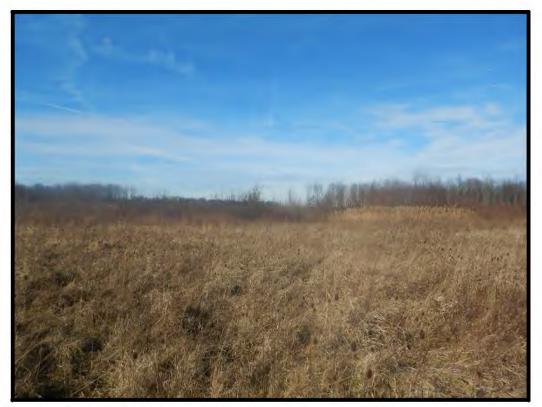
Figure 8. Typical conditions within the eastern portion of the project.

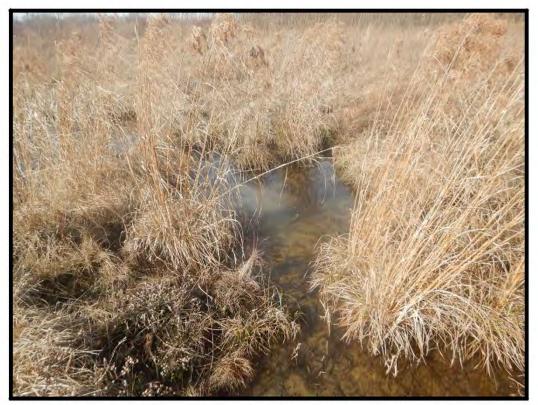
Figure 9. Some of the conditions within the designated wetlands.

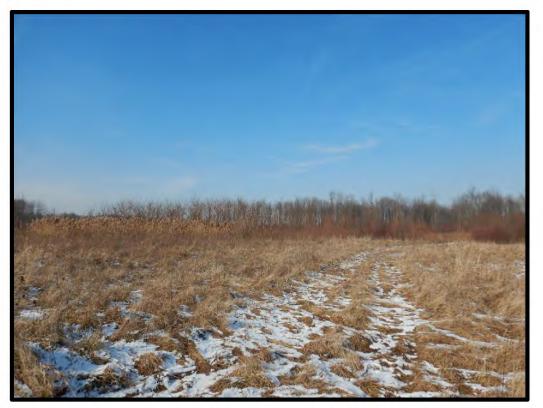
Figure 7. View of the general conditions of the project area facing north.

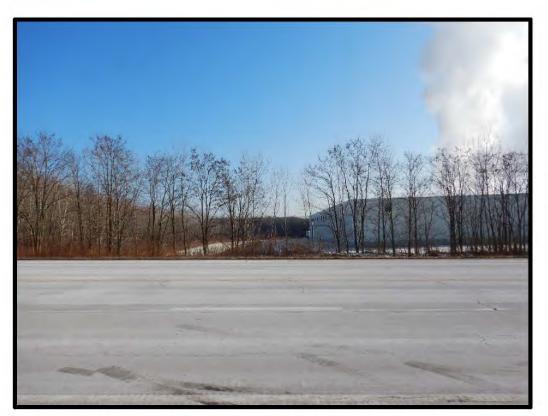
Figure 8. East view of a modern industrial building from the eastern boundary of the project area along Tod Avenue SW (SR 45).
