**Subject: Stark Ceramics –Removal Site
600 West Church Street, East Canton, Ohio
EPA Contract No. EP-S5-13-01
Technical Direction Document No. S05-0001-1405-204
Document Tracking No. 0152**

**FINAL REMOVAL SUMMARY REPORT
FOR THE
Stark Ceramics
600 West Church Street, East Canton, Ohio**

Technical Direction Document No. S05-0001-1405-204
Document Tracking No. 0152

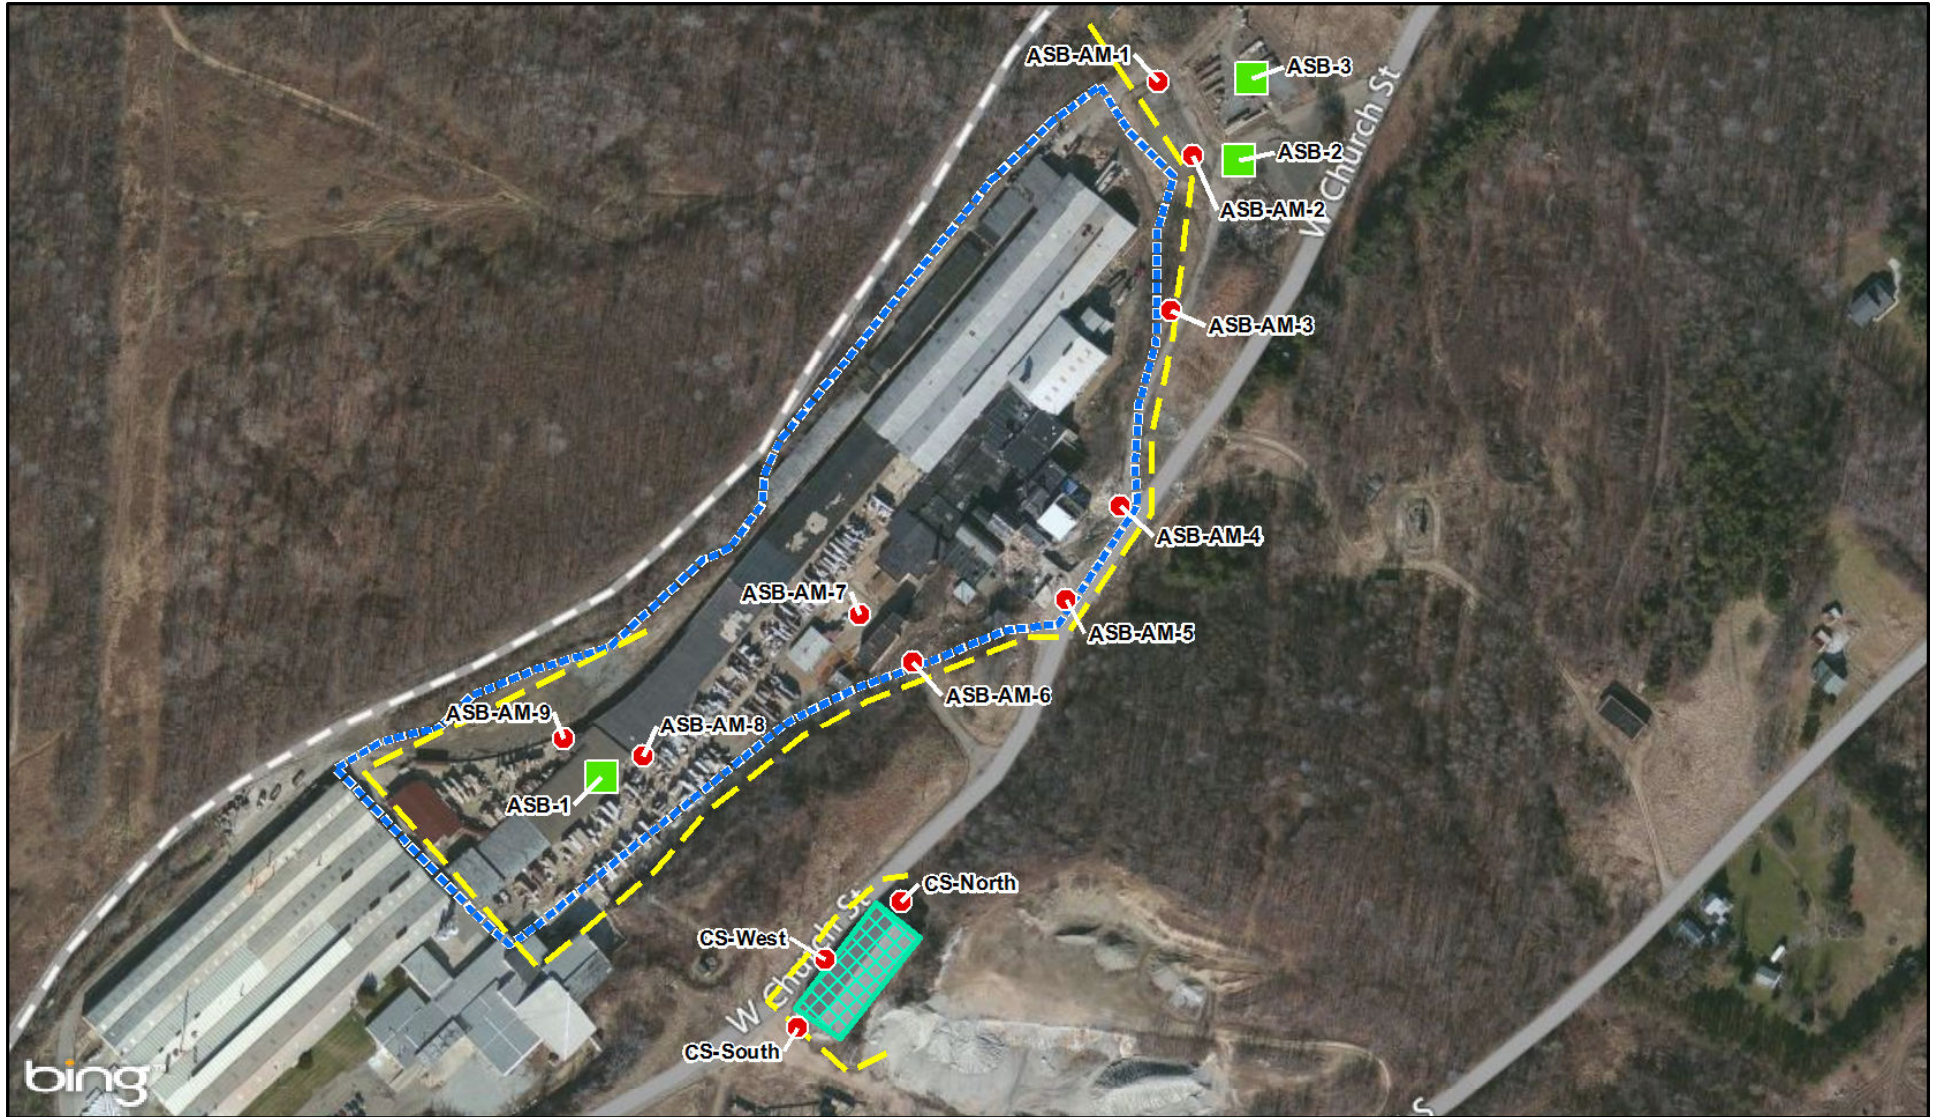
- Air Monitoring Location
- Air Sampling Location
- Air Monitoring Boundary
- Stark Ceramics Plants A & D – Former Manufacturing Area
- Covered Shed

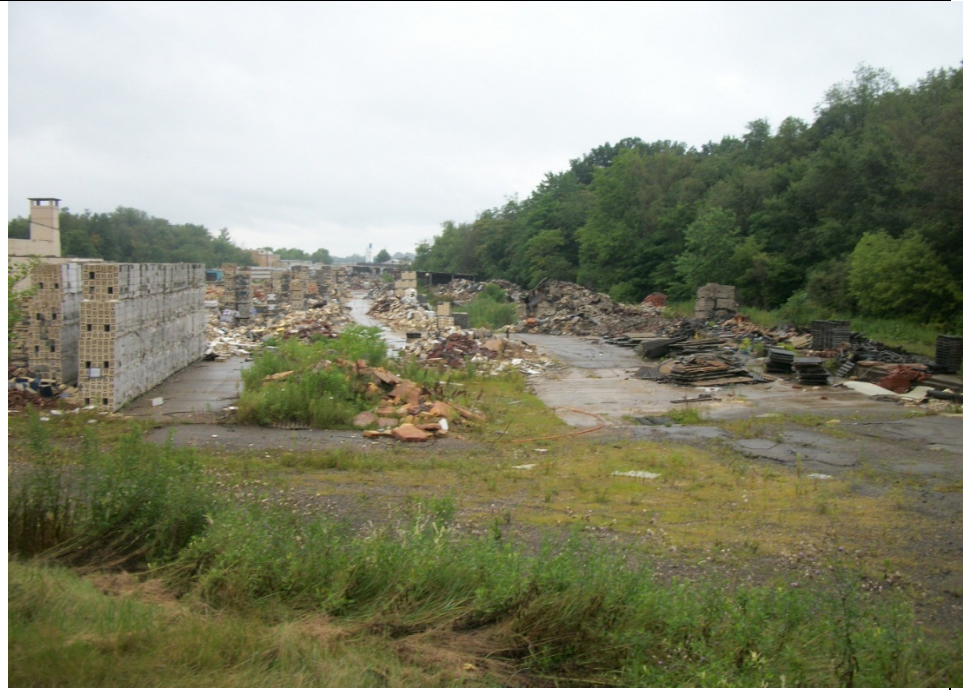
Description:
Asbestos-contaminated demolition debris prior to the start of the removal activities.

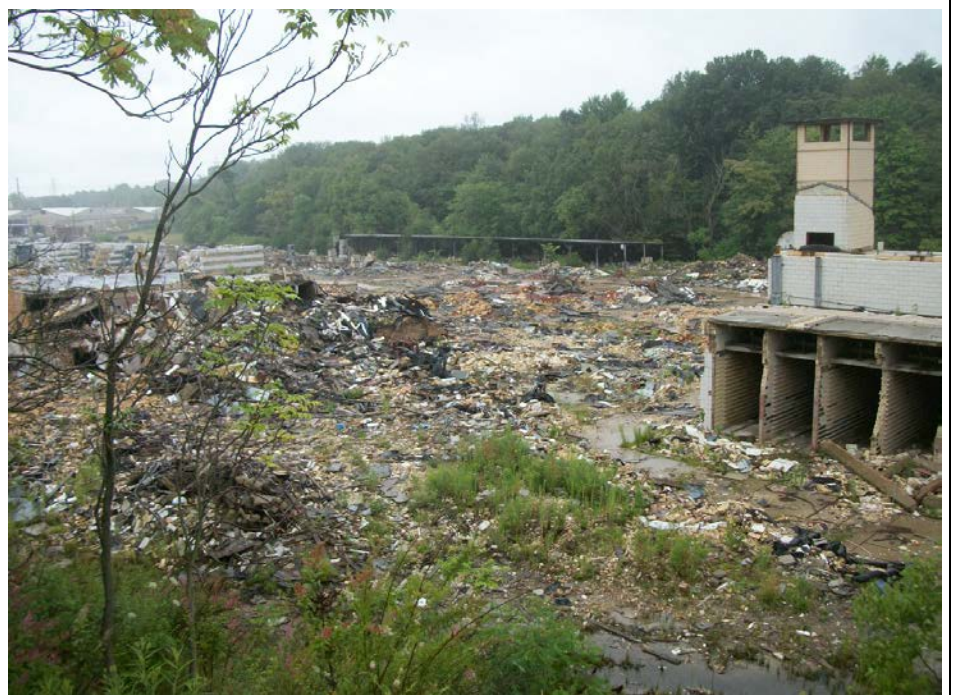
Photograph: 2

Description:
Asbestos-contaminated demolition debris prior to the start of the removal activities.

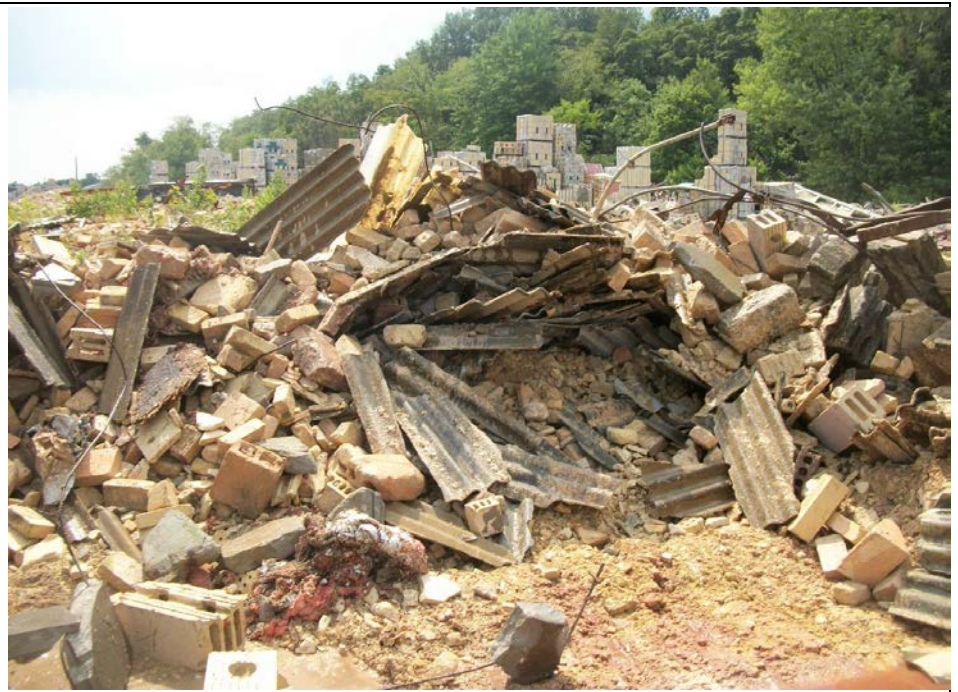
Photograph: 8

Description:
Asbestos-containing cement board panels (transite) mixed in with the demolition debris.

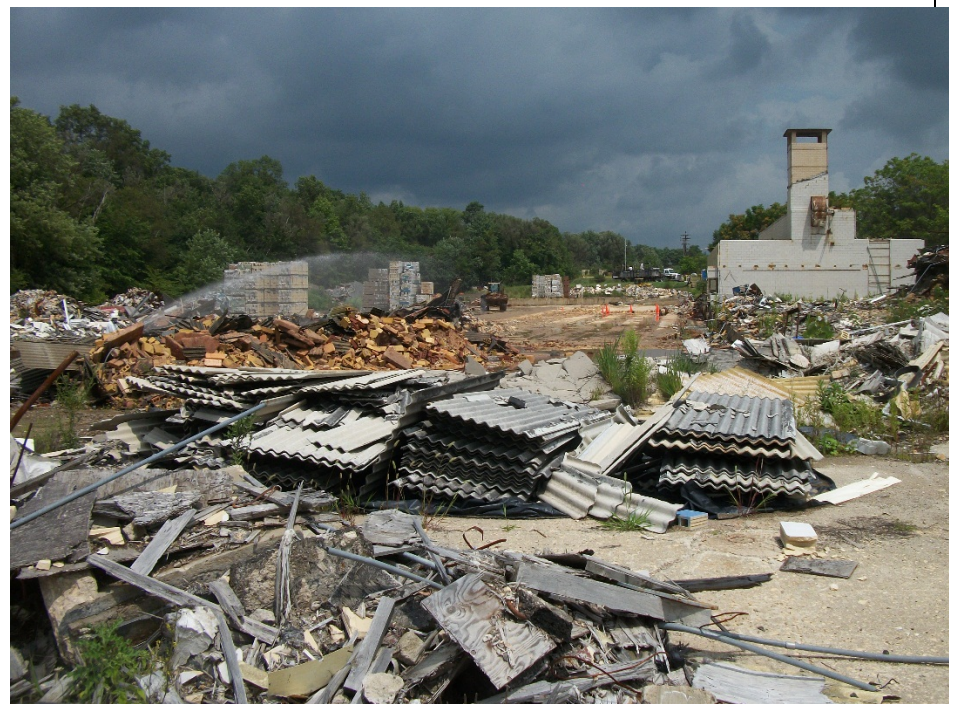
Photograph: 12

Description:
Asbestos-containing cement board panels (transite) mixed in with the demolition debris.

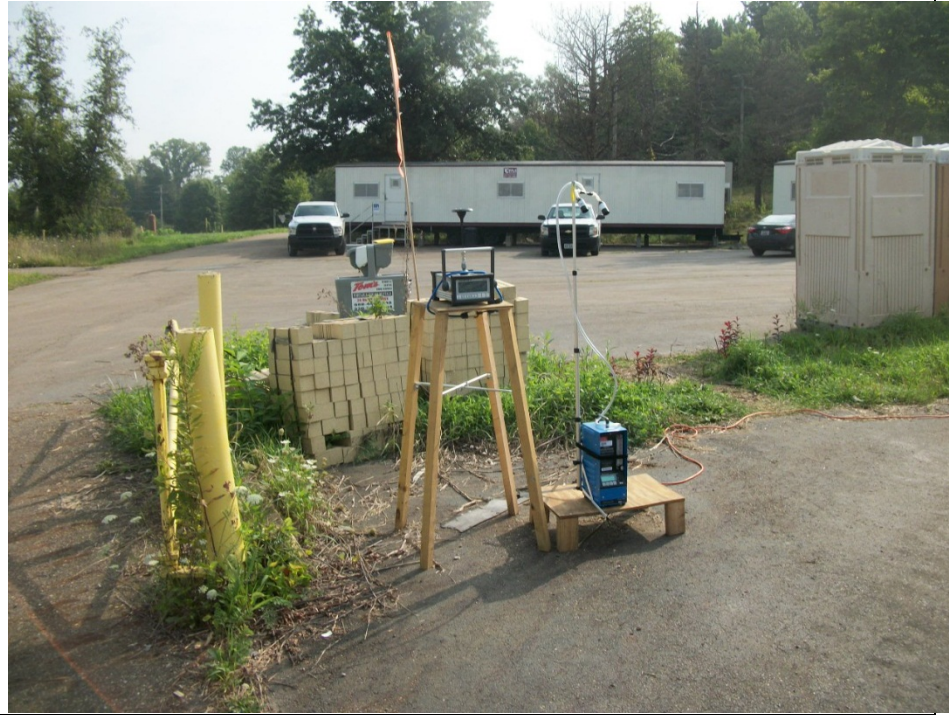
Description:
Air sampling and air monitoring station ASB-2 operational during the removal of the friable ACWM.

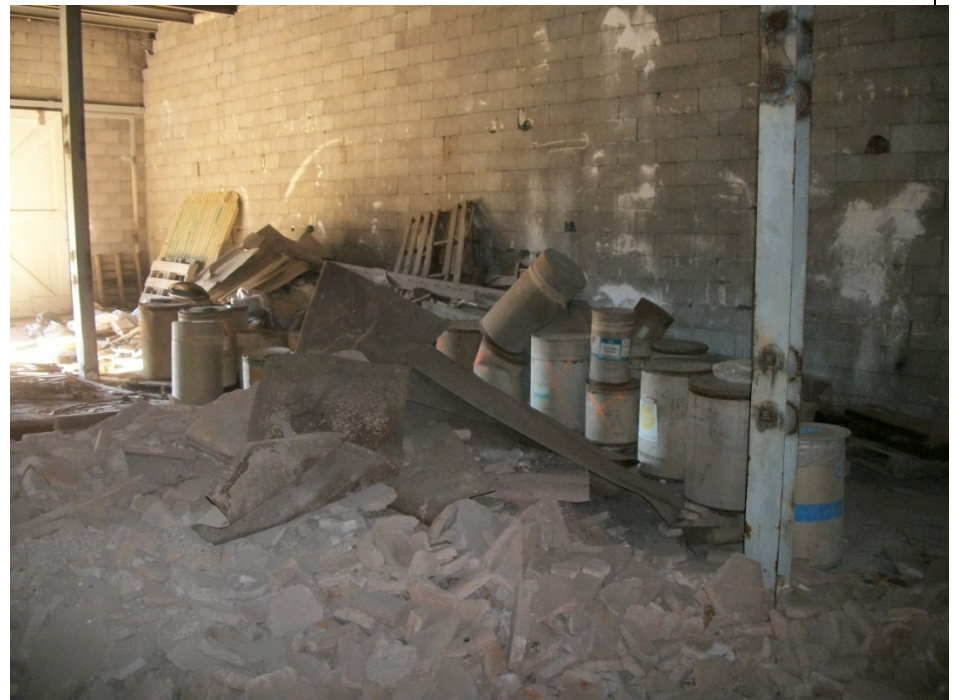
Photograph: 18

Description:
Fiber drums containing color dye powders observed inside the southwestern most building inside the former manufacturing area.

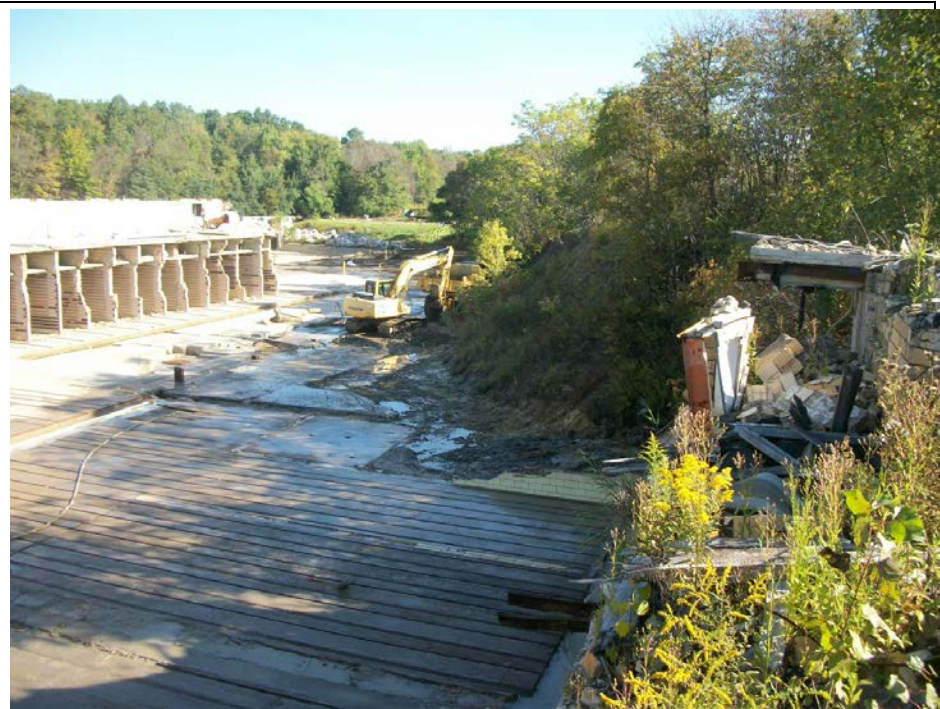
Photograph: 20

Description:
Excavation of transite fragments embedded in the surface soil along the northeast perimeter of the asbestos exclusion zone.

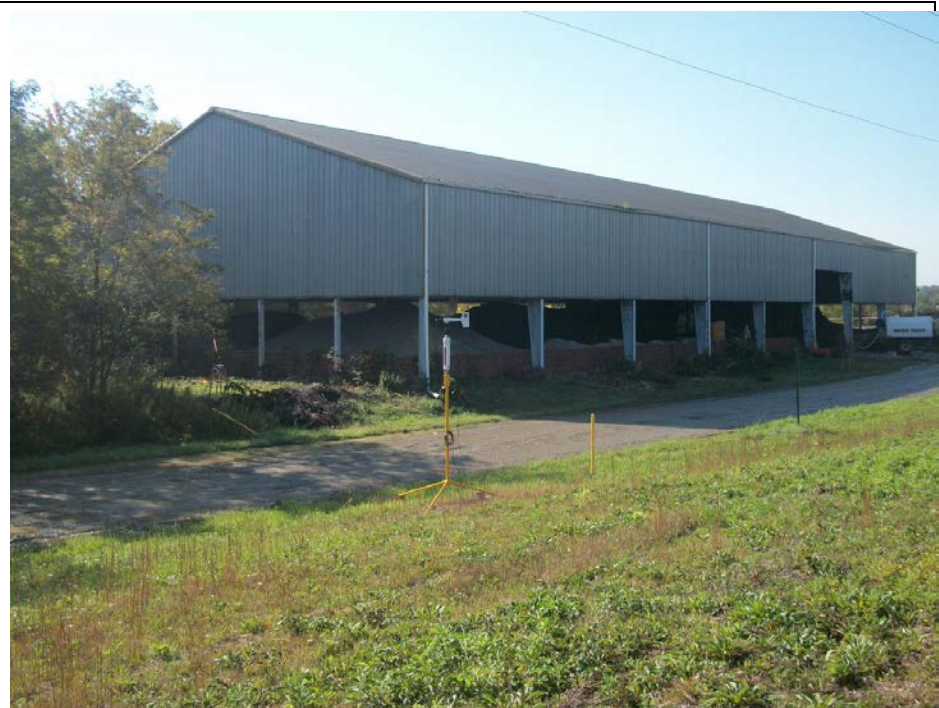
Photograph: 26

Description:
Covered shed containing
hazardous solids.

The stockpiled material within the covered shed was believed to be hazardous sediments precipitated from the glazing-process wastewater that discharged into the former on-site lagoons. In 1998, the OEPA issued orders to remove the hazardous sludge. This hazardous lagoon sludge was removed and staged in the covered shed.

The October 2011 site assessment included XRF screening, sampling, and laboratory analysis of stockpiled material in the covered shed. Laboratory analytical results for toxicity characteristic leaching procedure (TCLP) for metals ranged up to 300 milligrams per liter (mg/L) for barium and 210 mg/L for lead, indicating that the materials associated with these samples are characteristic D005 and D008 hazardous wastes. The highest concentration of lead is 42 times higher than the land disposal limit of 5.0 mg/L (40 CFR 261.24[b]).

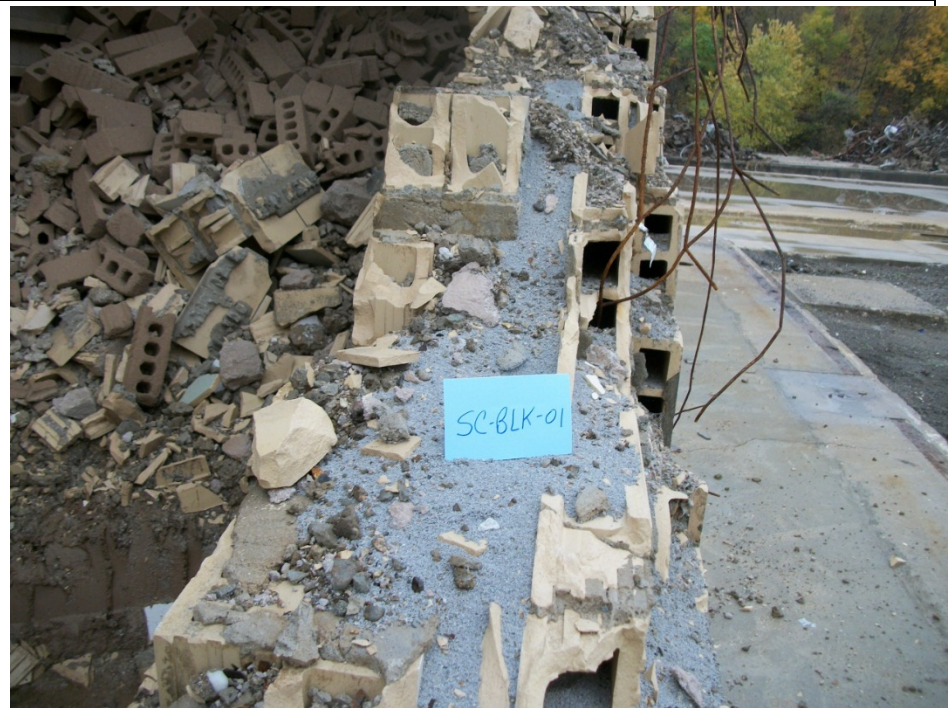
Photograph: 28

Description:
Building insulation containing asbestos observed between the walls of the partially demolished kiln building.

According to the pre-demolition asbestos survey, some asbestos still may be present inside the partially demolished kiln building. Tetra Tech observed damaged and partially intact transite panels on the northeast corner of the partially demolished kiln building.

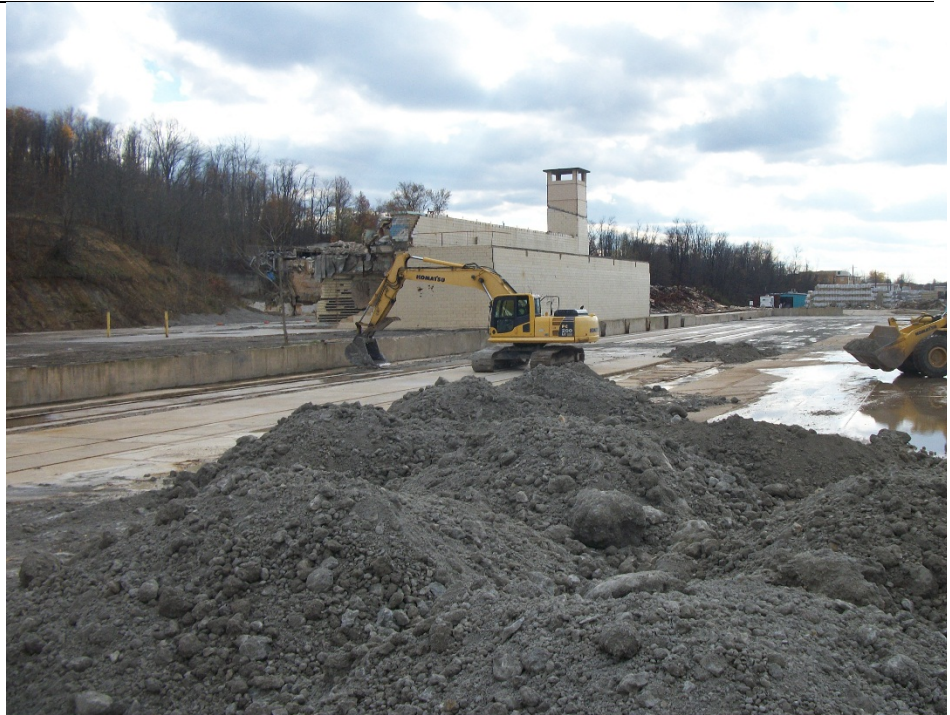
Description:
Backfilling pits and
trenches inside the
former asbestos
exclusion zone.

Upon the completion of the ACWM removal activities, the subsurface areas within the footprint of the asbestos exclusion zone were backfilled with fill material. This activity was completed to eliminate slip, trip, and fall hazards for unauthorized personnel accessing the site after the EPA and its contractors

The location of the backfill material is identified in Figure 4 in **Attachment A**. Some of the soil from this borrow area was used to backfill the pits, sumps, and trenches within the former asbestos exclusion zone. The railroad spur was partially backfilled. Broken ceramic blocks, gathered from various locations on site, were added to open sanitary and storm sewers to allow for water to flow through the sewer system. This backfill activity was conducted to eliminate safety hazards after EPA demobilizes from the site.

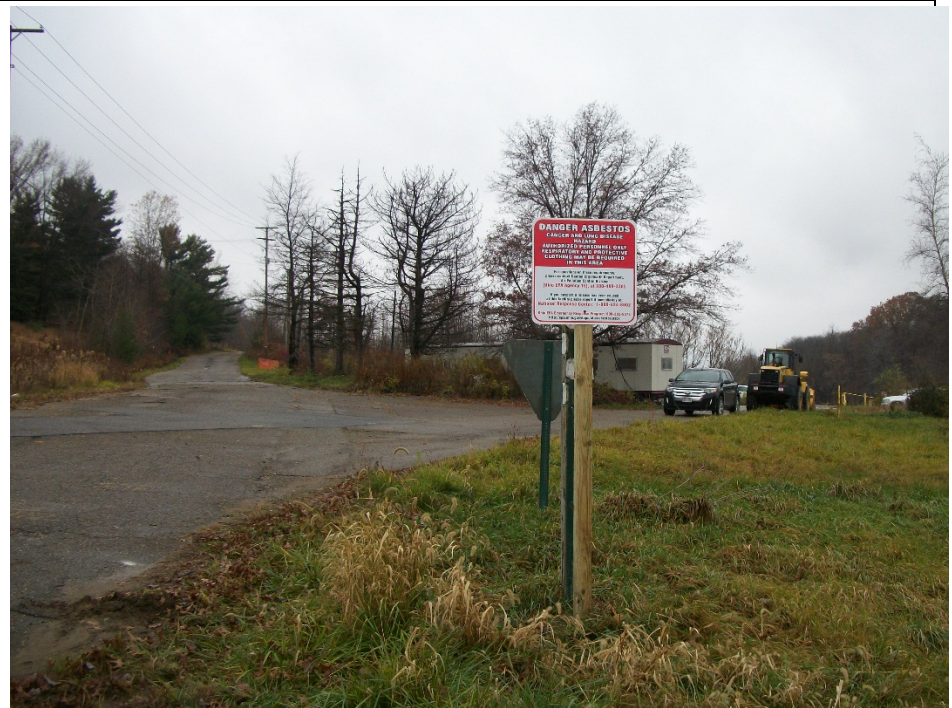
Photograph: 38

Description:
Asbestos warning signs posted at several locations within and around the former asbestos exclusion zone.

The final objective to the ACWM removal activity included the installation of asbestos signs on site. Asbestos signs were posted around the perimeter of the former asbestos exclusion zone and on the partially demolished kiln building located within the footprint of the former manufacturing area. The purpose of these signs were to inform individuals of an asbestos hazard within the former manufacturing area on site. Information on these asbestos signs included contact information for the National Response Center (NRC), OEPA Emergency Response Center, and City of Canton Health Department.
