RE: Midwest Electric  
Report  
Drinking Water Program  
Auglaize County  
PWS ID: OH0637012

Midwest Electric, Inc.  
06029 County Rd. 33A  
St. Marys, OH 45885

**LCR sampling locations \***

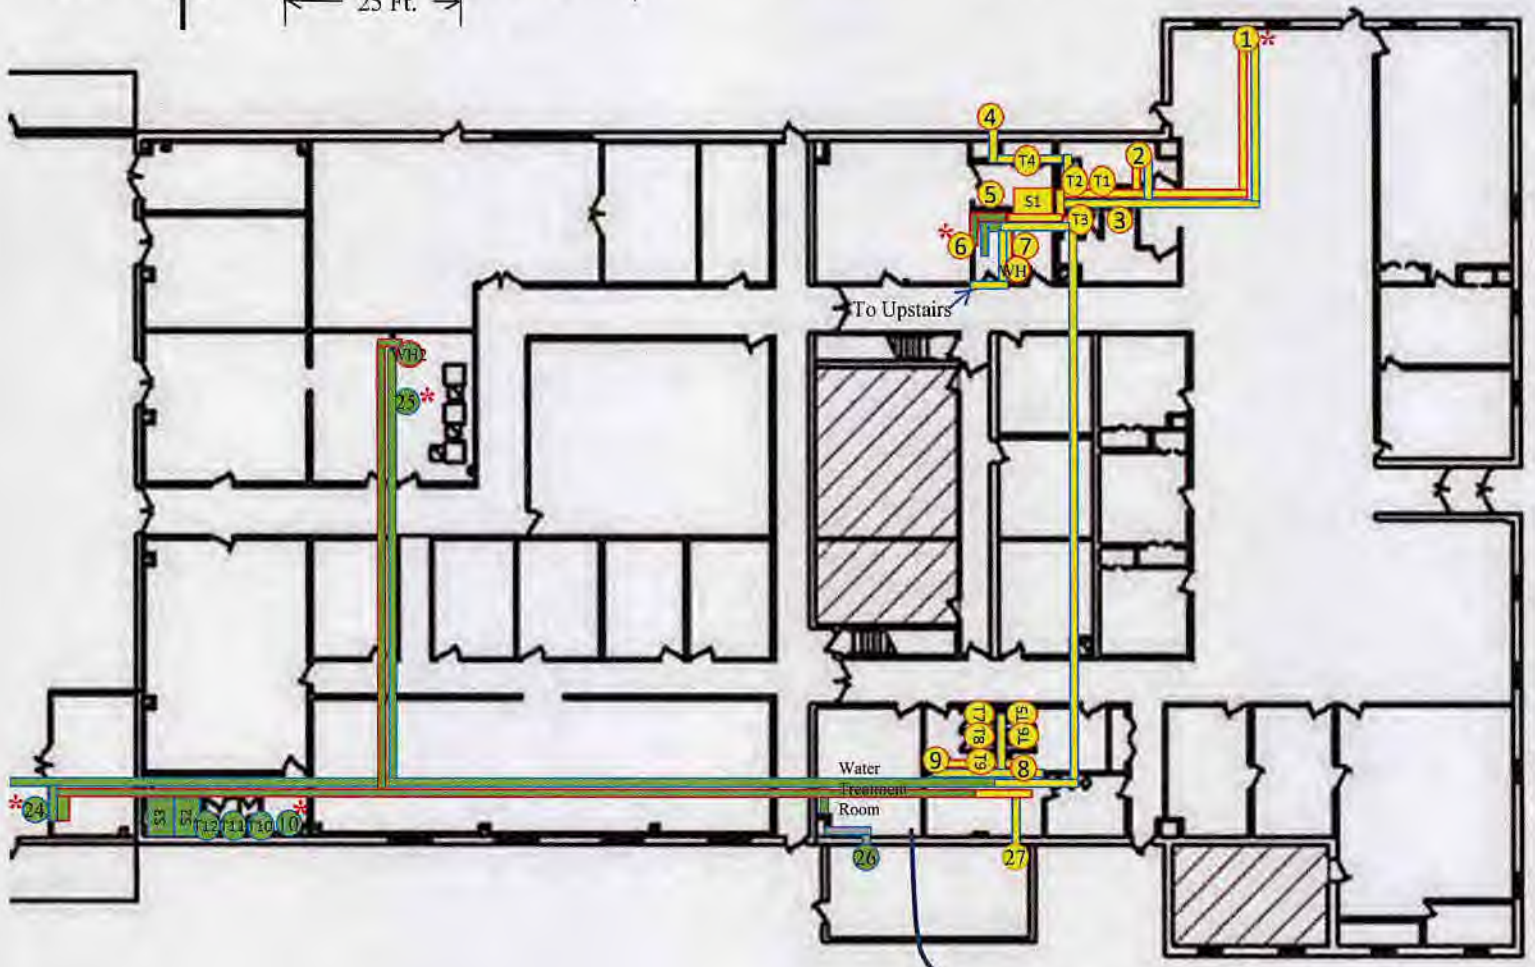
Office Area First Floor

Line from Well

1	Community Room Sink Faucet – Steel, Brass, & Plastic (2008)
2	Men's Community Room Bathroom Sink Faucet – Steel, Brass, & Plastic (2008)
3	Ladies Community Room Bathroom Sink Faucet – Steel, Brass, & Plastic (2008)
4	East Exterior Spigot – Brass (1963)
5	Ladies Locker Room Sink Faucet – Steel, Brass, & Plastic (2012)
6	Break Room Sink Faucet – Steel, Brass, & Plastic (2016)
7	Janitors Room Sink Faucet – Brass and Steel (1963)
8	Ladies West Bathroom Sink Faucet – Steel, Brass, & Plastic (2008)
9	Men's West Bathroom Sink Faucet – Steel, Brass, & Plastic (2008)
10	Lineman's Locker Room Sink Faucet – Steel and Brass (2008)
11	Garage Spigot – Brass (2008)
12	Garage Spigot – Brass (2008)
13	Garage Spigot – Brass (2008)
14	Garage Spigot – Brass (2008)
15	Garage Spigot – Brass (2008)
16	Garage Spigot – Brass (2008)
17	North Mechanical Room Spigot – Brass (2008)
18	Garage Spigot – Brass (2008)
19	Garage Spigot – Brass (2008)

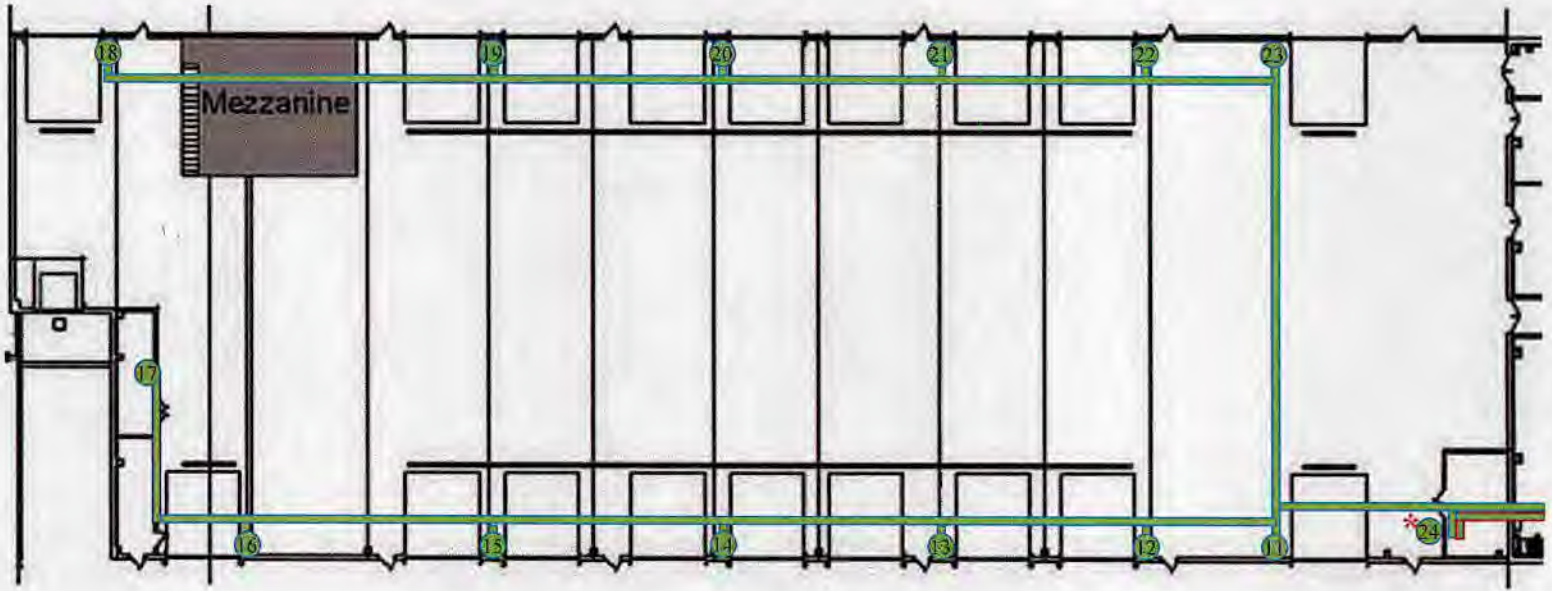
Garage Area First Floor

20	Garage Spigot – Brass (2008)
21	Garage Spigot – Brass (2008)
23	Garage Spigot – Brass (2008)
24	Garage Sink Faucet – Steel and Brass (2008)
25	Operations Mechanical Room Spigot (2008)
26	Generator Room Spigot – Brass on PVC Pipe (2008)
27	Generator Room Exterior Spigot – Brass (1963)
28	Upstairs Spigot – Brass (1963)
W11	Rheem Marathon Water Heater Janitor Closet (2008)
W12	Rheem Marathon Water Heater Operations Mechanical Room (2008)
S1	Ladies Locker Room Shower - Steel and Plastic (2008)
S2	Lineman's Locker Room Shower - Steel and Plastic (2008)
S3	Lineman's Locker Room Shower – Steel and Plastic (2008)
T1	Urinal Men's Community Room Restroom (2008)
T2	Toilet Men's Community Room Restroom (2008)
