City of Wellston Public Water System Lead (Pb) Components

PWSID# OH-4001912

Prepared February March 2017

Wellston OH, Lead Service Line Probability PWS OH-4001912

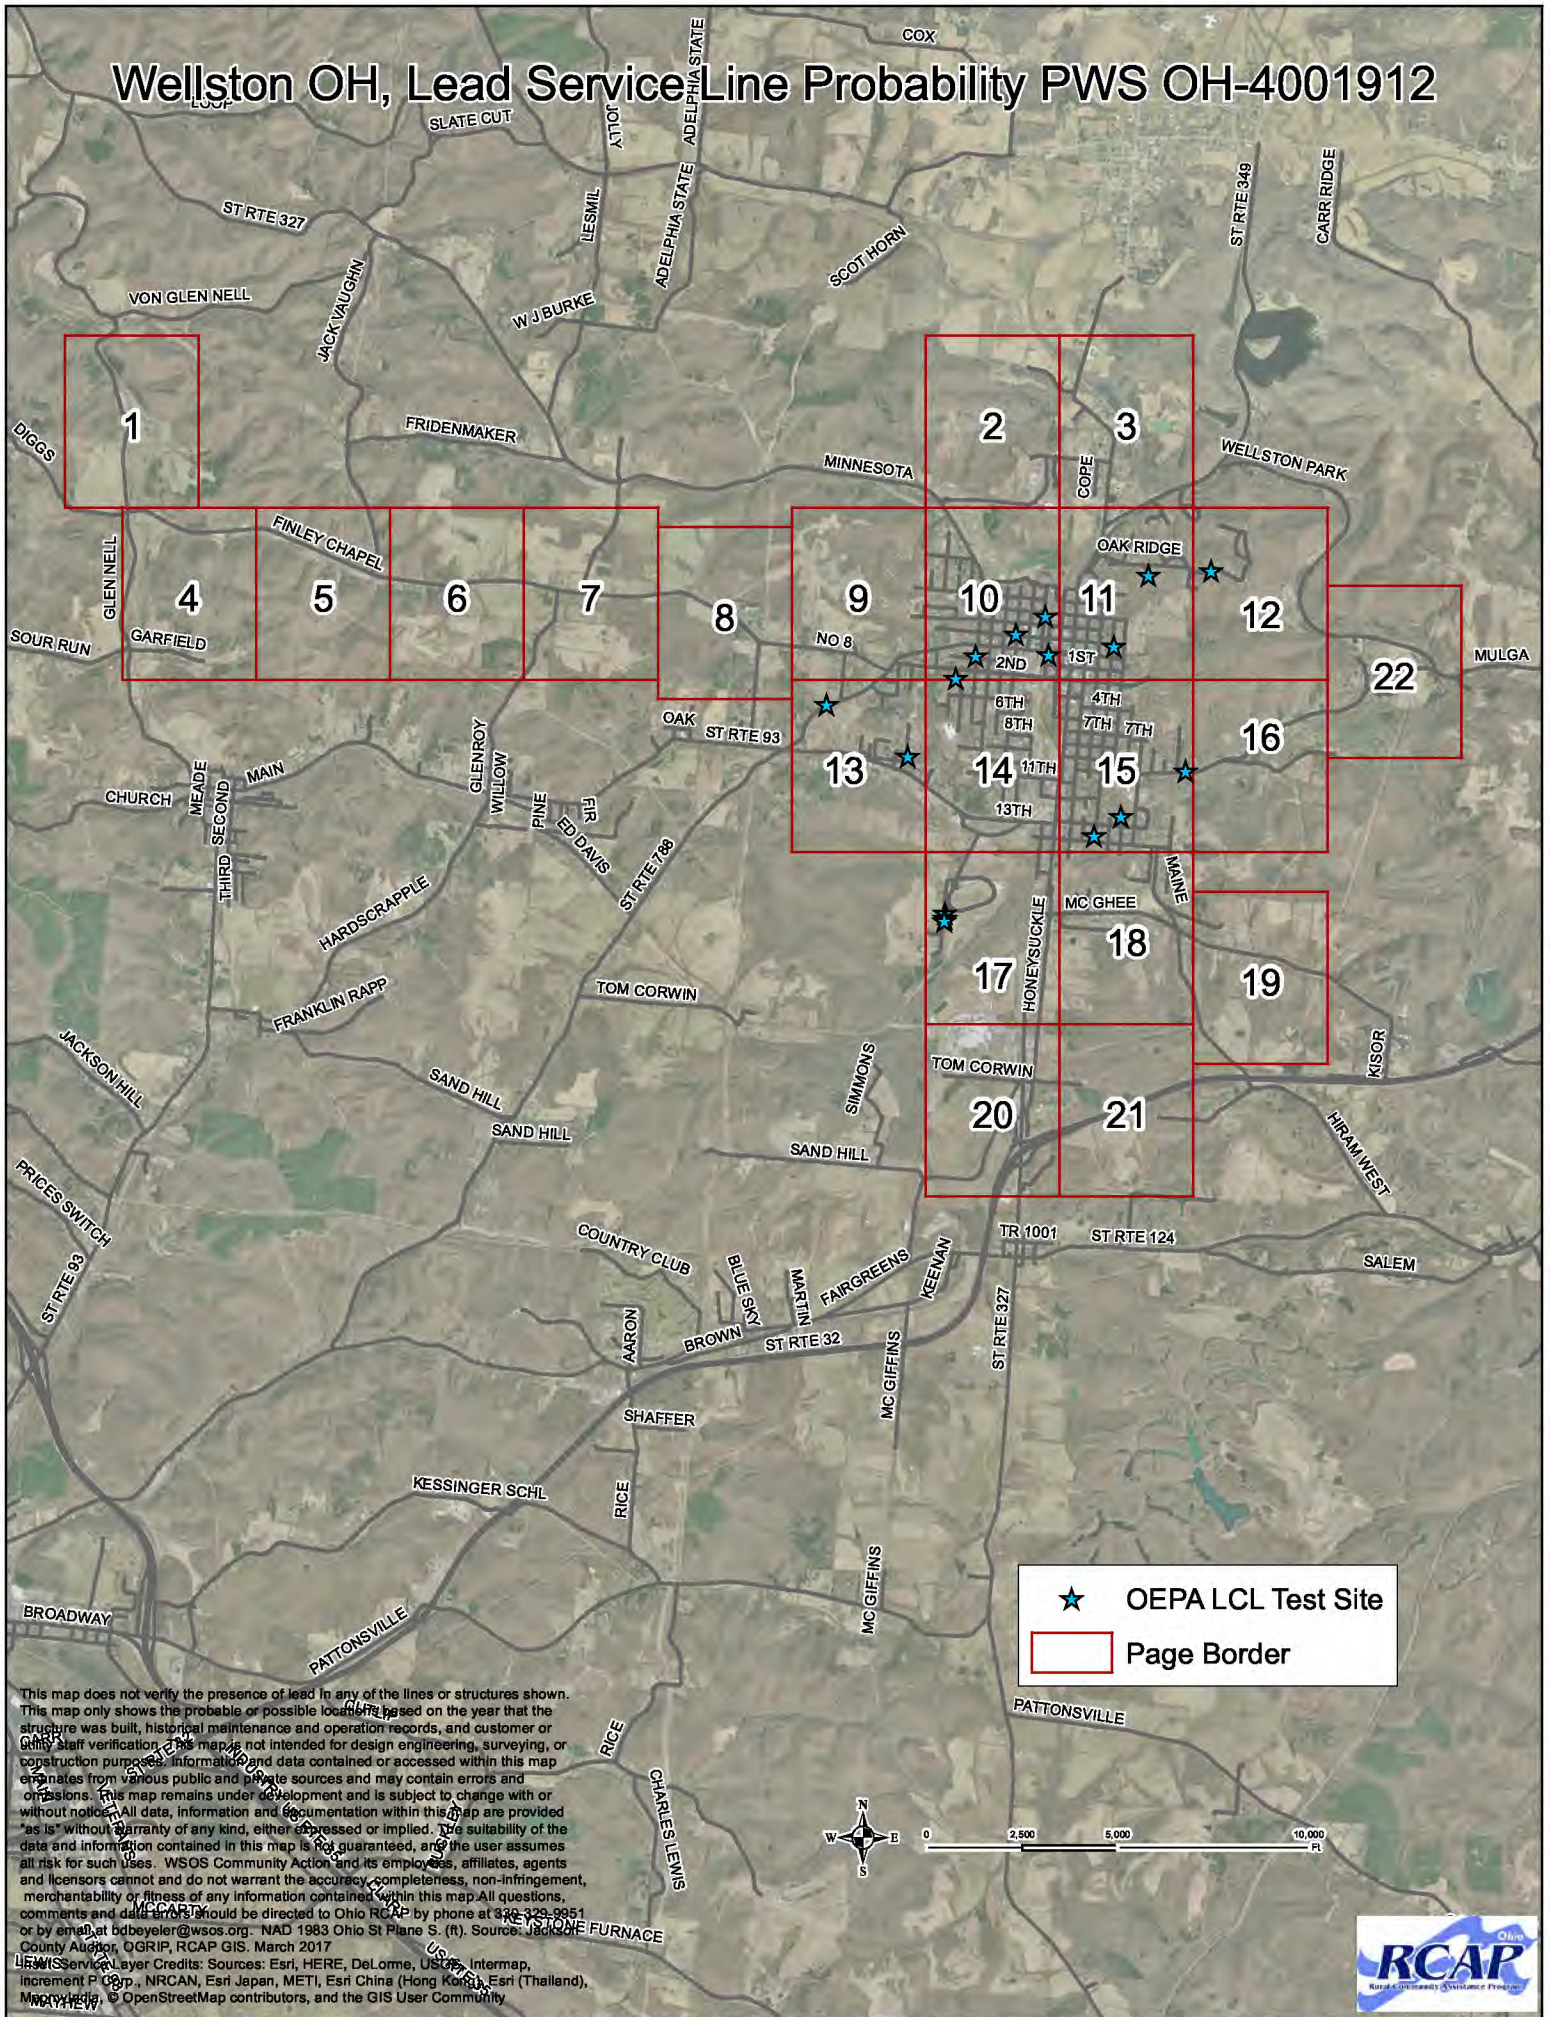
This map does not verify the presence of lead in any of the lines or structures shown. This map only shows the probable or possible location based on the year that the structure was built, historical maintenance and operation records, and customer or utility staff verification. This map is not intended for design engineering, surveying, or construction purposes. Information and data contained or accessed within this map originates from various public and private sources and may contain errors and omissions. This map remains under development and is subject to change with or without notice. All data, information and documentation within this map are provided "as is" without warranty of any kind, either expressed or implied. The suitability of the data and information contained in this map is not guaranteed, and the user assumes all risk for such uses. WSOS Community Action and its employees, affiliates, agents and licensors cannot and do not warrant the accuracy, completeness, non-infringement, merchantability or fitness of any information contained within this map. All questions, comments and data errors should be directed to Ohio RCAP by phone at 360-323-9951 or by email at bdbeyeler@wsos.org. NAD 1983 Ohio State Plane S. (R). Source: Jackson County Auditor, OGRIP, RCAP GIS. March 2017

To comply with Section 6109.121 of the Ohio Revised Code, enacted in September 2016, the City of Wellston in Jackson County, Ohio has created the following report and attached map to identify known and potential components of water service lines that contain lead (Pb).

The following information and attached map do not verify the presence of lead in any of the plumbing components or structures shown. The information and map only show the probable or possible locations based on the year that structures were built, or by the year that the plumbing component was installed.

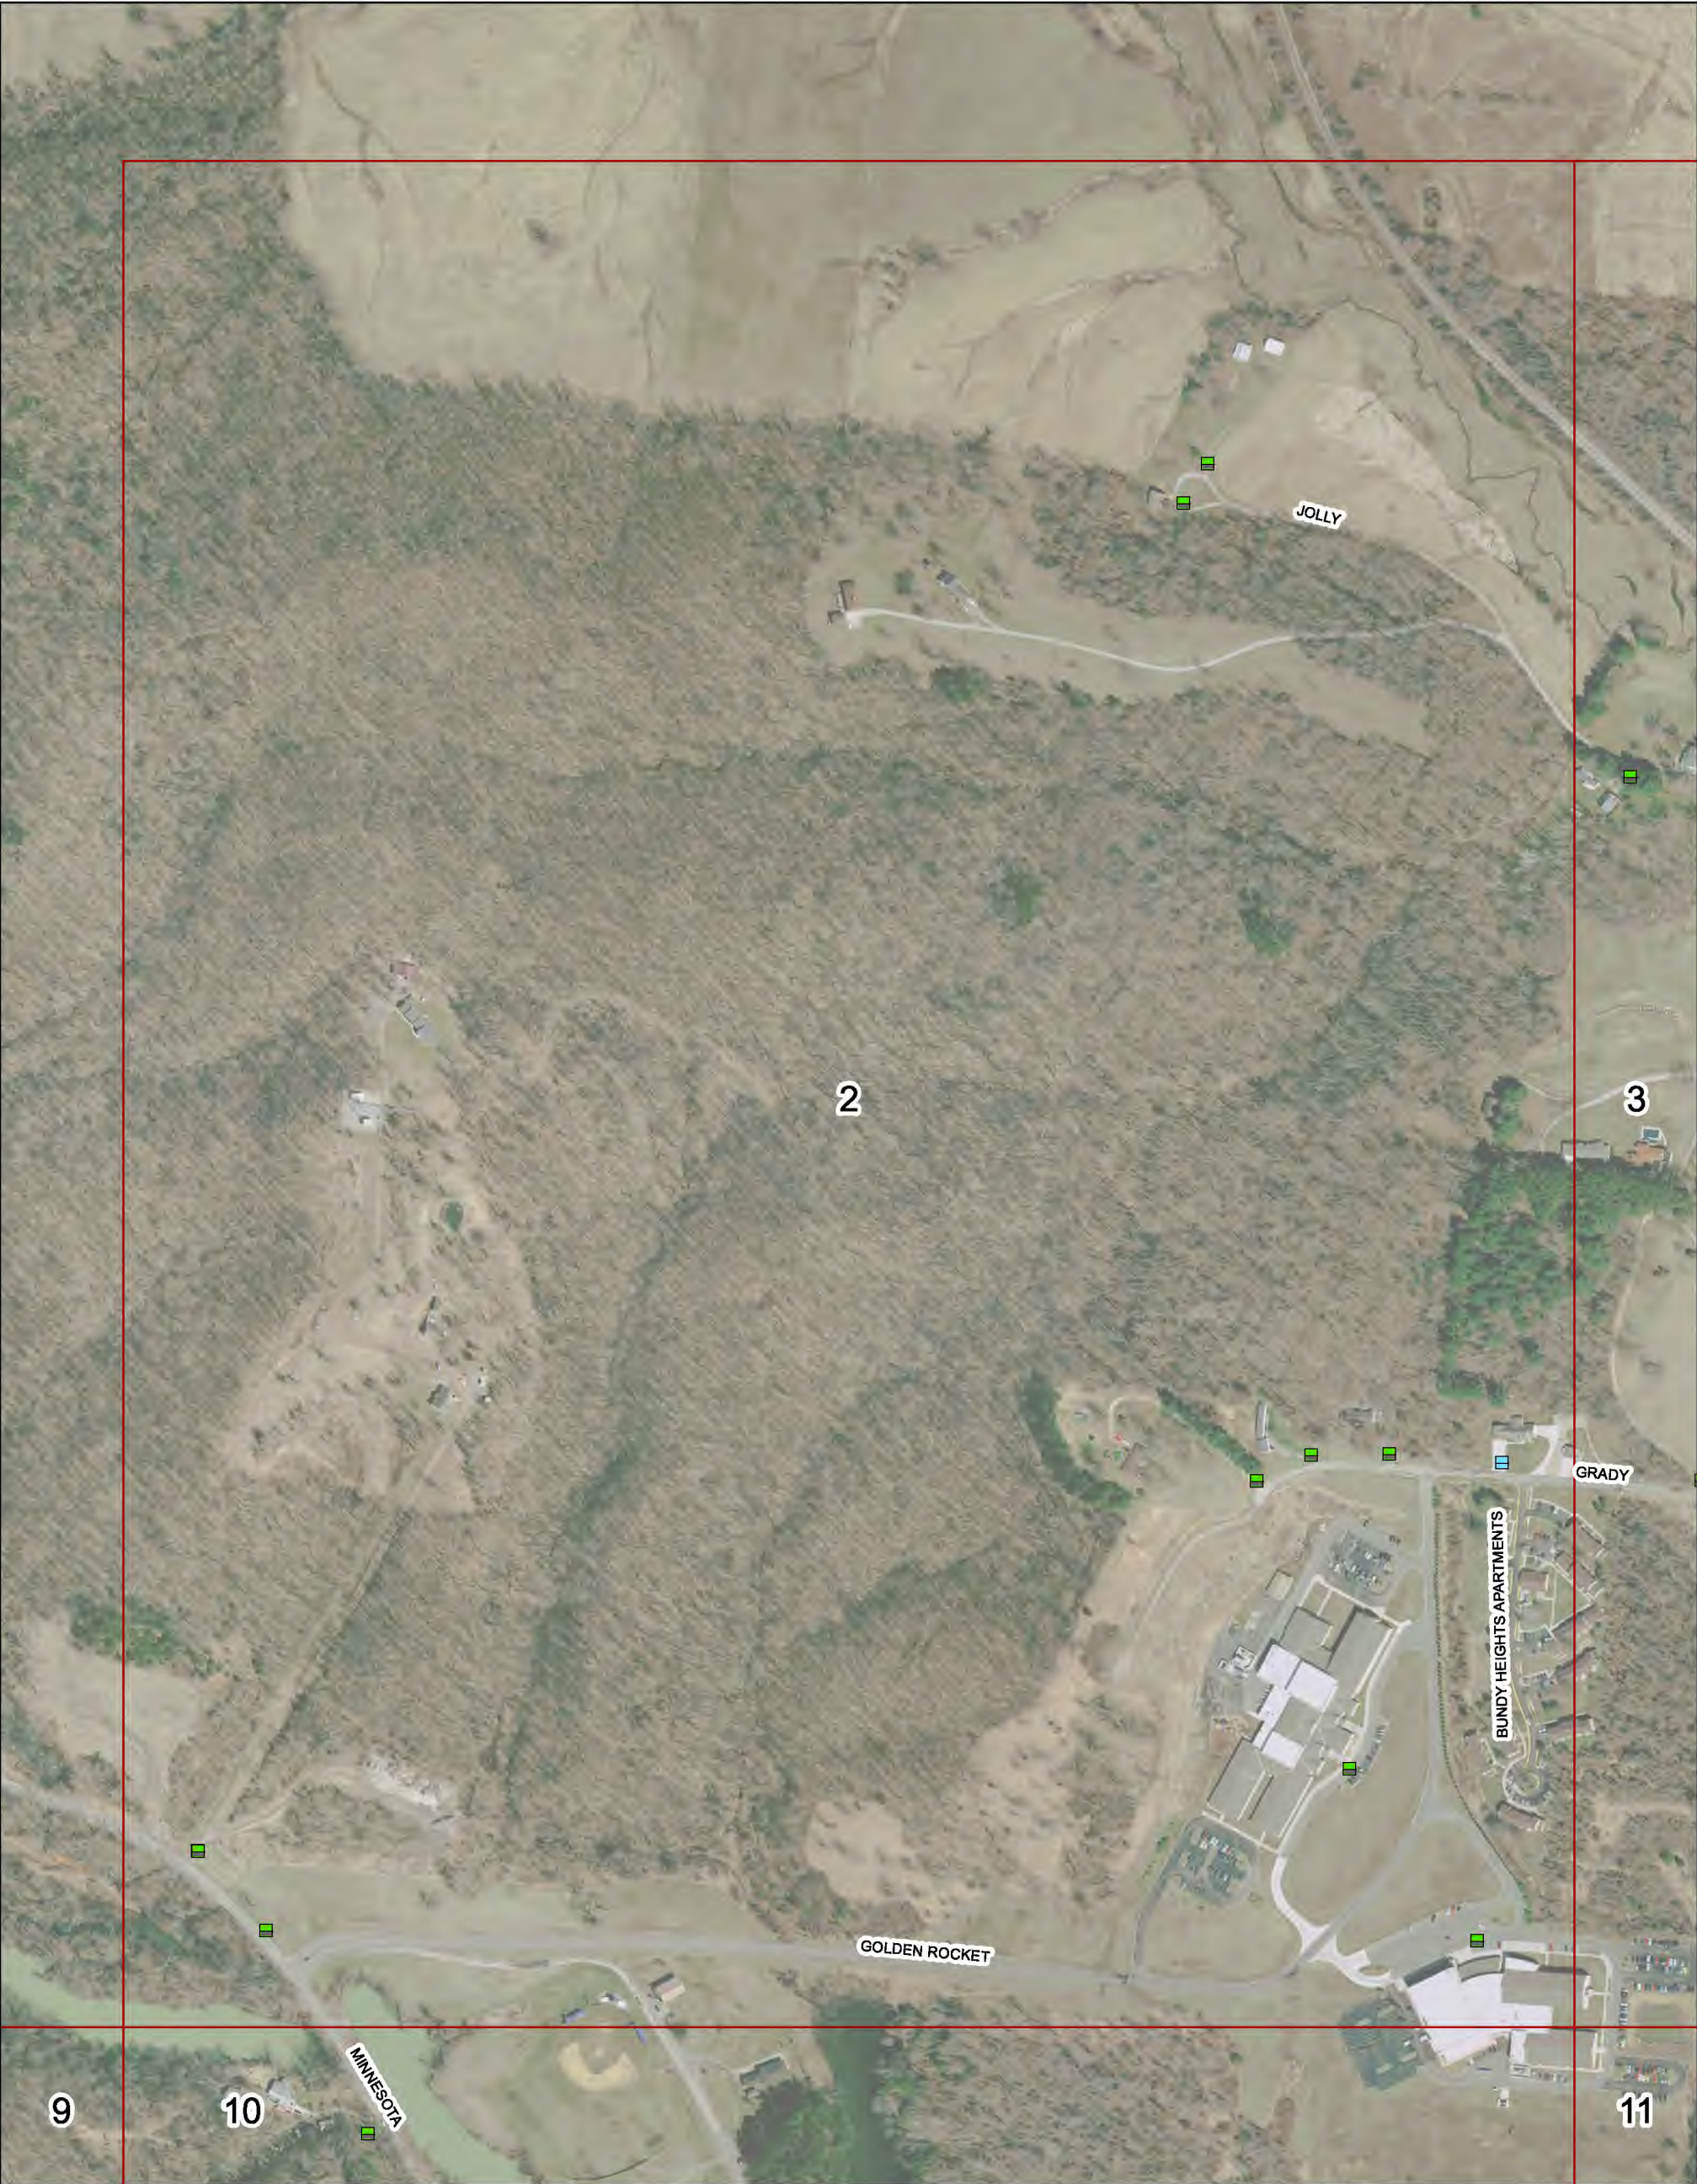
Wellston OH, Lead Service Line Probability PWS OH-4001912

Probability of Lead Service Line
Determined by year structure was built

This map does not verify the presence of lead in any of the lines or structures shown. This map only shows the probable or possible locations based on the year that the structure was built, historical maintenance and operation records, and customer or utility staff verification. This map is not intended for design engineering, surveying, or construction purposes. Information and data contained or accessed within this map emanates from various public and private sources and may contain errors and omissions. This map remains under development and is subject to change with or without notice. All data, information and documentation within this map are provided "as is" without warranty of any kind, either expressed or implied. The suitability of the data and information contained in this map is not guaranteed, and the user assumes all risk for such uses. WSOS Community Action and its employees, affiliates, agents and licensors cannot and do not warrant the accuracy, completeness, non-infringement, merchantability or fitness of any information contained within this map. All questions, comments and data errors should be directed to Ohio RCAP by phone at 330-329-9951 or by email at bdbeyeler@wsos.org. NAD 1983 Ohio St Plane S. (ft). Source: Jackson County Auditor, OGRIP, RCAP GIS. March 2017

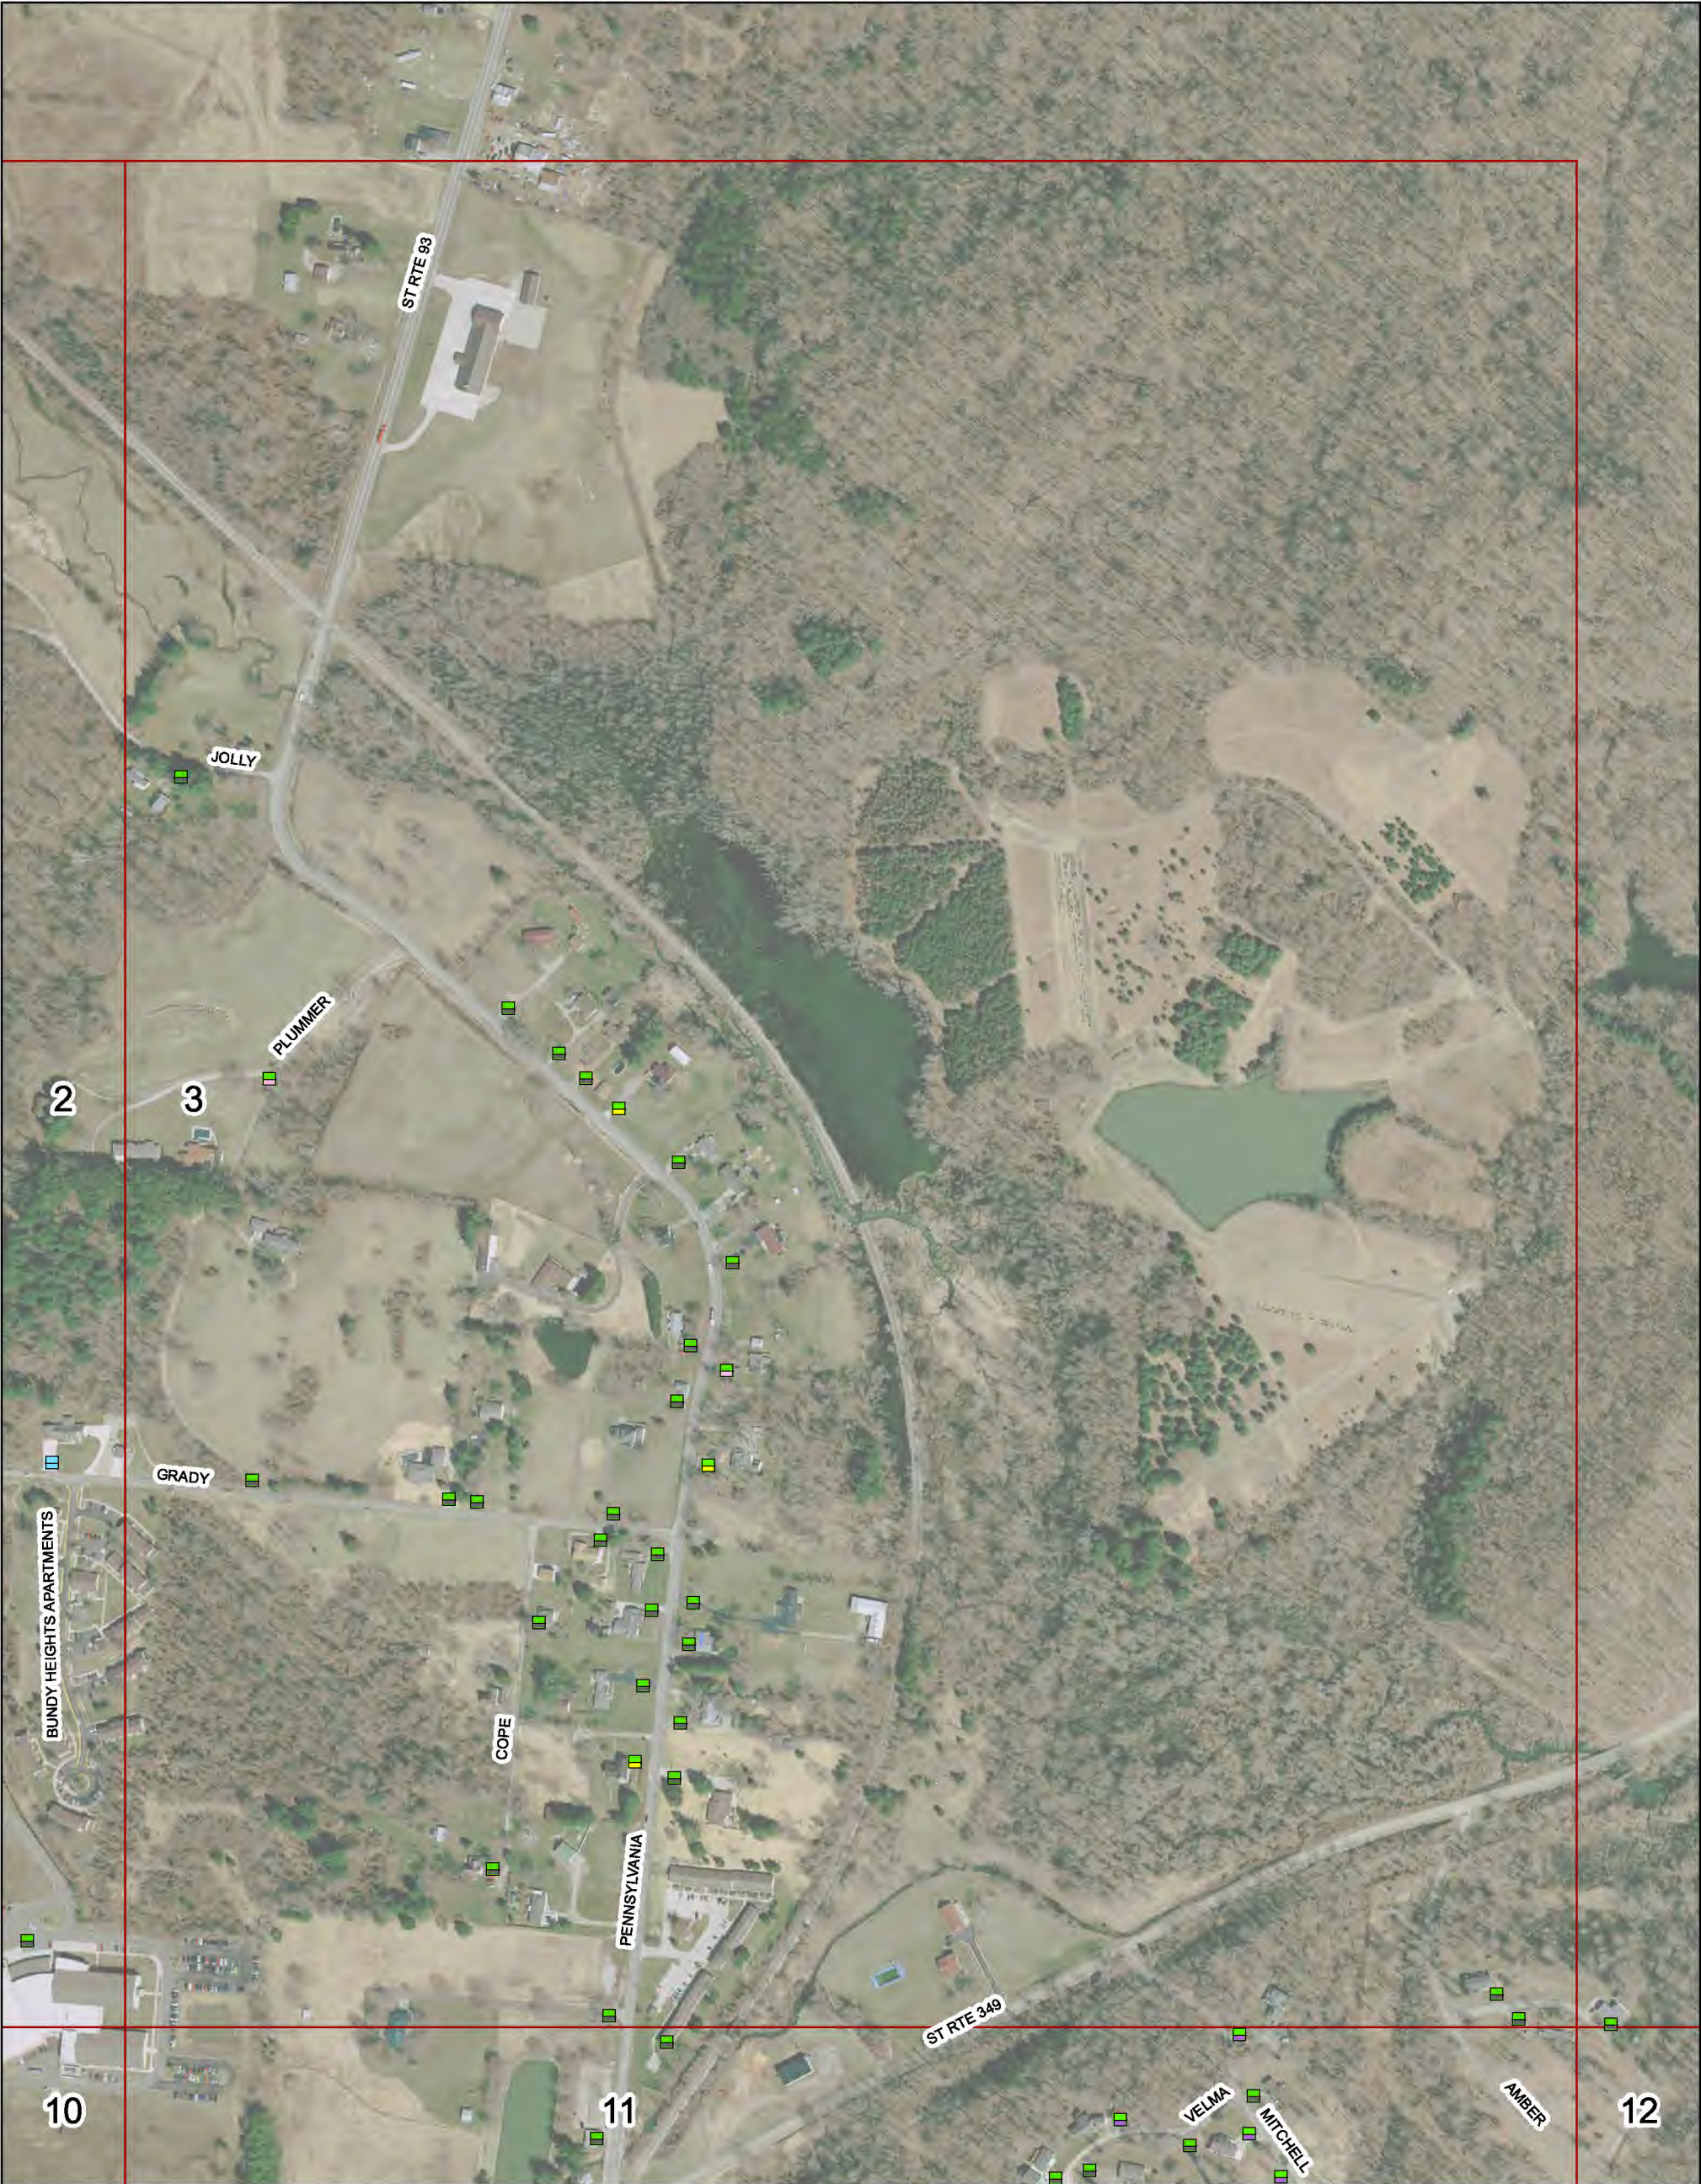
Wellston OH, Lead Service Line Probability PWS OH-4001912

This map does not verify the presence of lead in any of the lines or structures shown. This map only shows the probable or possible locations based on the year that the structure was built, historical maintenance and operation records, and customer or utility staff verification. This map is not intended for design engineering, surveying, or construction purposes. Information and data contained or accessed within this map emanates from various public and private sources and may contain errors and omissions. This map remains under development and is subject to change with or without notice. All data, information and documentation within this map are provided "as is" without warranty of any kind, either expressed or implied. The suitability of the data and information contained in this map is not guaranteed, and the user assumes all risk for such uses. WSOS Community Action and its employees, affiliates, agents and licensors cannot and do not warrant the accuracy, completeness, non-infringement, merchantability or fitness of any information contained within this map. All questions, comments and data errors should be directed to Ohio RCAP by phone at 330-329-9951 or by email at bdbeyeler@wsos.org. NAD 1983 Ohio State Plane S. (ft). Source: Jackson County Auditor, OGRIP, RCAP GIS. March 2017

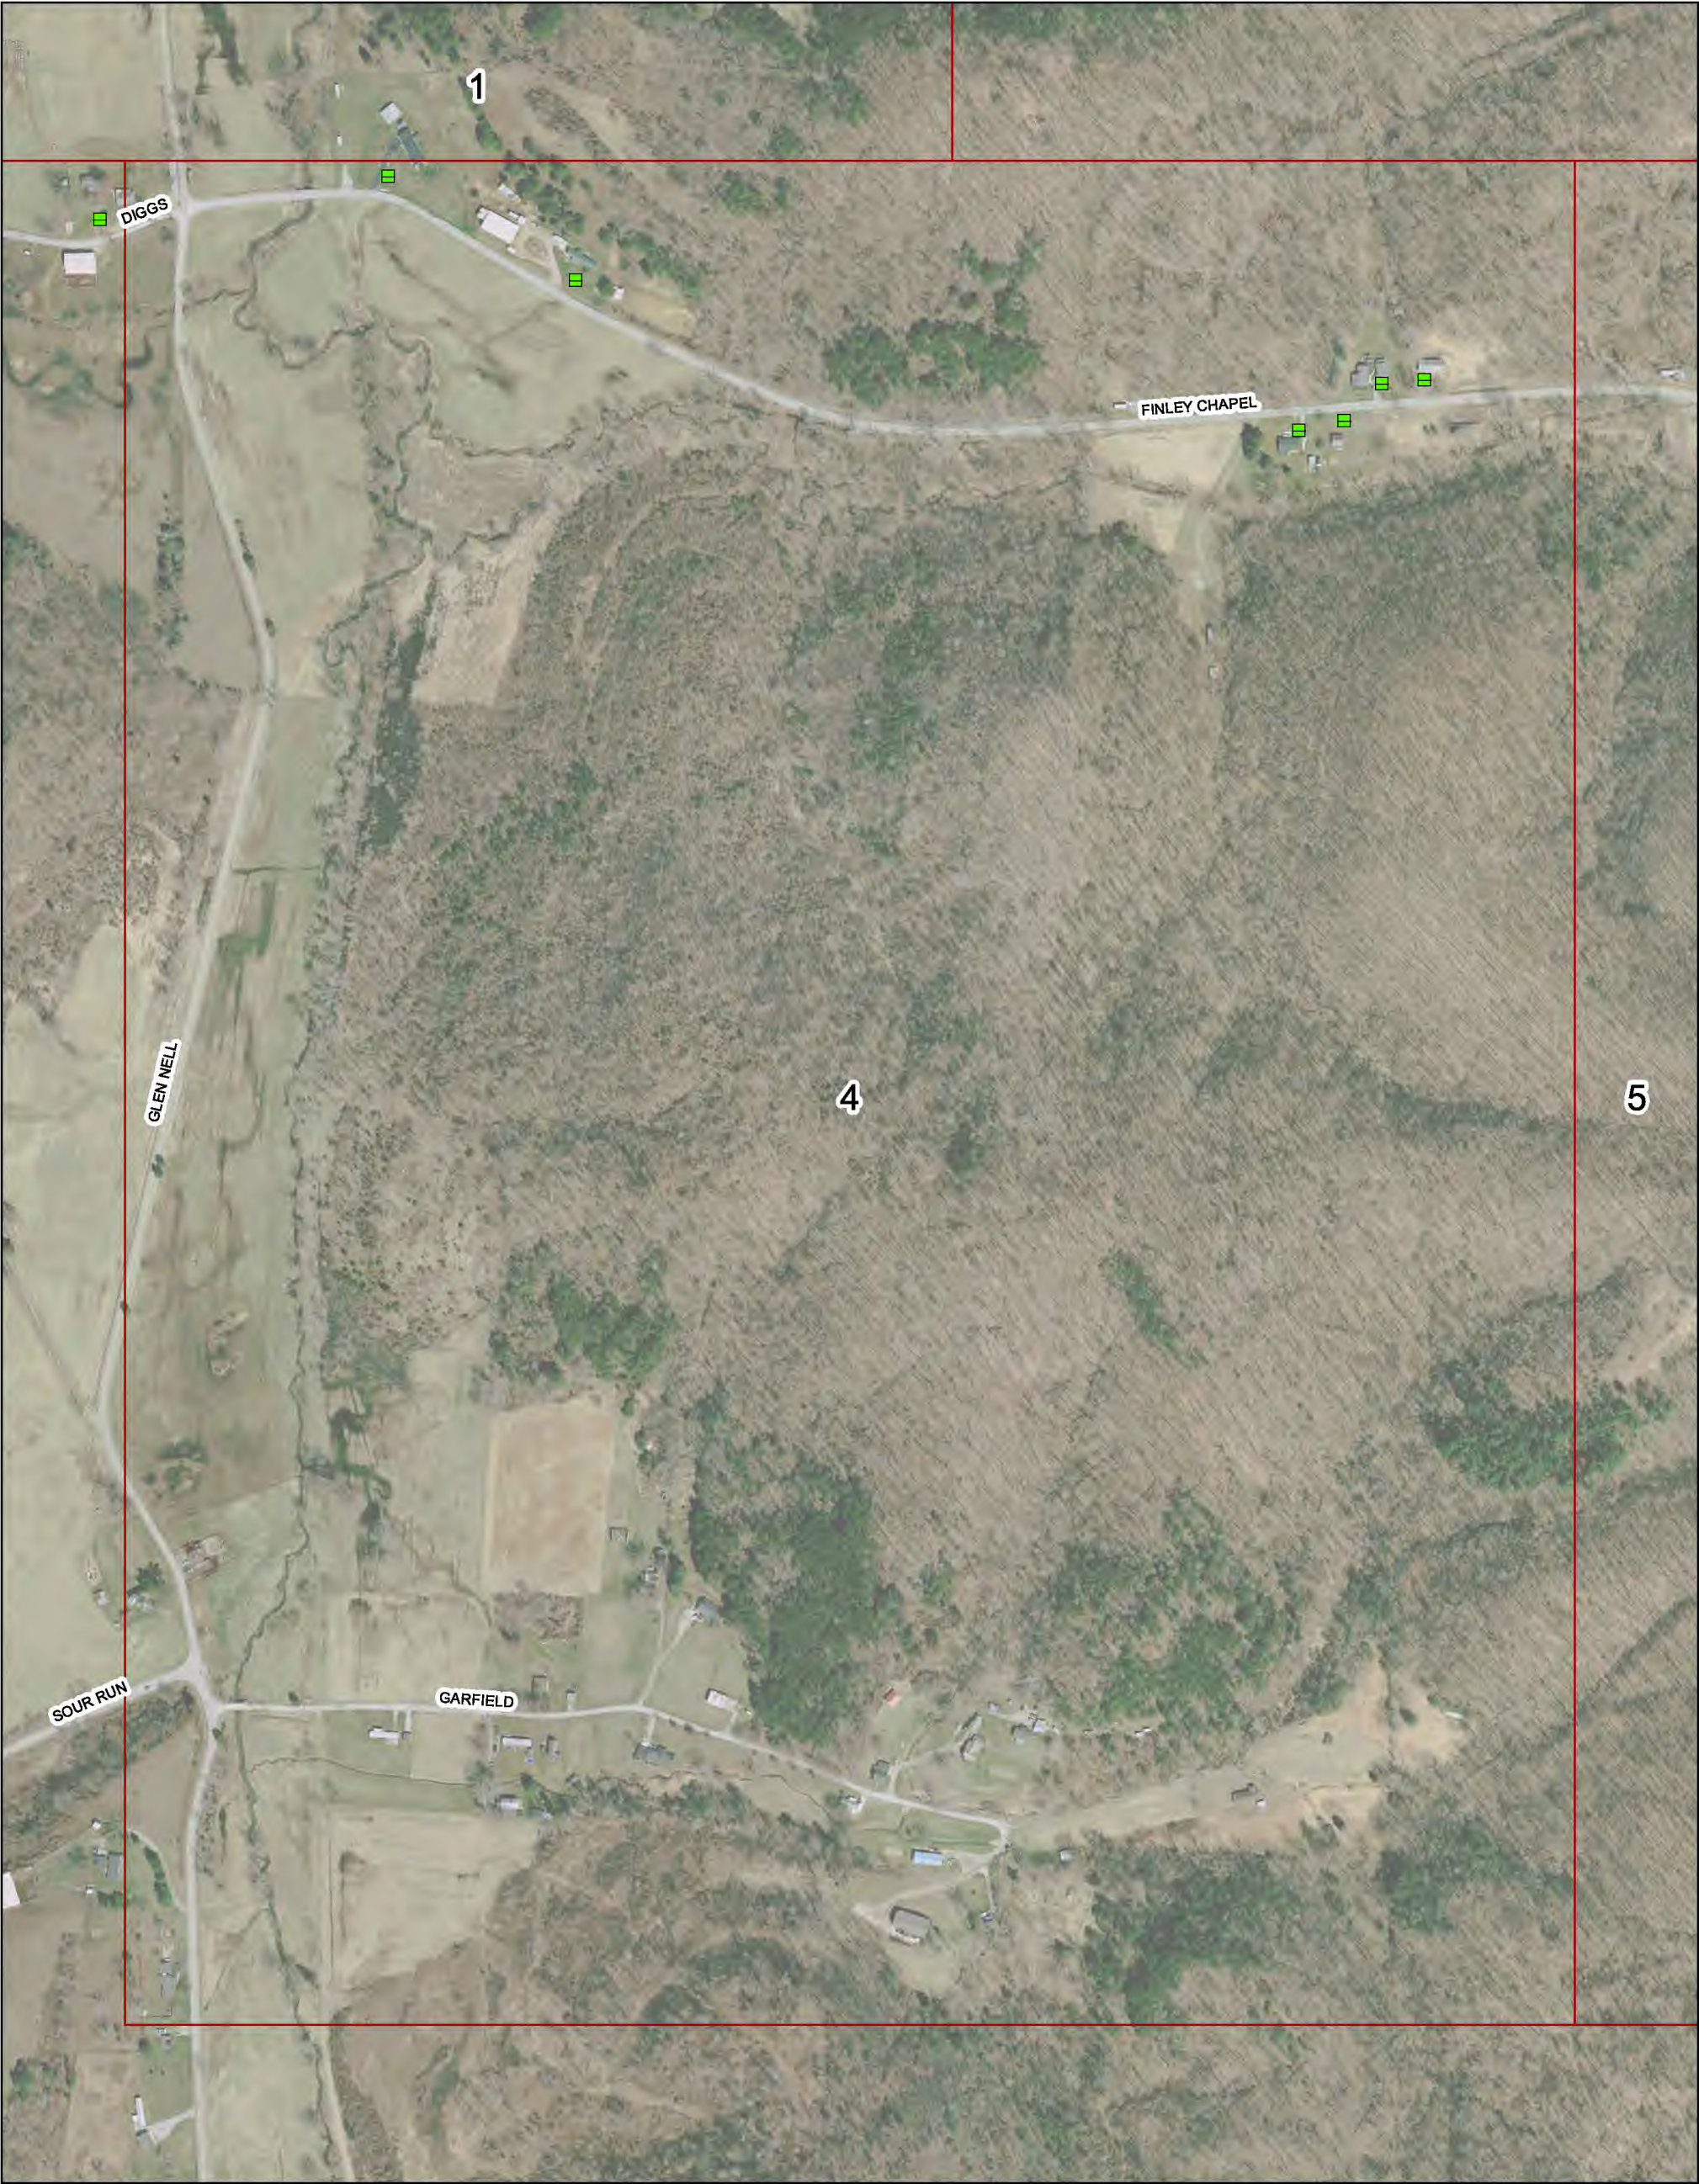
Wellston OH, Lead Service Line Probability PWS OH-4001912

Probability of Lead Service Line
Determined by year structure was built

This map does not verify the presence of lead in any of the lines or structures shown. This map only shows the probable or possible locations based on the year that the structure was built, historical maintenance and operation records, and customer or utility staff verification. This map is not intended for design engineering, surveying, or construction purposes. Information and data contained or accessed within this map emanates from various public and private sources and may contain errors and omissions. This map remains under development and is subject to change with or without notice. All data, information and documentation within this map are provided "as is" without warranty of any kind, either expressed or implied. The suitability of the data and information contained in this map is not guaranteed, and the user assumes all risk for such uses. WSOS Community Action and its employees, affiliates, agents and licensors cannot and do not warrant the accuracy, completeness, non-infringement, merchantability or fitness of any information contained within this map. All questions, comments and data errors should be directed to Ohio RCAP by phone at 330-329-9951 or by email at bdbeyeler@wsos.org. NAD 1983 Ohio St Plane S. (ft). Source: Jackson County Auditor, OGRIP, RCAP GIS. March 2017

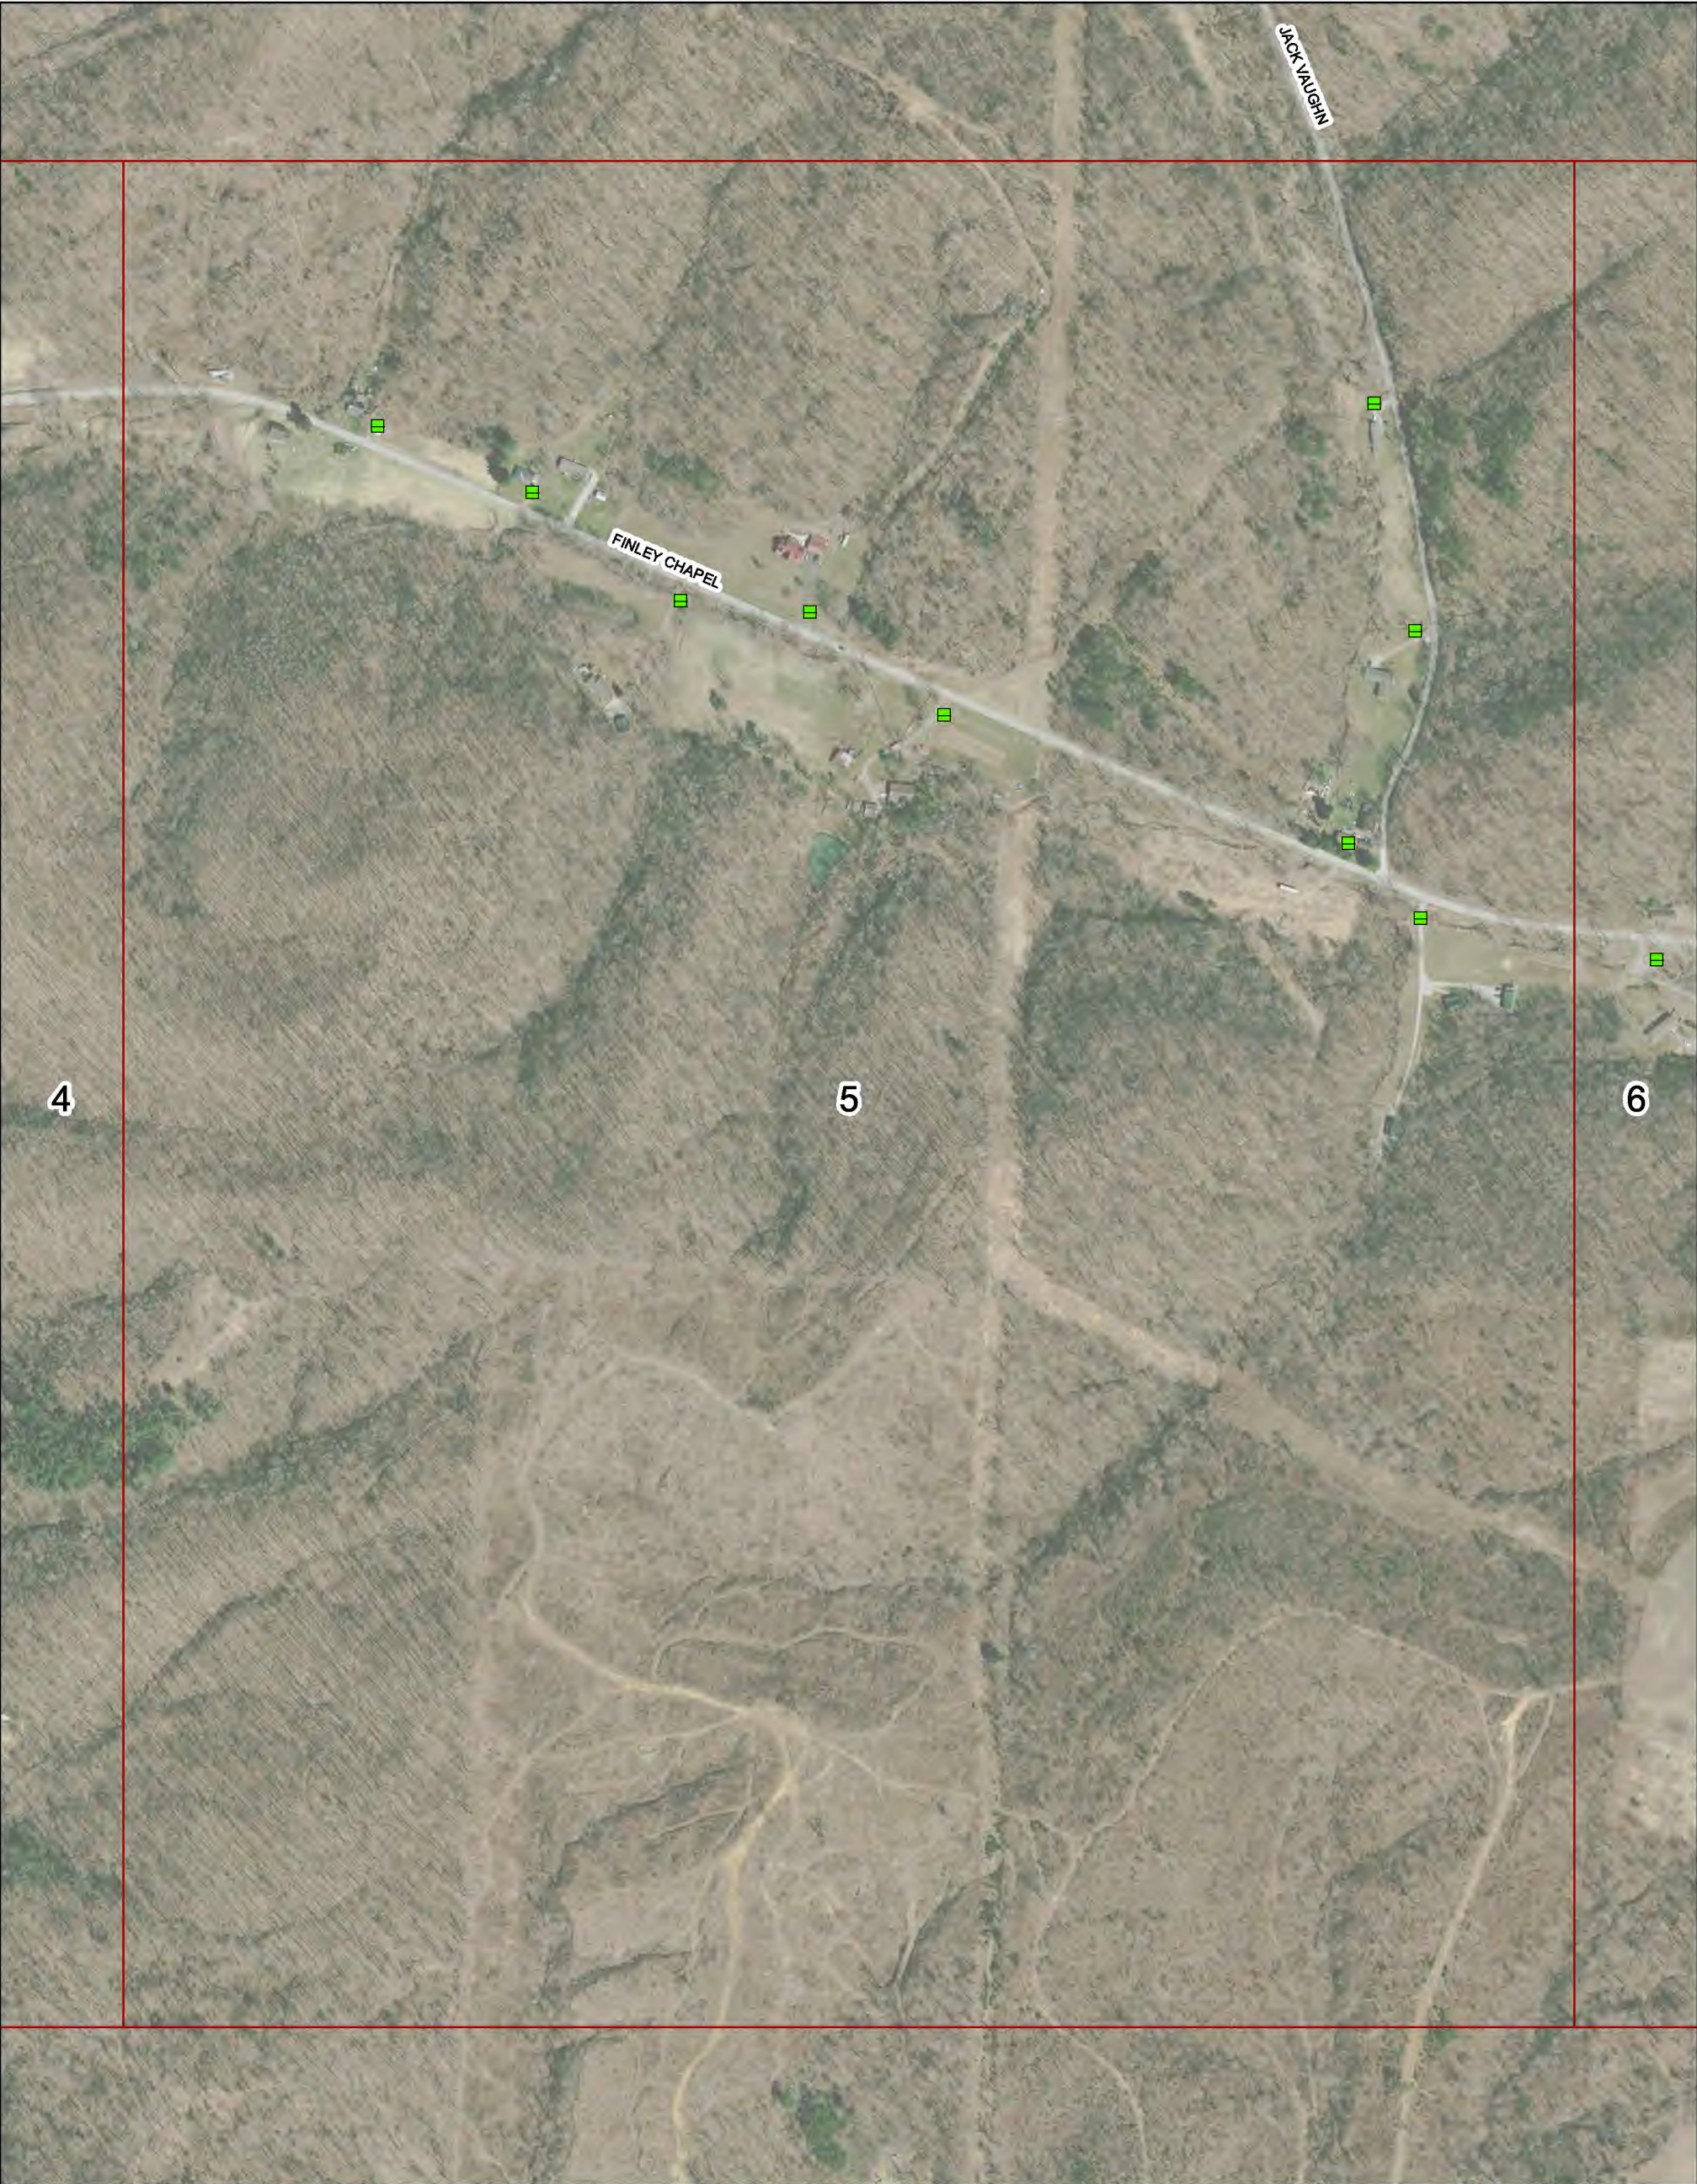
Wellston OH, Lead Service Line Probability PWS OH-4001912

Probability of Lead Service Line
Determined by year structure was built

This map does not verify the presence of lead in any of the lines or structures shown. This map only shows the probable or possible locations based on the year that the structure was built, historical maintenance and operation records, and customer or utility staff verification. This map is not intended for design engineering, surveying, or construction purposes. Information and data contained or accessed within this map emanates from various public and private sources and may contain errors and omissions. This map remains under development and is subject to change with or without notice. All data, information and documentation within this map are provided "as is" without warranty of any kind, either expressed or implied. The suitability of the data and information contained in this map is not guaranteed, and the user assumes all risk for such uses. WSOS Community Action and its employees, affiliates, agents and licensors cannot and do not warrant the accuracy, completeness, non-infringement, merchantability or fitness of any information contained within this map. All questions, comments and data errors should be directed to Ohio RCAP by phone at 330-329-9951 or by email at bdbeyeler@wsos.org. NAD 1983 Ohio St Plane S. (ft). Source: Jackson County Auditor, OGRIP, RCAP GIS. March 2017
