City of Wellston Public Water System Lead (Pb) Components

PWSID# OH-4001912

Prepared February March 2017

Wellston OH, Lead Service Line Probability PWS OH-4001912

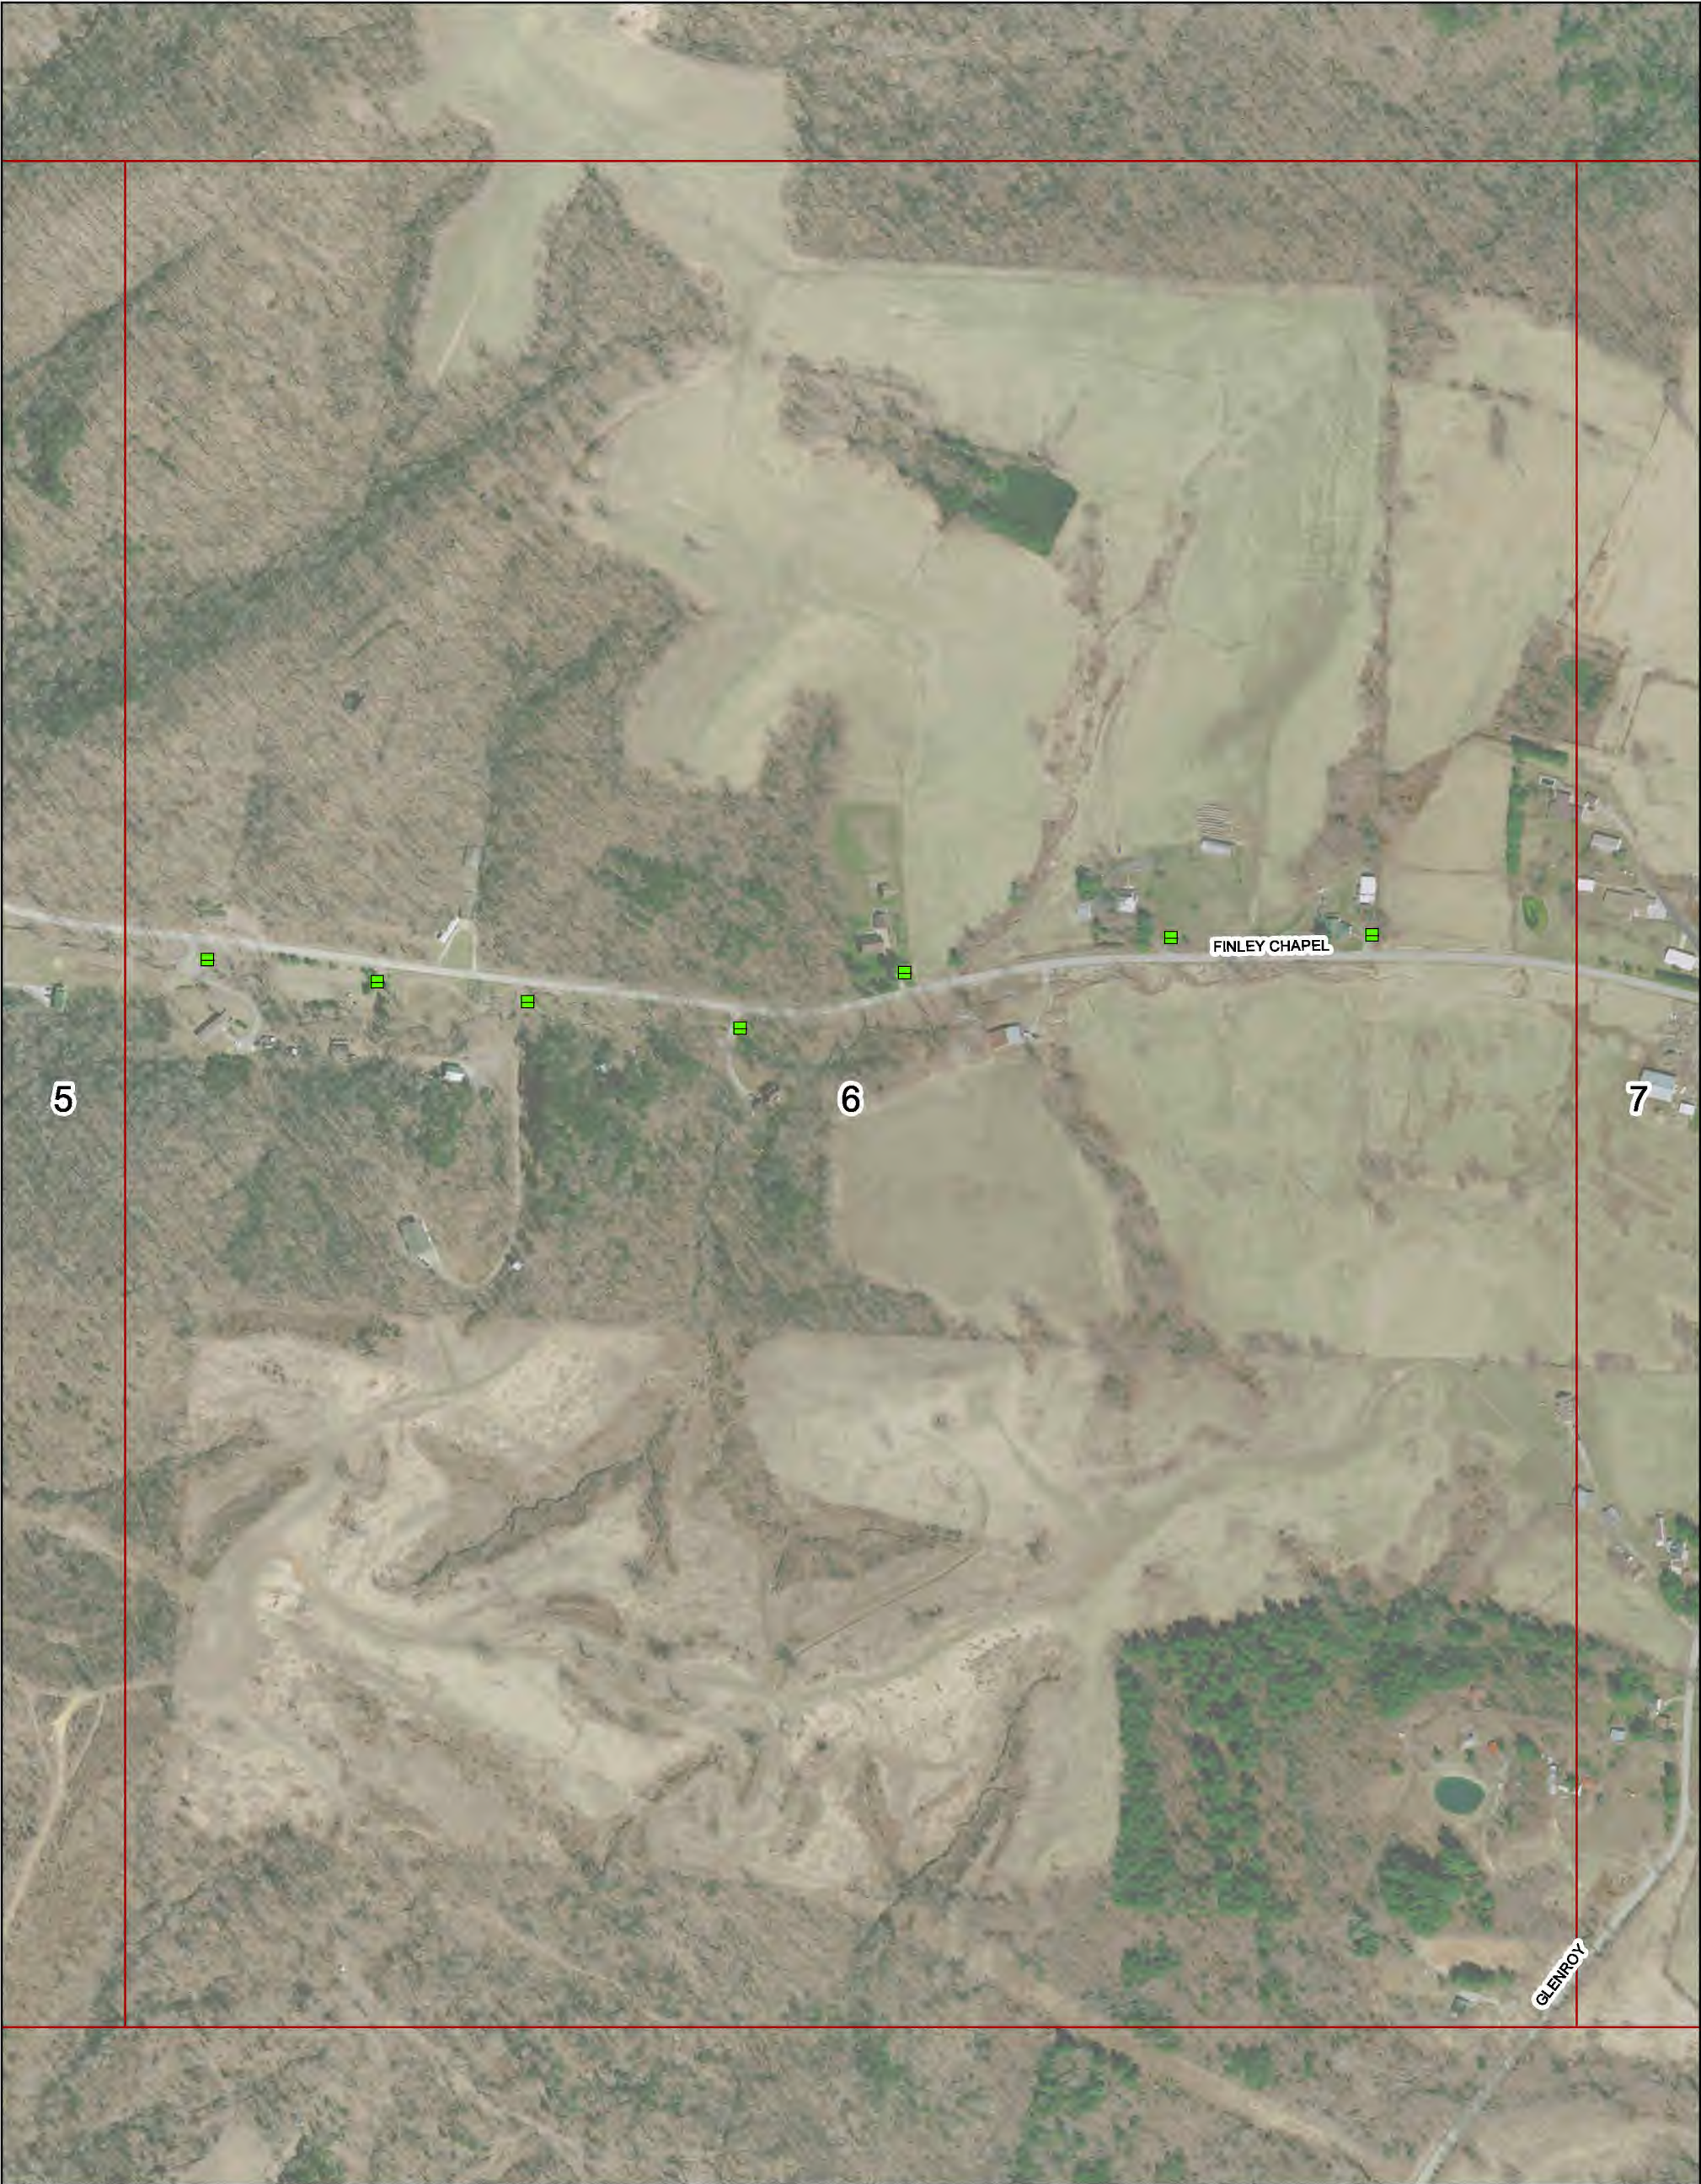
Wellston OH, Lead Service Line Probability PWS OH-4001912

Probability of Lead Service Line
Determined by year structure was built

This map does not verify the presence of lead in any of the lines or structures shown. This map only shows the probable or possible locations based on the year that the structure was built, historical maintenance and operation records, and customer or utility staff verification. This map is not intended for design engineering, surveying, or construction purposes. Information and data contained or accessed within this map emanates from various public and private sources and may contain errors and omissions. This map remains under development and is subject to change with or without notice. All data, information and documentation within this map are provided "as is" without warranty of any kind, either expressed or implied. The suitability of the data and information contained in this map is not guaranteed, and the user assumes all risk for such uses. WSOS Community Action and its employees, affiliates, agents and licensors cannot and do not warrant the accuracy, completeness, non-infringement, merchantability or fitness of any information contained within this map. All questions, comments and data errors should be directed to Ohio RCAP by phone at 330-329-9951 or by email at bdbeyeler@wsos.org. NAD 1983 Ohio St Plane S. (ft). Source: Jackson County Auditor, OGRIP, RCAP GIS. March 2017

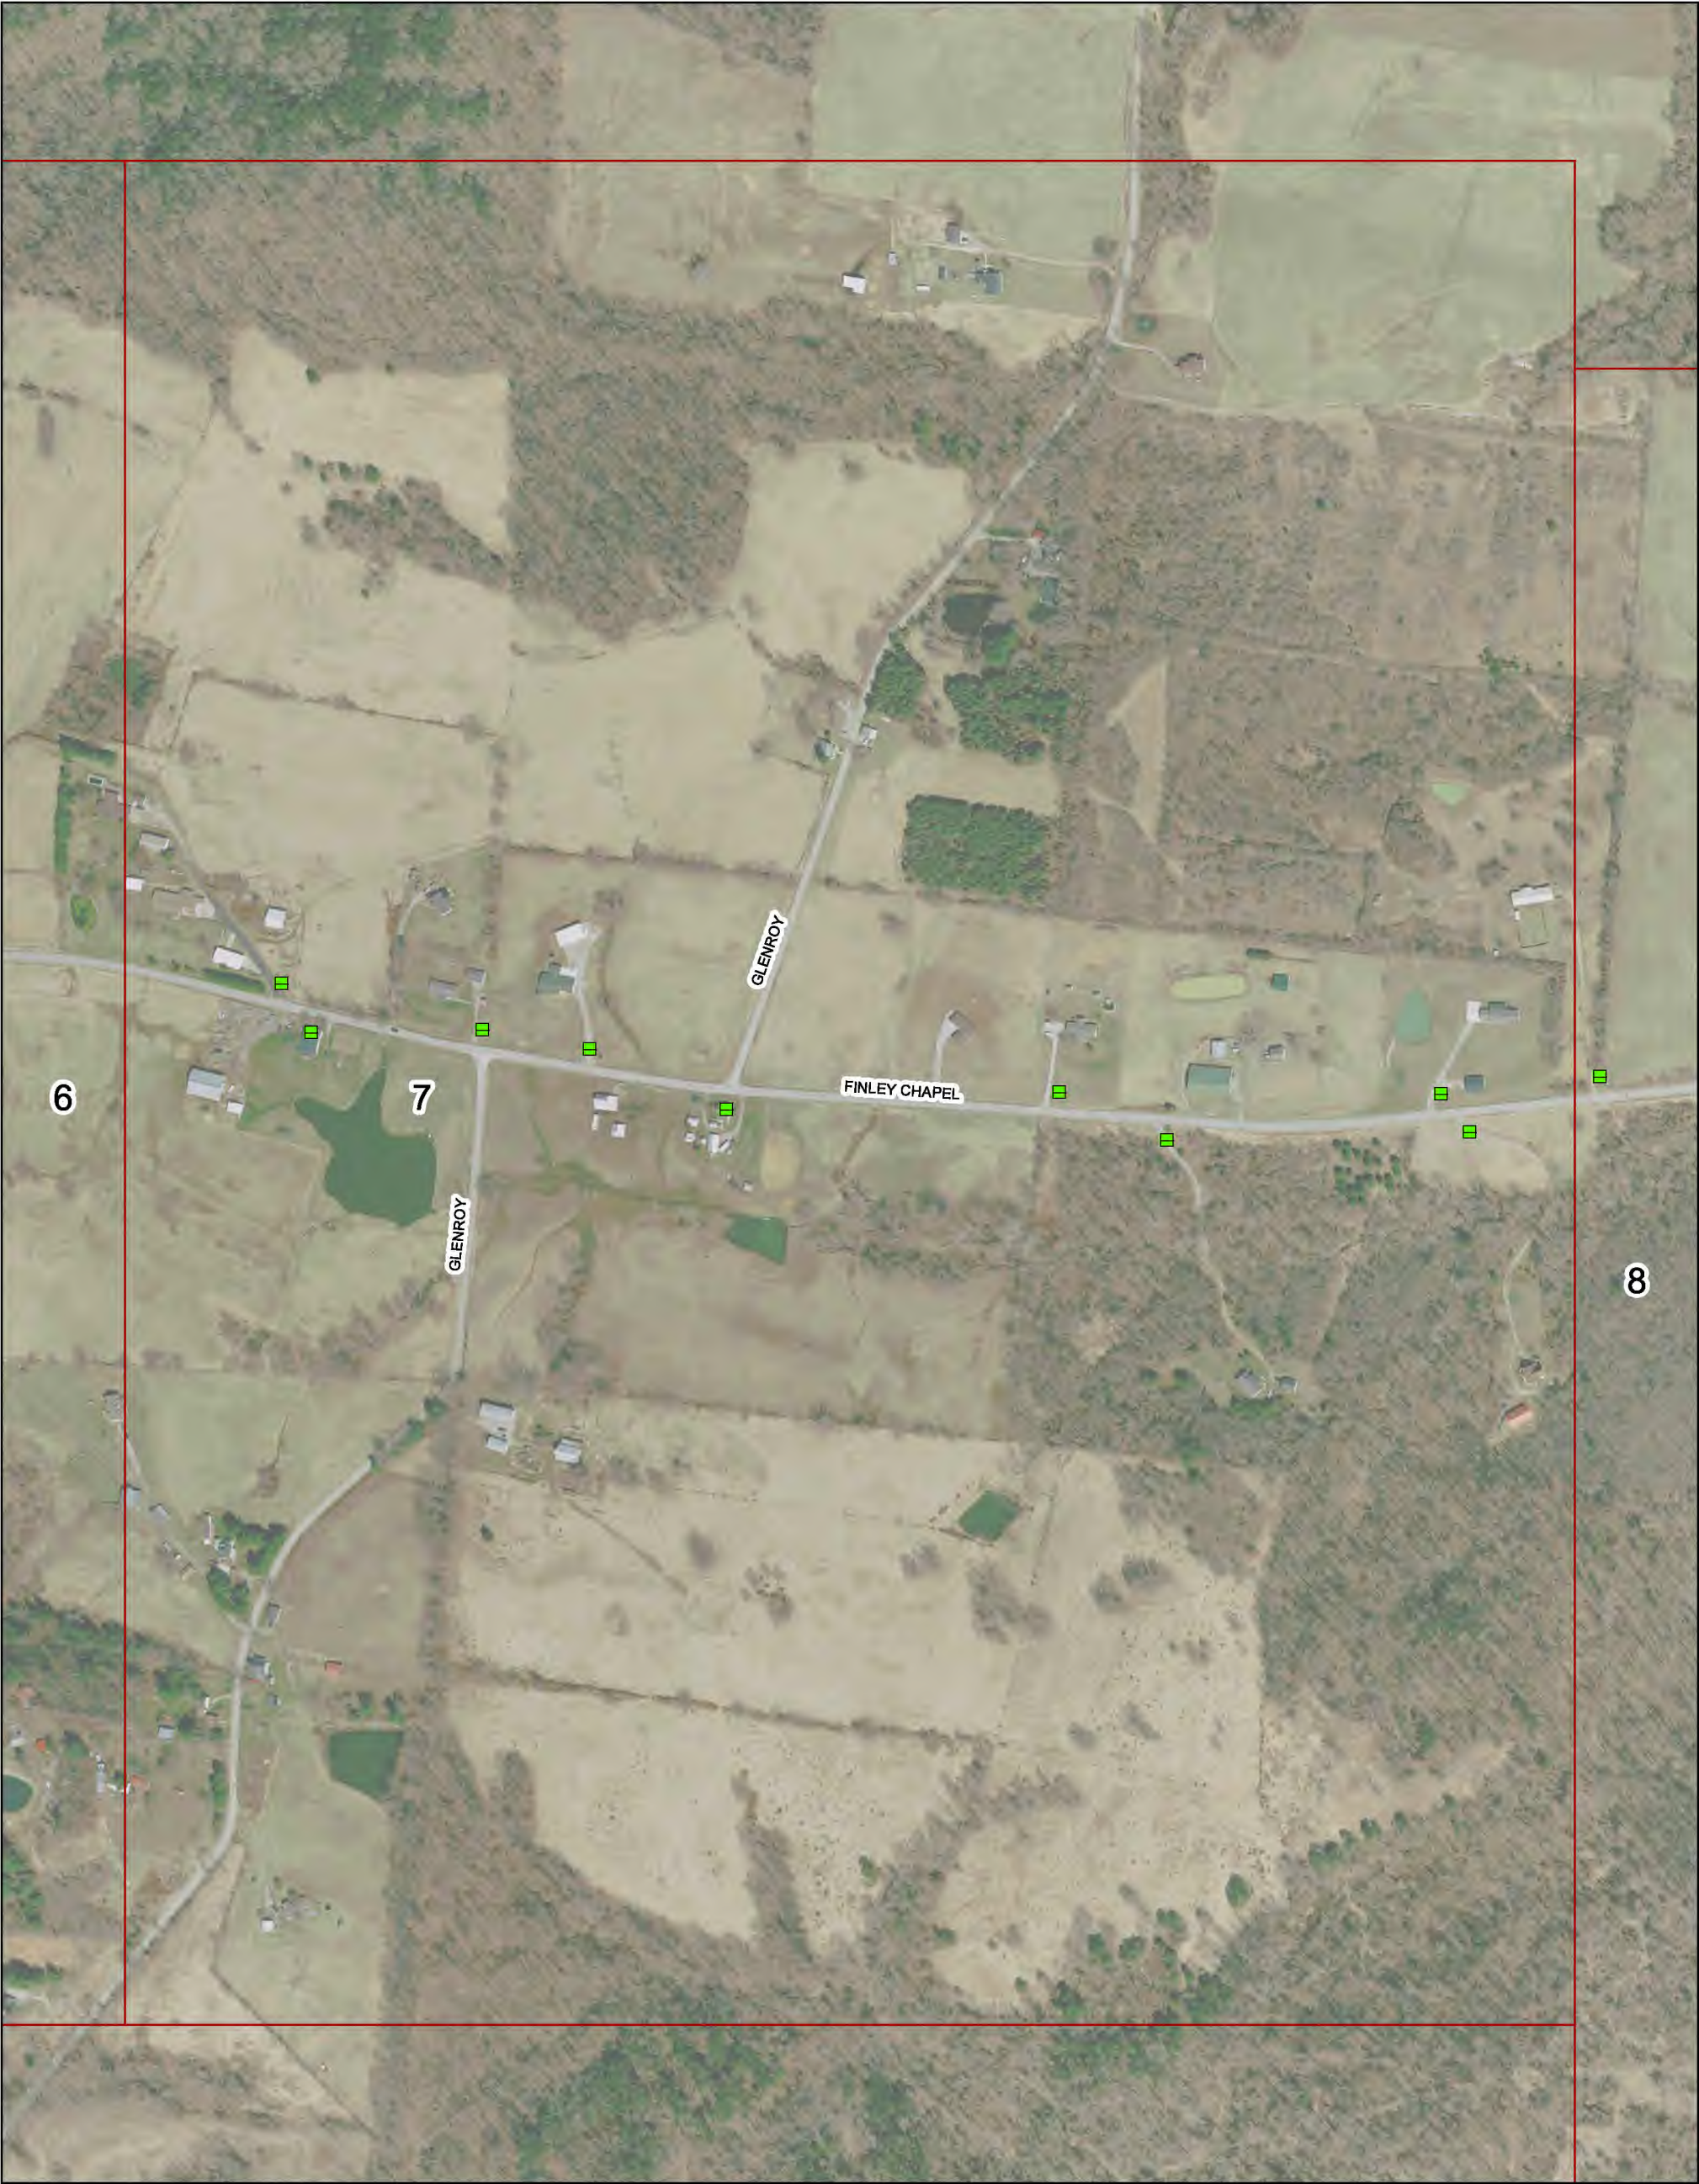
Wellston OH, Lead Service Line Probability PWS OH-4001912

Probability of Lead Service Line
Determined by year structure was built

This map does not verify the presence of lead in any of the lines or structures shown. This map only shows the probable or possible locations based on the year that the structure was built, historical maintenance and operation records, and customer or utility staff verification. This map is not intended for design engineering, surveying, or construction purposes. Information and data contained or accessed within this map emanates from various public and private sources and may contain errors and omissions. This map remains under development and is subject to change with or without notice. All data, information and documentation within this map are provided "as is" without warranty of any kind, either expressed or implied. The suitability of the data and information contained in this map is not guaranteed, and the user assumes all risk for such uses. WSOS Community Action and its employees, affiliates, agents and licensors cannot and do not warrant the accuracy, completeness, non-infringement, merchantability or fitness of any information contained within this map. All questions, comments and data errors should be directed to Ohio RCAP by phone at 330-329-9951 or by email at bdbeyeler@wsos.org. NAD 1983 Ohio St Plane S. (ft). Source: Jackson County Auditor, OGRIP, RCAP GIS. March 2017

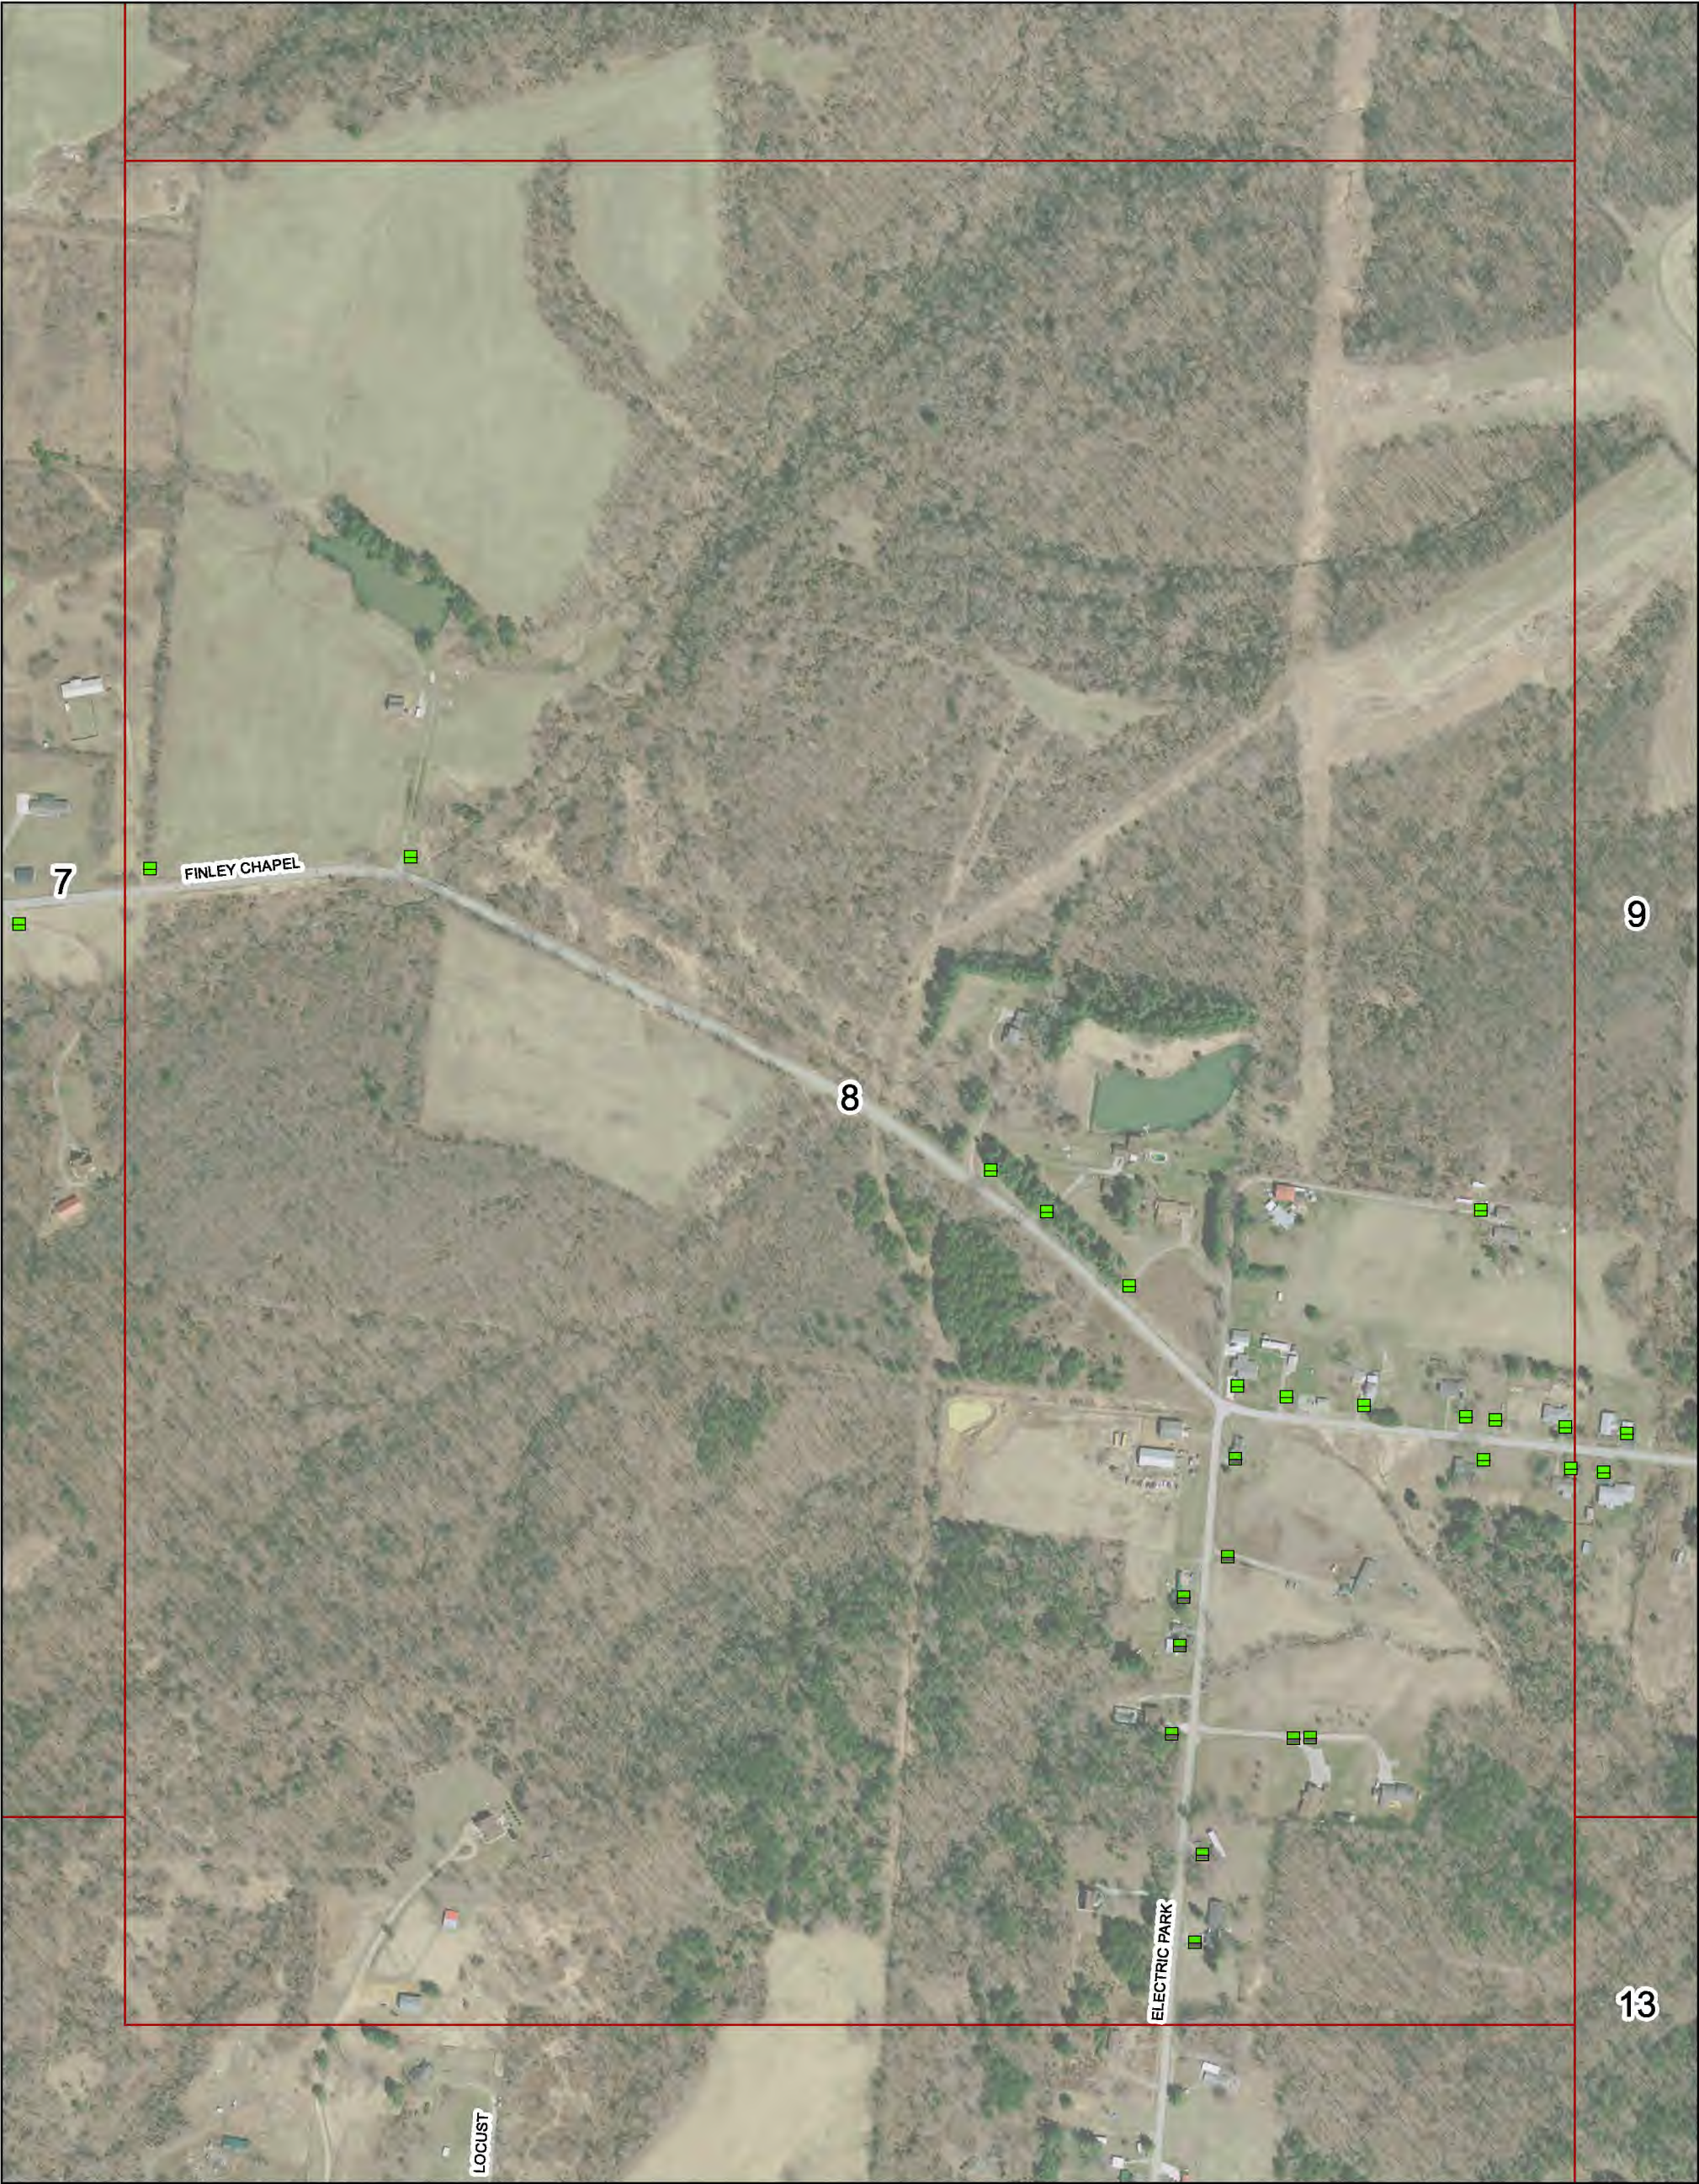
Wellston OH, Lead Service Line Probability PWS OH-4001912

Probability of Lead Service Line
Determined by year structure was built

This map does not verify the presence of lead in any of the lines or structures shown. This map only shows the probable or possible locations based on the year that the structure was built, historical maintenance and operation records, and customer or utility staff verification. This map is not intended for design engineering, surveying, or construction purposes. Information and data contained or accessed within this map emanates from various public and private sources and may contain errors and omissions. This map remains under development and is subject to change with or without notice. All data, information and documentation within this map are provided "as is" without warranty of any kind, either expressed or implied. The suitability of the data and information contained in this map is not guaranteed, and the user assumes all risk for such uses. WSOS Community Action and its employees, affiliates, agents and licensors cannot and do not warrant the accuracy, completeness, non-infringement, merchantability or fitness of any information contained within this map. All questions, comments and data errors should be directed to Ohio RCAP by phone at 330-329-9951 or by email at bdbeyeler@wsos.org. NAD 1983 Ohio St Plane S. (ft). Source: Jackson County Auditor, OGRIP, RCAP GIS. March 2017

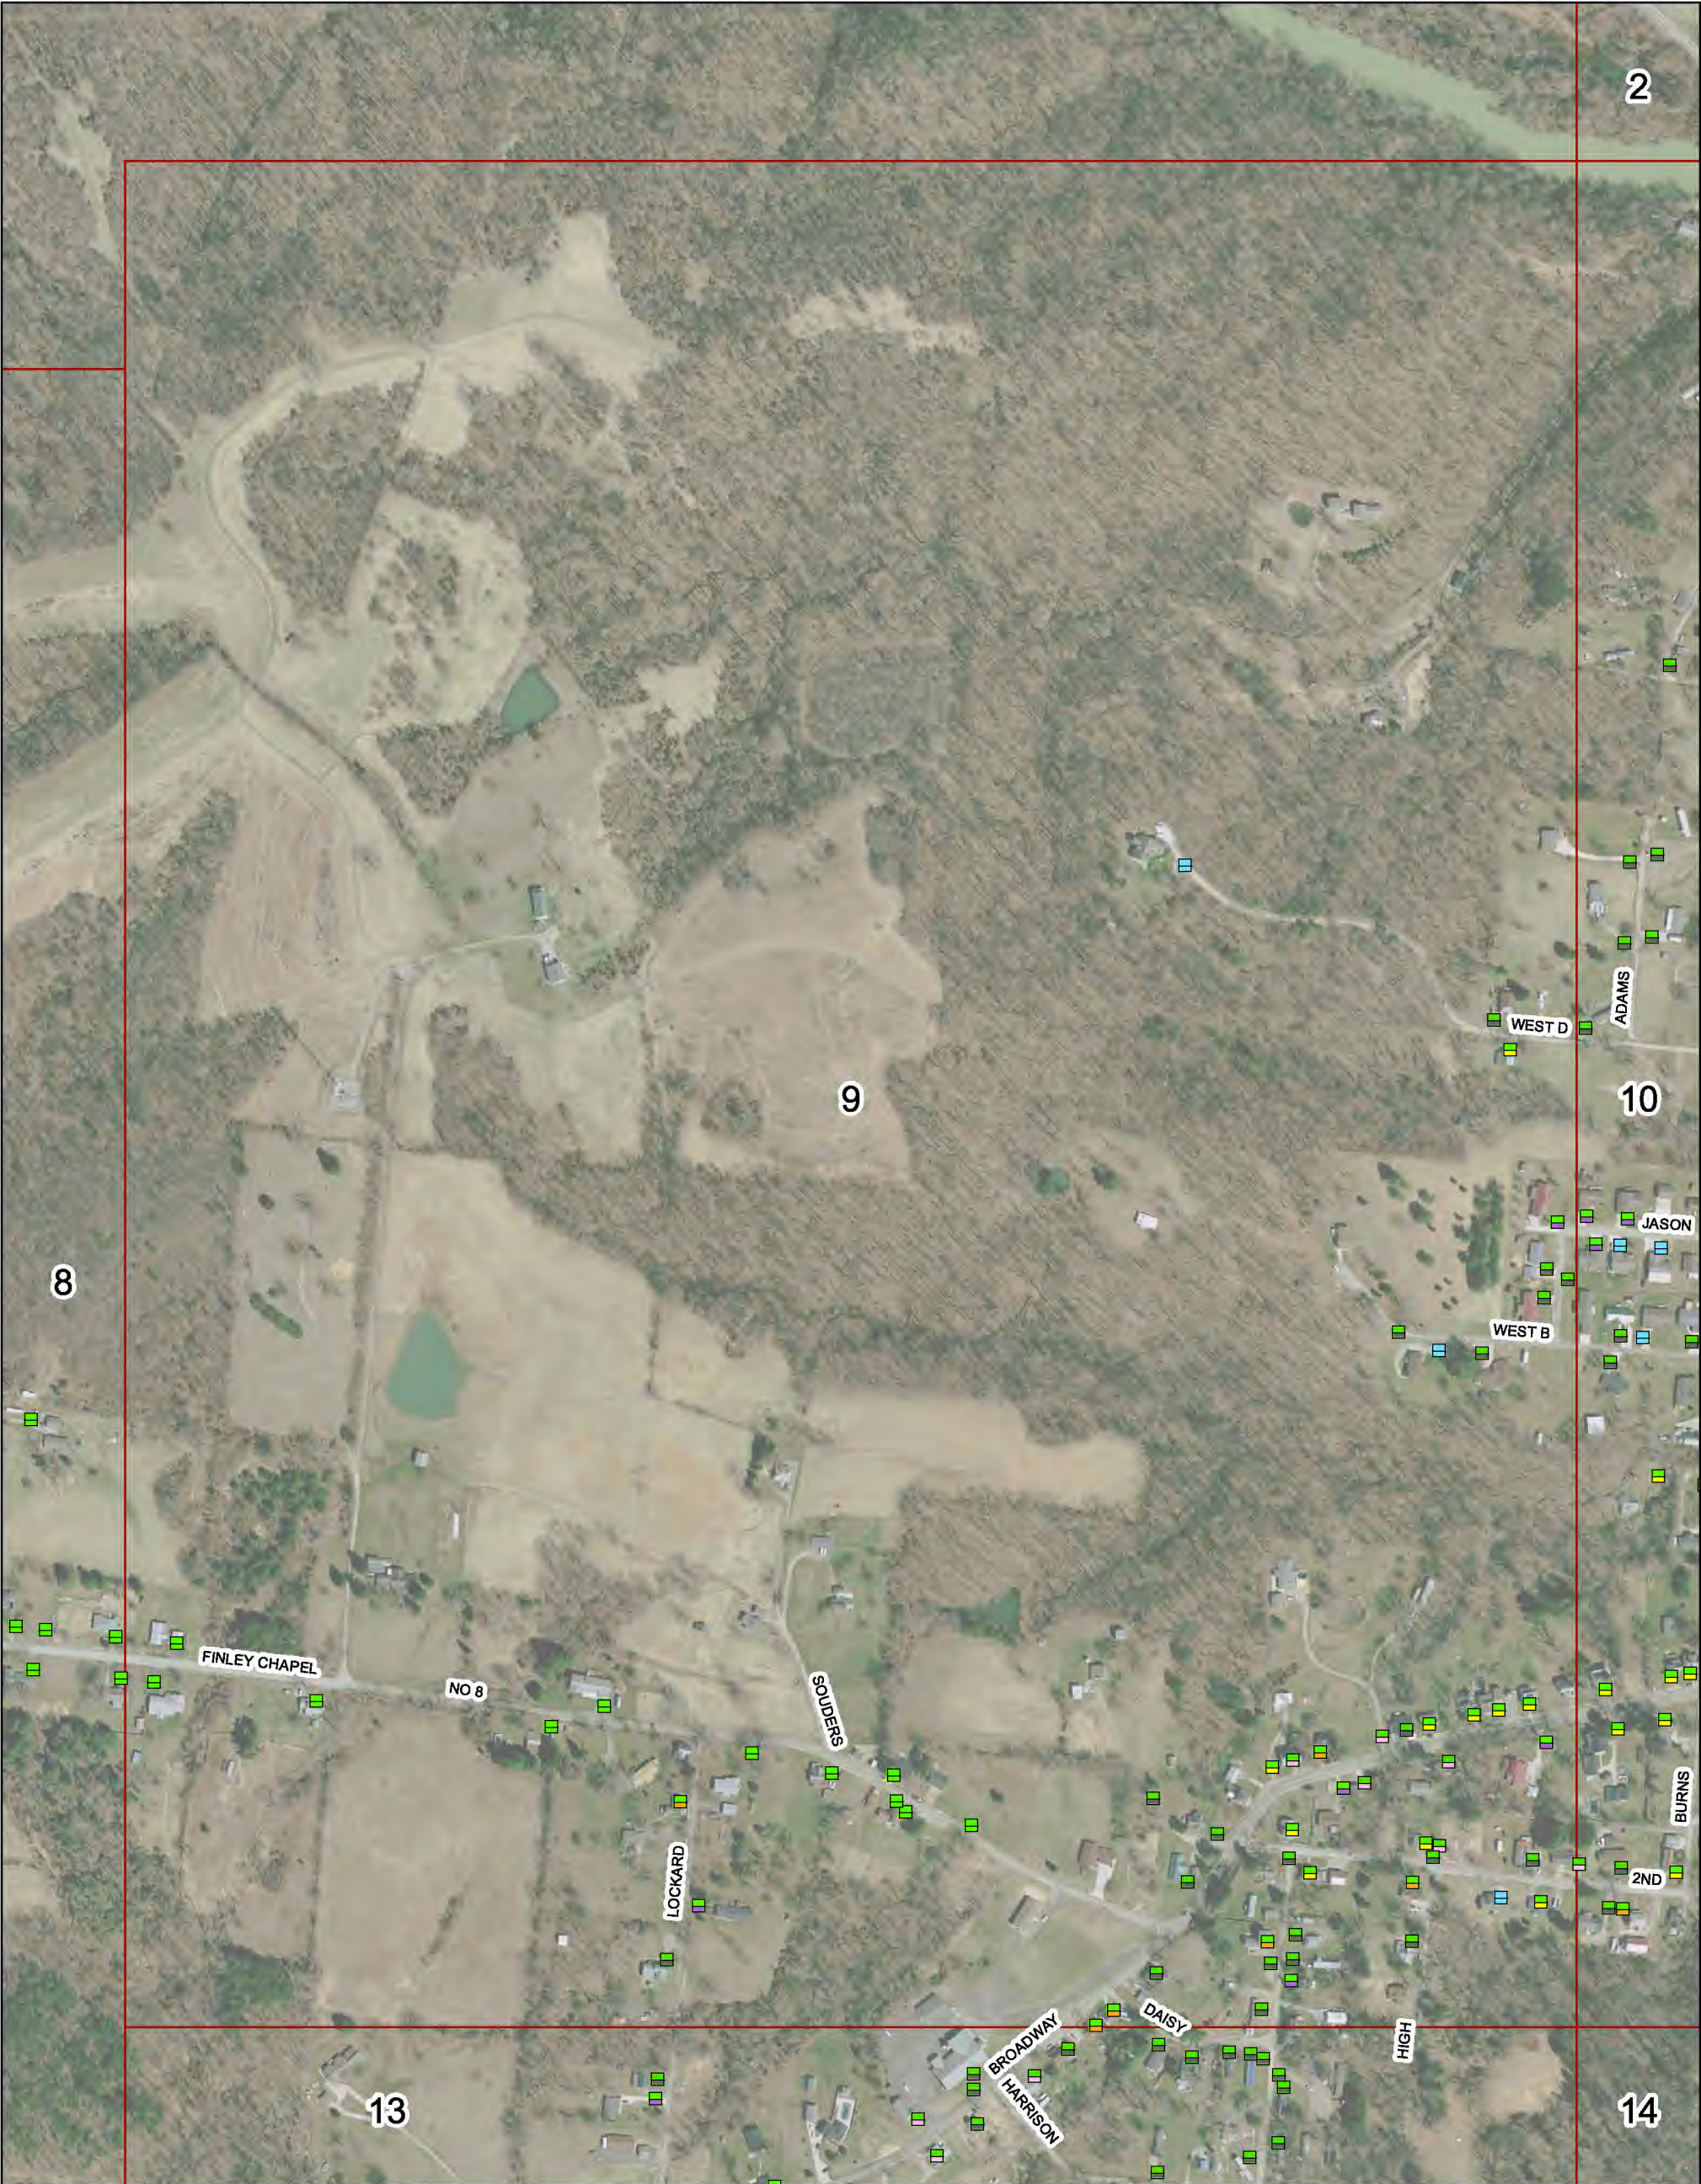
Wellston OH, Lead Service Line Probability PWS OH-4001912

Probability of Lead Service Line Determined by year structure was built

This map does not verify the presence of lead in any of the lines or structures shown. This map only shows the probable or possible locations based on the year that the structure was built, historical maintenance and operation records, and customer or utility staff verification. This map is not intended for design engineering, surveying, or construction purposes. Information and data contained or accessed within this map emanates from various public and private sources and may contain errors and omissions. This map remains under development and is subject to change with or without notice. All data, information and documentation within this map are provided "as is" without warranty of any kind, either expressed or implied. The suitability of the data and information contained in this map is not guaranteed, and the user assumes all risk for such uses. WSOS Community Action and its employees, affiliates, agents and licensors cannot and do not warrant the accuracy, completeness, non-infringement, merchantability or fitness of any information contained within this map. All questions, comments and data errors should be directed to Ohio RCAP by phone at 330-329-9951 or by email at bdbeyeler@wsos.org. NAD 1983 Ohio St Plane S. (ft). Source: Jackson County Auditor, OGRIP, RCAP GIS. March 2017

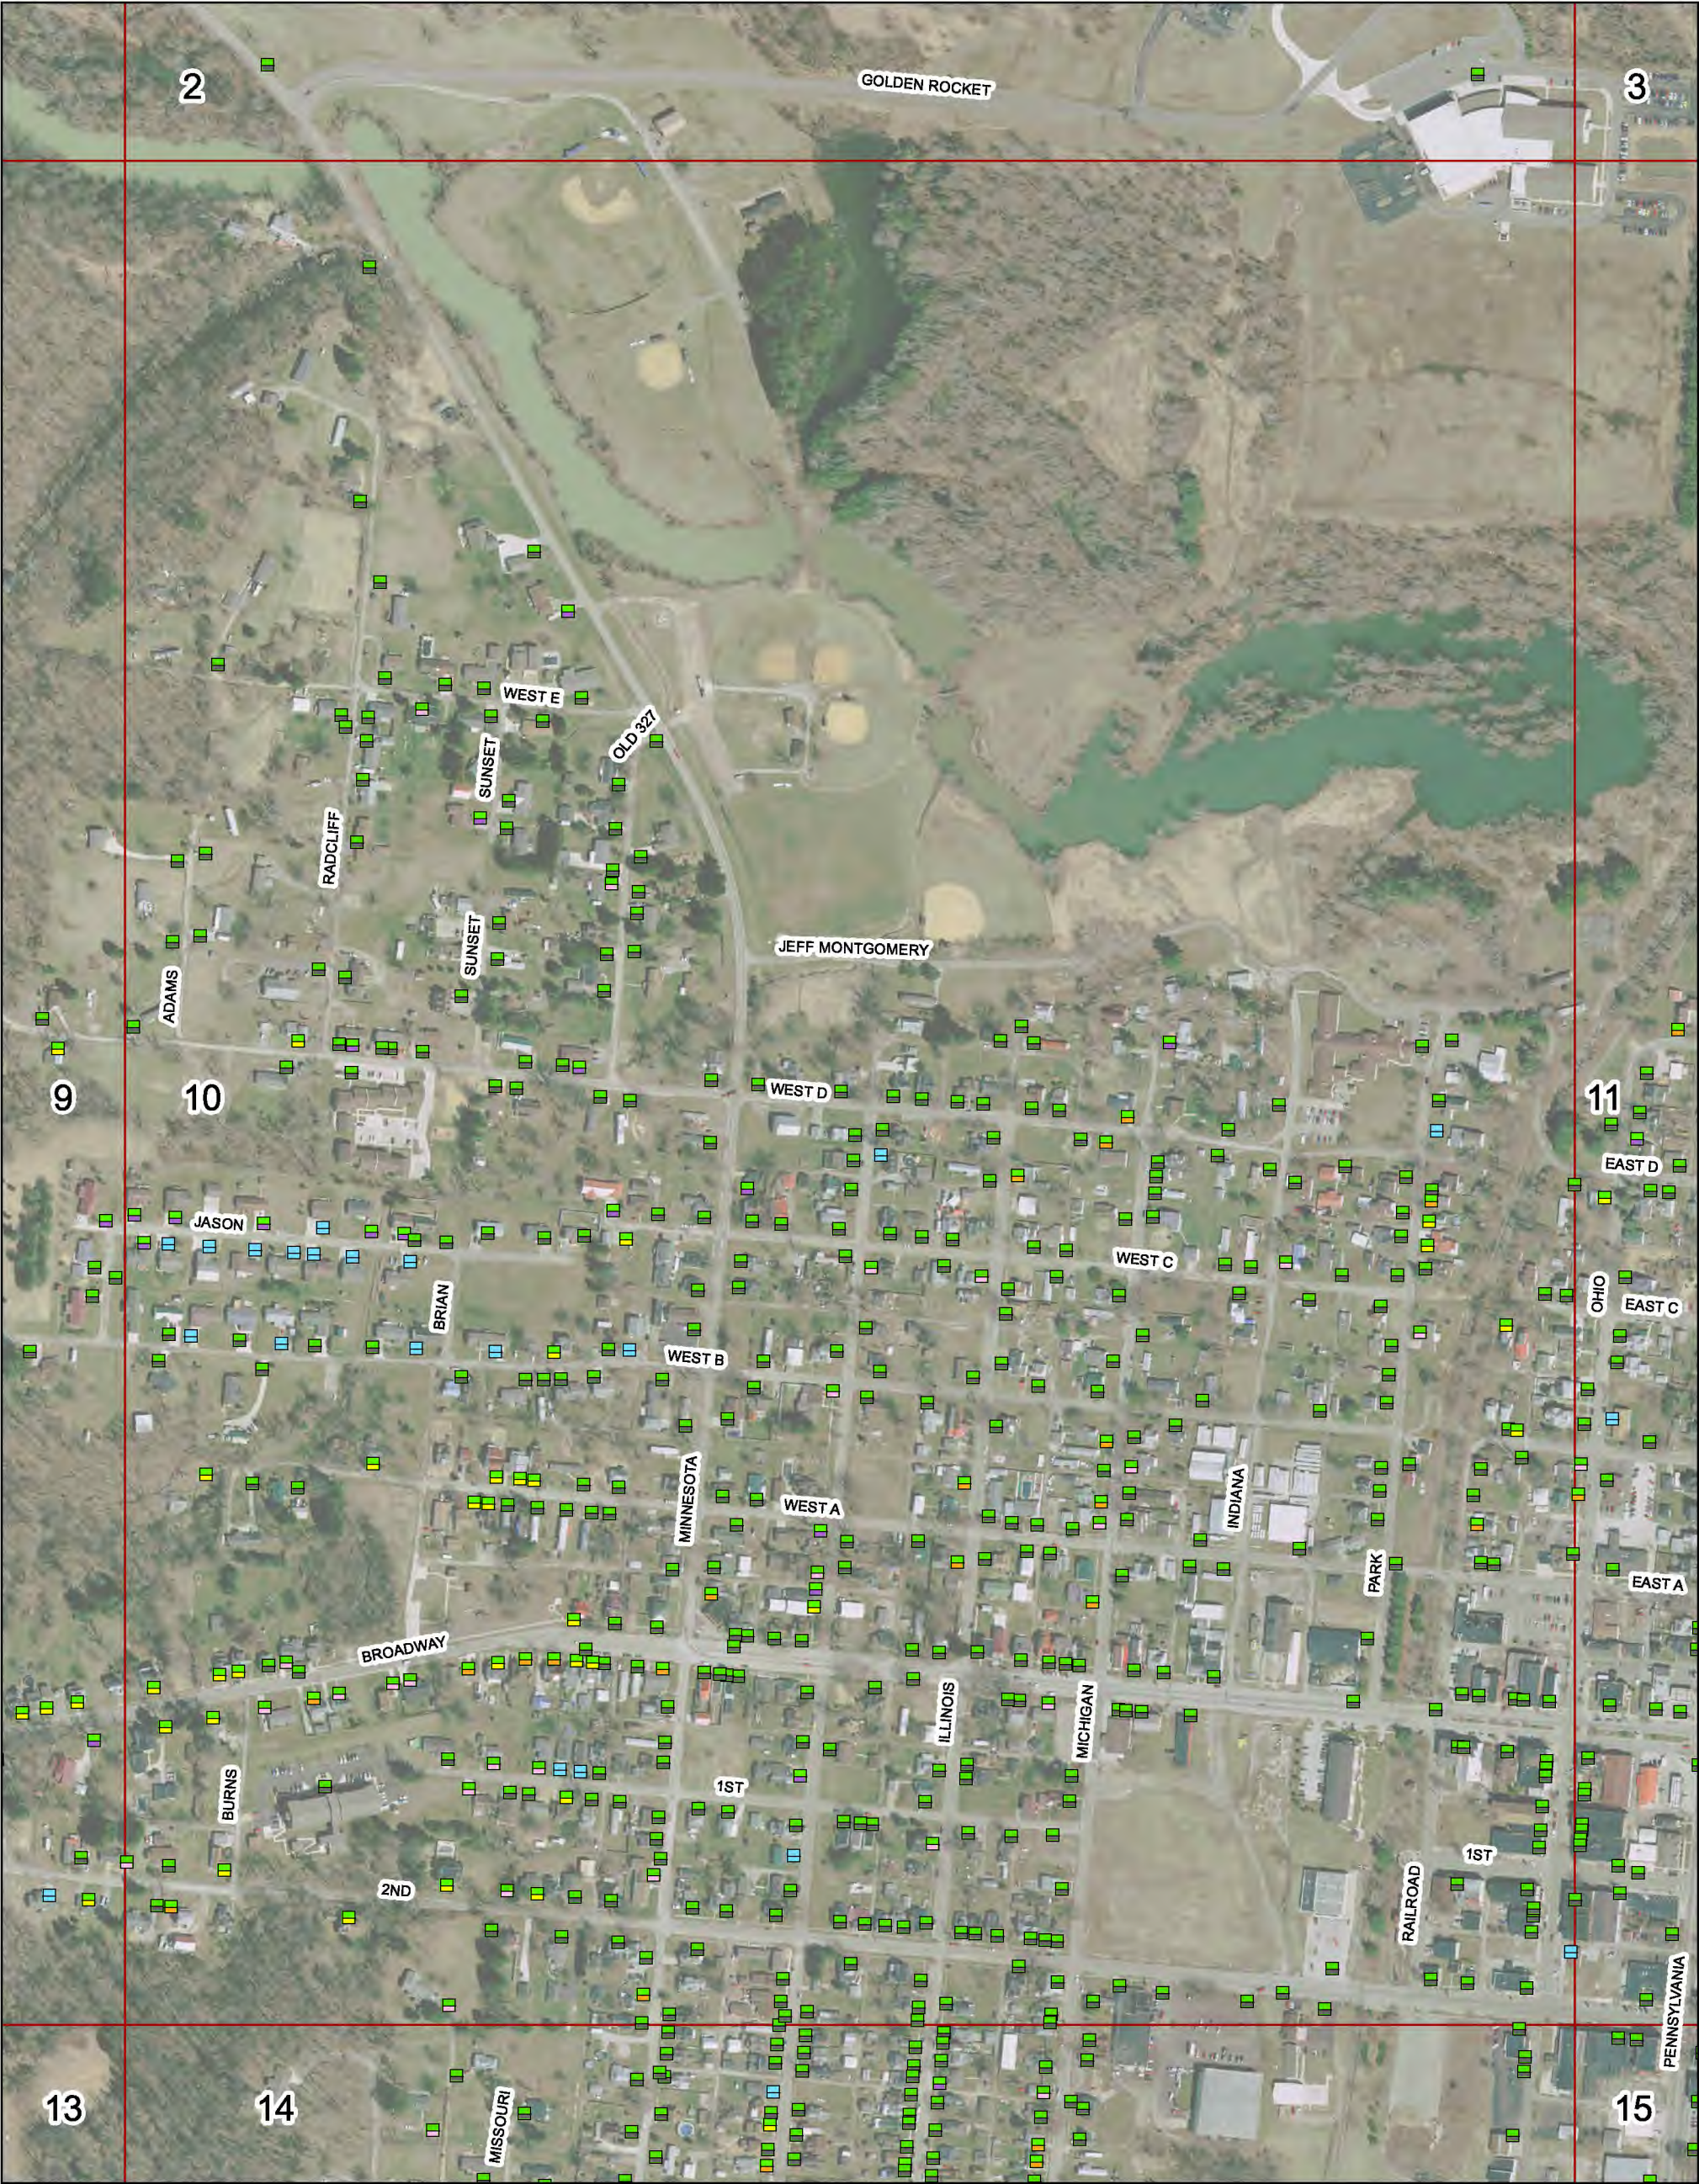
Wellston OH, Lead Service Line Probability PWS OH-4001912

Probability of Lead Service Line
Determined by year structure was built

This map does not verify the presence of lead in any of the lines or structures shown. This map only shows the probable or possible locations based on the year that the structure was built, historical maintenance and operation records, and customer or utility staff verification. This map is not intended for design engineering, surveying, or construction purposes. Information and data contained or accessed within this map emanates from various public and private sources and may contain errors and omissions. This map remains under development and is subject to change with or without notice. All data, information and documentation within this map are provided "as is" without warranty of any kind, either expressed or implied. The suitability of the data and information contained in this map is not guaranteed, and the user assumes all risk for such uses. WSOS Community Action and its employees, affiliates, agents and licensors cannot and do not warrant the accuracy, completeness, non-infringement, merchantability or fitness of any information contained within this map. All questions, comments and data errors should be directed to Ohio RCAP by phone at 330-329-9951 or by email at bdbeyeler@wsos.org. NAD 1983 Ohio St Plane S. (ft). Source: Jackson County Auditor, OGRIP, RCAP GIS, March 2017
