City of Wellston Public Water System Lead (Pb) Components

PWSID# OH-4001912

Prepared February March 2017

Wellston OH, Lead Service Line Probability PWS OH-4001912

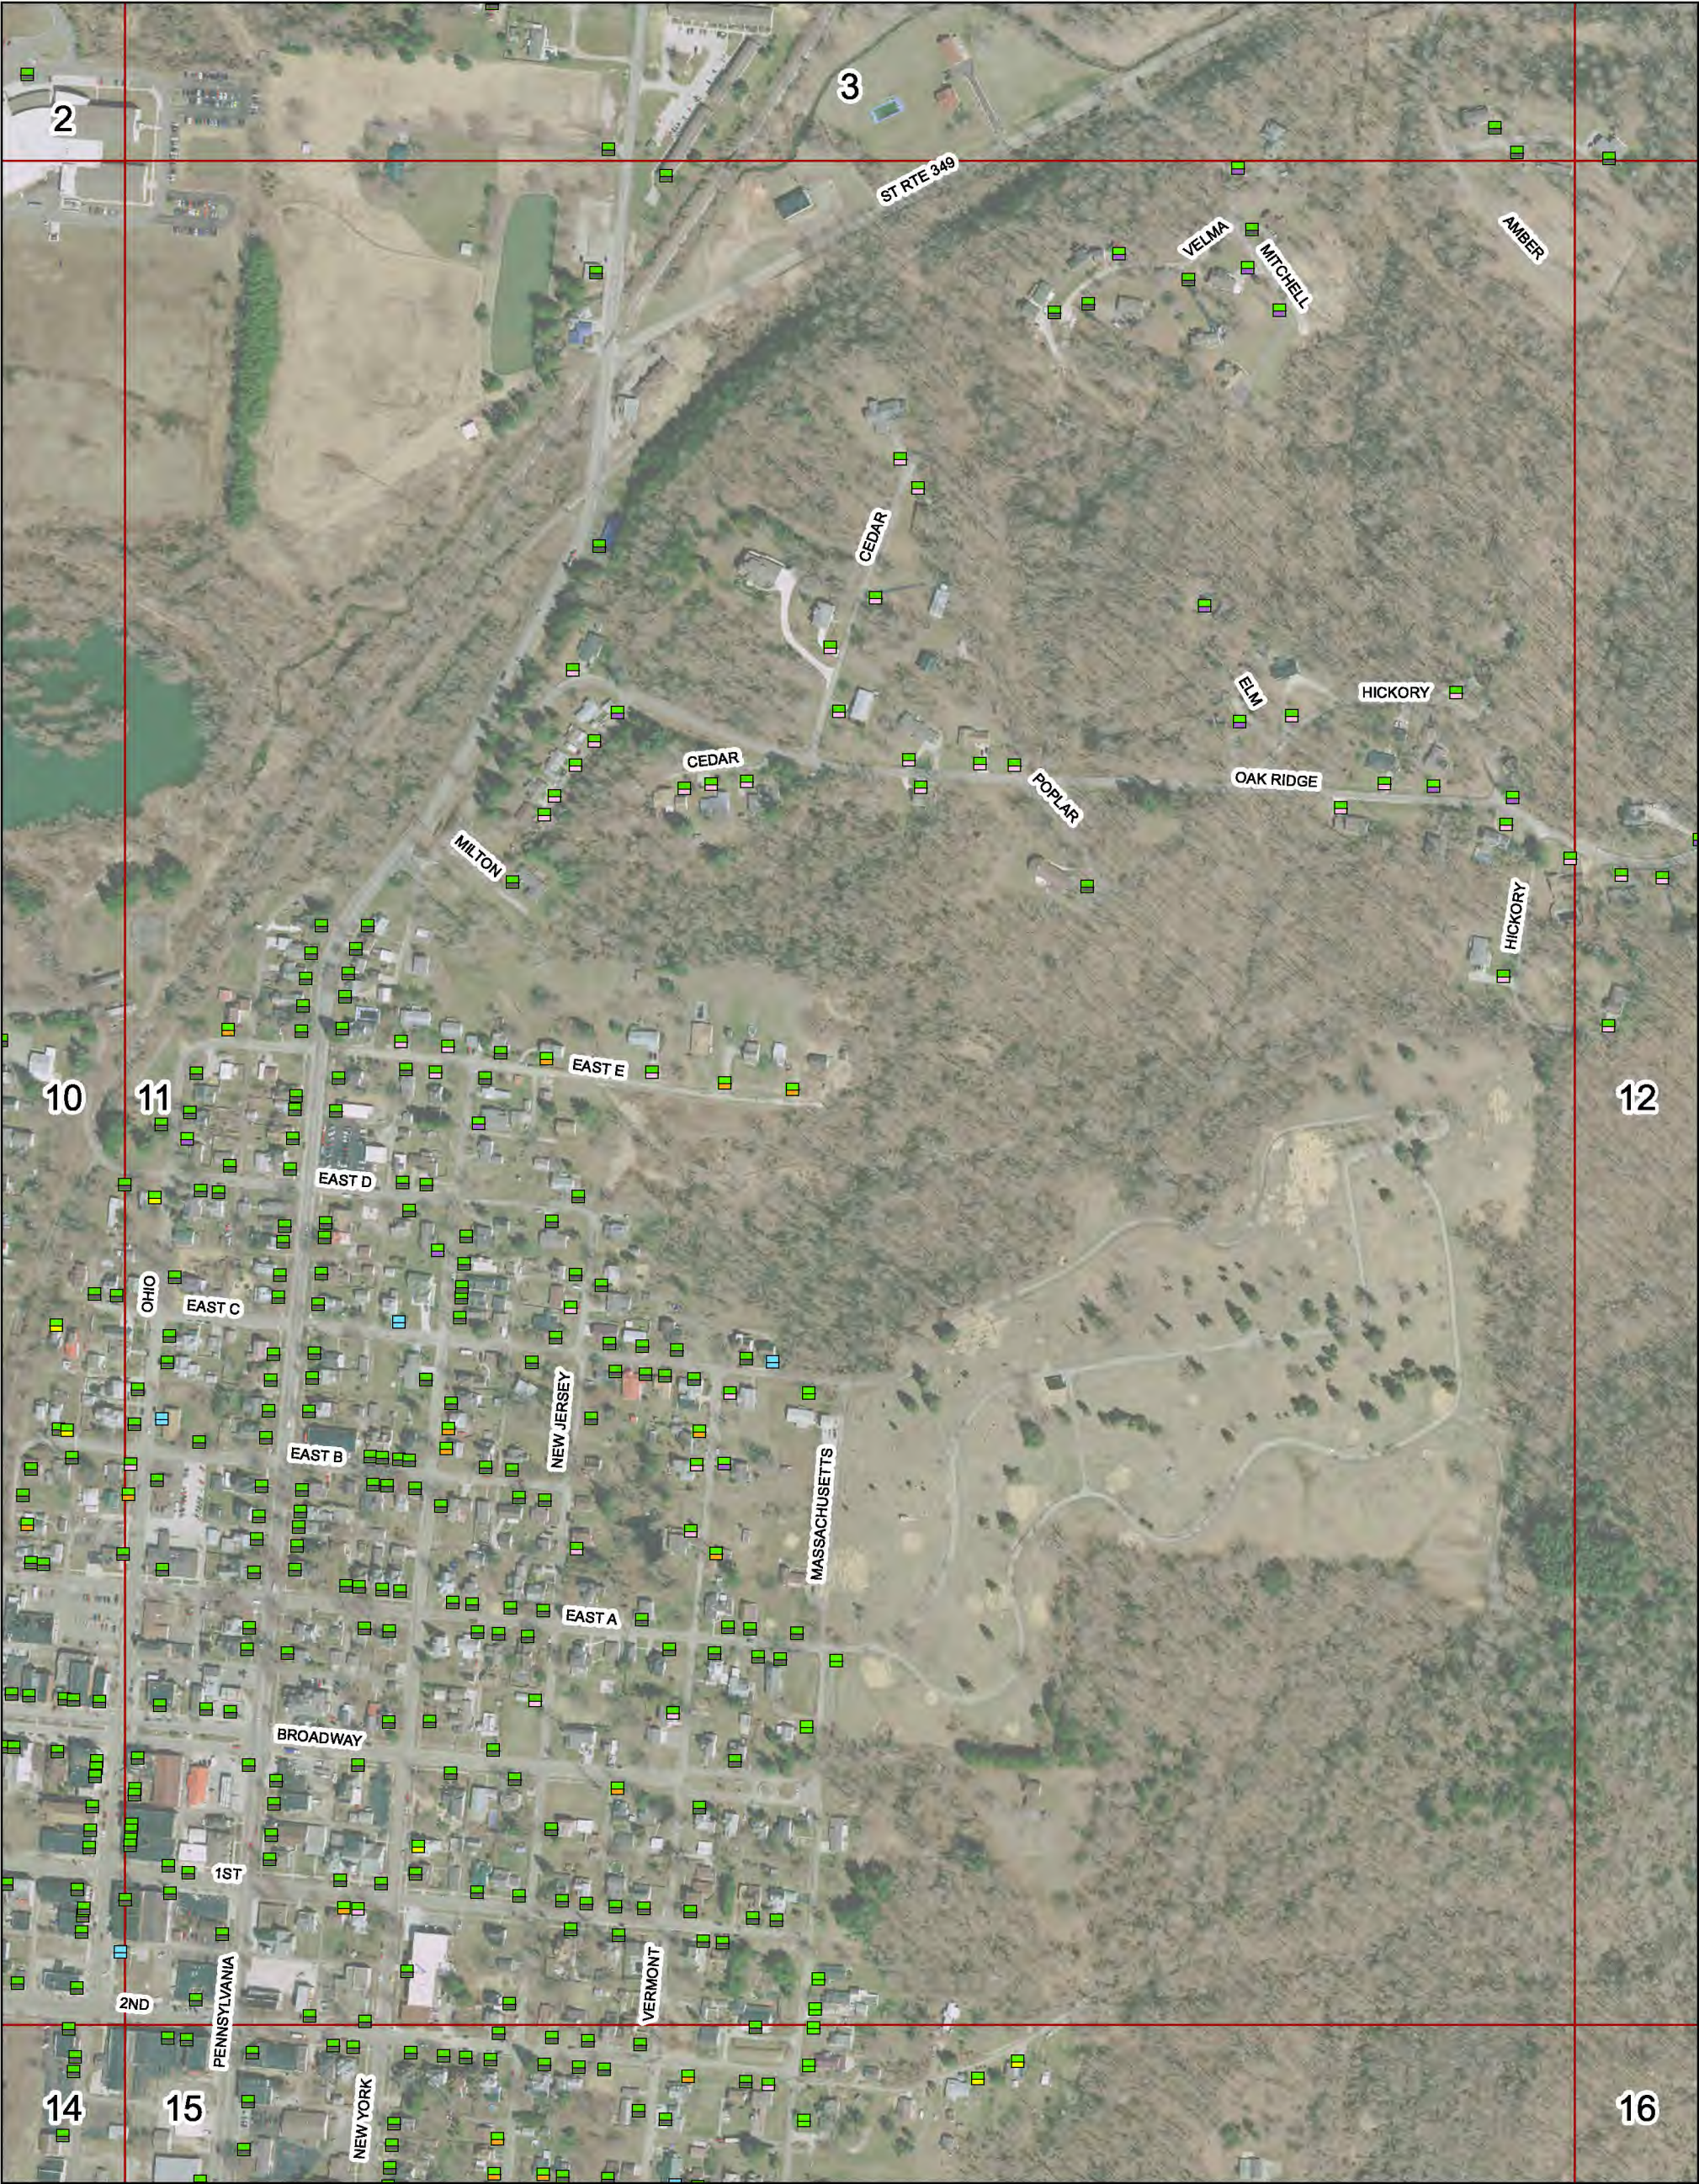
Wellston OH, Lead Service Line Probability PWS OH-4001912

Probability of Lead Service Line
Determined by year structure was built

This map does not verify the presence of lead in any of the lines or structures shown. This map only shows the probable or possible locations based on the year that the structure was built, historical maintenance and operation records, and customer or utility staff verification. This map is not intended for design engineering, surveying, or construction purposes. Information and data contained or accessed within this map emanates from various public and private sources and may contain errors and omissions. This map remains under development and is subject to change with or without notice. All data, information and documentation within this map are provided "as is" without warranty of any kind, either expressed or implied. The suitability of the data and information contained in this map is not guaranteed, and the user assumes all risk for such uses. WSOS Community Action and its employees, affiliates, agents and licensors cannot and do not warrant the accuracy, completeness, non-infringement, merchantability or fitness of any information contained within this map. All questions, comments and data errors should be directed to Ohio RCAP by phone at 330-329-9951 or by email at bdbeyeler@wsos.org. NAD 1983 Ohio St Plane S. (ft). Source: Jackson County Auditor, OGRIP, RCAP GIS. March 2017

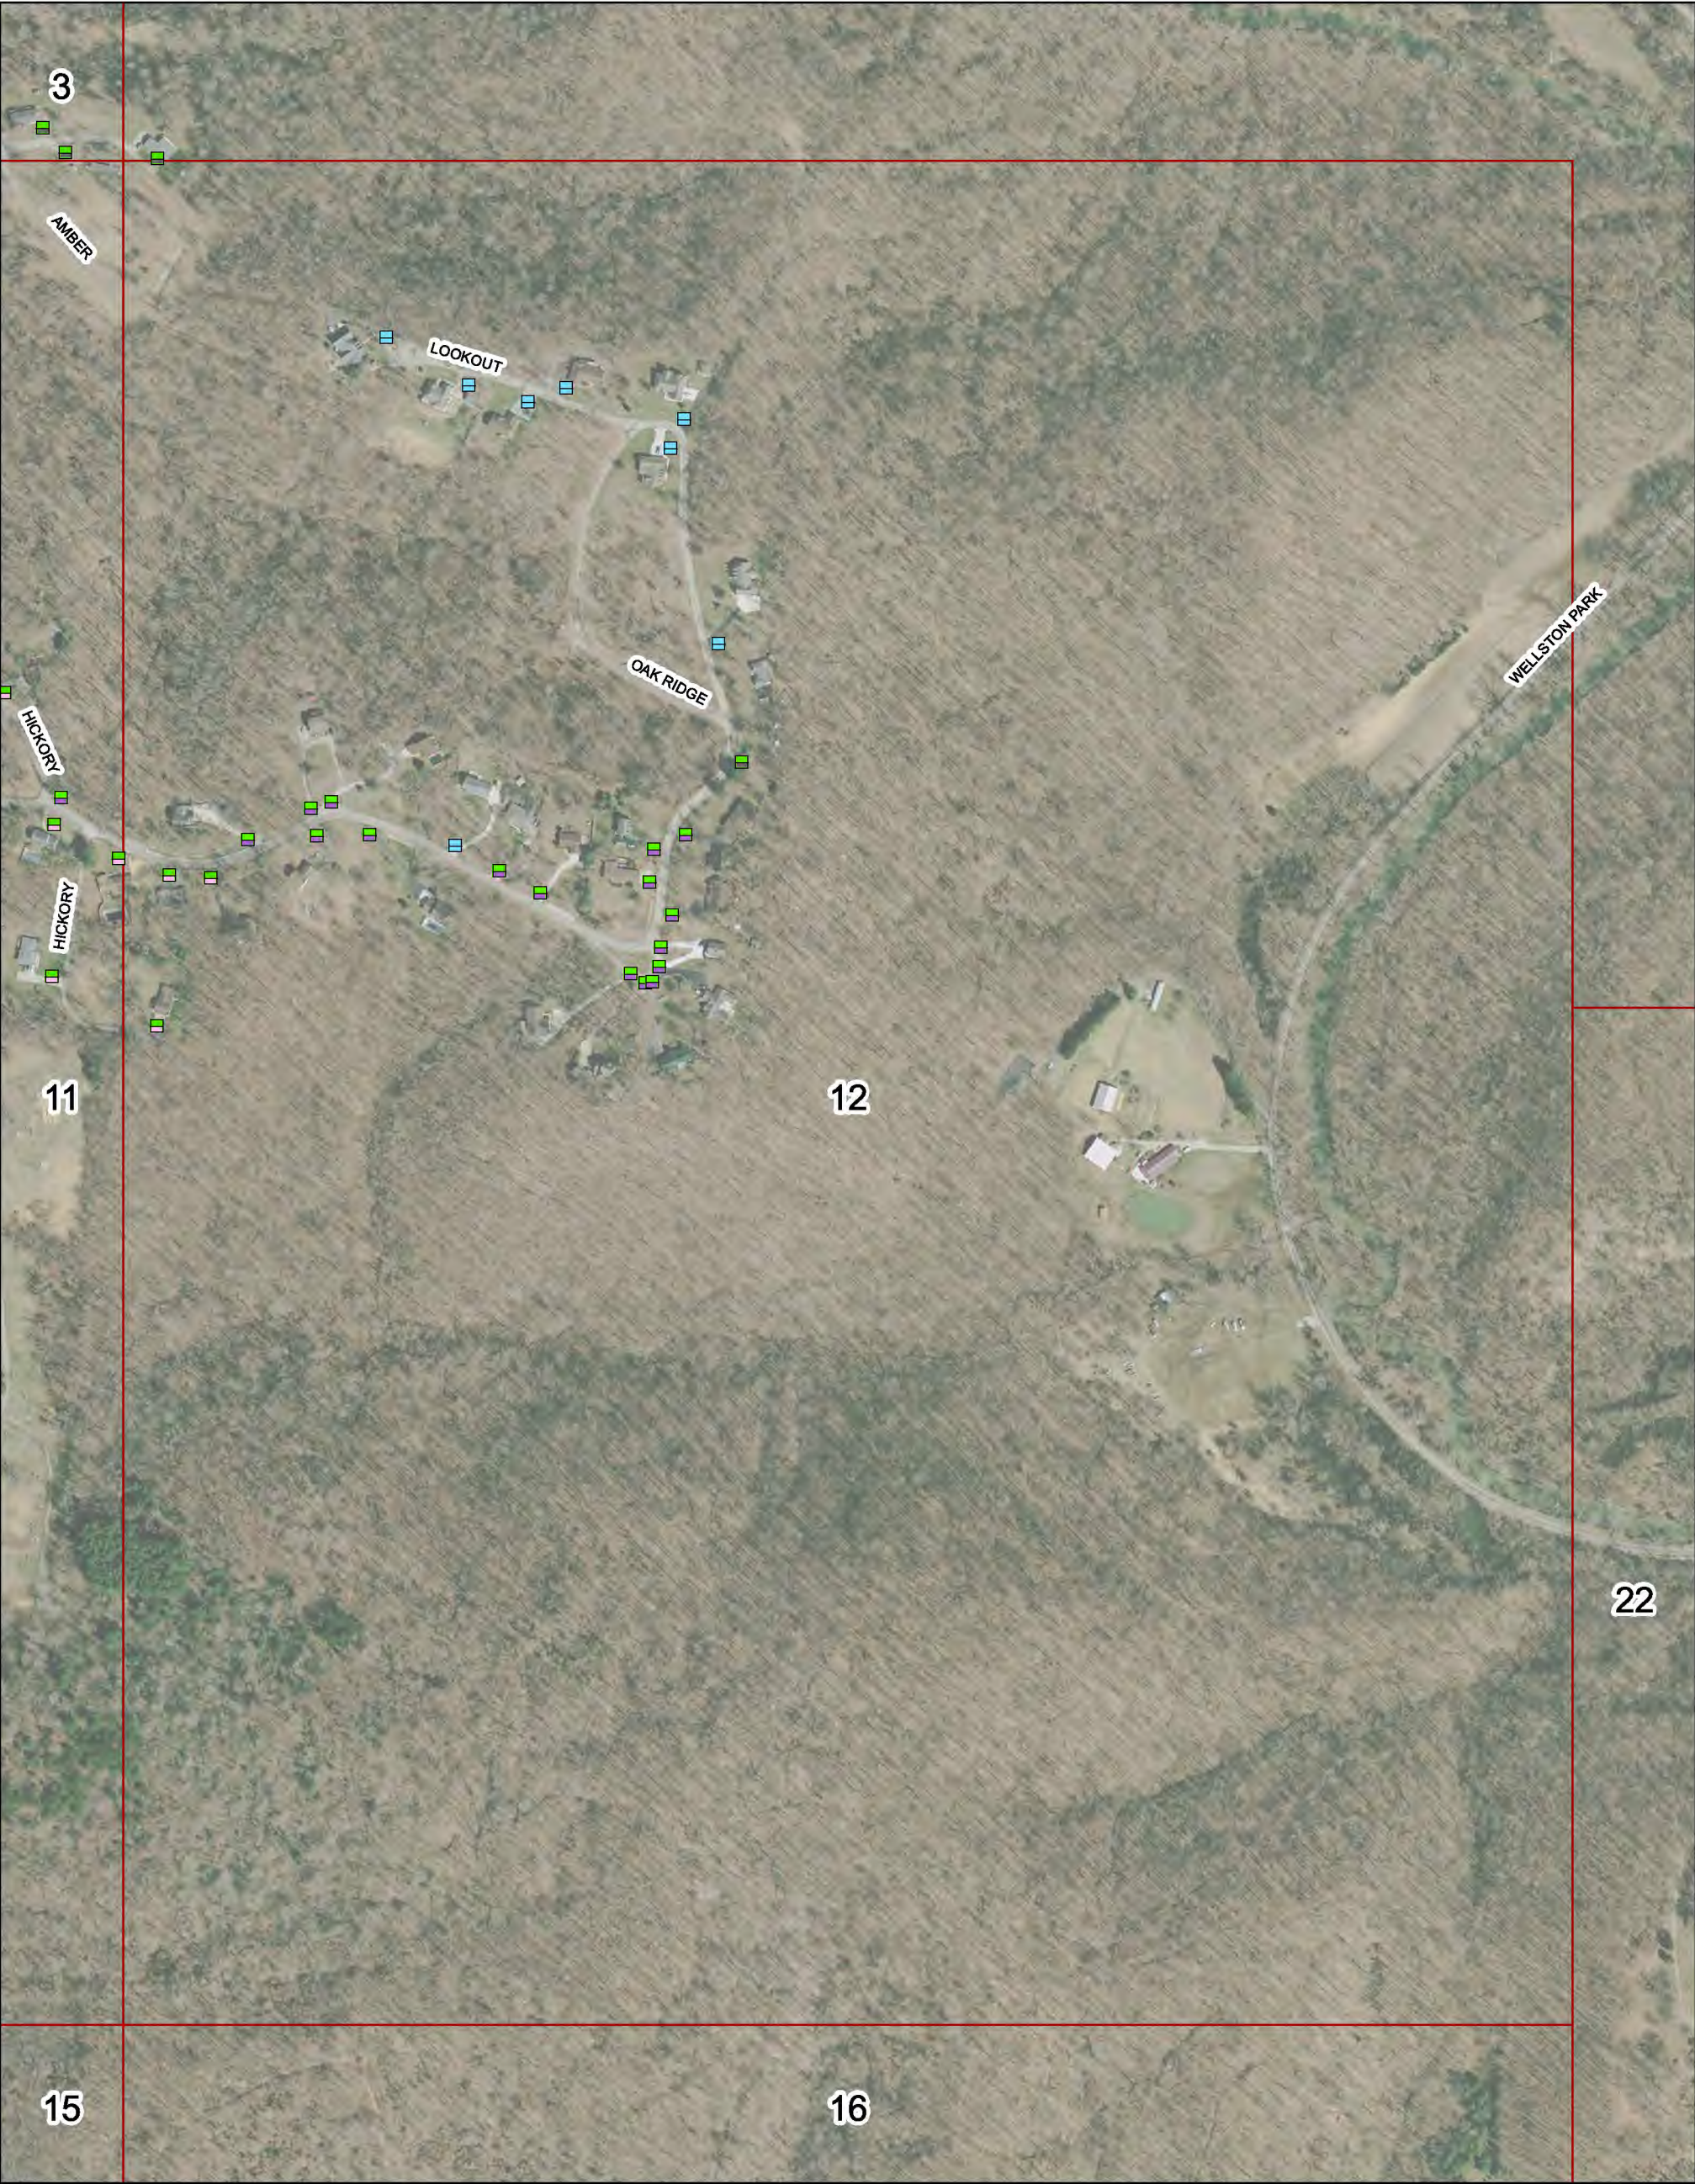
Wellston OH, Lead Service Line Probability PWS OH-4001912

Probability of Lead Service Line
Determined by year structure was built

This map does not verify the presence of lead in any of the lines or structures shown. This map only shows the probable or possible locations based on the year that the structure was built, historical maintenance and operation records, and customer or utility staff verification. This map is not intended for design engineering, surveying, or construction purposes. Information and data contained or accessed within this map emanates from various public and private sources and may contain errors and omissions. This map remains under development and is subject to change with or without notice. All data, information and documentation within this map are provided "as is" without warranty of any kind, either expressed or implied. The suitability of the data and information contained in this map is not guaranteed, and the user assumes all risk for such uses. WSOS Community Action and its employees, affiliates, agents and licensors cannot and do not warrant the accuracy, completeness, non-infringement, merchantability or fitness of any information contained within this map. All questions, comments and data errors should be directed to Ohio RCAP by phone at 330-329-9951 or by email at bdbeyeler@wsos.org. NAD 1983 Ohio St Plane S. (ft). Source: Jackson County Auditor, OGRIP, RCAP GIS. March 2017

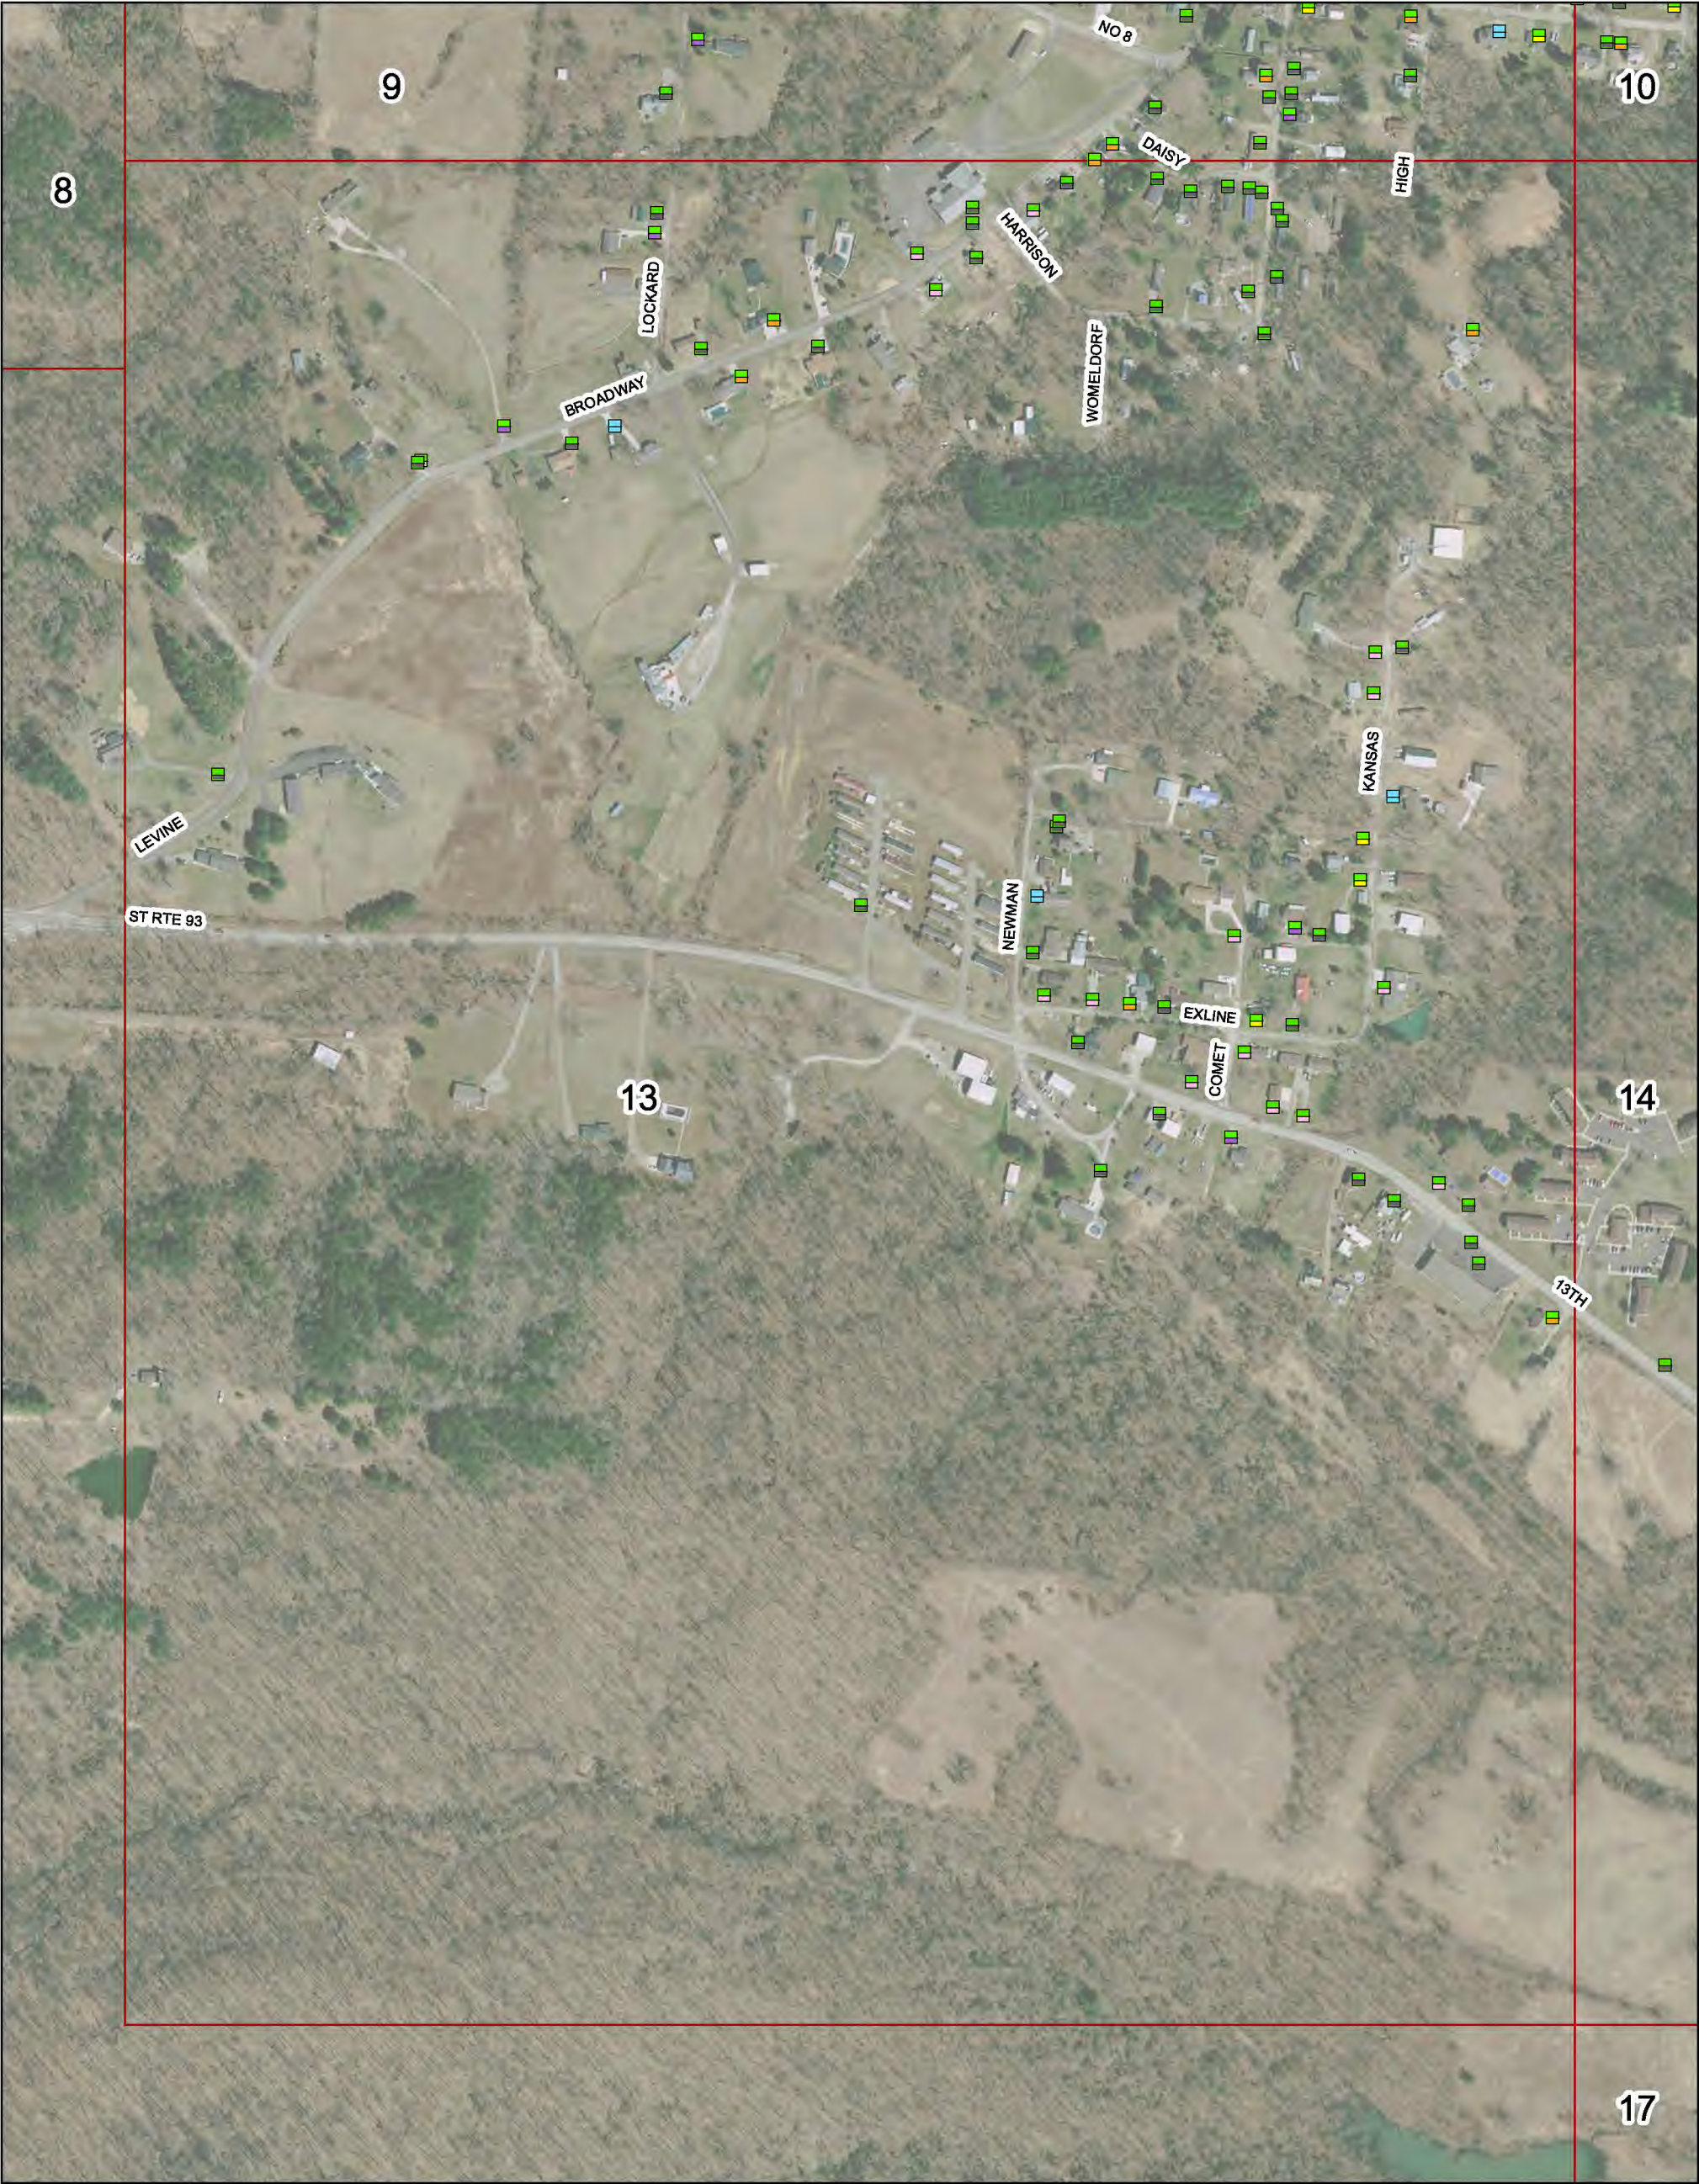
Wellston OH, Lead Service Line Probability PWS OH-4001912

Probability of Lead Service Line
Determined by year structure was built

This map does not verify the presence of lead in any of the lines or structures shown. This map only shows the probable or possible locations based on the year that the structure was built, historical maintenance and operation records, and customer or utility staff verification. This map is not intended for design engineering, surveying, or construction purposes. Information and data contained or accessed within this map emanates from various public and private sources and may contain errors and omissions. This map remains under development and is subject to change with or without notice. All data, information and documentation within this map are provided "as is" without warranty of any kind, either expressed or implied. The suitability of the data and information contained in this map is not guaranteed, and the user assumes all risk for such uses. WSOS Community Action and its employees, affiliates, agents and licensors cannot and do not warrant the accuracy, completeness, non-infringement, merchantability or fitness of any information contained within this map. All questions, comments and data errors should be directed to Ohio RCAP by phone at 330-329-9951 or by email at bdbeyeler@wsos.org. NAD 1983 Ohio St Plane S. (ft). Source: Jackson County Auditor, OGRIP, RCAP GIS, March 2017

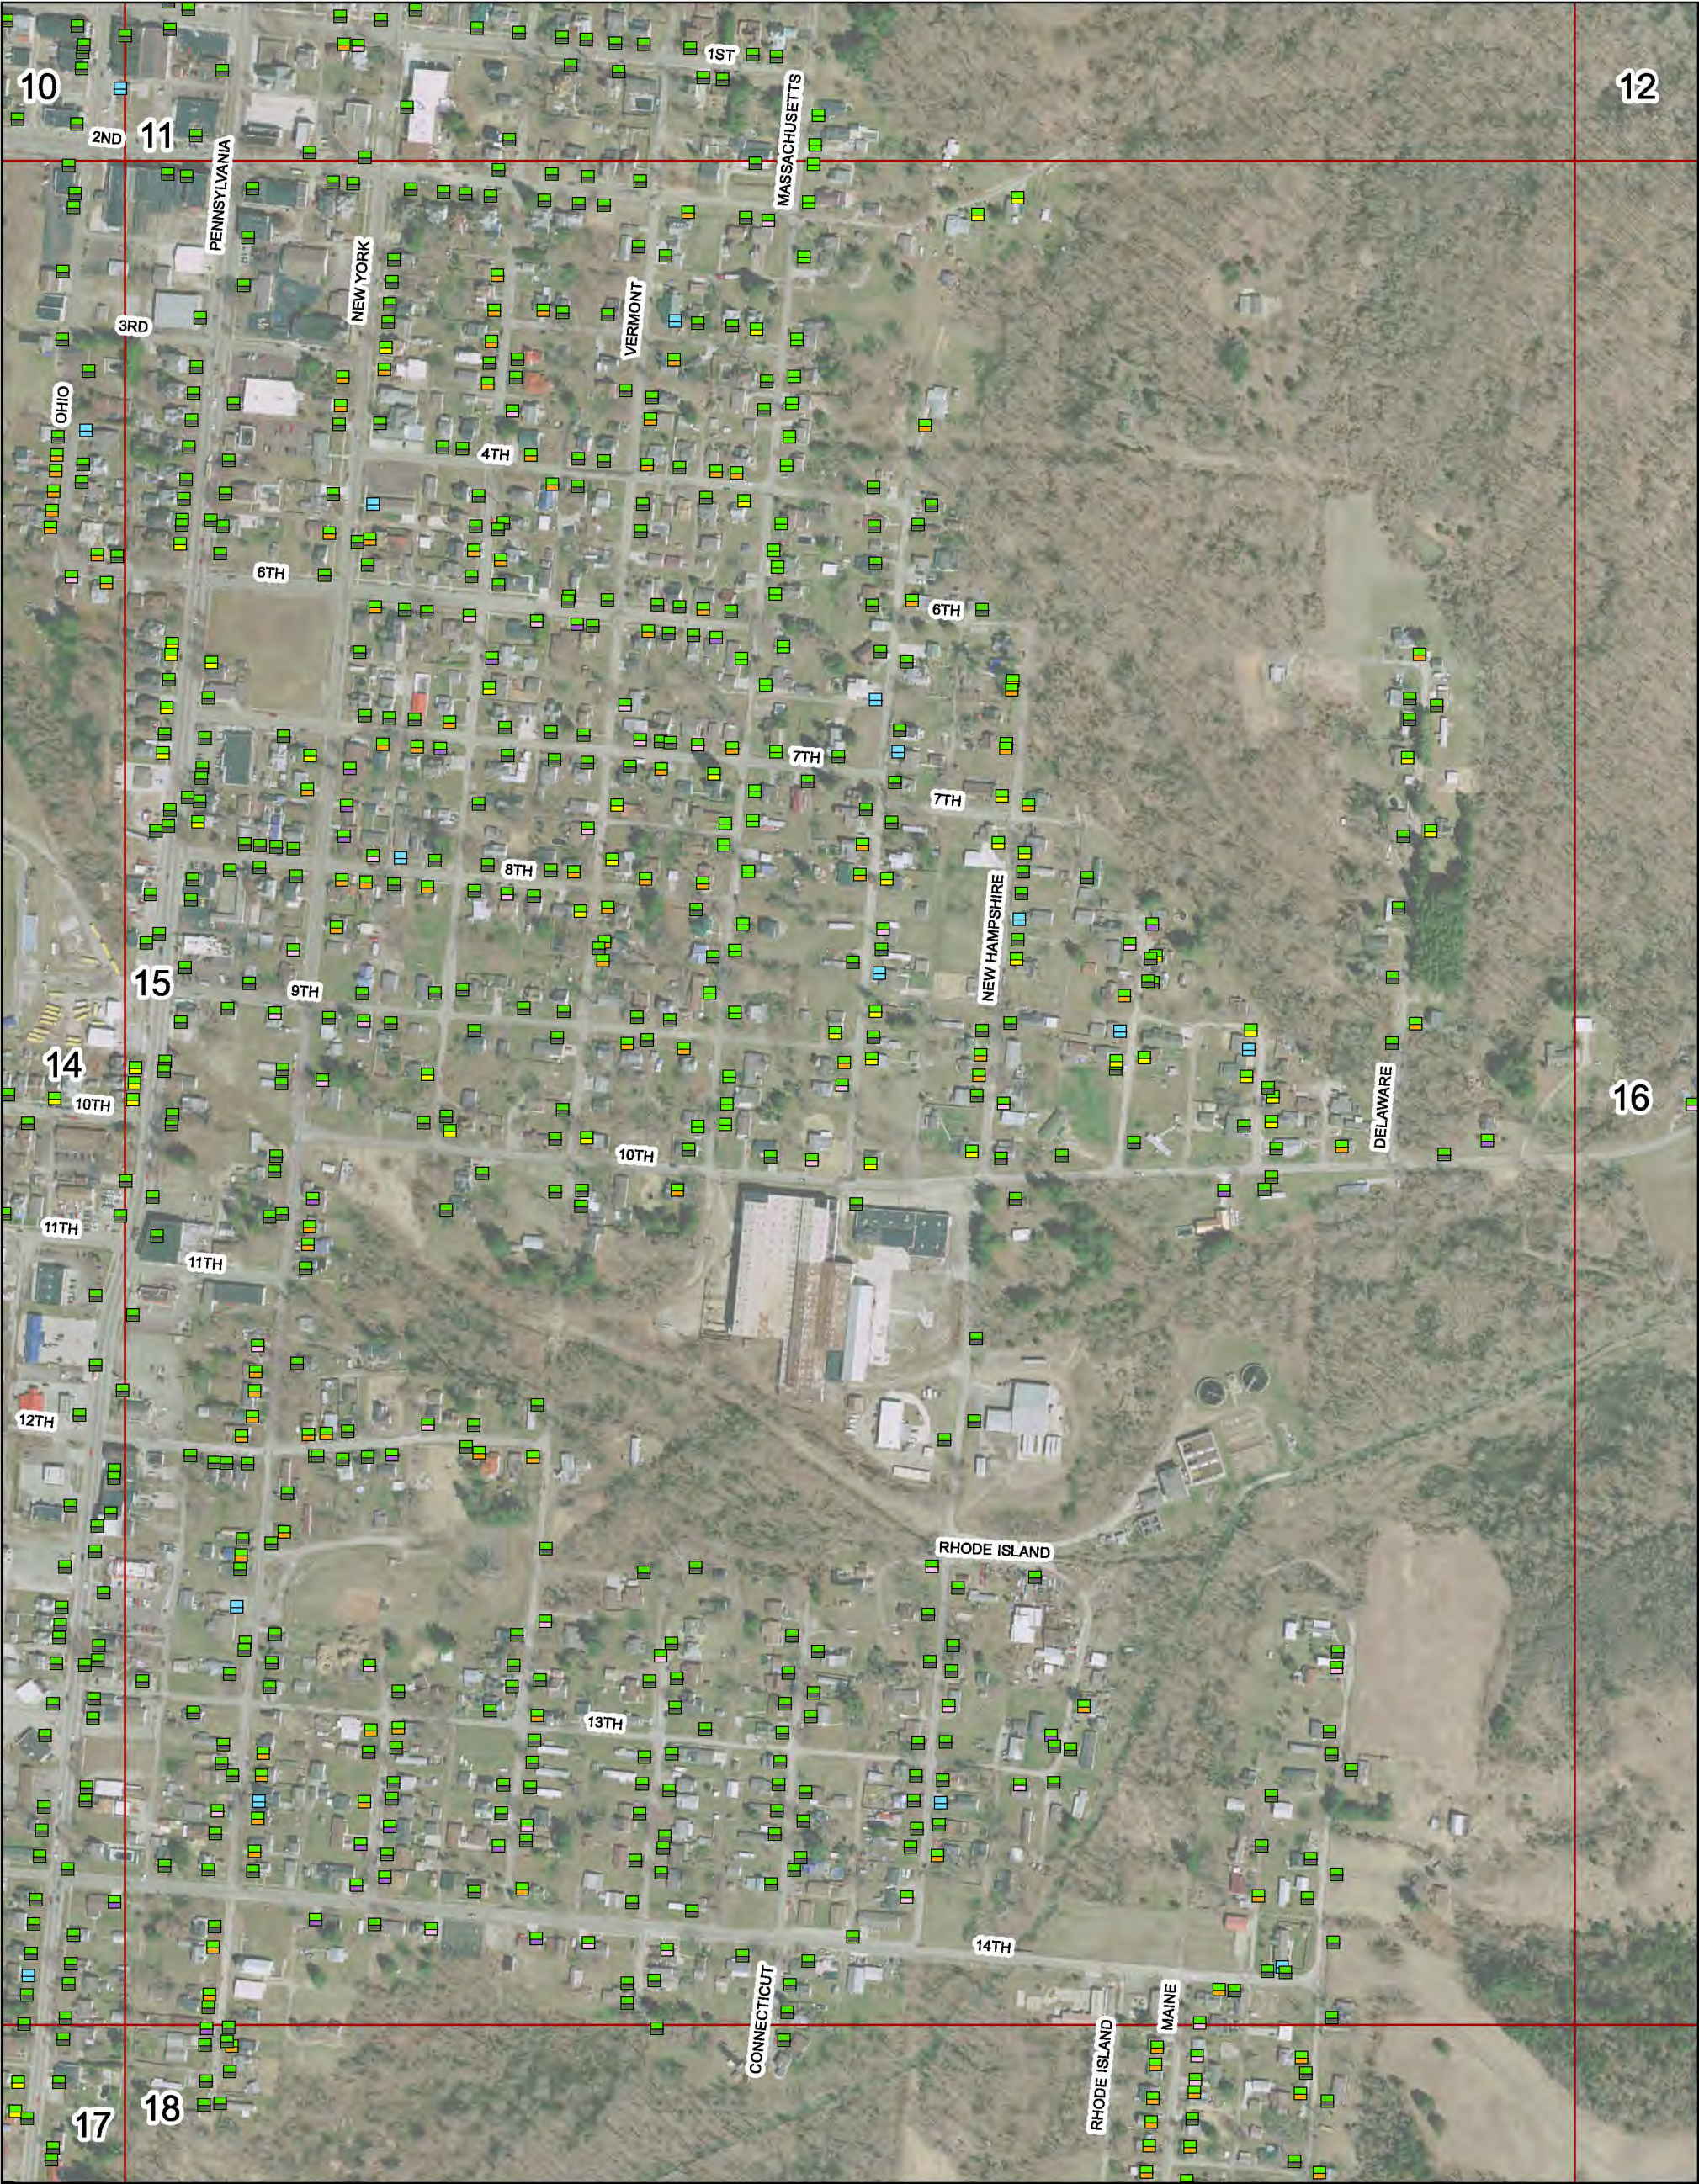
Wellston OH, Lead Service Line Probability PWS OH-4001912

Probability of Lead Service Line
Determined by year structure was built

This map does not verify the presence of lead in any of the lines or structures shown. This map only shows the probable or possible locations based on the year that the structure was built, historical maintenance and operation records, and customer or utility staff verification. This map is not intended for design engineering, surveying, or construction purposes. Information and data contained or accessed within this map emanates from various public and private sources and may contain errors and omissions. This map remains under development and is subject to change with or without notice. All data, information and documentation within this map are provided "as is" without warranty of any kind, either expressed or implied. The suitability of the data and information contained in this map is not guaranteed, and the user assumes all risk for such uses. WSOS Community Action and its employees, affiliates, agents and licensors cannot and do not warrant the accuracy, completeness, non-infringement, merchantability or fitness of any information contained within this map. All questions, comments and data errors should be directed to Ohio RCAP by phone at 330-329-9951 or by email at bdbeyeler@wsos.org. NAD 1983 Ohio St Plane S. (ft). Source: Jackson County Auditor, OGRIP, RCAP GIS. March 2017

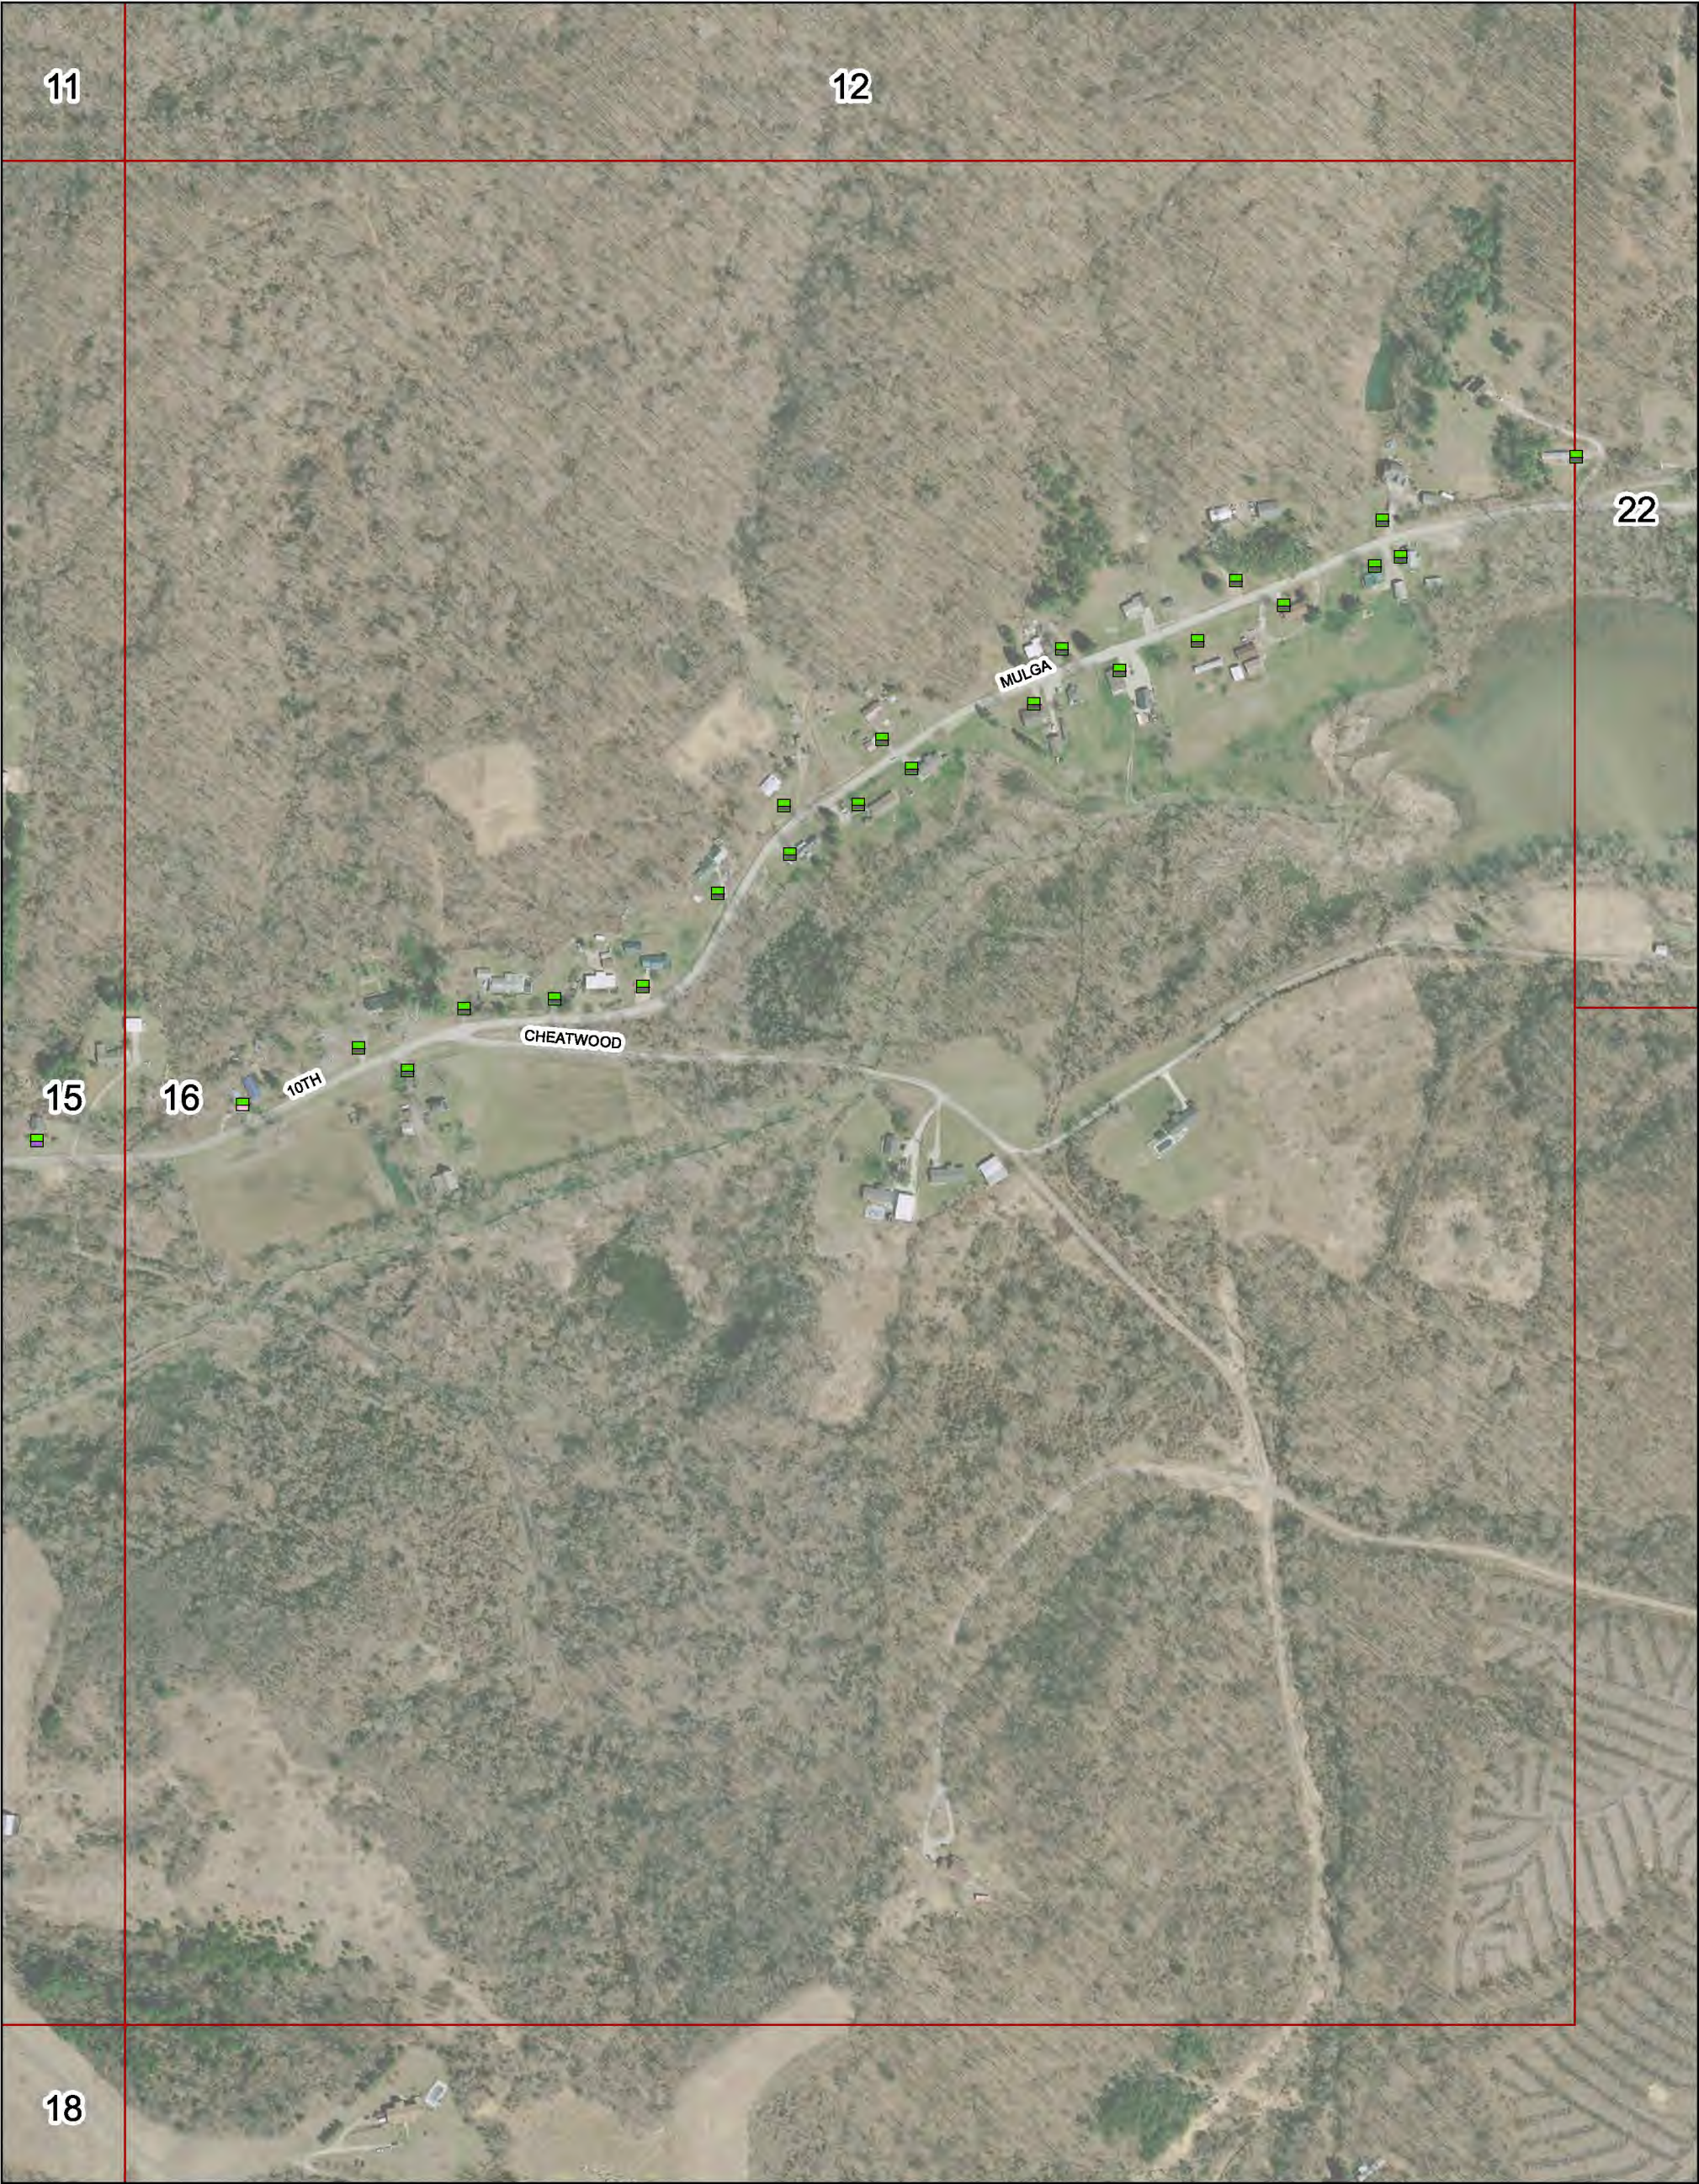
Wellston OH, Lead Service Line Probability PWS OH-4001912

Probability of Lead Service Line
Determined by year structure was built

This map does not verify the presence of lead in any of the lines or structures shown. This map only shows the probable or possible locations based on the year that the structure was built, historical maintenance and operation records, and customer or utility staff verification. This map is not intended for design engineering, surveying, or construction purposes. Information and data contained or accessed within this map emanates from various public and private sources and may contain errors and omissions. This map remains under development and is subject to change with or without notice. All data, information and documentation within this map are provided "as is" without warranty of any kind, either expressed or implied. The suitability of the data and information contained in this map is not guaranteed, and the user assumes all risk for such uses. WSOS Community Action and its employees, affiliates, agents and licensors cannot and do not warrant the accuracy, completeness, non-infringement, merchantability or fitness of any information contained within this map. All questions, comments and data errors should be directed to Ohio RCAP by phone at 330-329-9951 or by email at bdbeyeler@wsos.org. NAD 1983 Ohio St Plane S. (ft). Source: Jackson County Auditor, OGRIP, RCAP GIS. March 2017
