City of Wellston Public Water System Lead (Pb) Components

PWSID# OH-4001912

Prepared February March 2017

Wellston OH, Lead Service Line Probability PWS OH-4001912

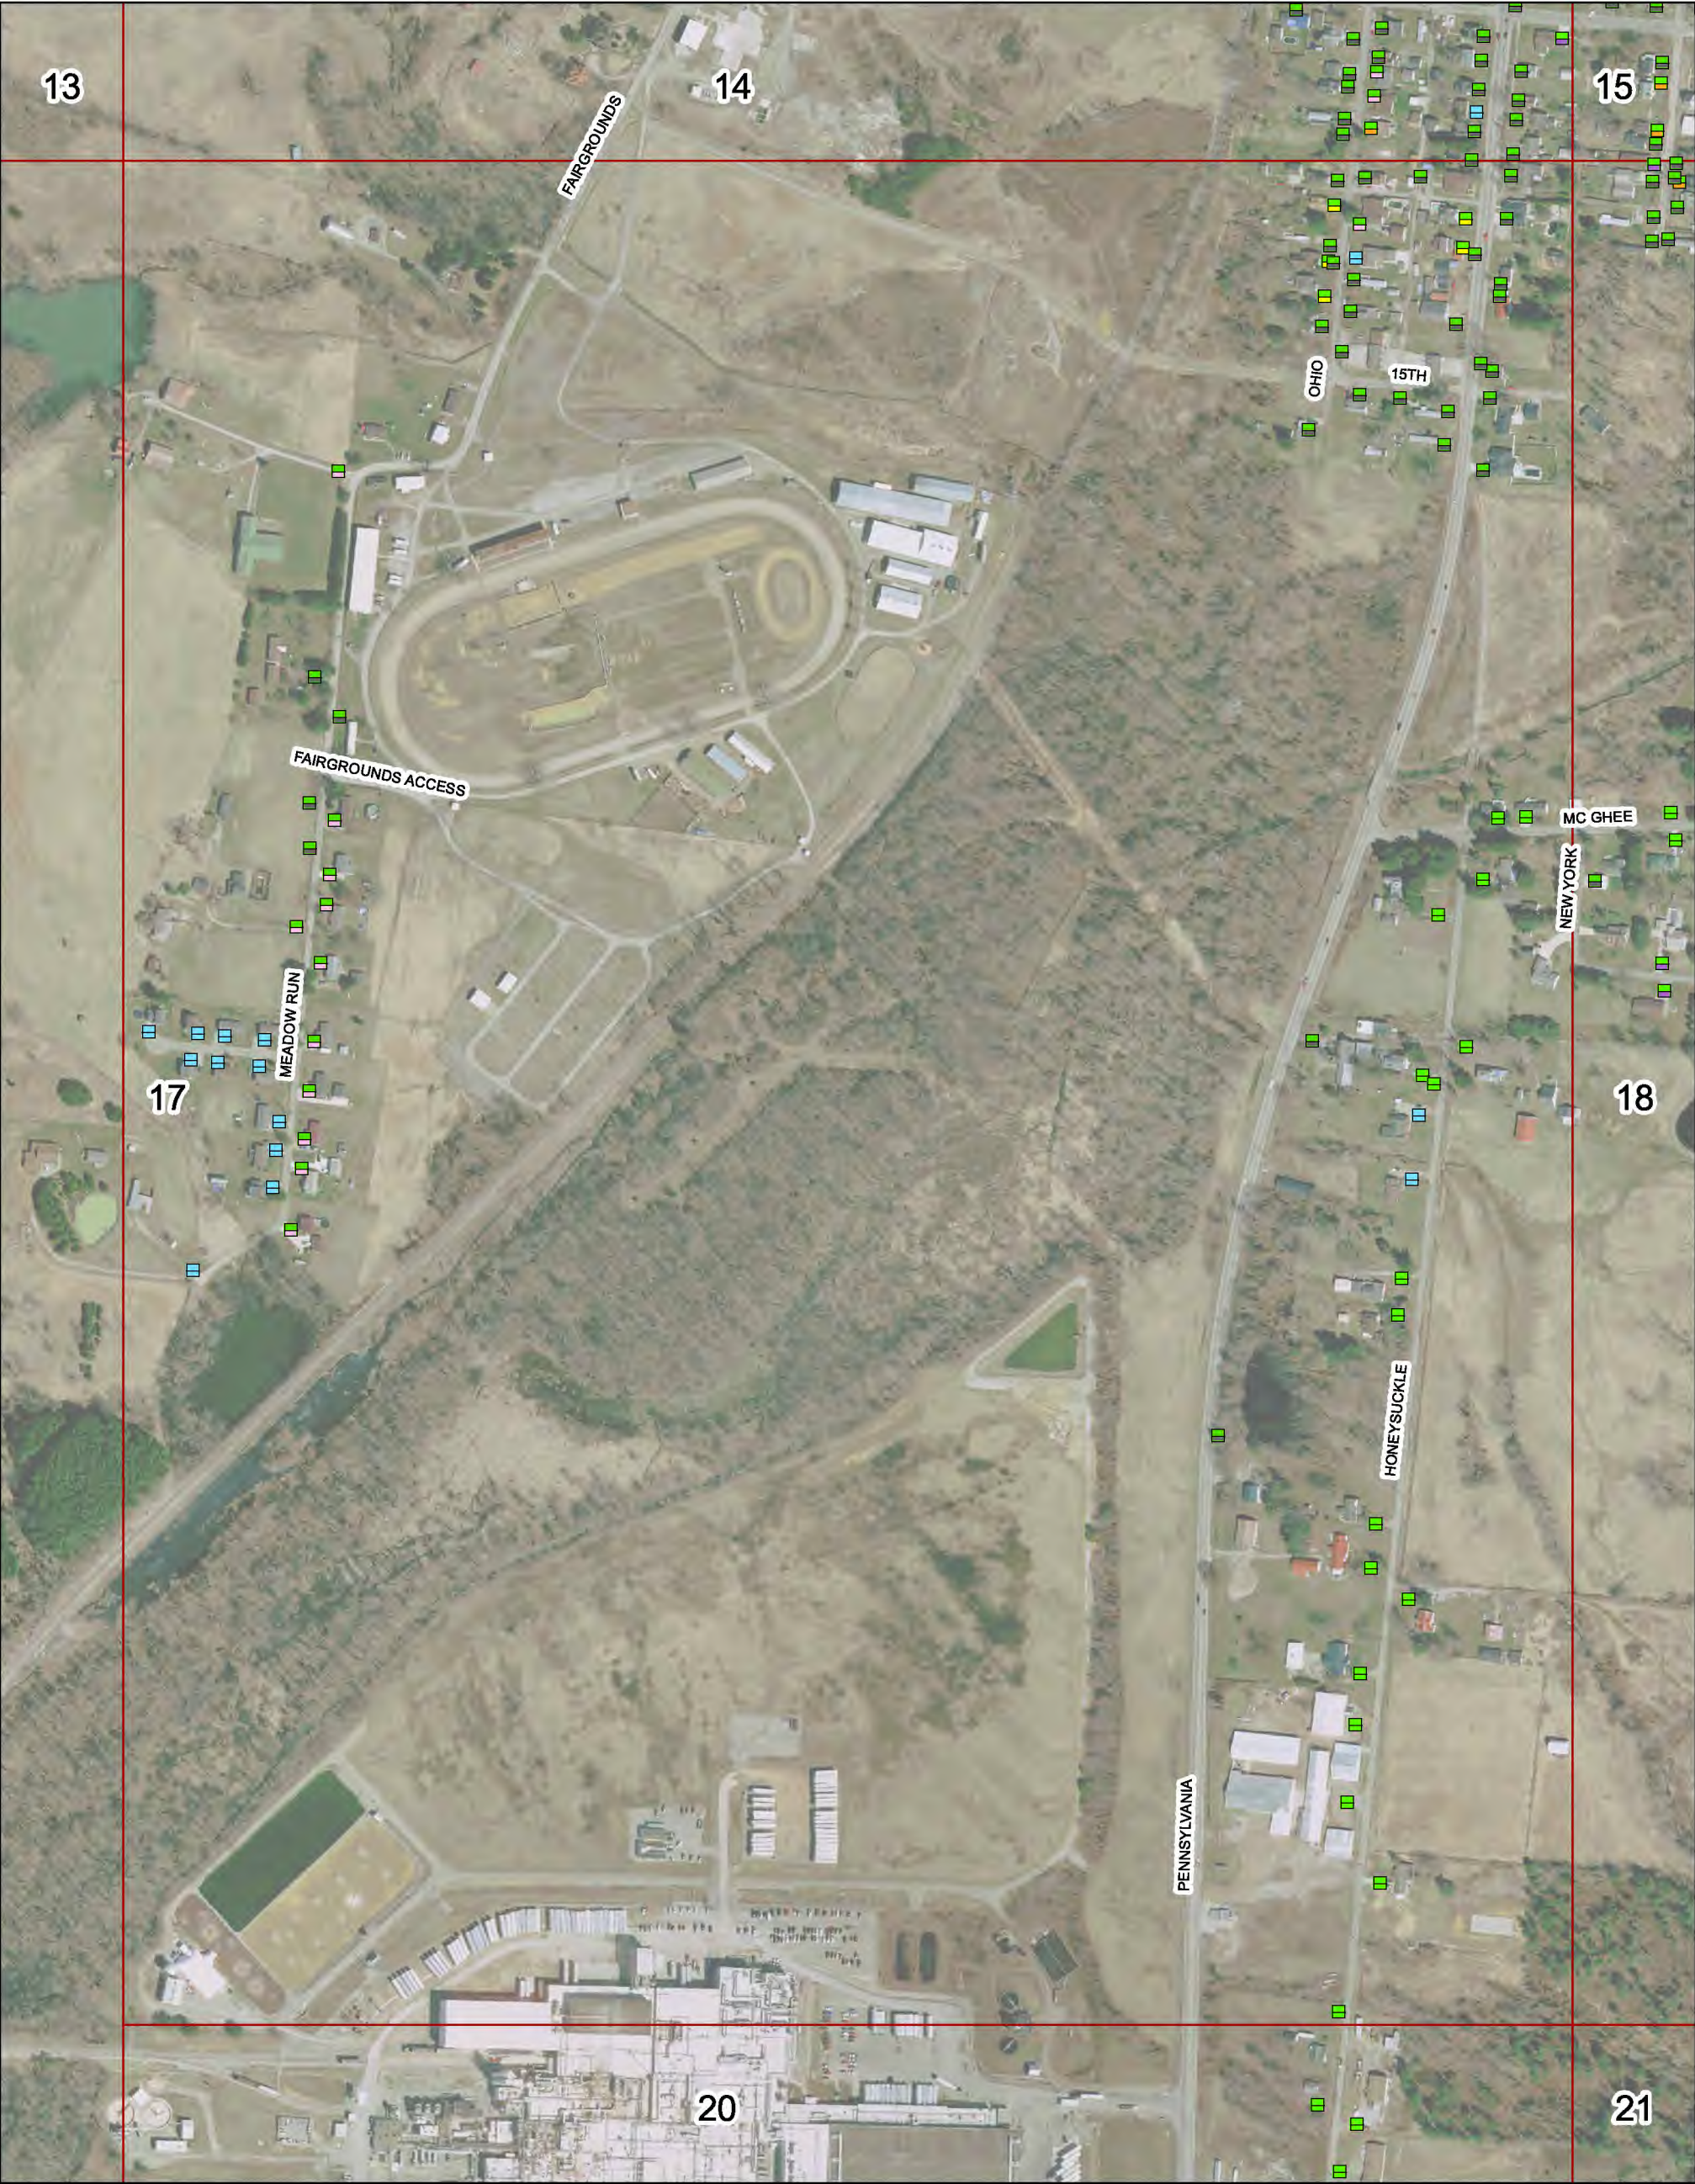
Wellston OH, Lead Service Line Probability PWS OH-4001912

Probability of Lead Service Line
Determined by year structure was built

This map does not verify the presence of lead in any of the lines or structures shown. This map only shows the probable or possible locations based on the year that the structure was built, historical maintenance and operation records, and customer or utility staff verification. This map is not intended for design engineering, surveying, or construction purposes. Information and data contained or accessed within this map emanates from various public and private sources and may contain errors and omissions. This map remains under development and is subject to change with or without notice. All data, information and documentation within this map are provided "as is" without warranty of any kind, either expressed or implied. The suitability of the data and information contained in this map is not guaranteed, and the user assumes all risk for such uses. WSOS Community Action and its employees, affiliates, agents and licensors cannot and do not warrant the accuracy, completeness, non-infringement, merchantability or fitness of any information contained within this map. All questions, comments and data errors should be directed to Ohio RCAP by phone at 330-329-9951 or by email at bdbeyeler@wsos.org. NAD 1983 Ohio St Plane S. (ft). Source: Jackson County Auditor, OGRIP, RCAP GIS, March 2017

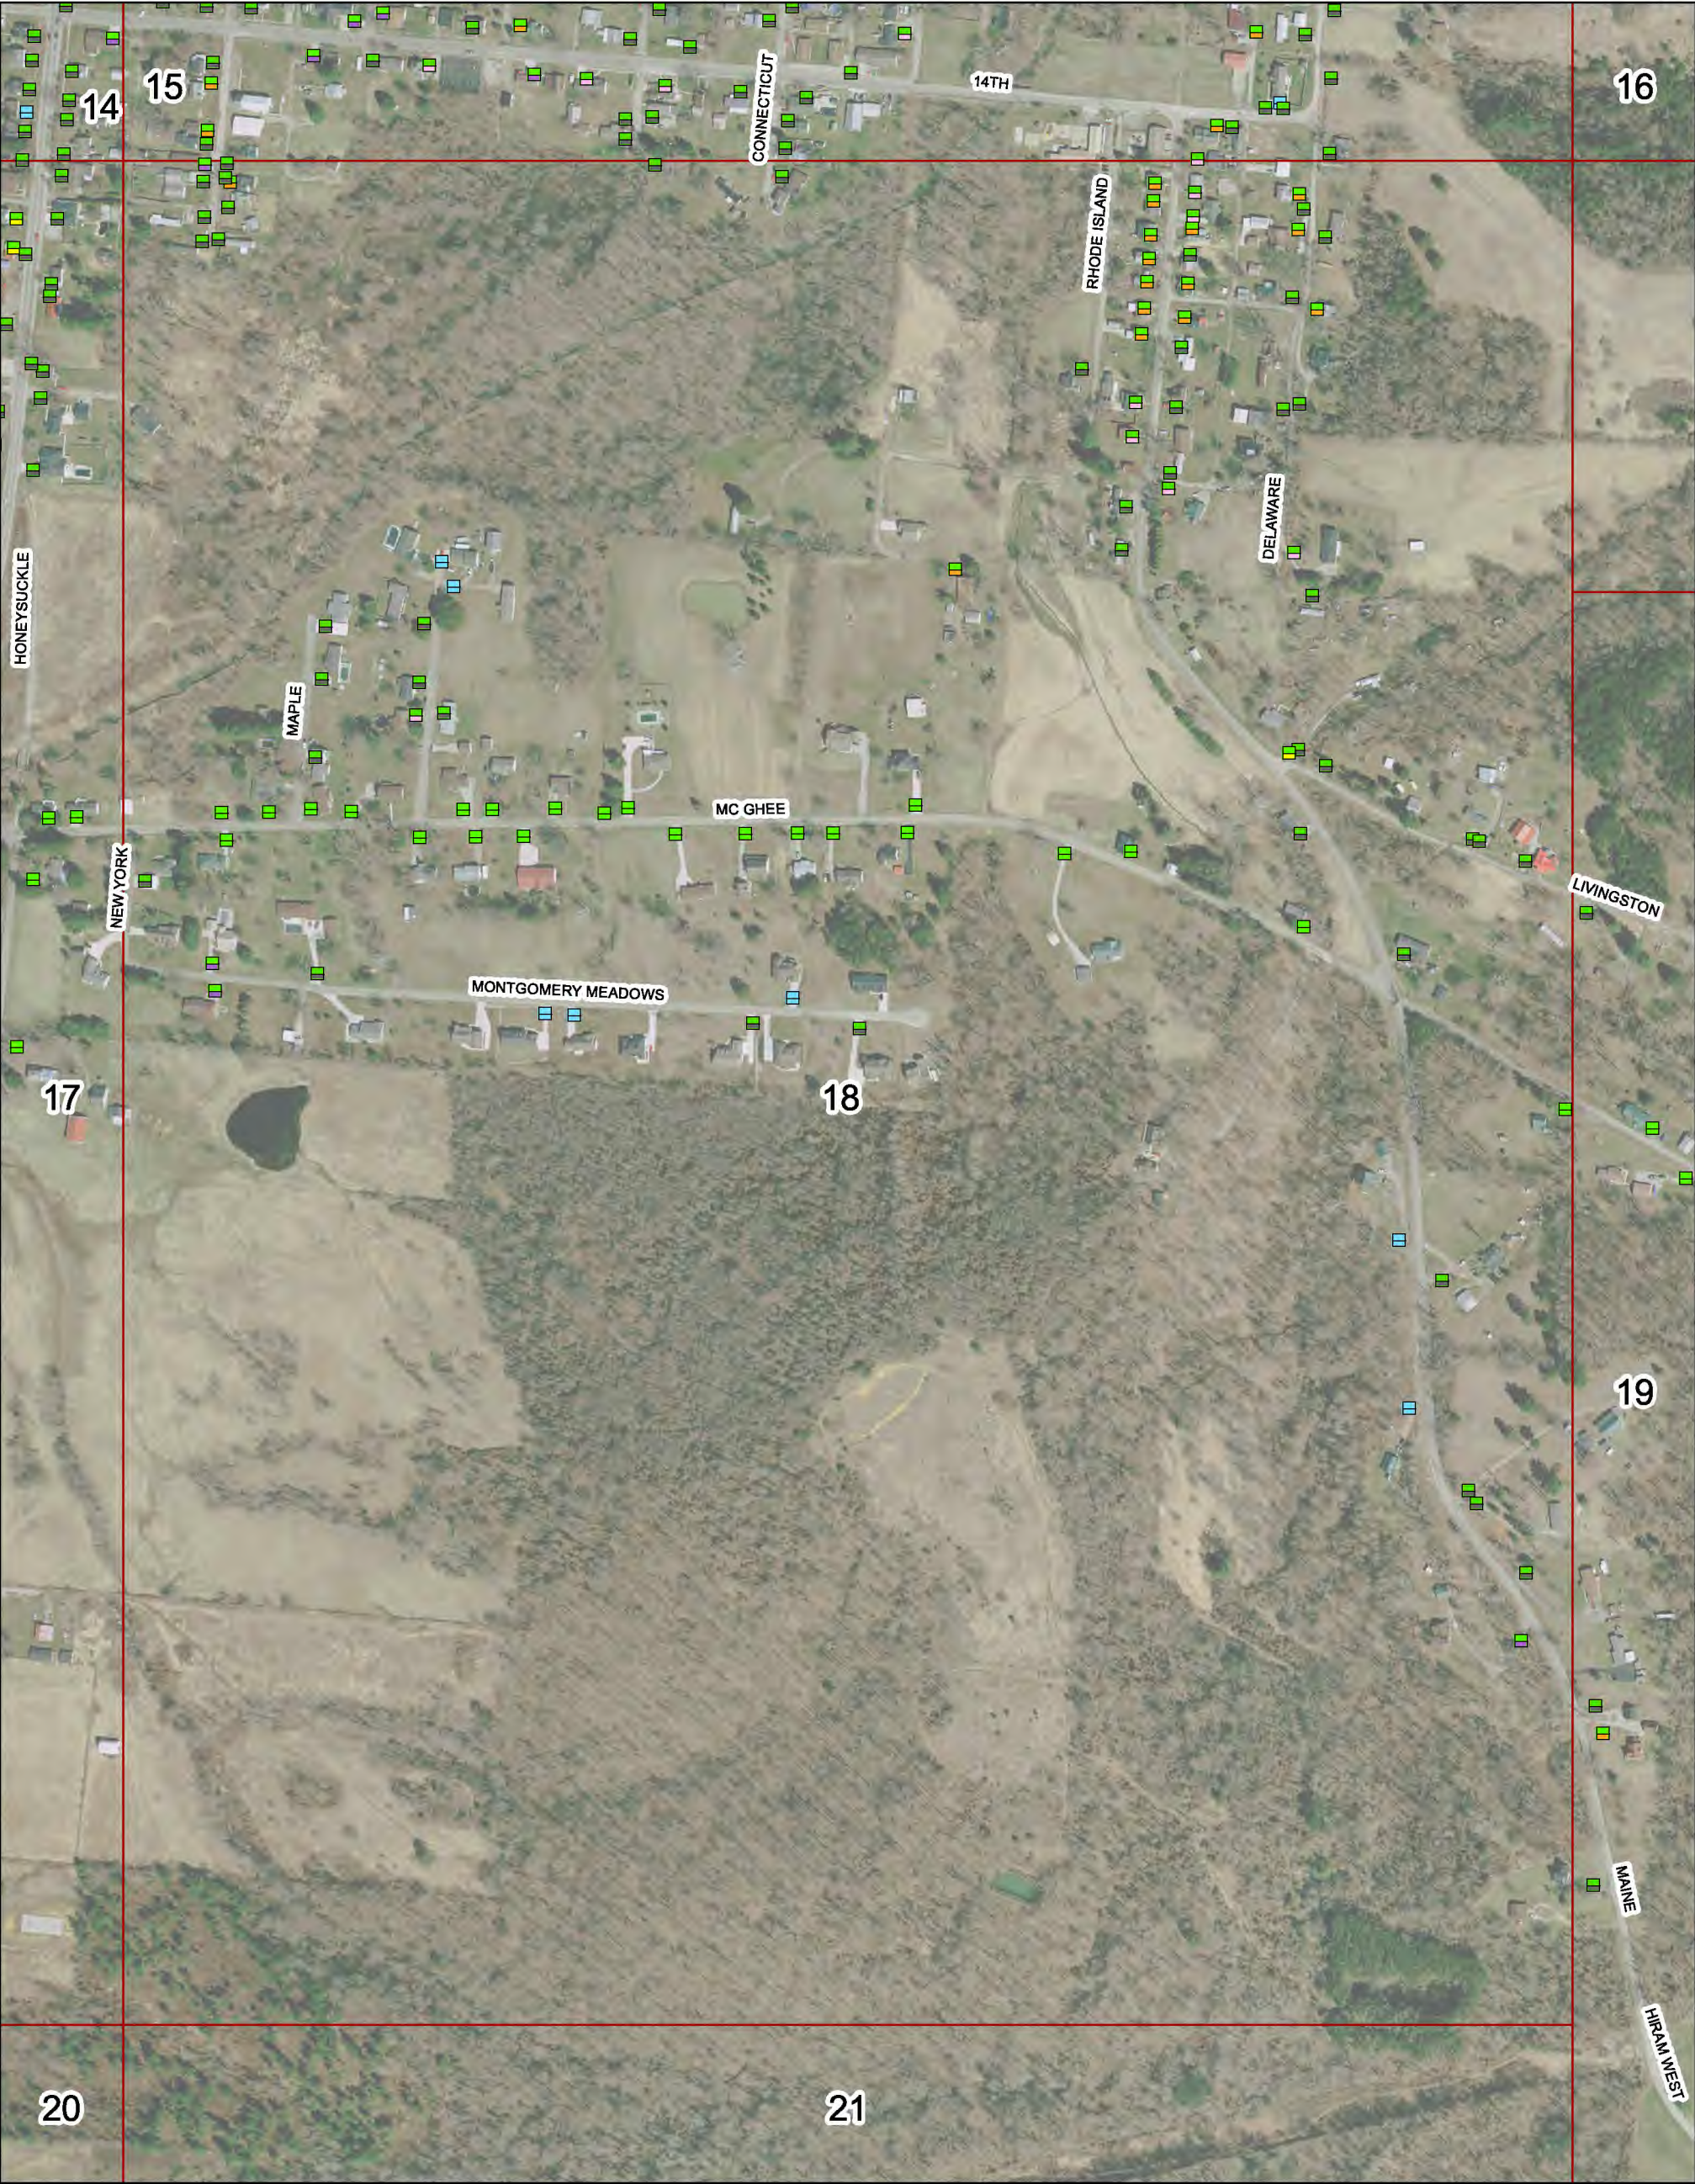
Wellston OH, Lead Service Line Probability PWS OH-4001912

Probability of Lead Service Line
Determined by year structure was built

This map does not verify the presence of lead in any of the lines or structures shown. This map only shows the probable or possible locations based on the year that the structure was built, historical maintenance and operation records, and customer or utility staff verification. This map is not intended for design engineering, surveying, or construction purposes. Information and data contained or accessed within this map emanates from various public and private sources and may contain errors and omissions. This map remains under development and is subject to change with or without notice. All data, information and documentation within this map are provided "as is" without warranty of any kind, either expressed or implied. The suitability of the data and information contained in this map is not guaranteed, and the user assumes all risk for such uses. WSOS Community Action and its employees, affiliates, agents and licensors cannot and do not warrant the accuracy, completeness, non-infringement, merchantability or fitness of any information contained within this map. All questions, comments and data errors should be directed to Ohio RCAP by phone at 330-329-9951 or by email at bdbeyeler@wsos.org. NAD 1983 Ohio St Plane S. (ft). Source: Jackson County Auditor, OGRIP, RCAP GIS. March 2017

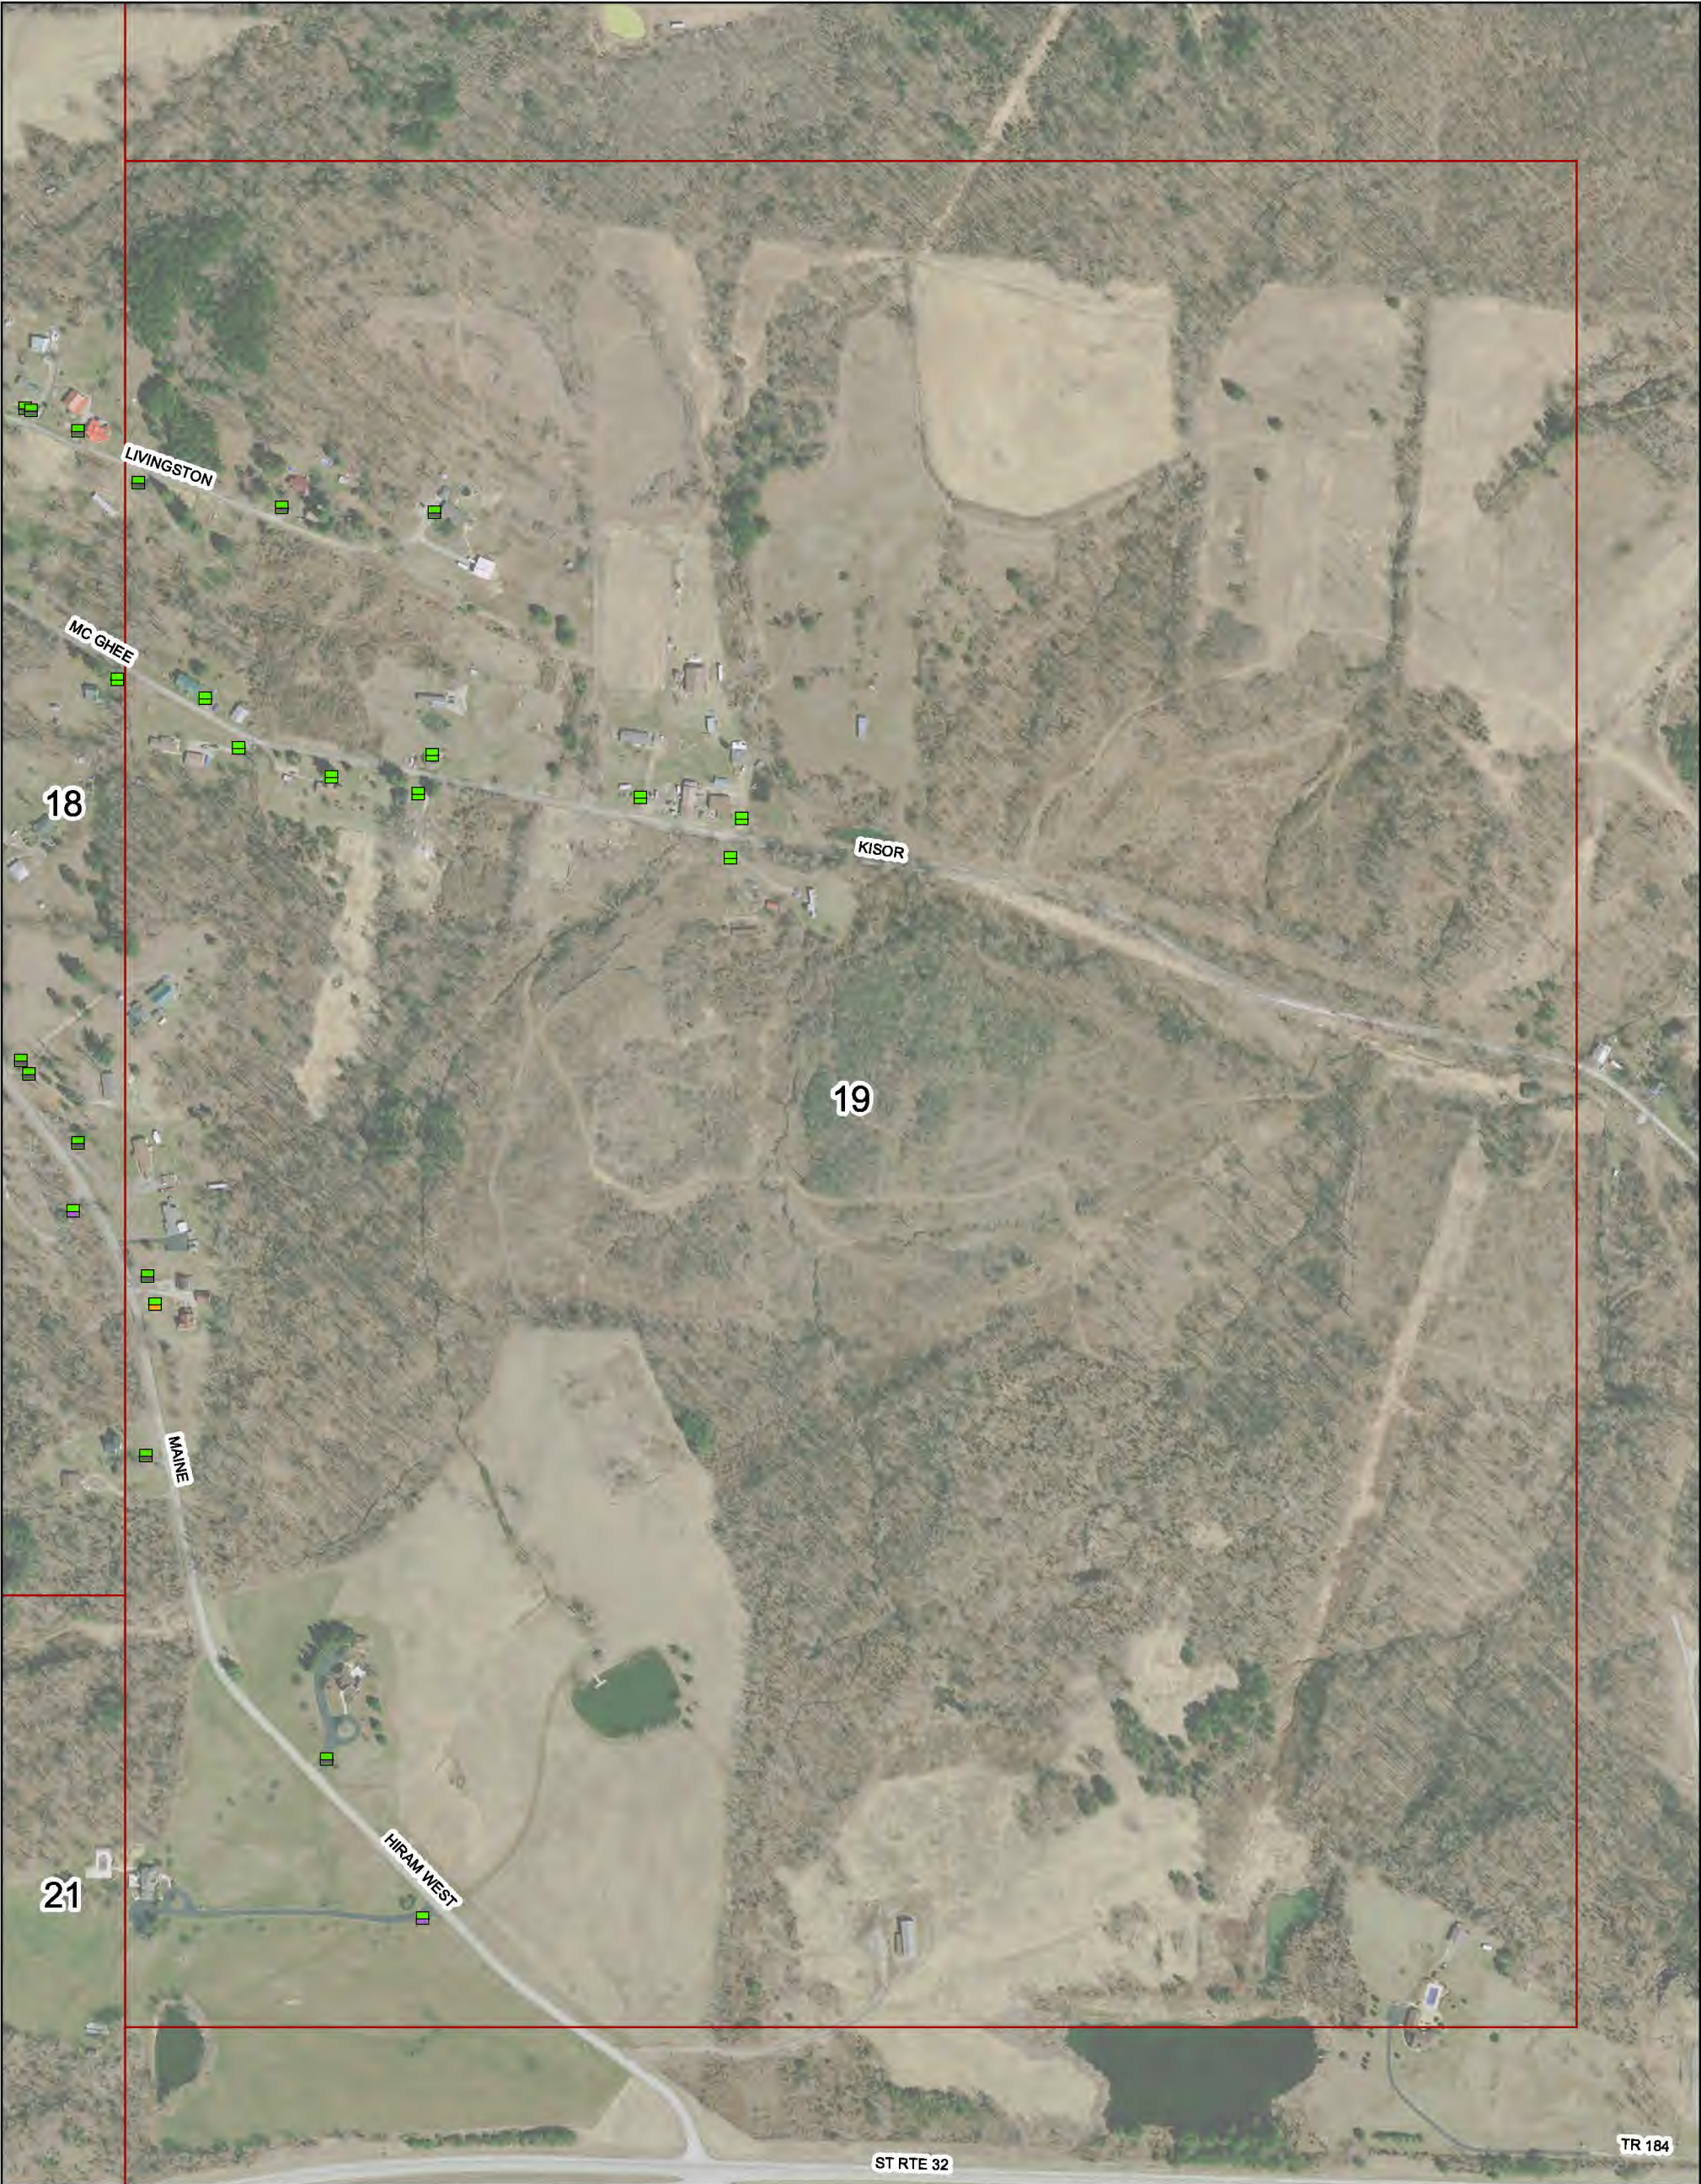
Wellston OH, Lead Service Line Probability PWS OH-4001912

Probability of Lead Service Line
Determined by year structure was built

This map does not verify the presence of lead in any of the lines or structures shown. This map only shows the probable or possible locations based on the year that the structure was built, historical maintenance and operation records, and customer or utility staff verification. This map is not intended for design engineering, surveying, or construction purposes. Information and data contained or accessed within this map emanates from various public and private sources and may contain errors and omissions. This map remains under development and is subject to change with or without notice. All data, information and documentation within this map are provided "as is" without warranty of any kind, either expressed or implied. The suitability of the data and information contained in this map is not guaranteed, and the user assumes all risk for such uses. WSOS Community Action and its employees, affiliates, agents and licensors cannot and do not warrant the accuracy, completeness, non-infringement, merchantability or fitness of any information contained within this map. All questions, comments and data errors should be directed to Ohio RCAP by phone at 330-329-9951 or by email at bdbeyeler@wsos.org. NAD 1983 Ohio St Plane S. (ft). Source: Jackson County Auditor, OGRIP, RCAP GIS. March 2017

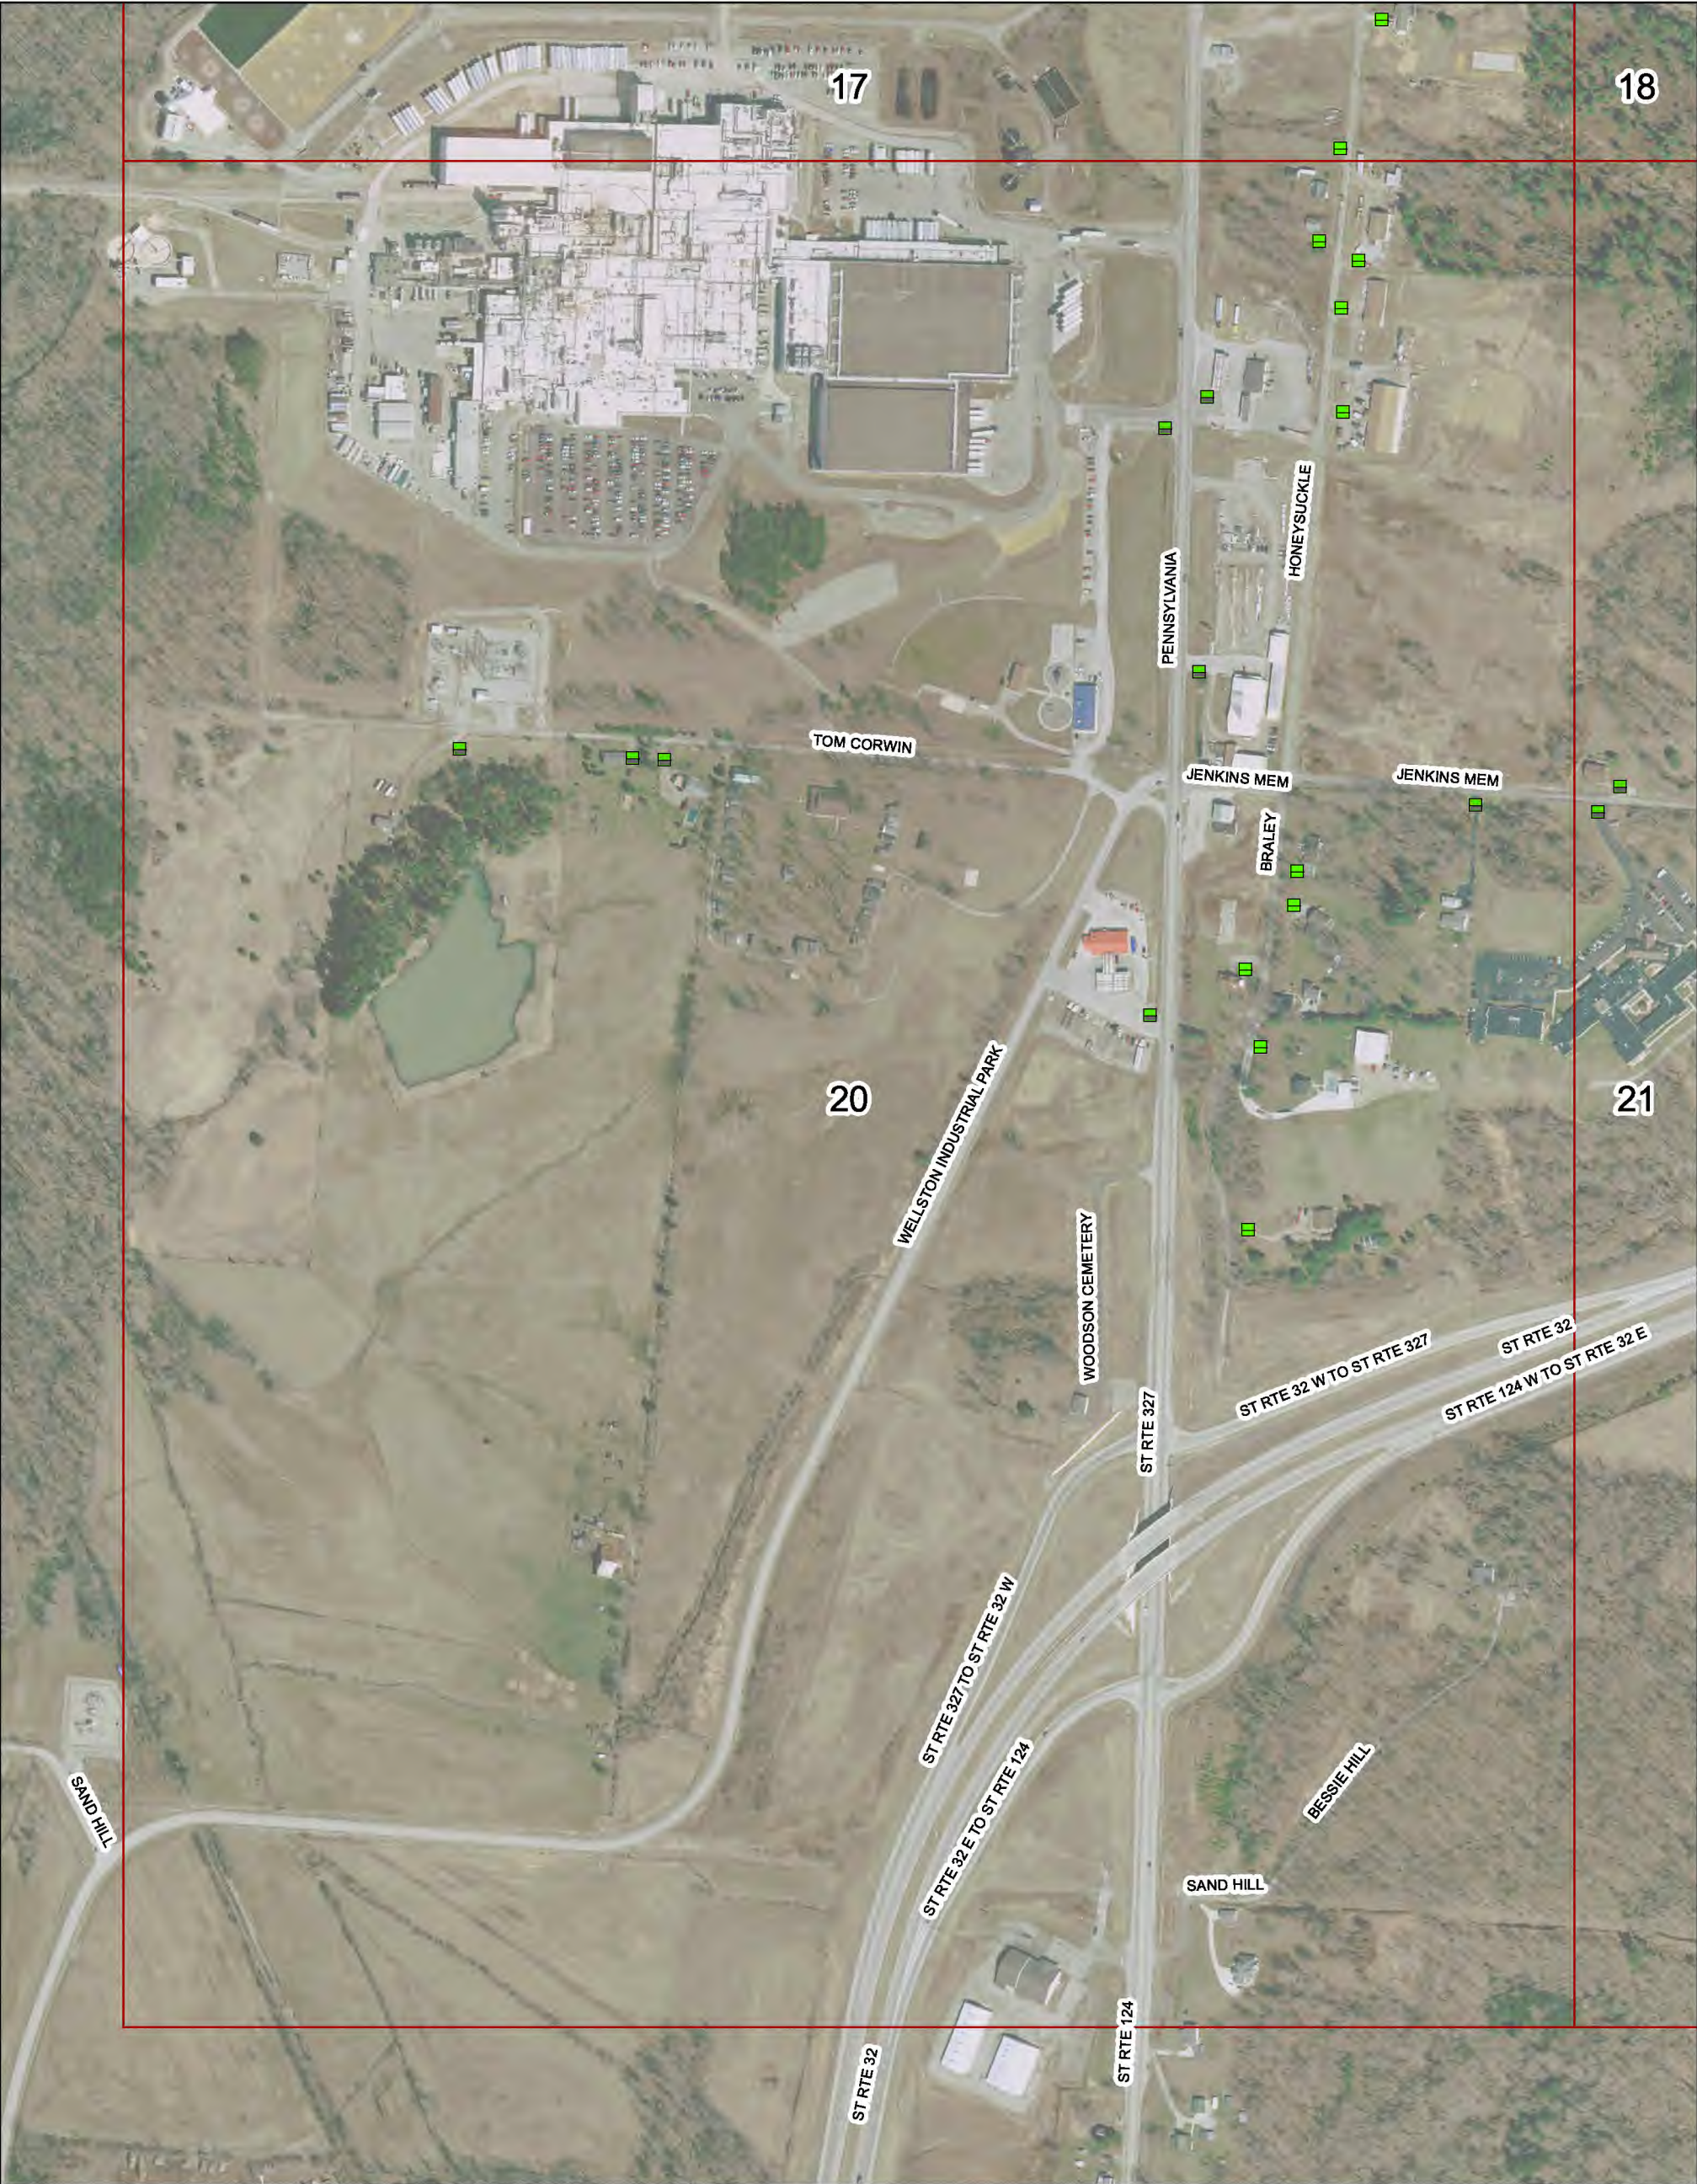
Wellston OH, Lead Service Line Probability PWS OH-4001912

Probability of Lead Service Line
Determined by year structure was built

This map does not verify the presence of lead in any of the lines or structures shown. This map only shows the probable or possible locations based on the year that the structure was built, historical maintenance and operation records, and customer or utility staff verification. This map is not intended for design engineering, surveying, or construction purposes. Information and data contained or accessed within this map emanates from various public and private sources and may contain errors and omissions. This map remains under development and is subject to change with or without notice. All data, information and documentation within this map are provided "as is" without warranty of any kind, either expressed or implied. The suitability of the data and information contained in this map is not guaranteed, and the user assumes all risk for such uses. WSOS Community Action and its employees, affiliates, agents and licensors cannot and do not warrant the accuracy, completeness, non-infringement, merchantability or fitness of any information contained within this map. All questions, comments and data errors should be directed to Ohio RCAP by phone at 330-329-9951 or by email at bdbeyeler@wsos.org. NAD 1983 Ohio State Plane S. (ft). Source: Jackson County Auditor, OGRIP, RCAP GIS, March 2017

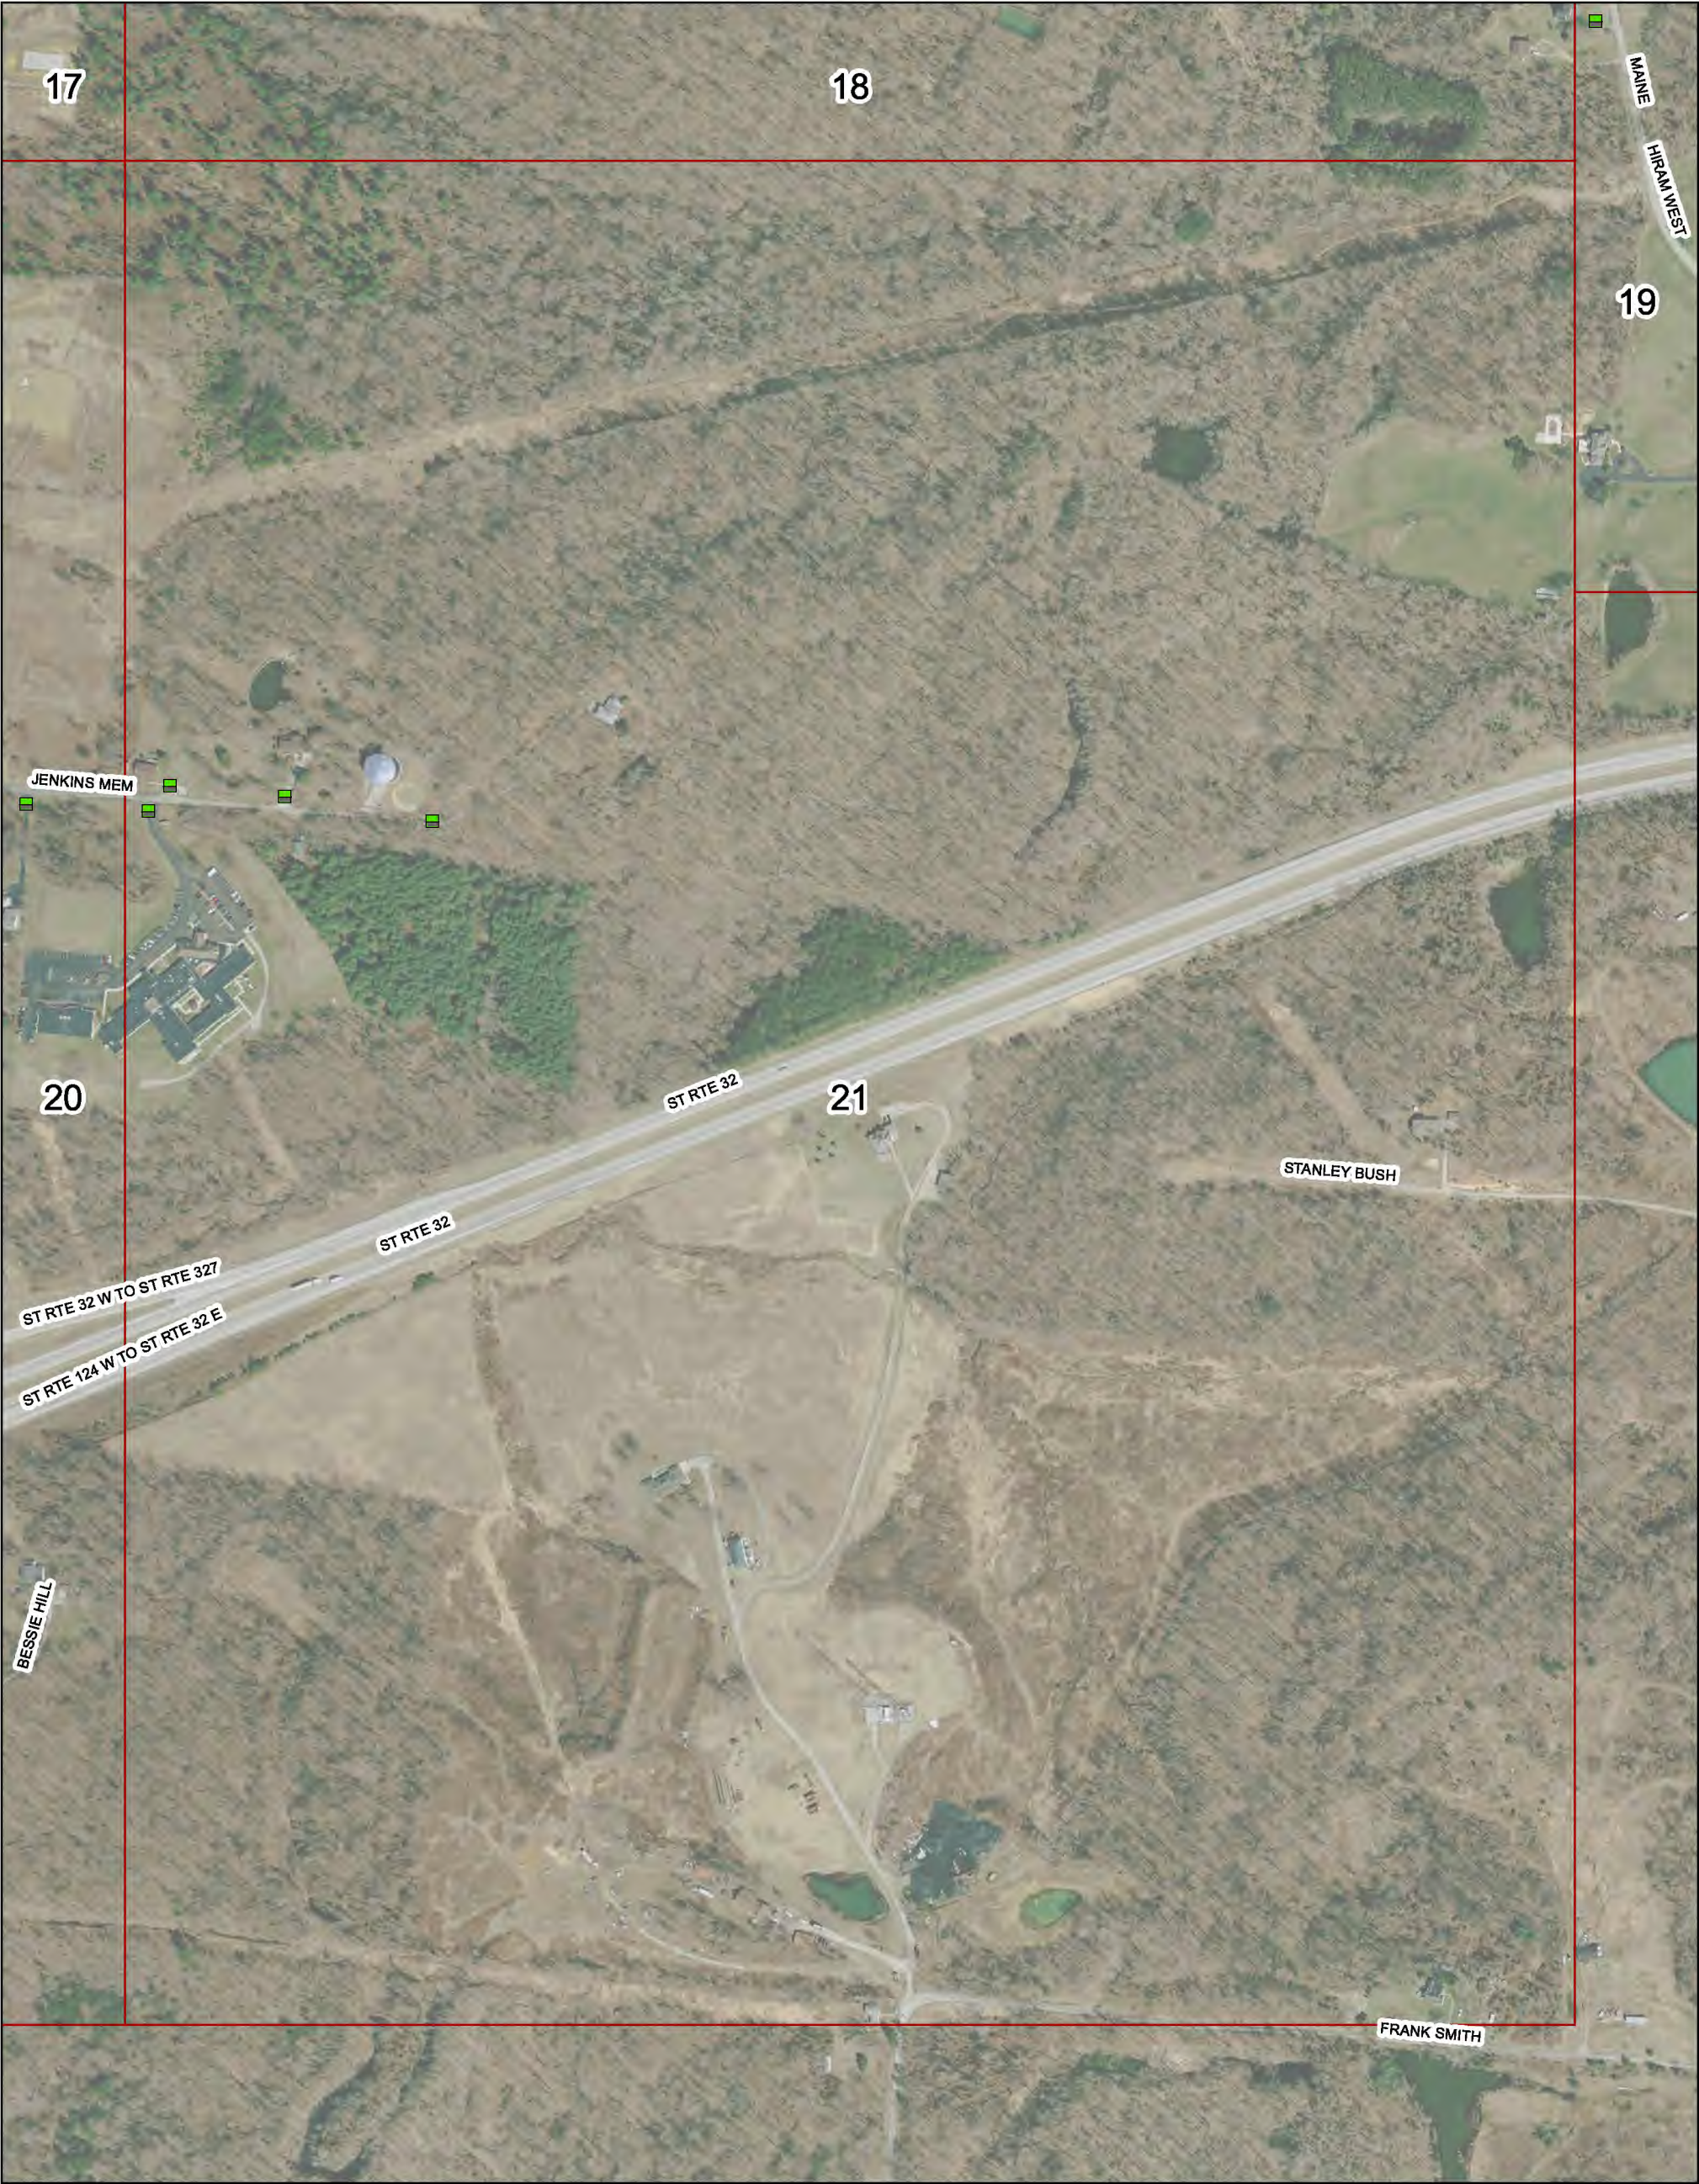
Wellston OH, Lead Service Line Probability PWS OH-4001912

Probability of Lead Service Line
Determined by year structure was built

This map does not verify the presence of lead in any of the lines or structures shown. This map only shows the probable or possible locations based on the year that the structure was built, historical maintenance and operation records, and customer or utility staff verification. This map is not intended for design engineering, surveying, or construction purposes. Information and data contained or accessed within this map emanates from various public and private sources and may contain errors and omissions. This map remains under development and is subject to change with or without notice. All data, information and documentation within this map are provided "as is" without warranty of any kind, either expressed or implied. The suitability of the data and information contained in this map is not guaranteed, and the user assumes all risk for such uses. WSOS Community Action and its employees, affiliates, agents and licensors cannot and do not warrant the accuracy, completeness, non-infringement, merchantability or fitness of any information contained within this map. All questions, comments and data errors should be directed to Ohio RCAP by phone at 330-329-9951 or by email at bdbeyeler@wsos.org. NAD 1983 Ohio St Plane S. (ft). Source: Jackson County Auditor, OGRIP, RCAP GIS. March 2017
