City of Wellston Public Water System Lead (Pb) Components

PWSID# OH-4001912

Prepared February March 2017

Wellston OH, Lead Service Line Probability PWS OH-4001912

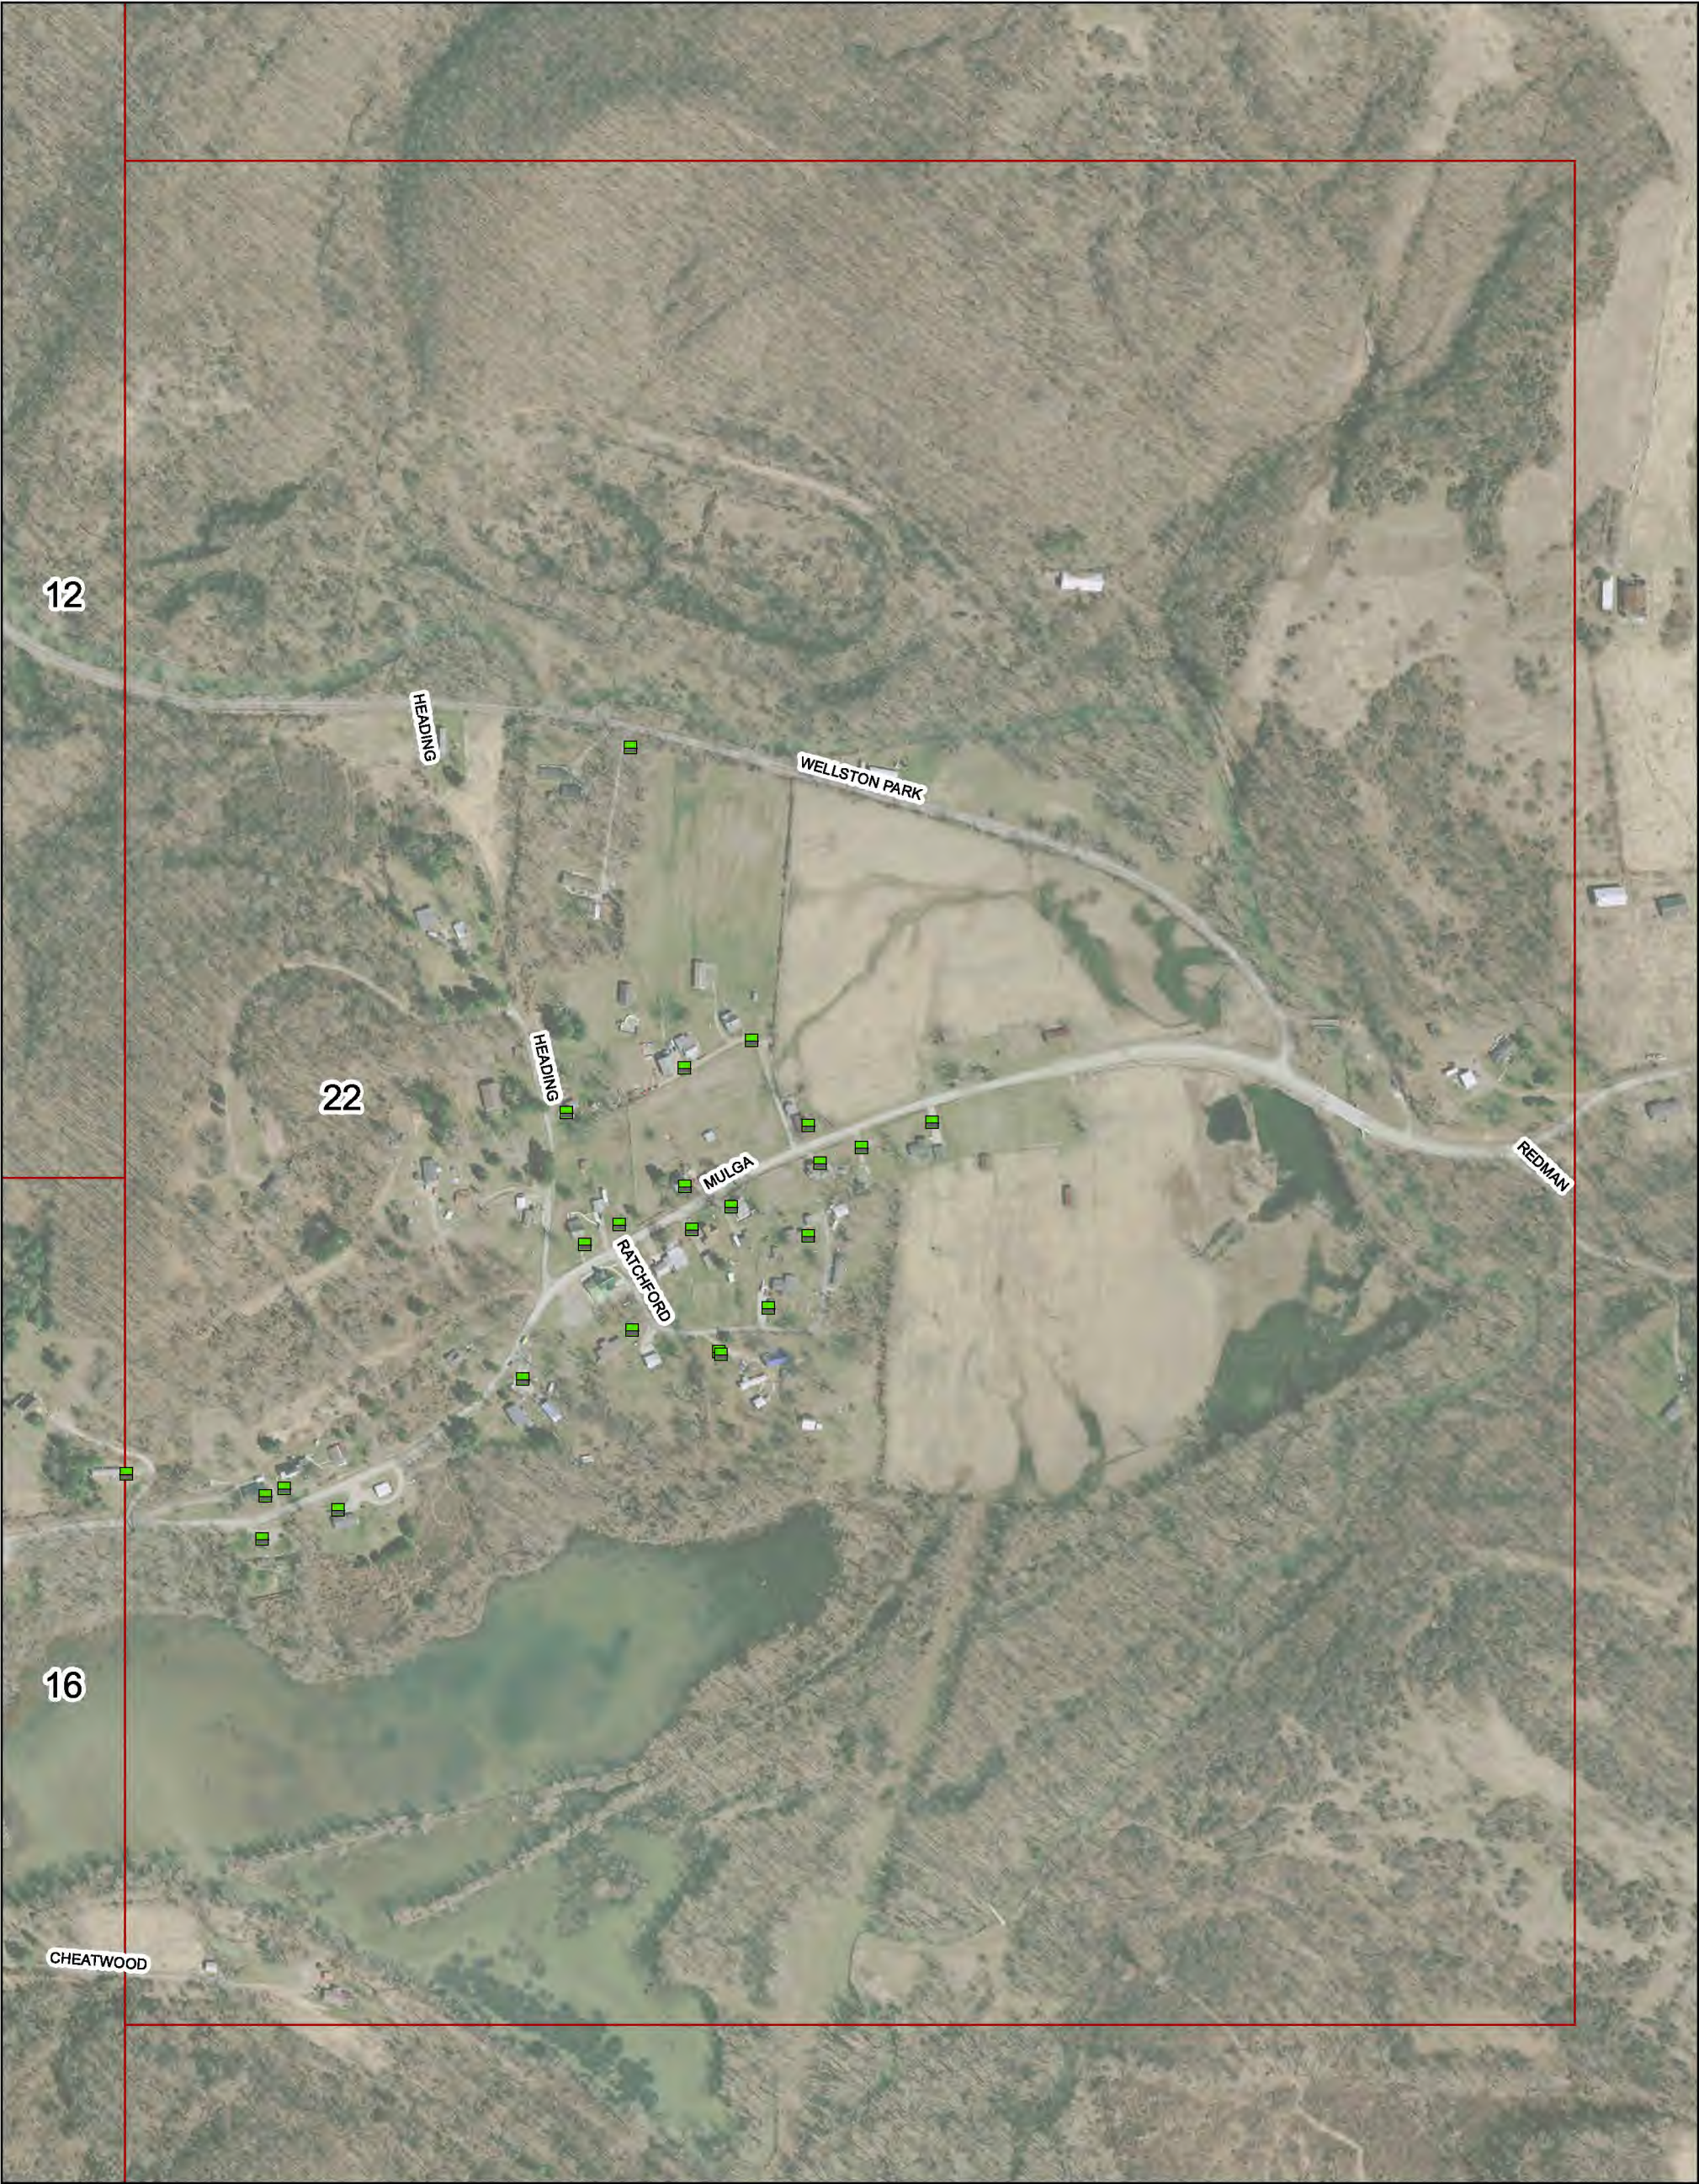
Wellston OH, Lead Service Line Probability PWS OH-4001912

Probability of Lead Service Line
Determined by year structure was built

This map does not verify the presence of lead in any of the lines or structures shown. This map only shows the probable or possible locations based on the year that the structure was built, historical maintenance and operation records, and customer or utility staff verification. This map is not intended for design engineering, surveying, or construction purposes. Information and data contained or accessed within this map emanates from various public and private sources and may contain errors and omissions. This map remains under development and is subject to change with or without notice. All data, information and documentation within this map are provided "as is" without warranty of any kind, either expressed or implied. The suitability of the data and information contained in this map is not guaranteed, and the user assumes all risk for such uses. WSOS Community Action and its employees, affiliates, agents and licensors cannot and do not warrant the accuracy, completeness, non-infringement, merchantability or fitness of any information contained within this map. All questions, comments and data errors should be directed to Ohio RCAP by phone at 330-329-9951 or by email at bdbeyeler@wsos.org. NAD 1983 Ohio St Plane S. (ft). Source: Jackson County Auditor, OGRIP, RCAP GIS. March 2017
