Re: Ross Incineration Services, Inc.
EPA ID: OHD 048 415 665
Ohio ID: 02-47-0295
Submittal of Corrective Measures Completion of Work Report for Dawley Ditch

DAWLEY DITCH
CORRECTIVE MEASURES COMPLETION OF WORK

Ross Incineration Services, Inc.
36790 Giles Road
Grafton, Ohio 44044
December 2021

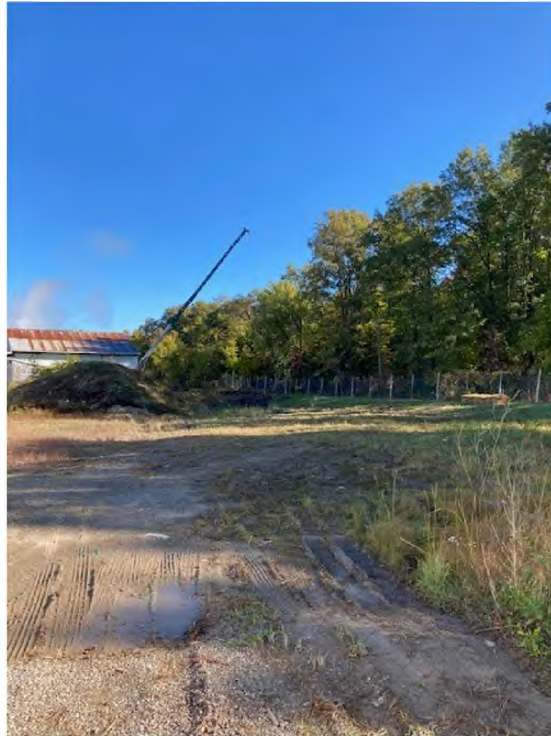
October 8, 2020 – Tree and vegetation removal activities in Dawley Ditch. Long reach crane used to reach over the facility fenceline. Looking North.

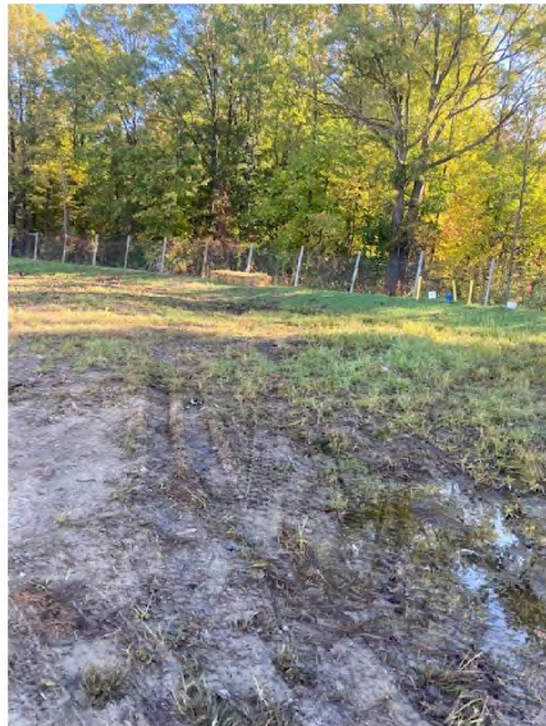
October 8, 2020 – Tree and vegetation removal activities in Dawley Ditch. Straw staged in the area. Looking East.

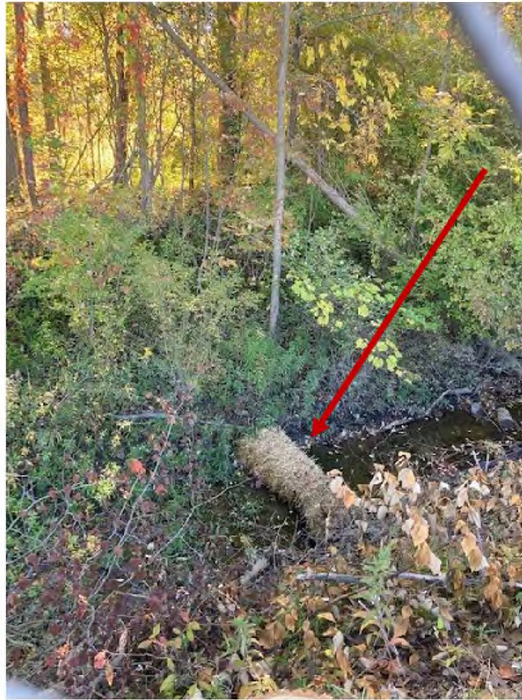
October 8, 2020 – Tree and vegetation removal activities in Dawley Ditch. Straw placed downstream of the working area to prevent potential sediment from moving downstream during remediation activities. Looking East.

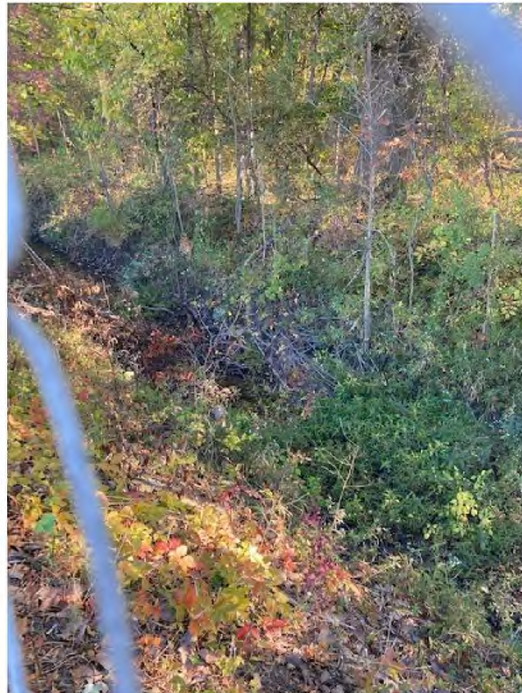
October 8, 2020 – Tree and vegetation removal activities in Dawley Ditch. Dawley Ditch shown containing scrub/shrub vegetation. Looking Northeast.

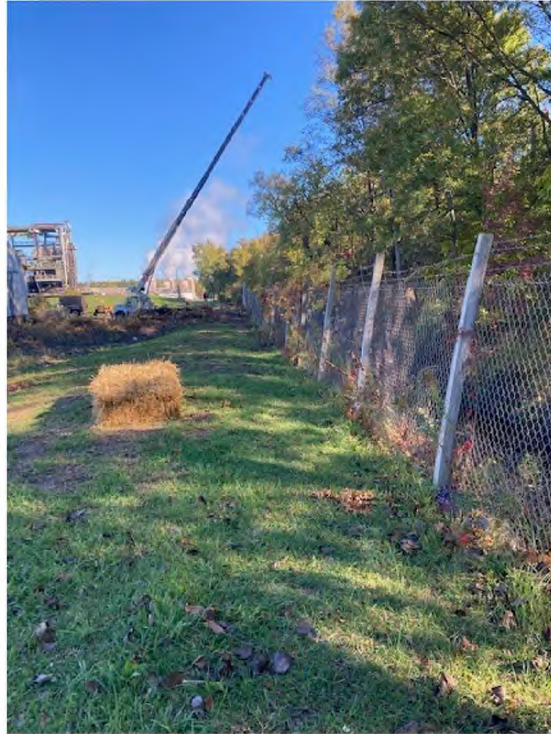
October 8, 2020 – Tree and vegetation removal activities in Dawley Ditch. Long reach crane used to reach over the facility fenceline. Looking North.

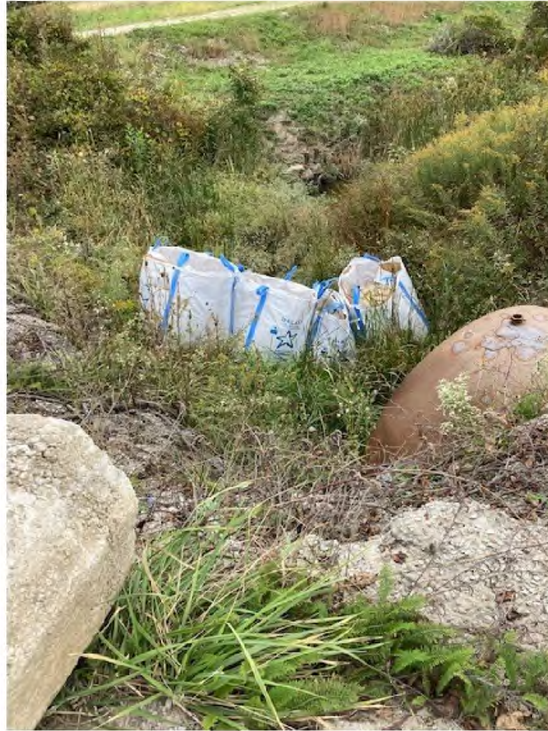
September 20, 2021 – Sand-filled totes used to prevent water flow downstream to the excavation area. Placed prior to beginning excavation.

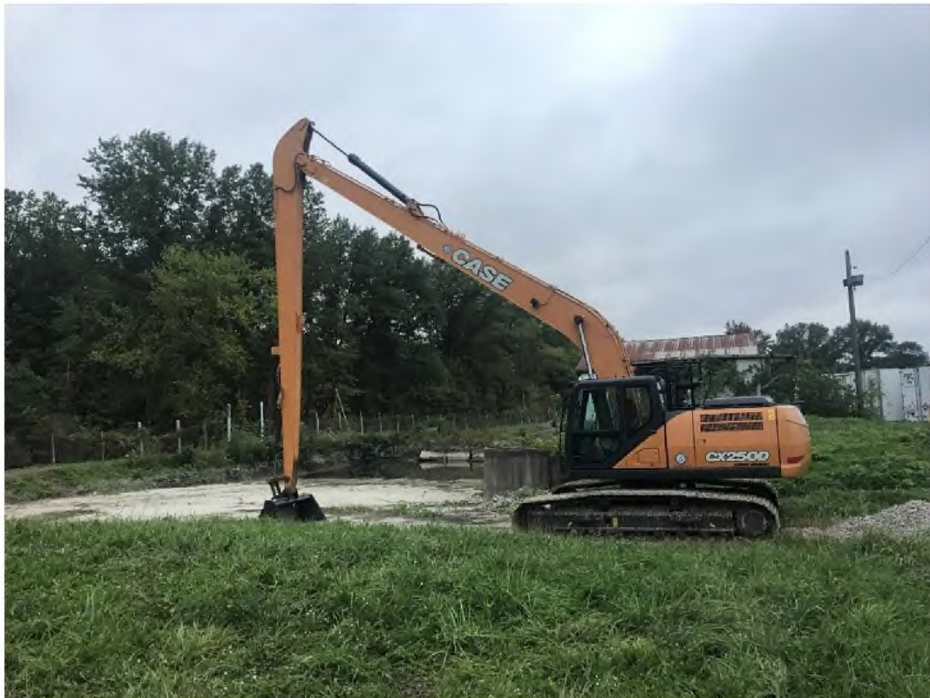
September 28, 2021 – Tree and vegetation removal activities in Dawley Ditch. Long reach backhoe used to reach over the facility fence line. Looking South.

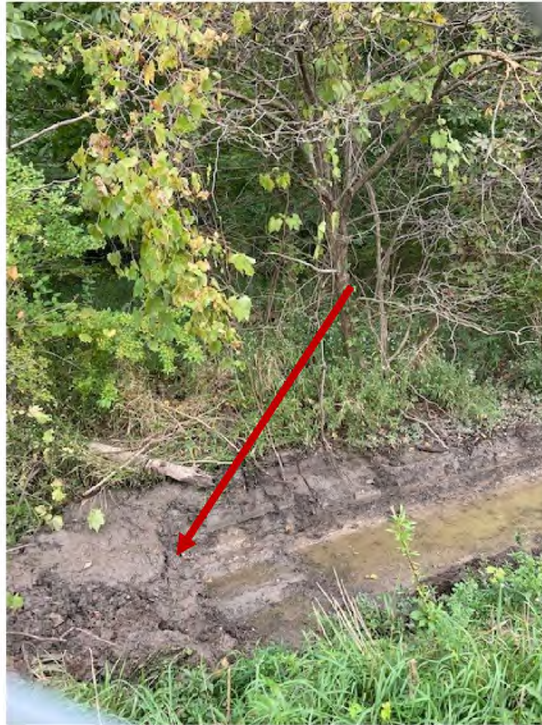
September 28, 2021 – Upstream remediation area, beginning excavation. Note earthen dam created to help prevent flow of water through ditch during excavation on left side of the photo. Looking East.

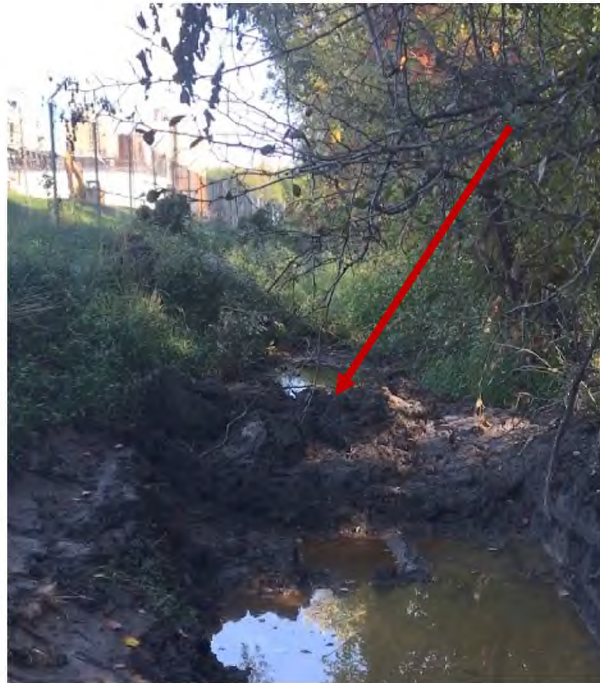
September 28, 2021 – Upstream remediation area, beginning excavation. Note earthen dam created to help prevent flow of water through ditch during excavation. Looking North.

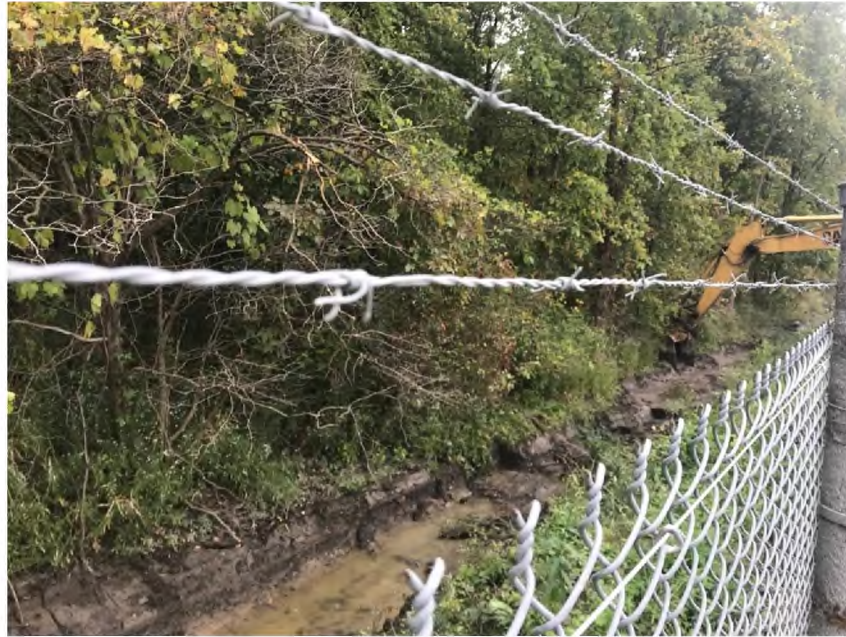
September 28, 2021 – Excavation of sediment and at least 6" underlying clays in Dawley Ditch. Looking Southeast.

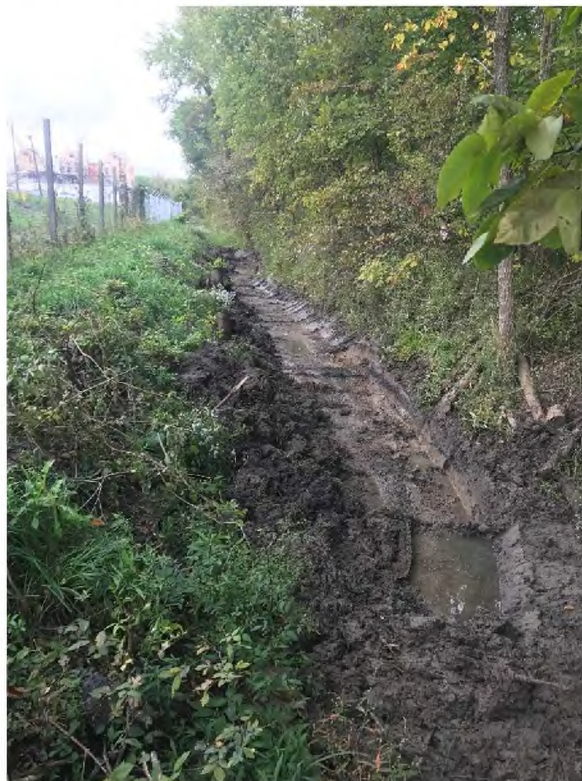
September 28, 2021 – Upstream remediation area, beginning excavation. Looking North.

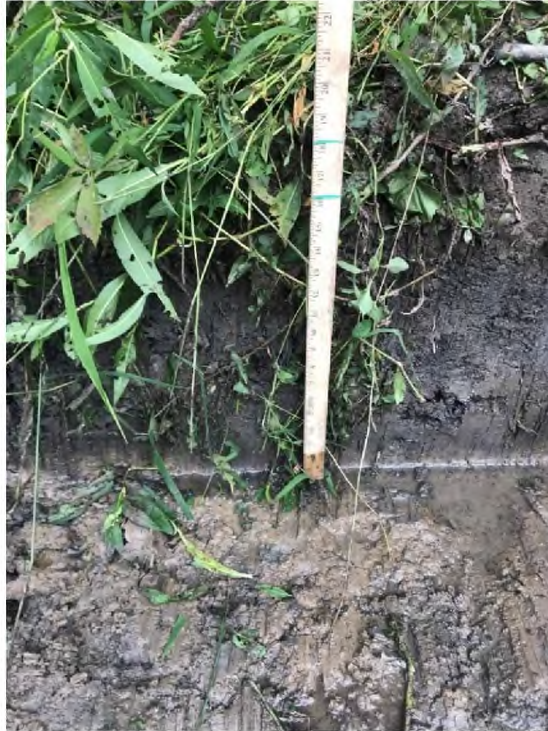
September 28, 2021 – Documentation of excavation of sediment and at least 6" underlying clays in Dawley Ditch.

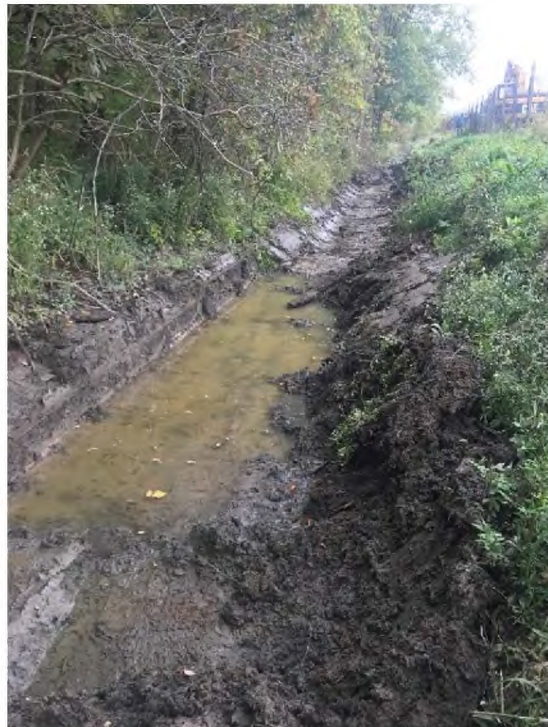
September 28, 2021 – Excavation of sediment and at least 6" underlying clays in Dawley Ditch. Looking South.

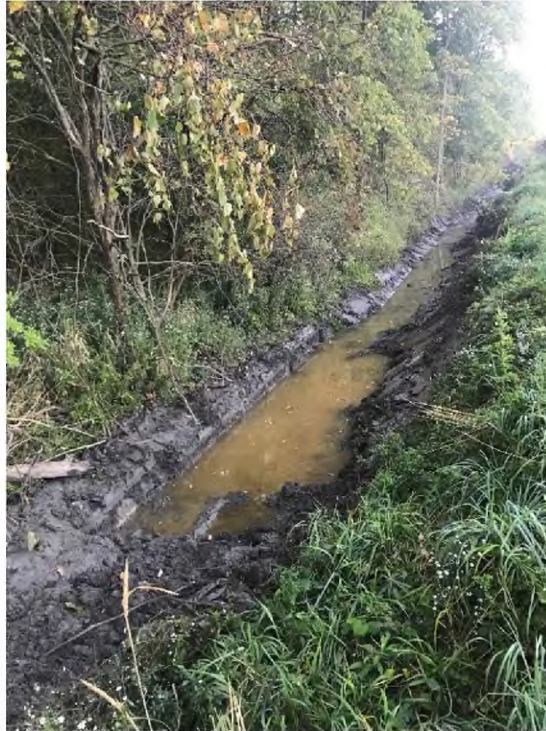
September 28, 2021 – Excavation of sediment and at least 6" underlying clays in Dawley Ditch. Looking South.

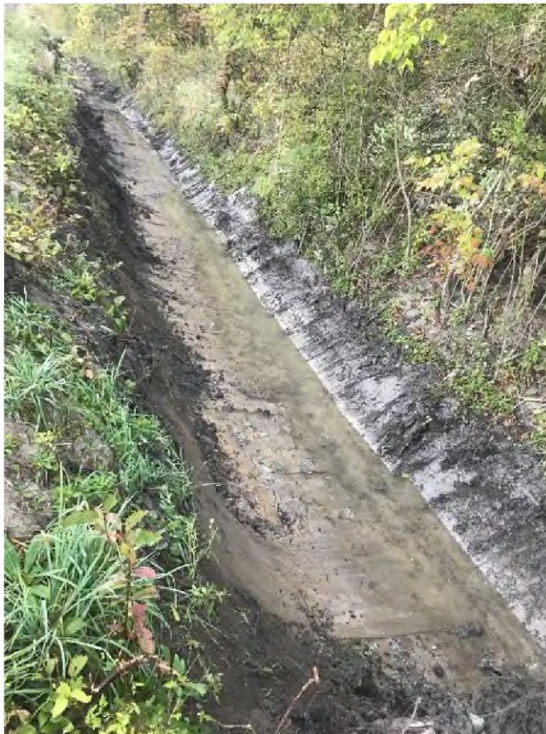
September 28, 2021 – Excavation of sediment and at least 6" underlying clays in Dawley Ditch. Looking North.

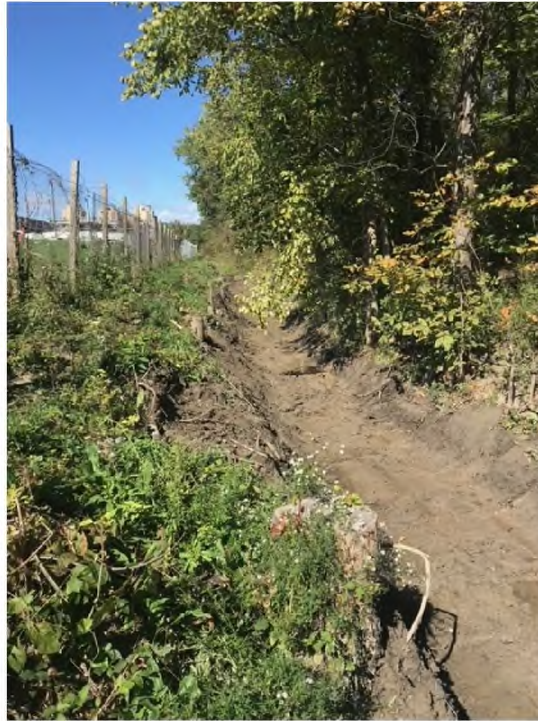
September 30, 2021 – Excavation of sediment and at least 6" underlying clays in Dawley Ditch. Note sides are compacted to prevent sediment runoff after project completion. Looking North.

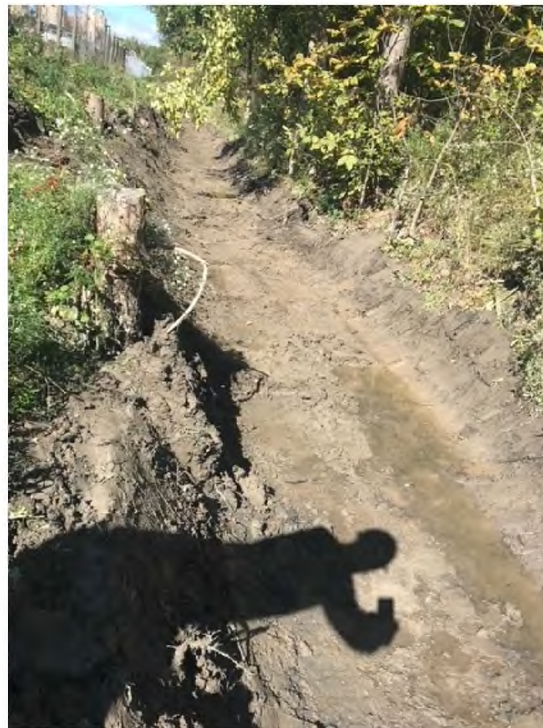
September 30, 2021 – Excavation of sediment and at least 6" underlying clays in Dawley Ditch. Note sides are compacted to prevent sediment runoff after project completion. Looking North.

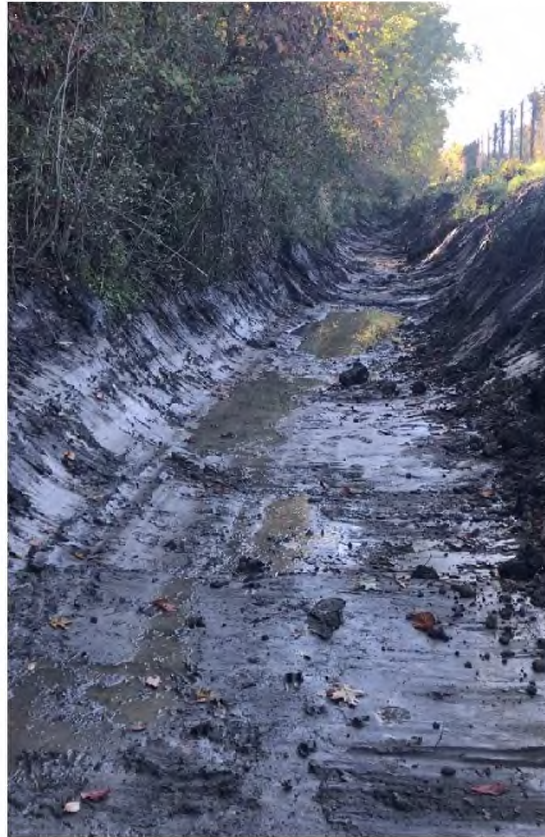
September 30, 2021 – Excavation of sediment and at least 6" underlying clays in Dawley Ditch. Note sides are compacted to prevent sediment runoff after project completion. Looking South.

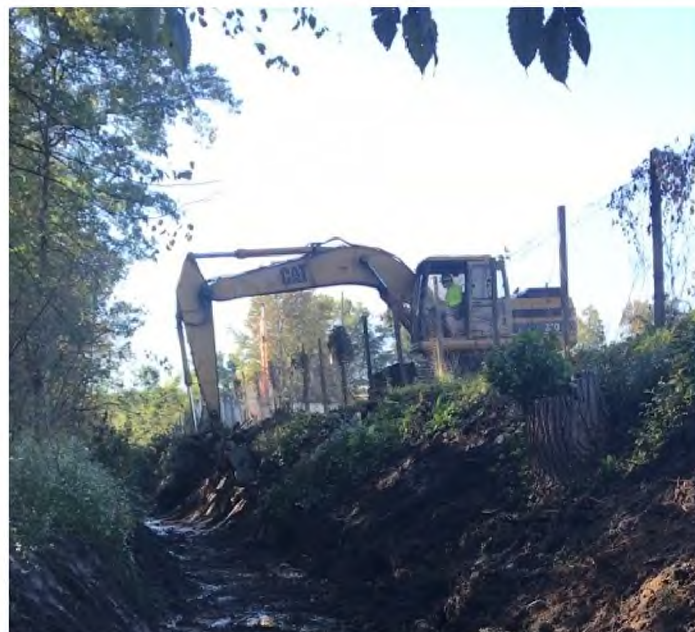
September 30, 2021 – Excavation of sediment and at least 6" underlying clays in Dawley Ditch. Backhoe compacting sides to prevent sediment runoff after project completion. Looking South.

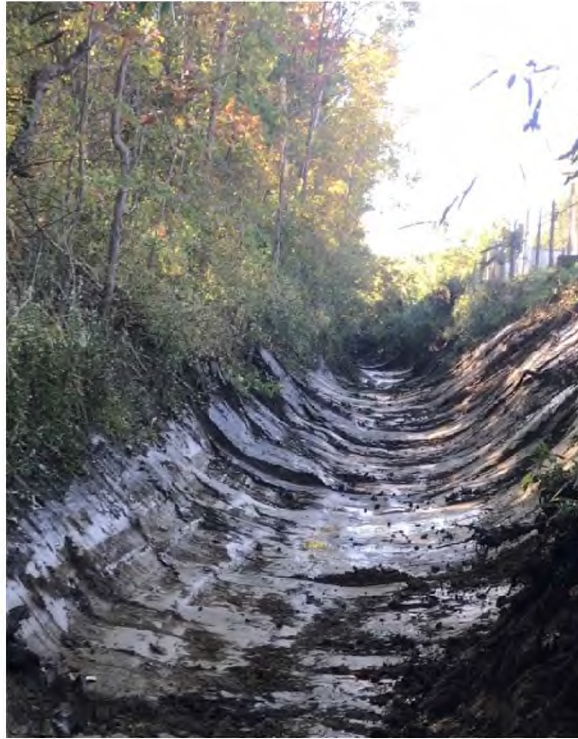
September 30, 2021 – Excavation of sediment and at least 6" underlying clays in Dawley Ditch. Southern-most point of excavation. Sides have been compacted to prevent sediment runoff after project completion. Looking South.
