Re: Ross Incineration Services, Inc.
EPA ID: OHD 048 415 665
Ohio ID: 02-47-0295
Submittal of Corrective Measures Completion of Work Report for Implementation of
Waterfowl Deterrent in the Freshwater Lake

**[Corrective Measures Completion of Work Report
For Implementation of Waterfowl and Nuisance Bird Deterrent Plan]**

**WATERFOWL DETERRENT PLAN IMPLEMENTATION
CORRECTIVE MEASURES COMPLETION OF WORK**

**Ross Incineration Services, Inc.
36790 Giles Road
Grafton, Ohio 44044
October 2021**

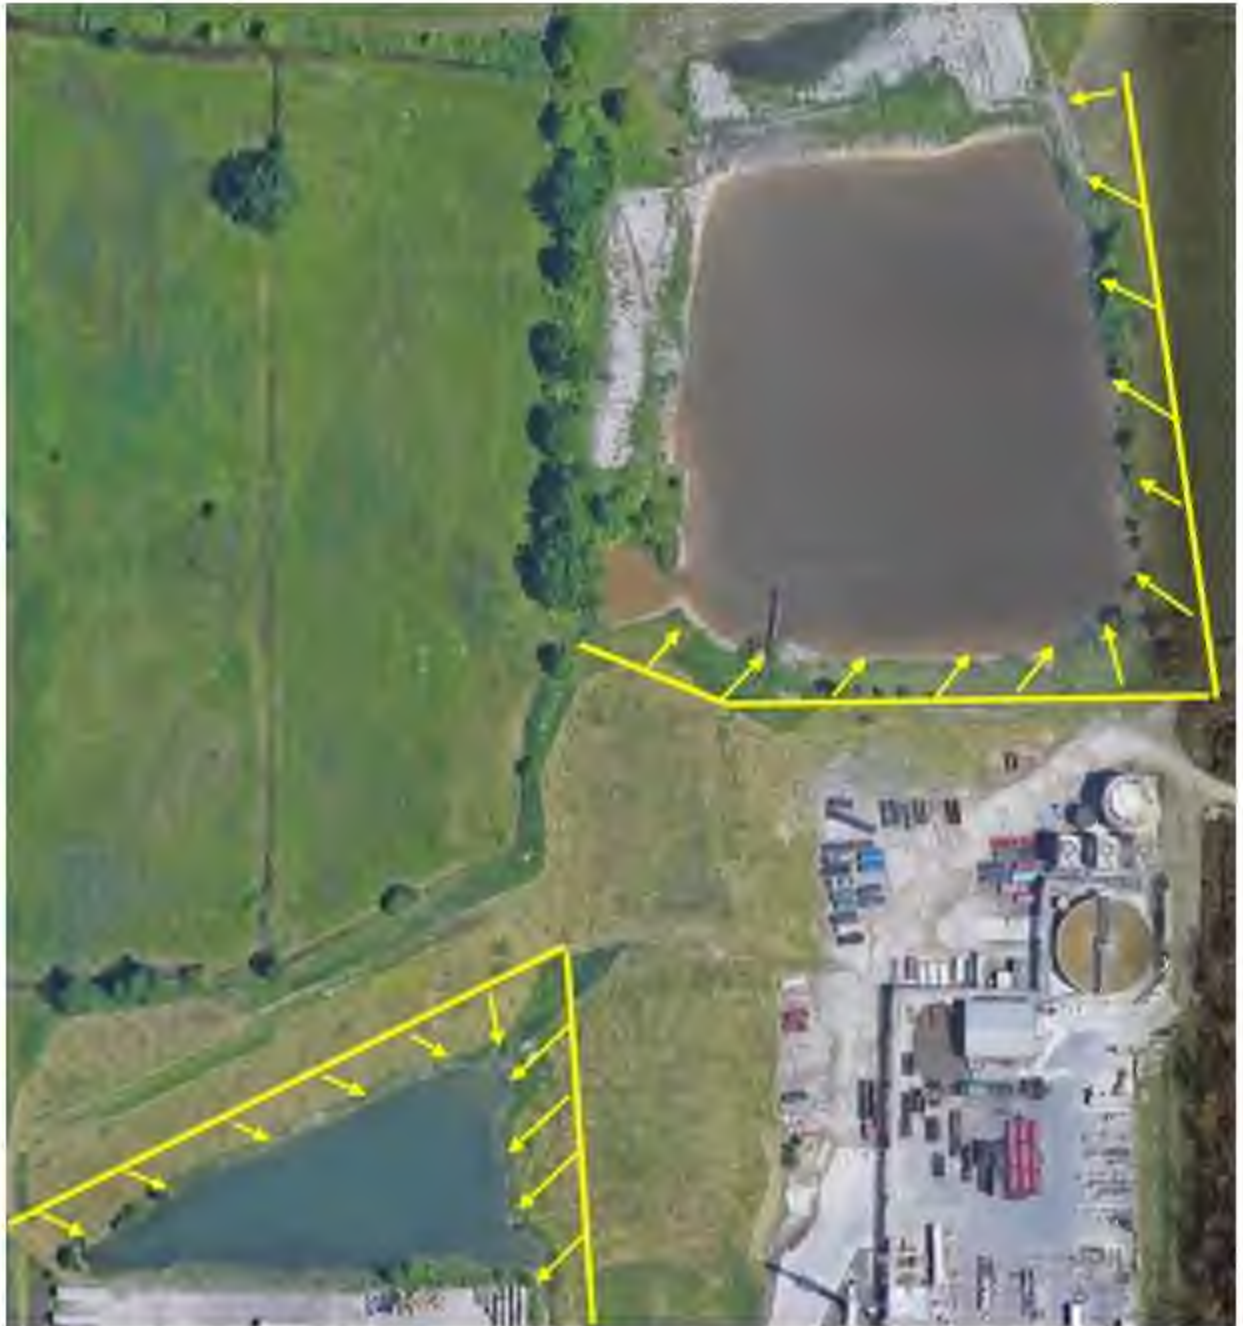
Waterbody Buffer Zones

Attachment B – Waterbody Buffer Zones shows the locations of the established buffer zones. **Attachment C – Project Photographs** includes photos of the project implementation.

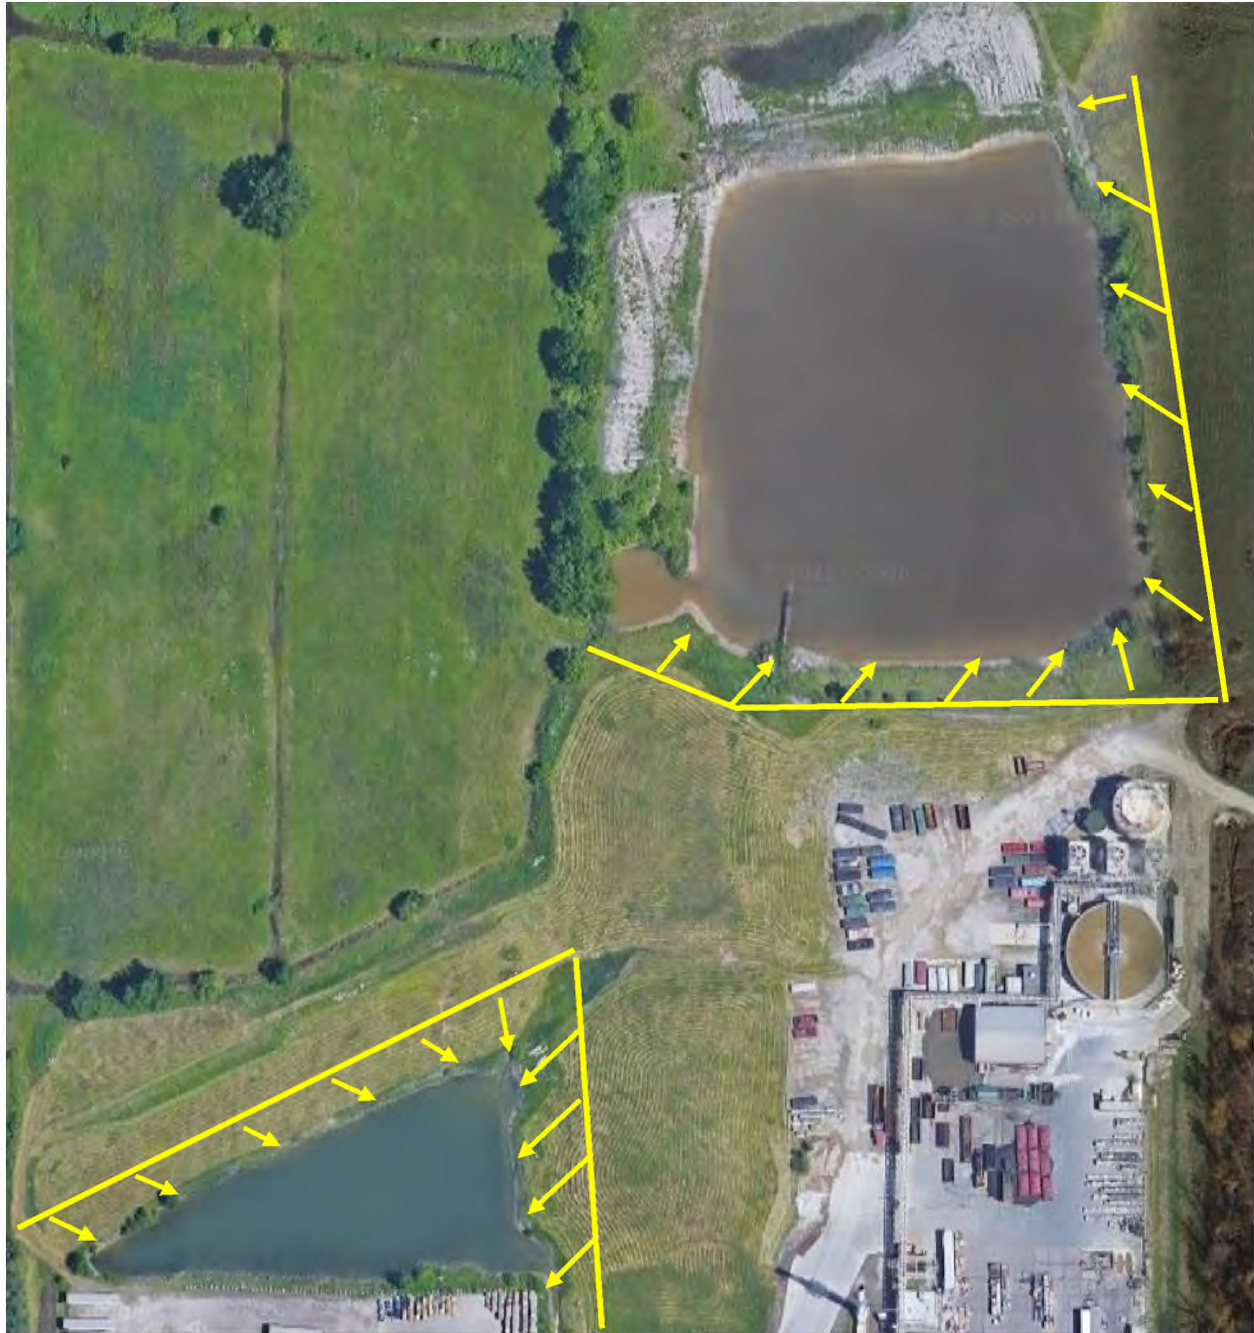
On June 1, 2021, RIS seeded areas on the eastern and northern edges of the Rainwater Pond (RWP). RIS also seeded the areas to the south and east of the Freshwater Lake (FWL). The areas were previously marked with property boundary flags to denote areas where mowing should no longer occur. Both grass seed and wildflower mix were planted.

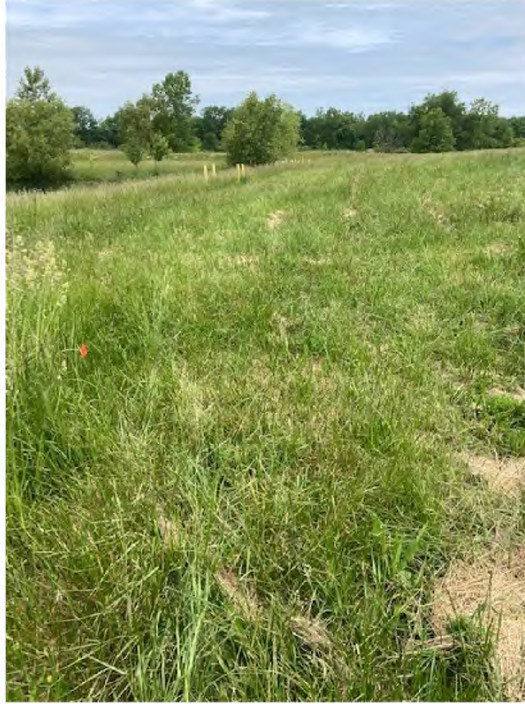
June 1, 2021, East of RWP – looking North. Property boundary flags are evident to the left in the photo, buffer area begins to the left of the boundary flags.

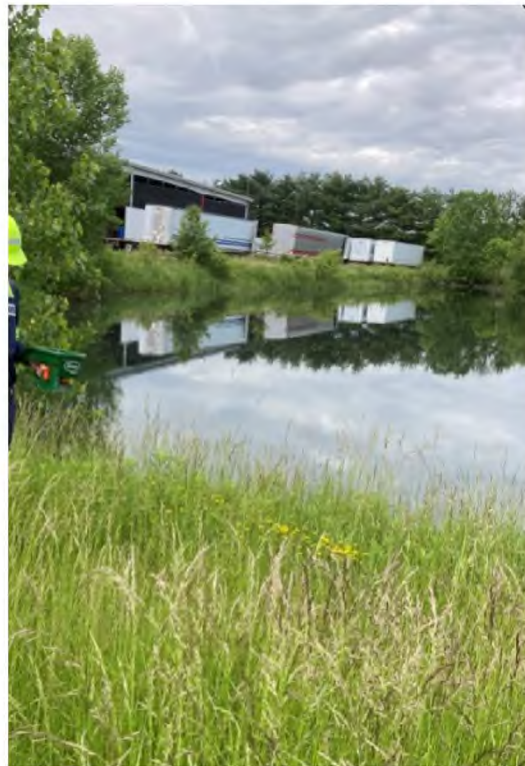
June 1, 2021, East of RWP – looking Southwest. Staged empty trailer and the CSF are seen south of the RWP. Vegetative buffer area is shown in the foreground of the photo.

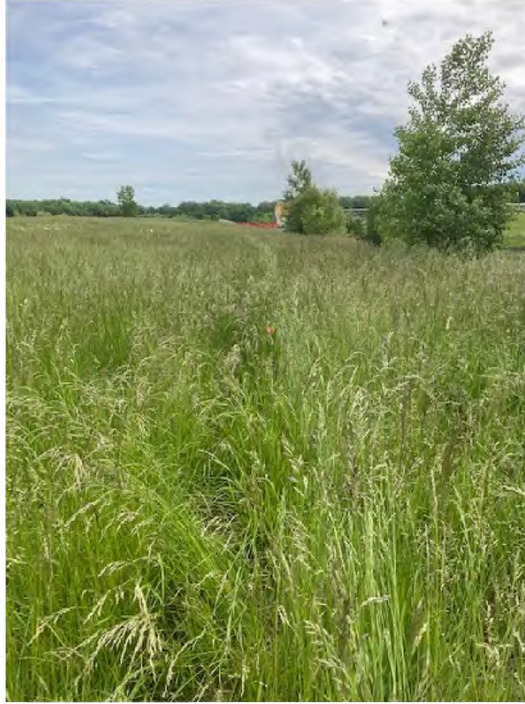
June 1, 2021, North of RWP looking East. Buffer flag can be found in the center of the photo, and buffer area is shown on the right side of the photo.

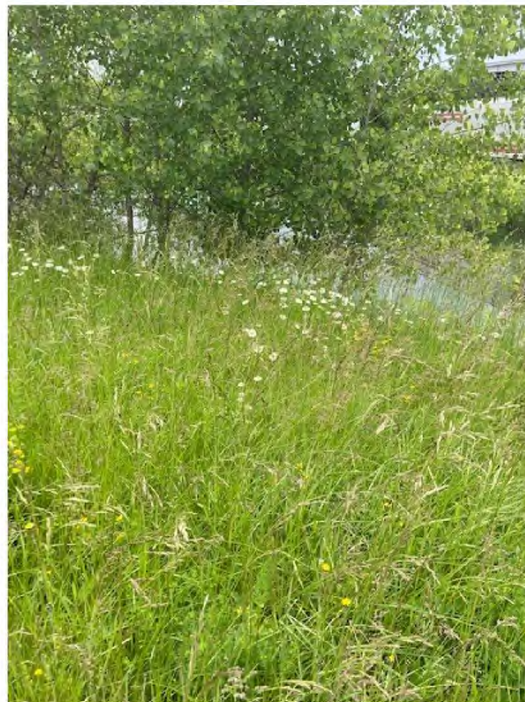
June 1, 2021, North of RWP looking Southeast. Vegetated buffer area north of RWP, RWP can be seen in the middle of the photo.

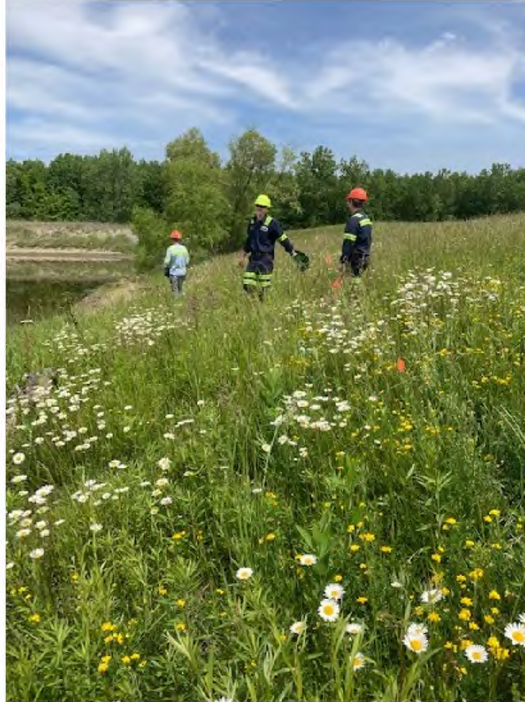
June 1, 2021, East side of Freshwater Lake looking north. Buffer flags are evident in the middle of the photo. Area is being planted with grasses and wildflower seed.

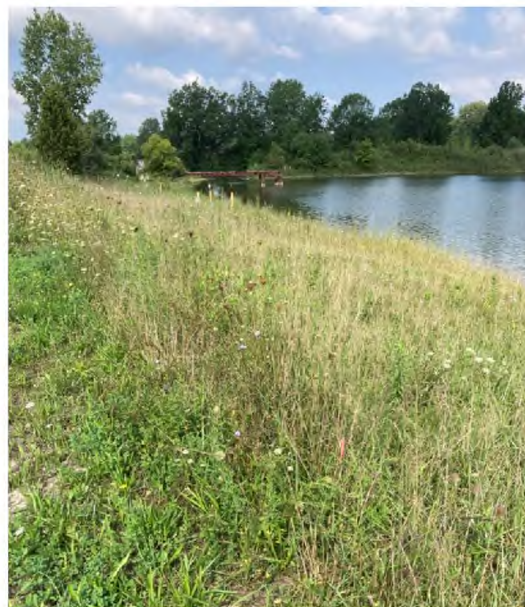
June 1, 2021, South side of Freshwater Lake looking west. Buffer flags are evident in the middle of the photo. Vegetated buffer is evident on the right side of the photo.

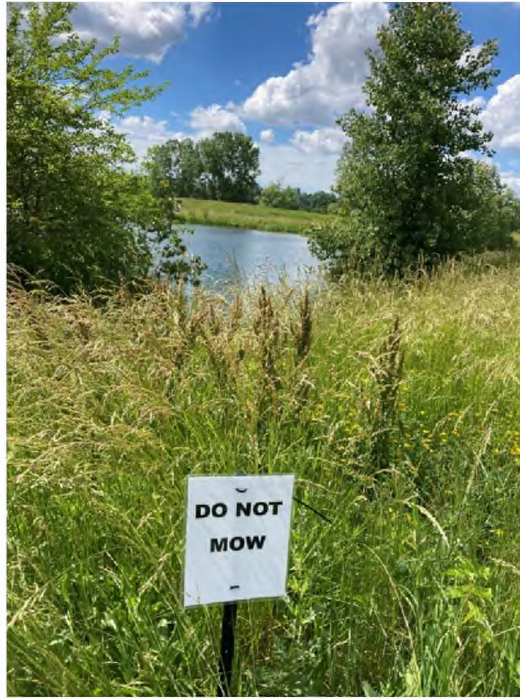
June 28, 2021, Signage placed around FWL and RWP to deter mowing of the area, which in turn allowed the waterfowl buffer to become established.

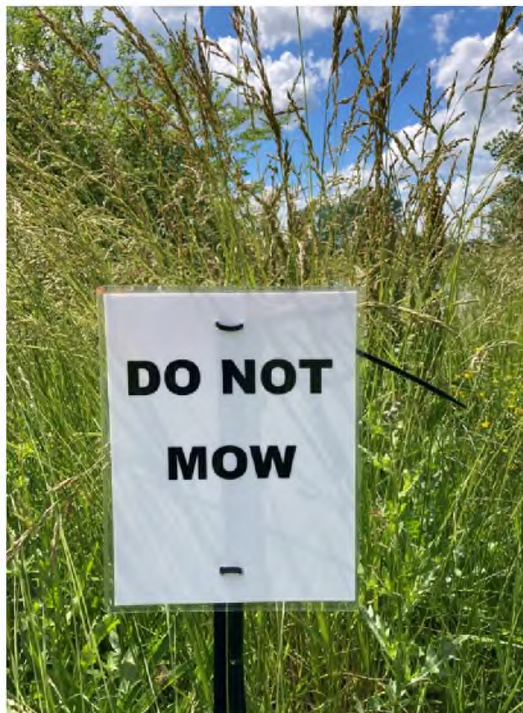
June 28, 2021, Signage placed around FWL and RWP to deter mowing of the area, which in turn allowed the waterfowl buffer to become established.

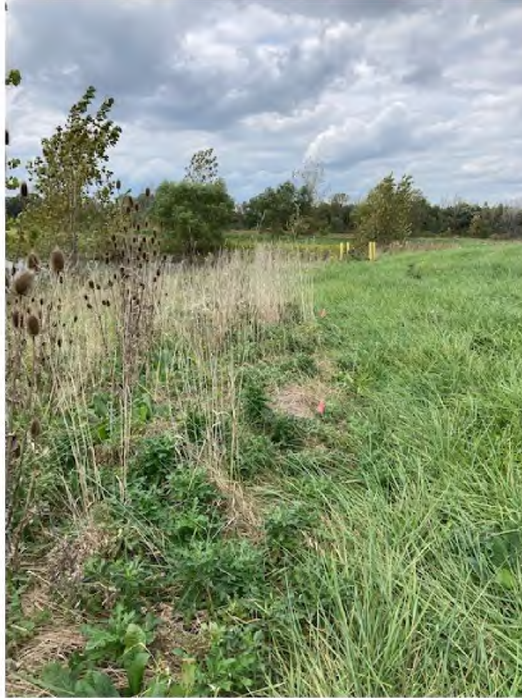
October 12, 2021, East of RWP – looking North. Vegetative buffer is evident on the left side of the photo.

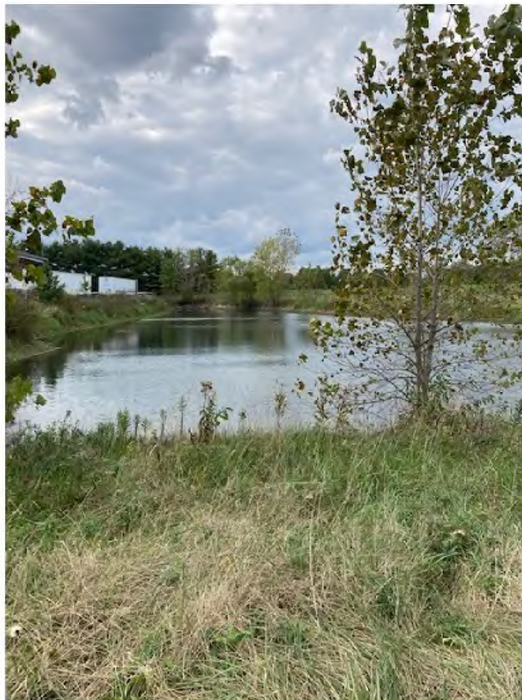
October 12, 2021, East of RWP – looking West. Vegetative buffer is evident in the foreground.

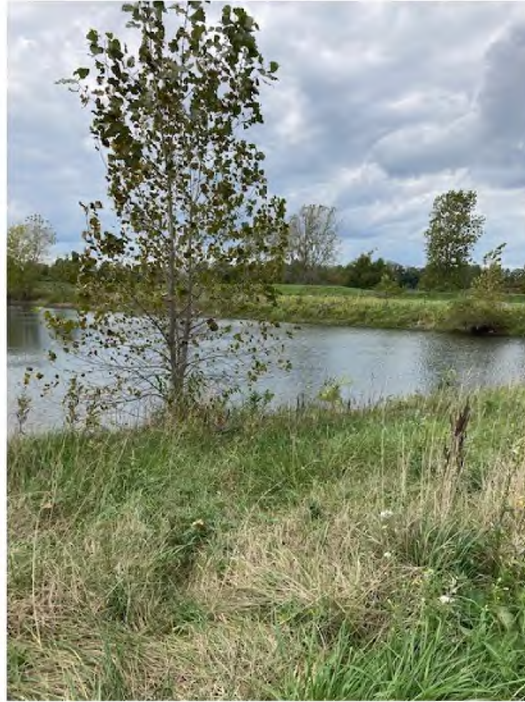
October 12, 2021, East of RWP – looking Northwest. Vegetative buffer is evident in the foreground, and on the North side of the RWP.

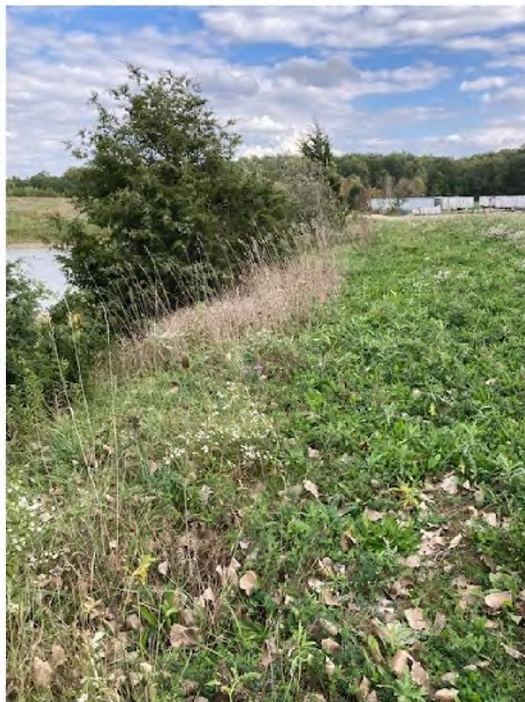
October 12, 2021, South of the FWL looking East. Vegetative buffer is evident on the left side of the photo.

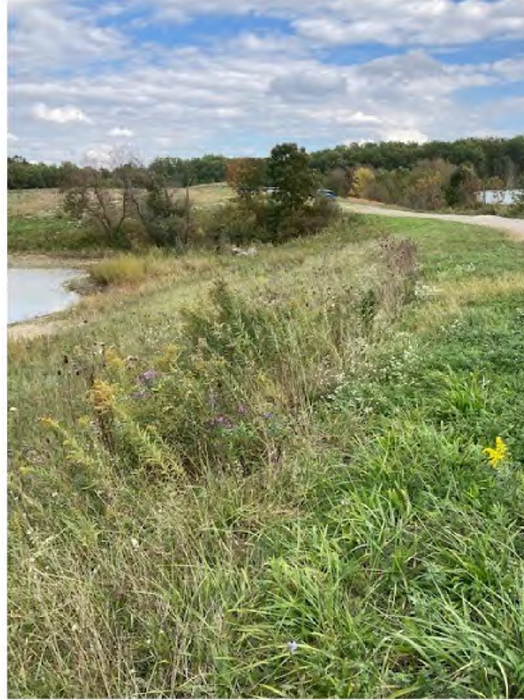
October 12, 2021, South of the FWL looking East. Vegetative buffer is evident on the left side of the photo.

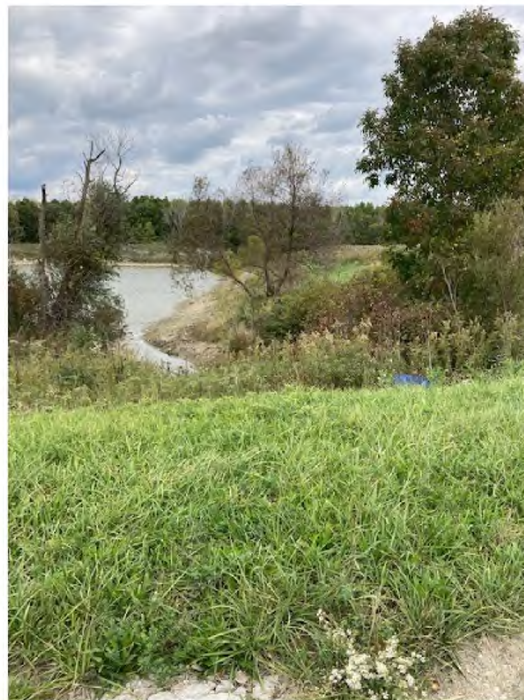
October 12, 2021, South of the FWL looking North. Vegetative buffer is evident in the foreground of the photo.

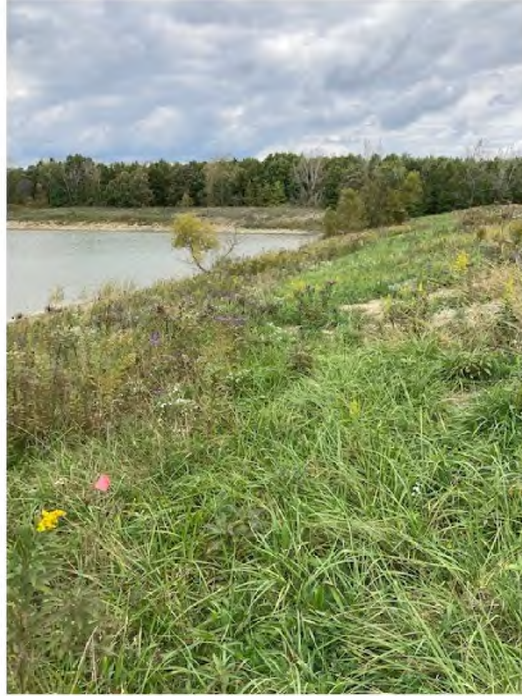
October 12, 2021, East of the FWL looking North. Vegetative buffer is evident in the foreground and left side of the photo.
