**Re: TCE Interim Measure Implementation Report
Material Sciences Corporation
460 West Main Street
Canfield, Ohio
OHD000810283
August Mack Project Number JY2380.372**

August Mack Environmental, Inc. (August Mack), on behalf of Material Sciences Corporation (MSC), is submitting this Trichloroethene (TCE) Interim Measure Implementation Report for the MSC facility located at 460 West Main Street, Canfield, Ohio (Site). This report includes pertinent Site background information, a description of recent field activities, sampling procedures, laboratory analytical results, and planned next steps.

**Material Sciences Corporation
Canfield**
**Site Plan with TCE IM
Sampling Locations**

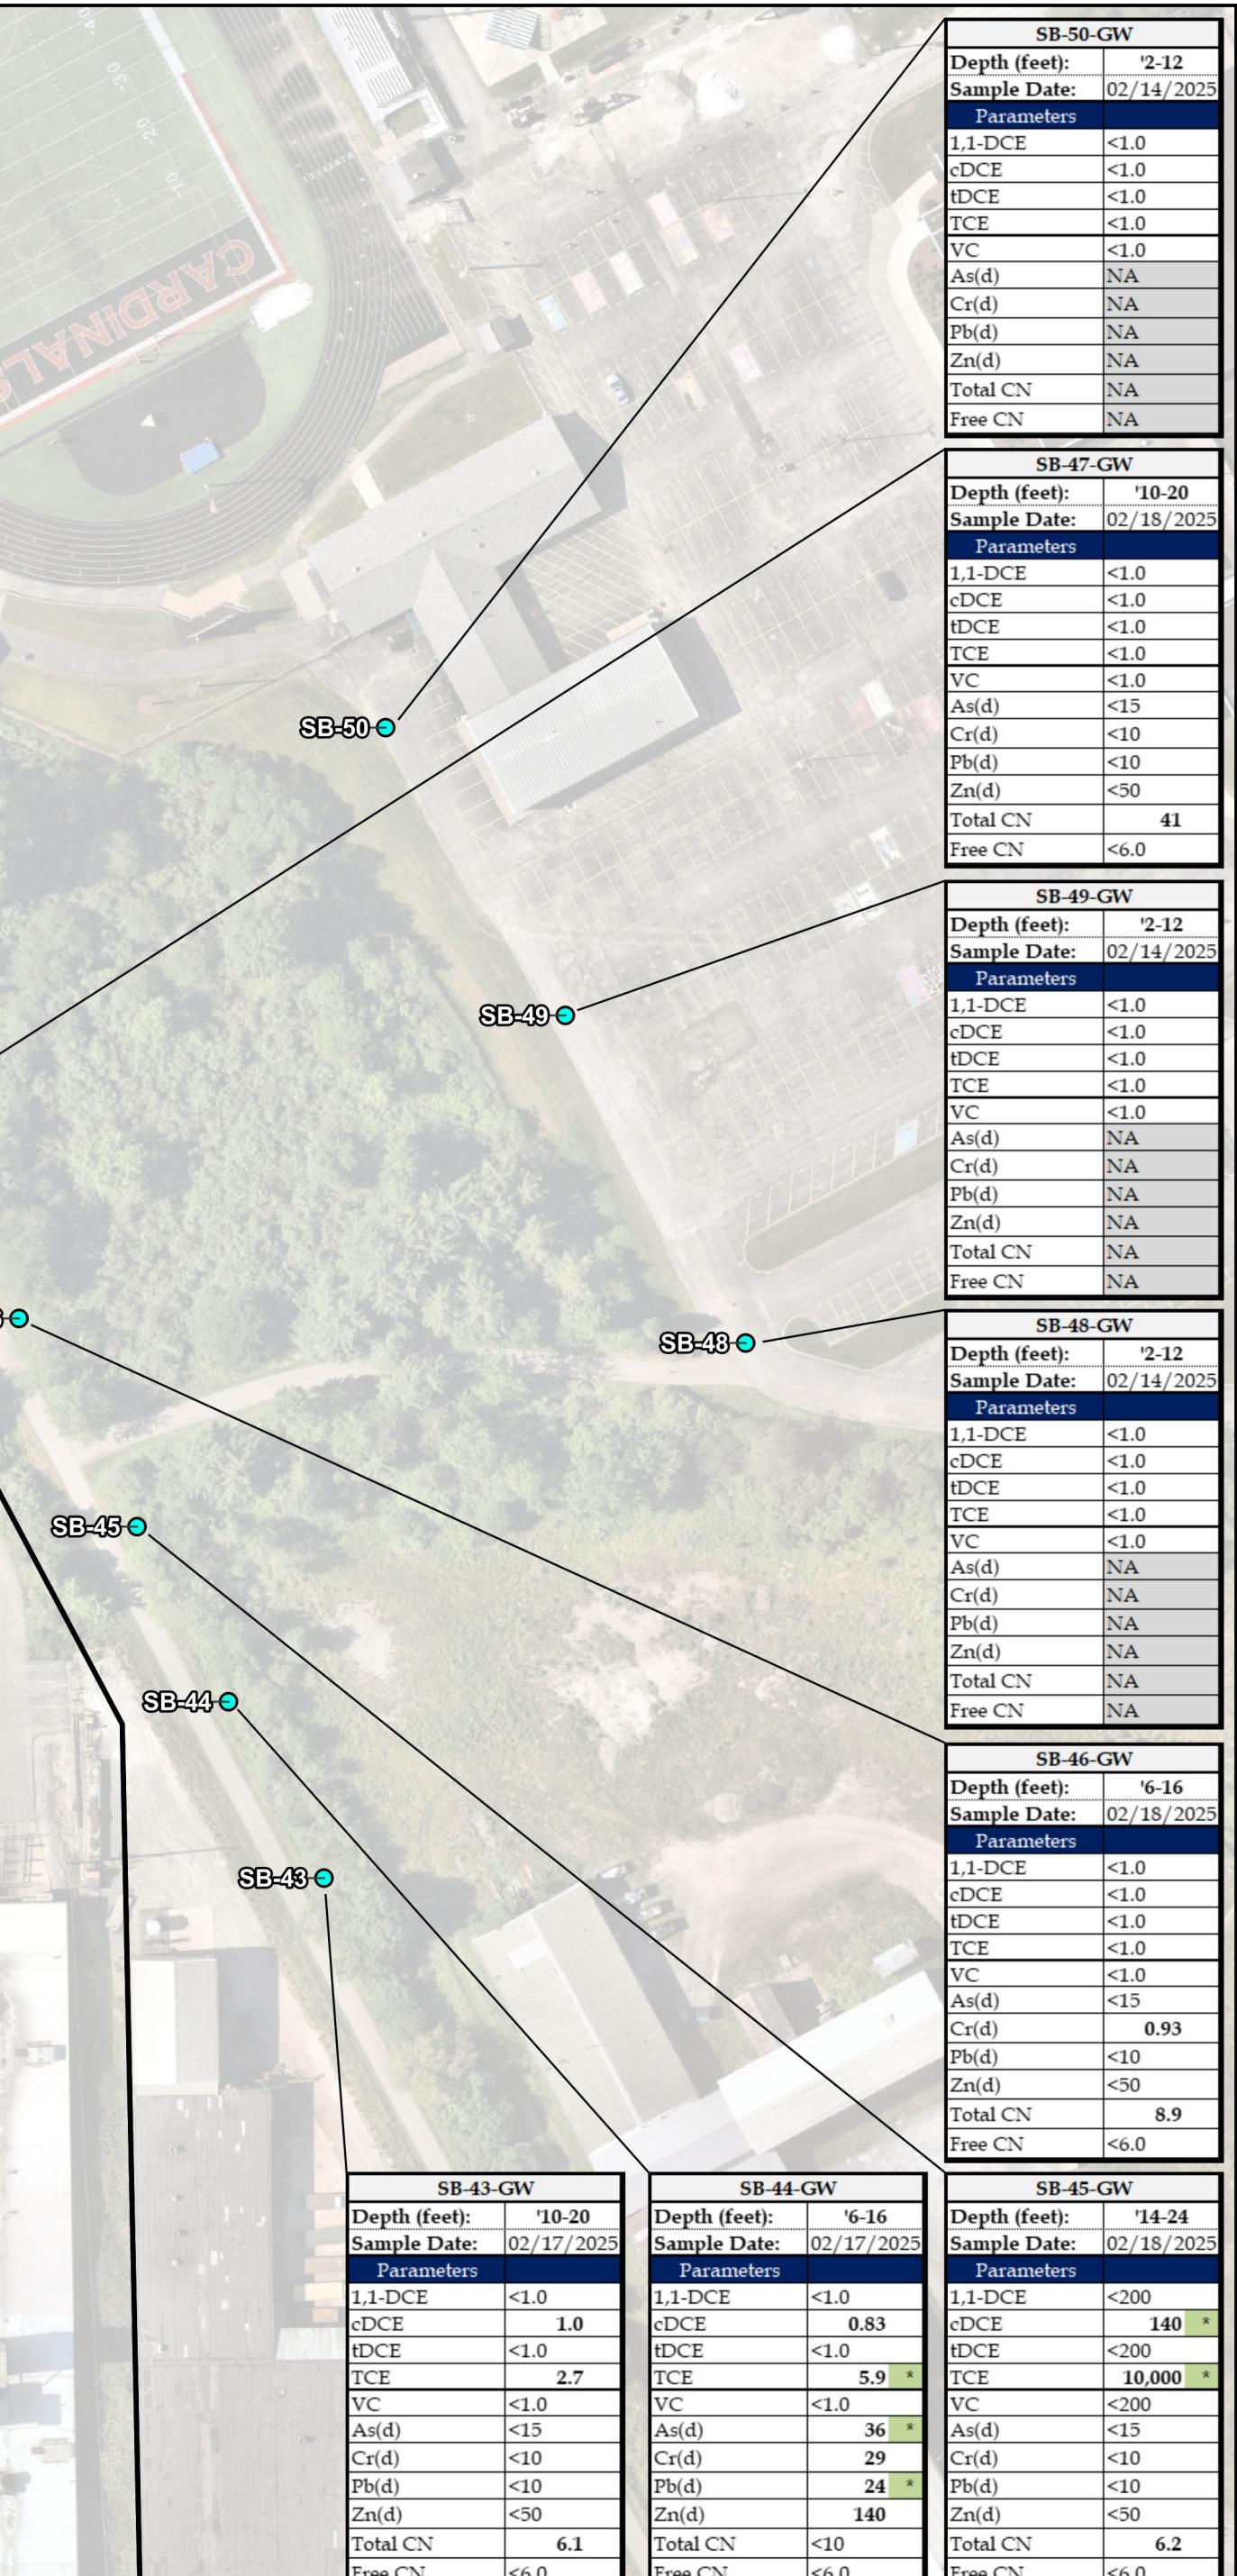
4401 Rockside Road, Suite 300
Independence, Ohio 44131 (330) 576-3229
August Mack ENVIRONMENTAL
PROJECT NO.: JY2380.372 DATE: 03/27/2025
FIGURE: 2 SCALE: 1:1,000
CREATED BY: CC

* = At or Above Ohio EPA GWPS

Subject Property
Grab Groundwater Sample

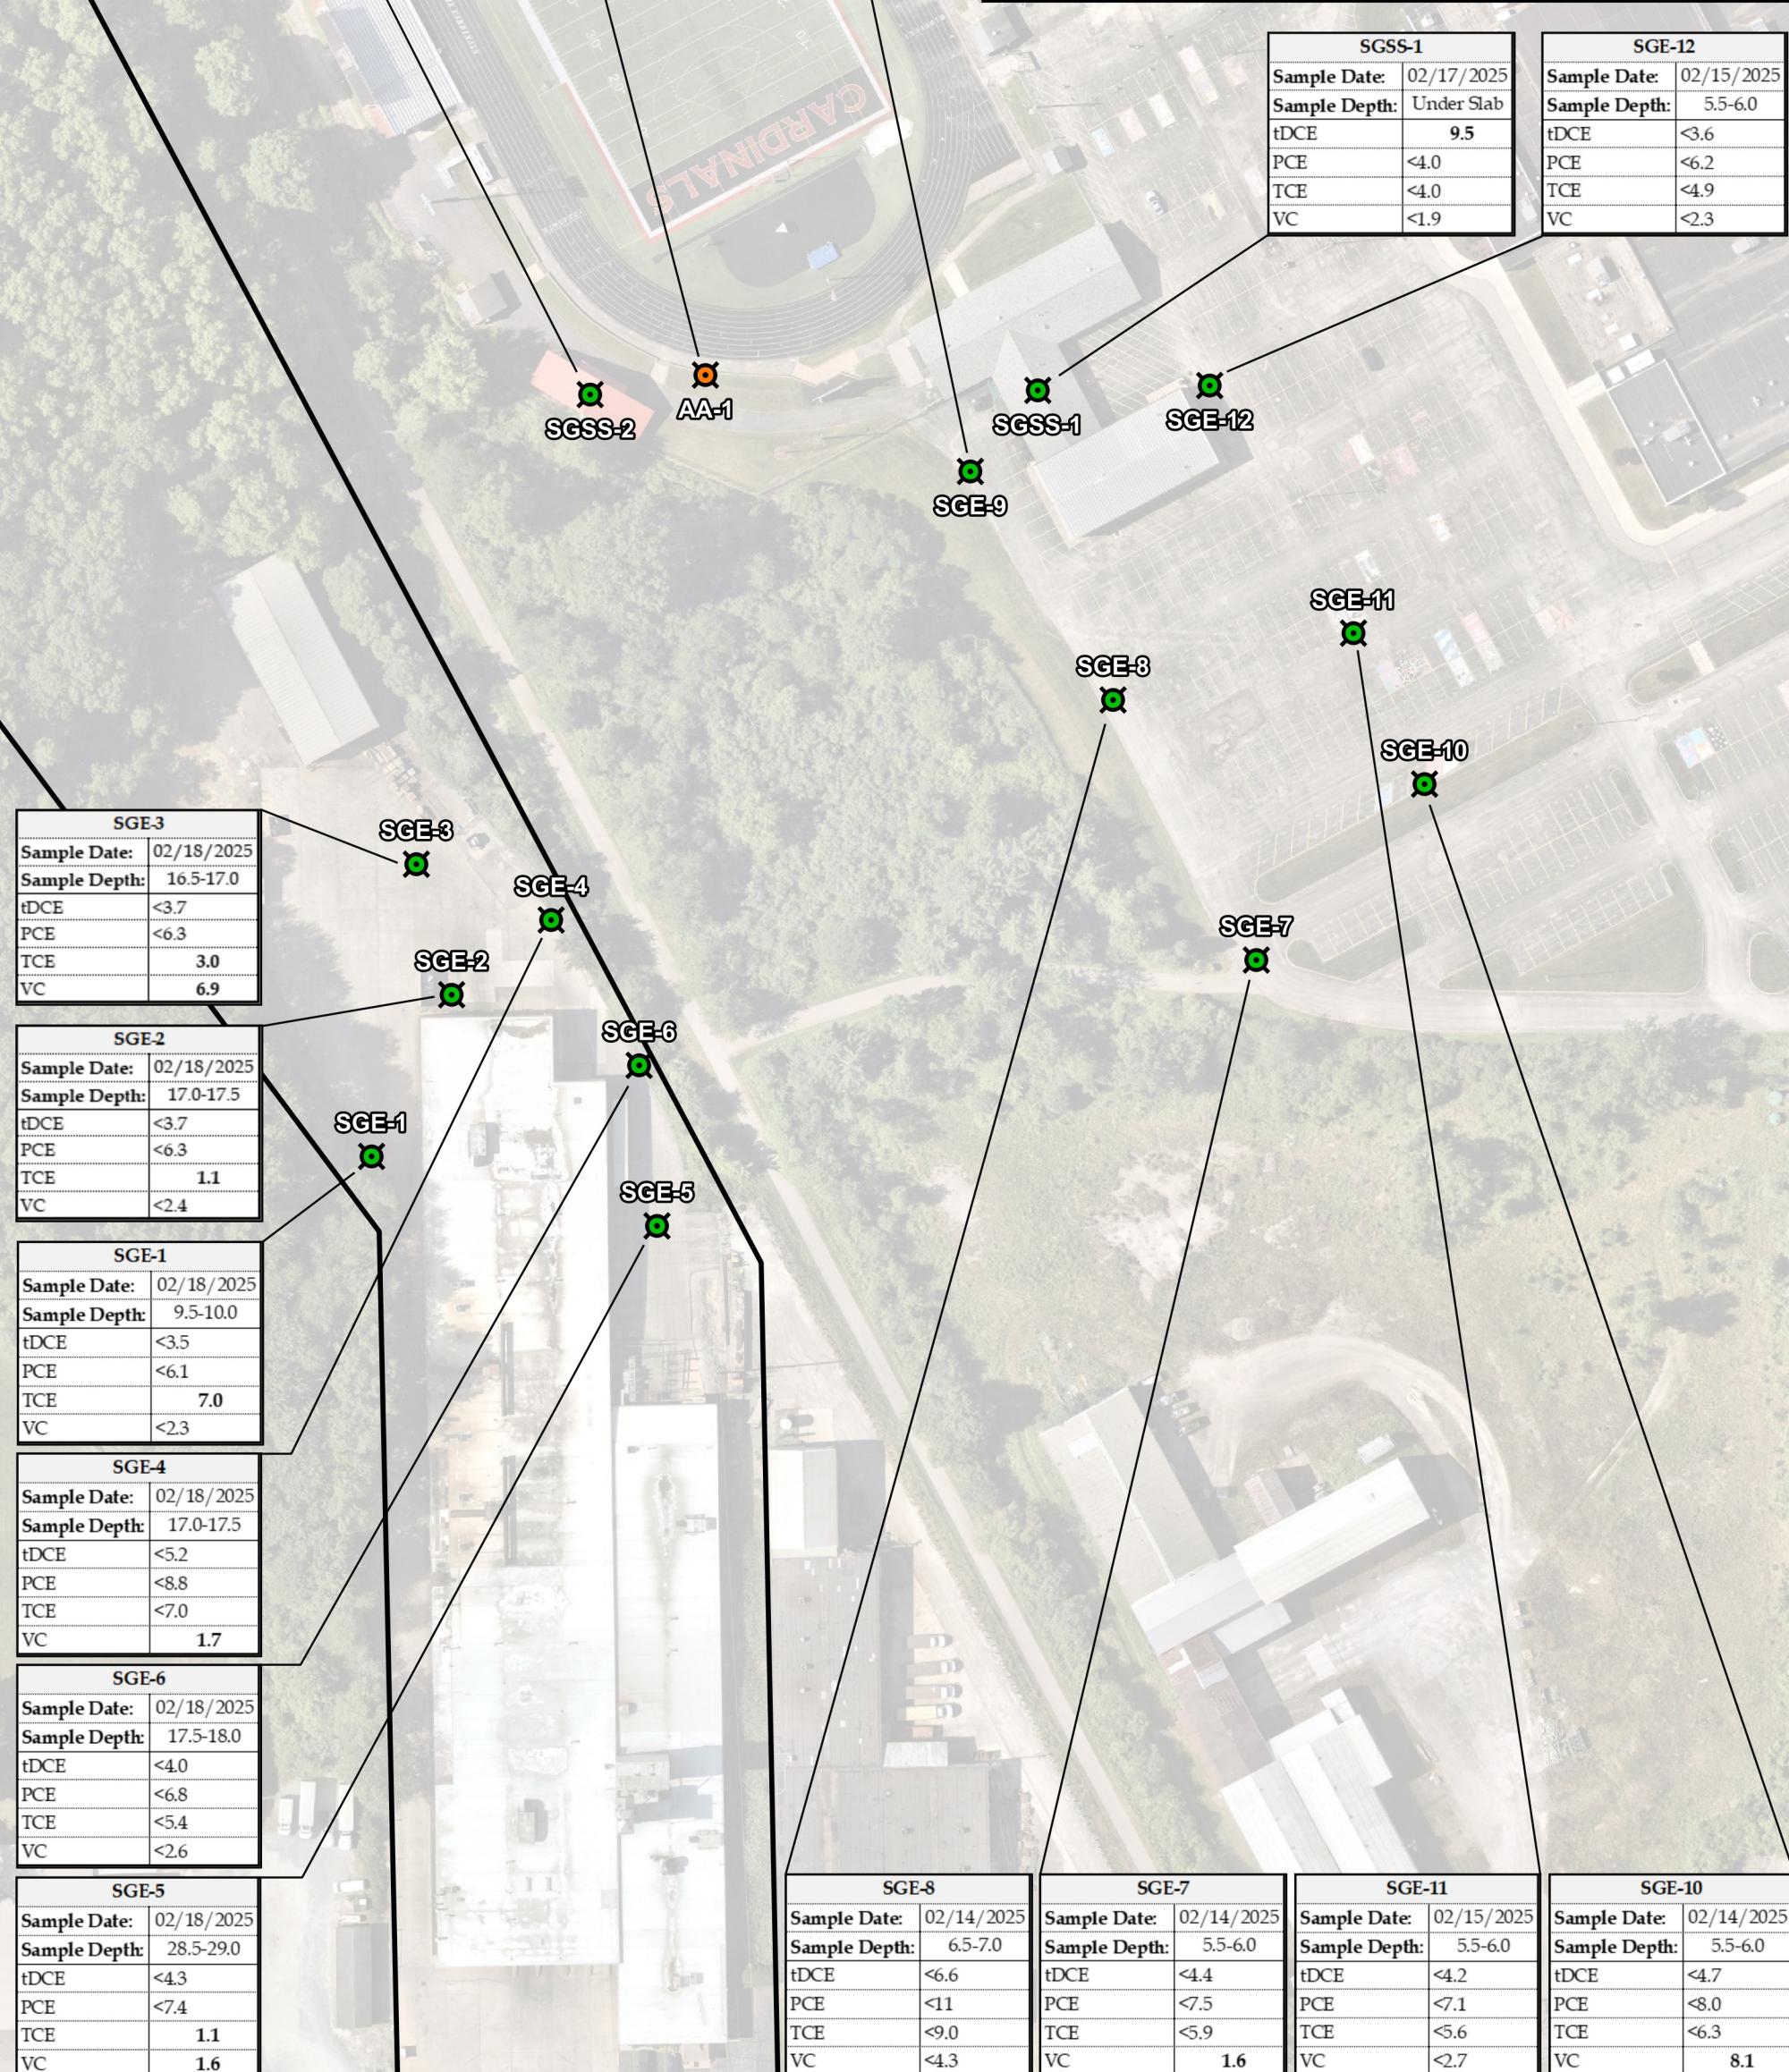
Subject Property
Vapor Intrusion Sample Location
Ambient Air Sample Location

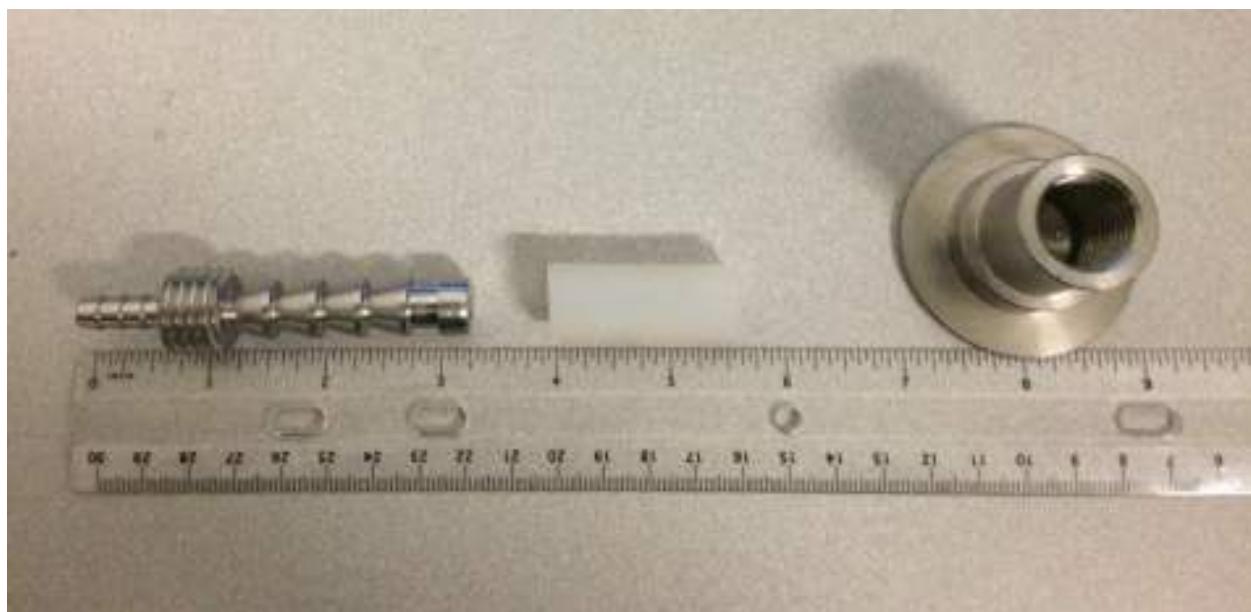
- One (1) two (2) inch long, 1/2-inch diameter, barbed stainless steel pin with a 3/4-inch long, 1/4-inch diameter, barbed stainless steel nipple used to connect to a sampling apparatus (a 1/2 inch threaded section separates these two (2) portions);
- One (1) 1 and 1/2-inch silicone sleeve that covers the 1/2-inch diameter portion of the pin
- One (1) threaded recessed plug constructed of stainless steel.

All Vapor Pin® construction materials are decontaminated using a Liquinox® detergent wash and triple rinsed prior to installation. The silicone sleeve is placed around the 1/2-inch diameter part of the pin to ensure an air tight seal in annular space. Each Vapor Pin® is then driven into the drilled inner hole using a manufacturer supplied installation/extraction tool, such that the bottom of the threaded section of the pin rests on the base of the outer diameter drilled hole. The threaded recessed plug is then threaded onto each Vapor Pin® to make the apparatus flush to grade.
