RE: GRAYMONT DOLIME (OH)
Report
Drinking Water Program
Ottawa County
PWS ID: OH6254112

GRAYMONT DOLIME (OH) INC

21880 West State Route 163, PO Box 158, Genoa, Ottawa County, Ohio
PWS #OH6254112

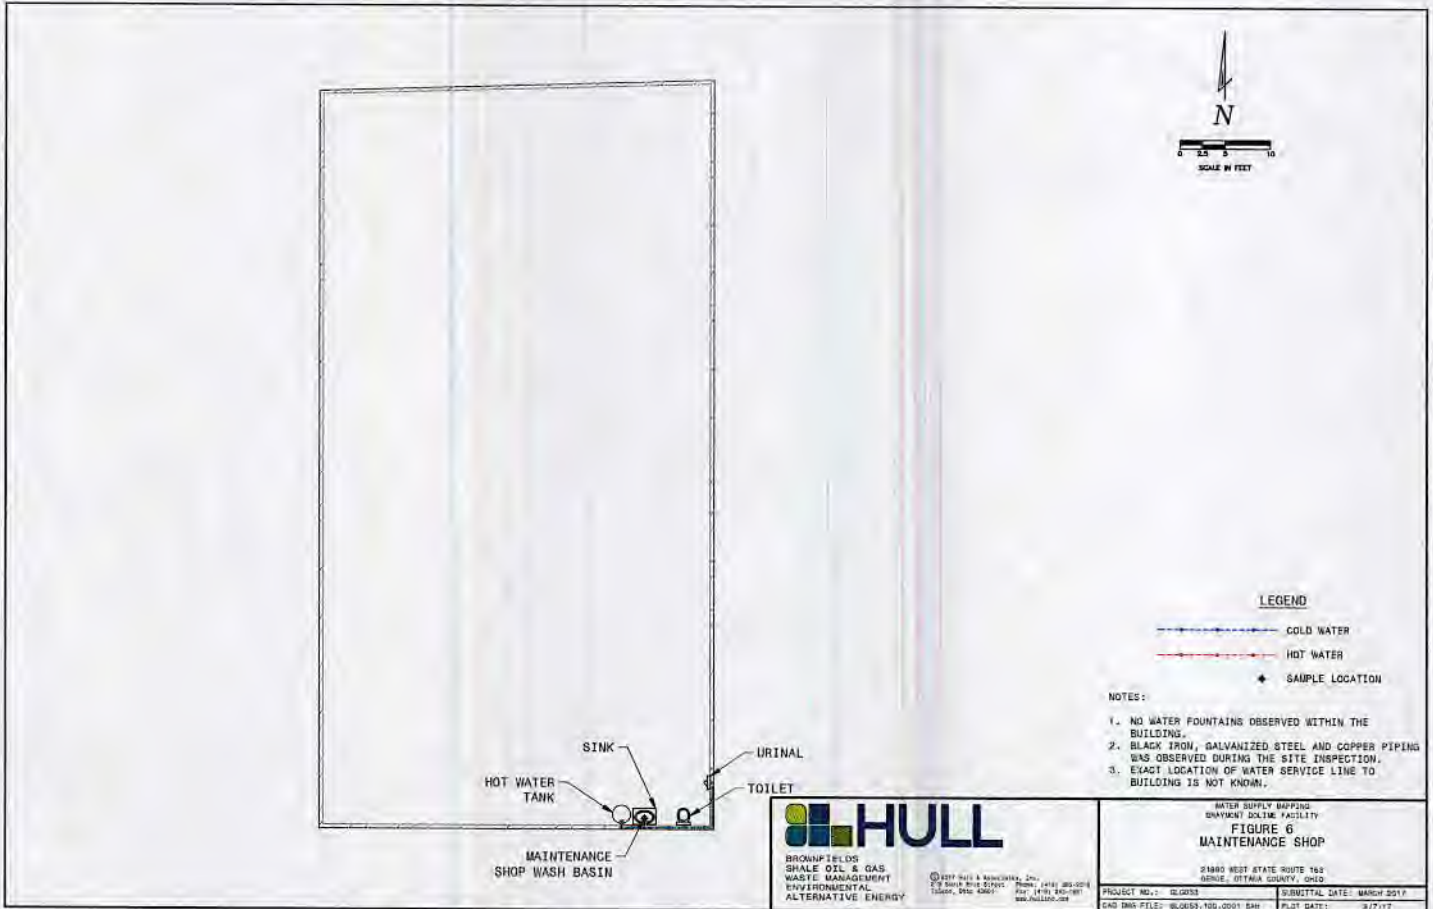
1. NO WATER FOUNTAINS OBSERVED WITHIN THE BUILDING.
2. GALVANIZED STEEL AND PEV PIPING OBSERVED DURING THE SITE INSPECTION.
3. EXACT LOCATION OF WATER SERVICE LINE TO BUILDING IS NOT KNOWN.
