LANCASTER COUNTRY CLUB

BUILT: 1975 ADDITION: 1995

Lancaster Country Club Maintenance Building

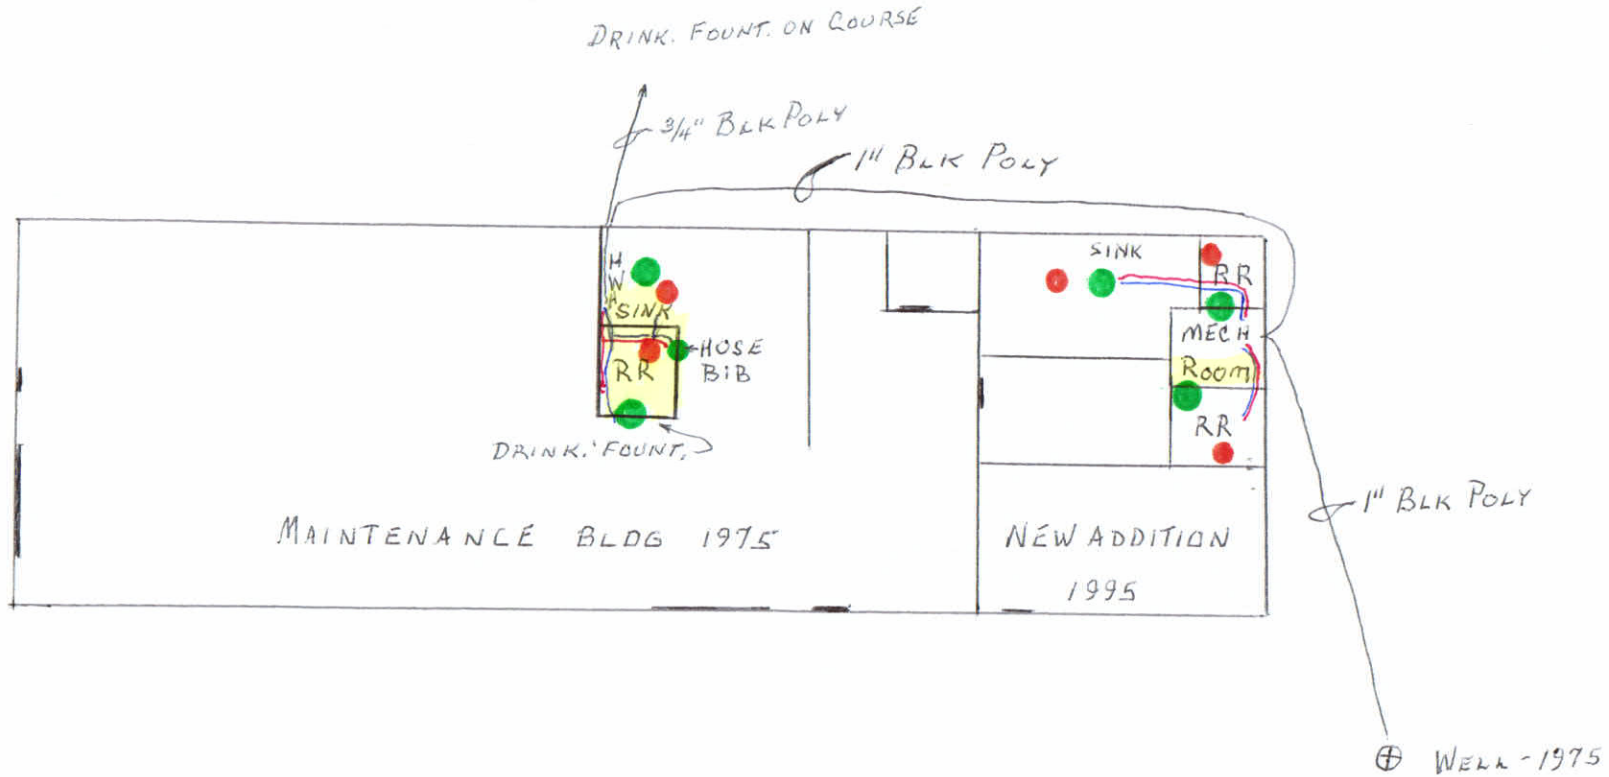
● POTENTIAL SOLDER BEFORE 1998

● PIPING END POINT

● SAMPLE SITE

- Before 1998 there was no limit on lead, may have materials with greater than 8% lead and are at a higher risk of contributing lead to the drinking water than materials manufactured after 1998.
- 1998-2014 lead solder was banned and there was lower content in brass
- After 1998 plumbing materials were required to have less than 0.25% lead by weight and have the lowest risk for contributing lead to the drinking water

SCALE 1" = 20'

The Golf Course Maintenance Building was built in 1975 and the well was drilled that same year. A one inch black poly pipe was installed from the well to the back of the building up through the floor. All piping installed in this building was copper with solder connections. The plumbing services a restroom, a shop clean up sink, a hose bib and a drinking fountain.

An addition to the building was finished in 1995. The footprint of the building was over the path of the one-inch poly line. A new line was installed into the new addition into a mechanical room where a new pressure tank was placed. A line was taken from the mechanical room and attached to the line running to the original building. The plumbing inside the new addition is black poly pipe into the pressure tank. From the pressure tank copper pipe (w/ soldered joints) runs through a cartridge filter, then splits off one line running to the HWH then both pipes into a manifold hot & cold. From the manifold separate lines run to the member's restroom, the employee's restroom and the break room sink. All lines from the manifold are polybutylene. A quarter inch tap at the pressure tank allows for testing raw water.
