FORMER RANCO PLAIN CITY FACILITY

RCRA STATEMENT OF BASIS

Ranco North America, Inc.

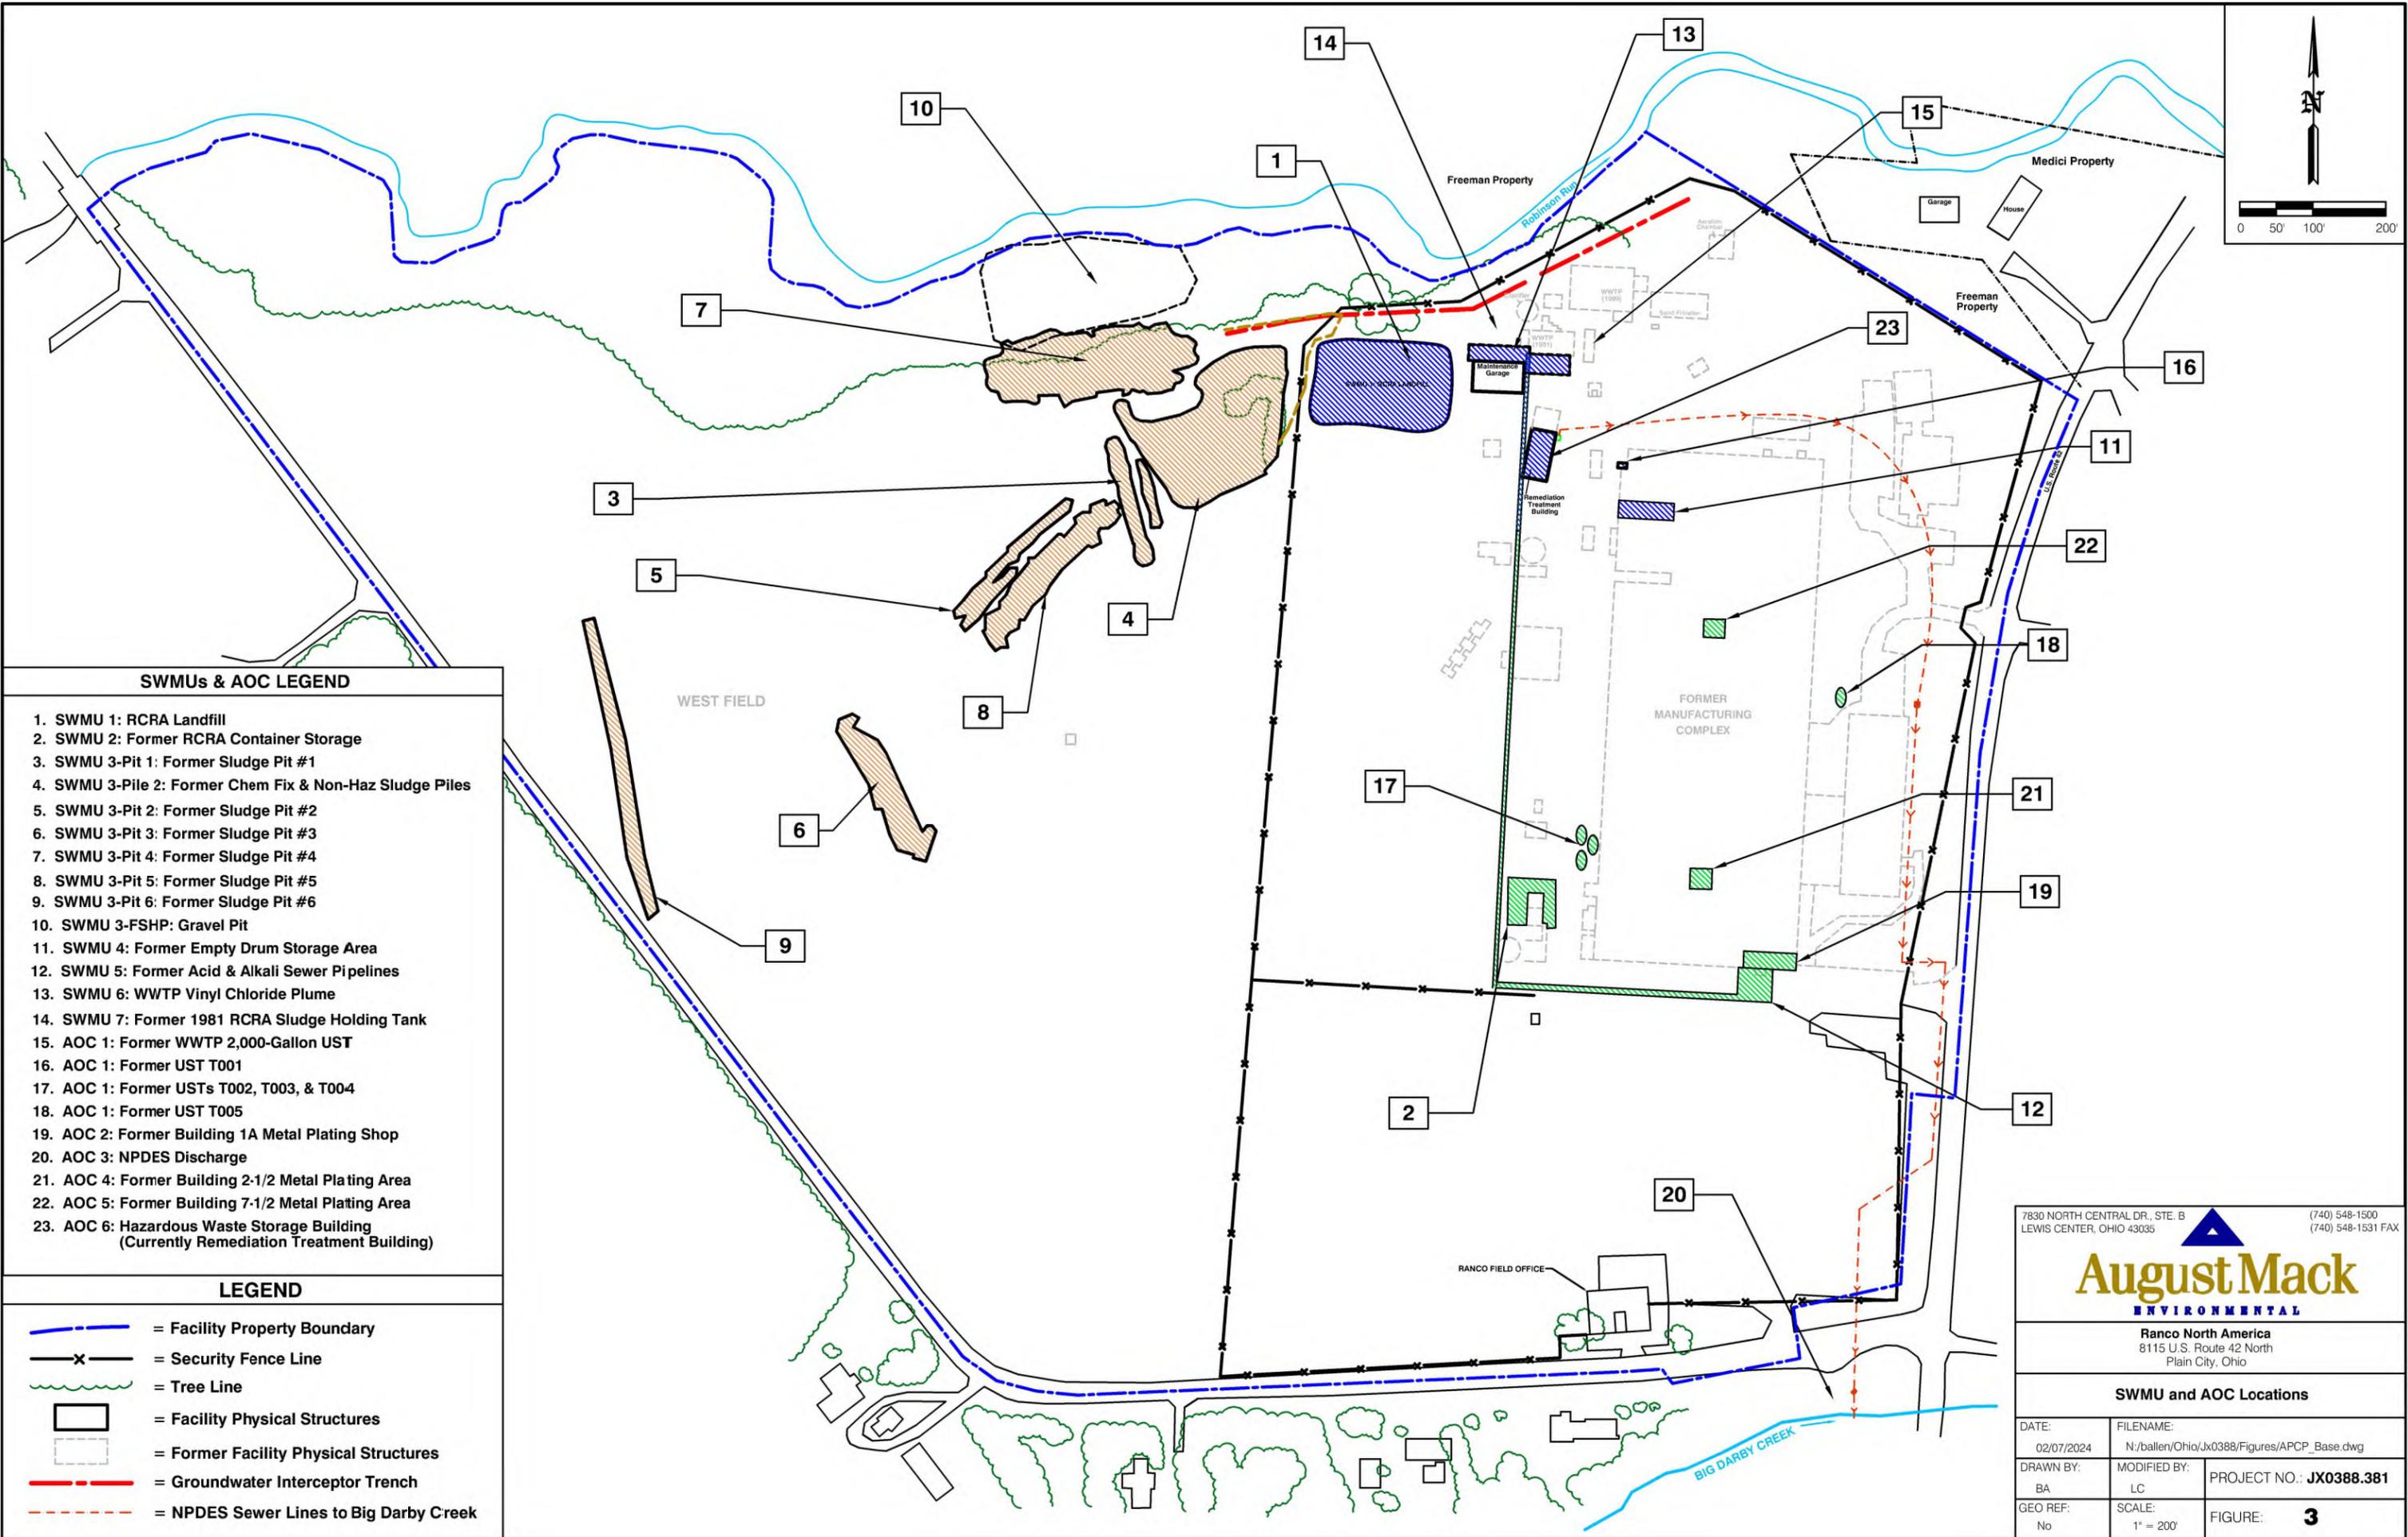
SWMU and AOC Locations

- SWMUs & AOC LEGEND**
1. SWMU 1: RCRA Landfill
 2. SWMU 2: Former RCRA Container Storage
 3. SWMU 3-Pit 1: Former Sludge Pit #1
 4. SWMU 3-Pile 2: Former Chem Fix & Non-Haz Sludge Piles

5. SWMU 3-Pit 2: Former Sludge Pit #2
 6. SWMU 3-Pit 3: Former Sludge Pit #3
 7. SWMU 3-Pit 4: Former Sludge Pit #4
 8. SWMU 3-Pit 5: Former Sludge Pit #5

22. AOC 5: Former Building 7-1/2 Metal Plating Area
 23. AOC 6: Hazardous Waste Storage Building (Currently Remediation Treatment Building)

The following summarizes SWMUs 1 through 7, AOCs 1 through 6, and the three primary areas of ground water contamination, which are collectively referred to as AOC 7. Summaries include a description of the current conditions and remaining environmental concerns in each, and the remedies proposed by Ranco and Ohio EPA. Extensive coordination between Ohio EPA and Ranco during development of the Corrective Action Report has resulted in Ranco proposing various remedies with Ohio EPA's concurrence resulting in no significant differences between proposed remedies offered by Ranco and Ohio EPA. Figure 3 shows the location and description of SWMUs 1 through 7, AOCs 1 through 6. The ground water contamination areas (designated as SWMU 7) are shown on Figures 6a, 6b, and 6c.

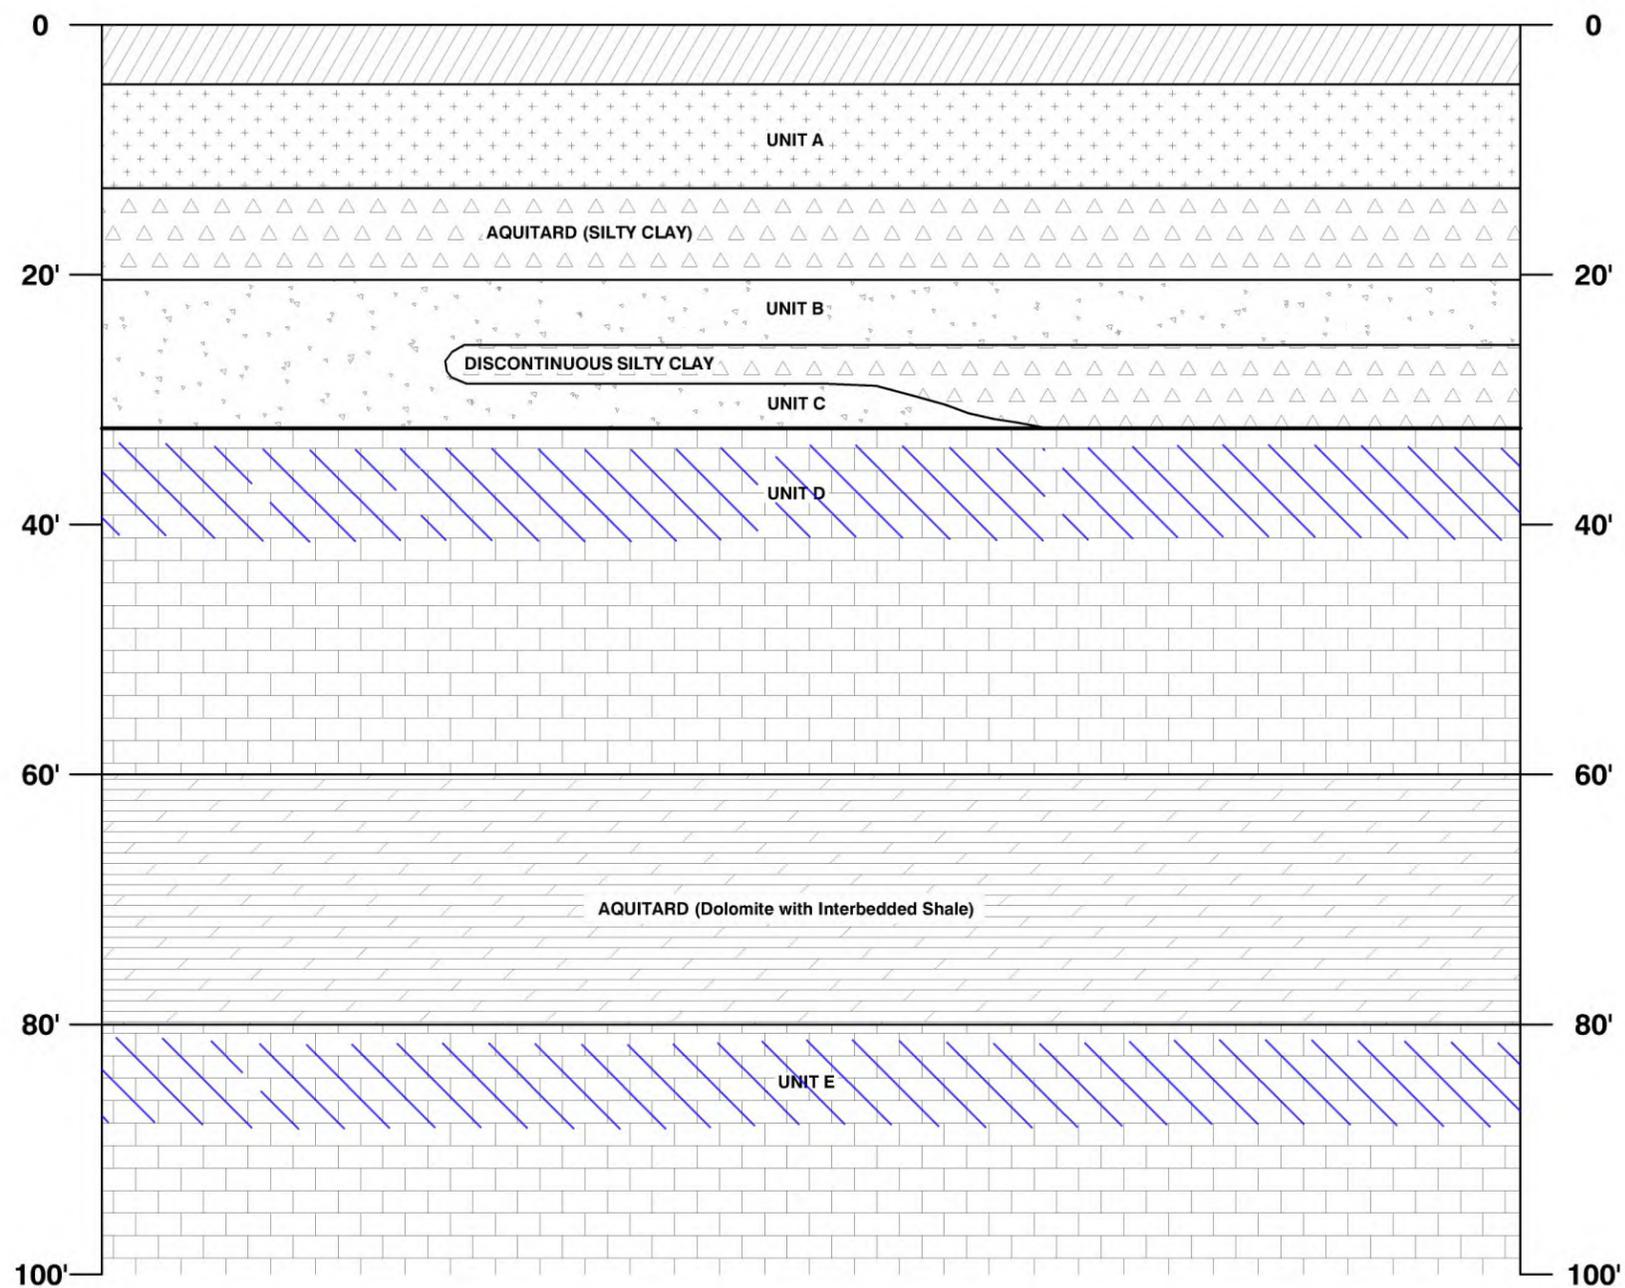
Hydrogeologic Schematic

NOTE: Units B & C are variable and not present in every location.

The understanding of the hydrogeology of the site has been established through numerous investigations beginning in the late 1980s and through 2018. The geologic setting of the facility consists of a stratified sequence of unconsolidated glacial deposits overlying dolomite bedrock. There are five (5) named water-bearing formations (units), plus a clay glacial till layer which forms an aquitard that separates the upper most aquifer from the deeper formations (Figure 5). From shallowest to deepest, the key hydrogeological features are:

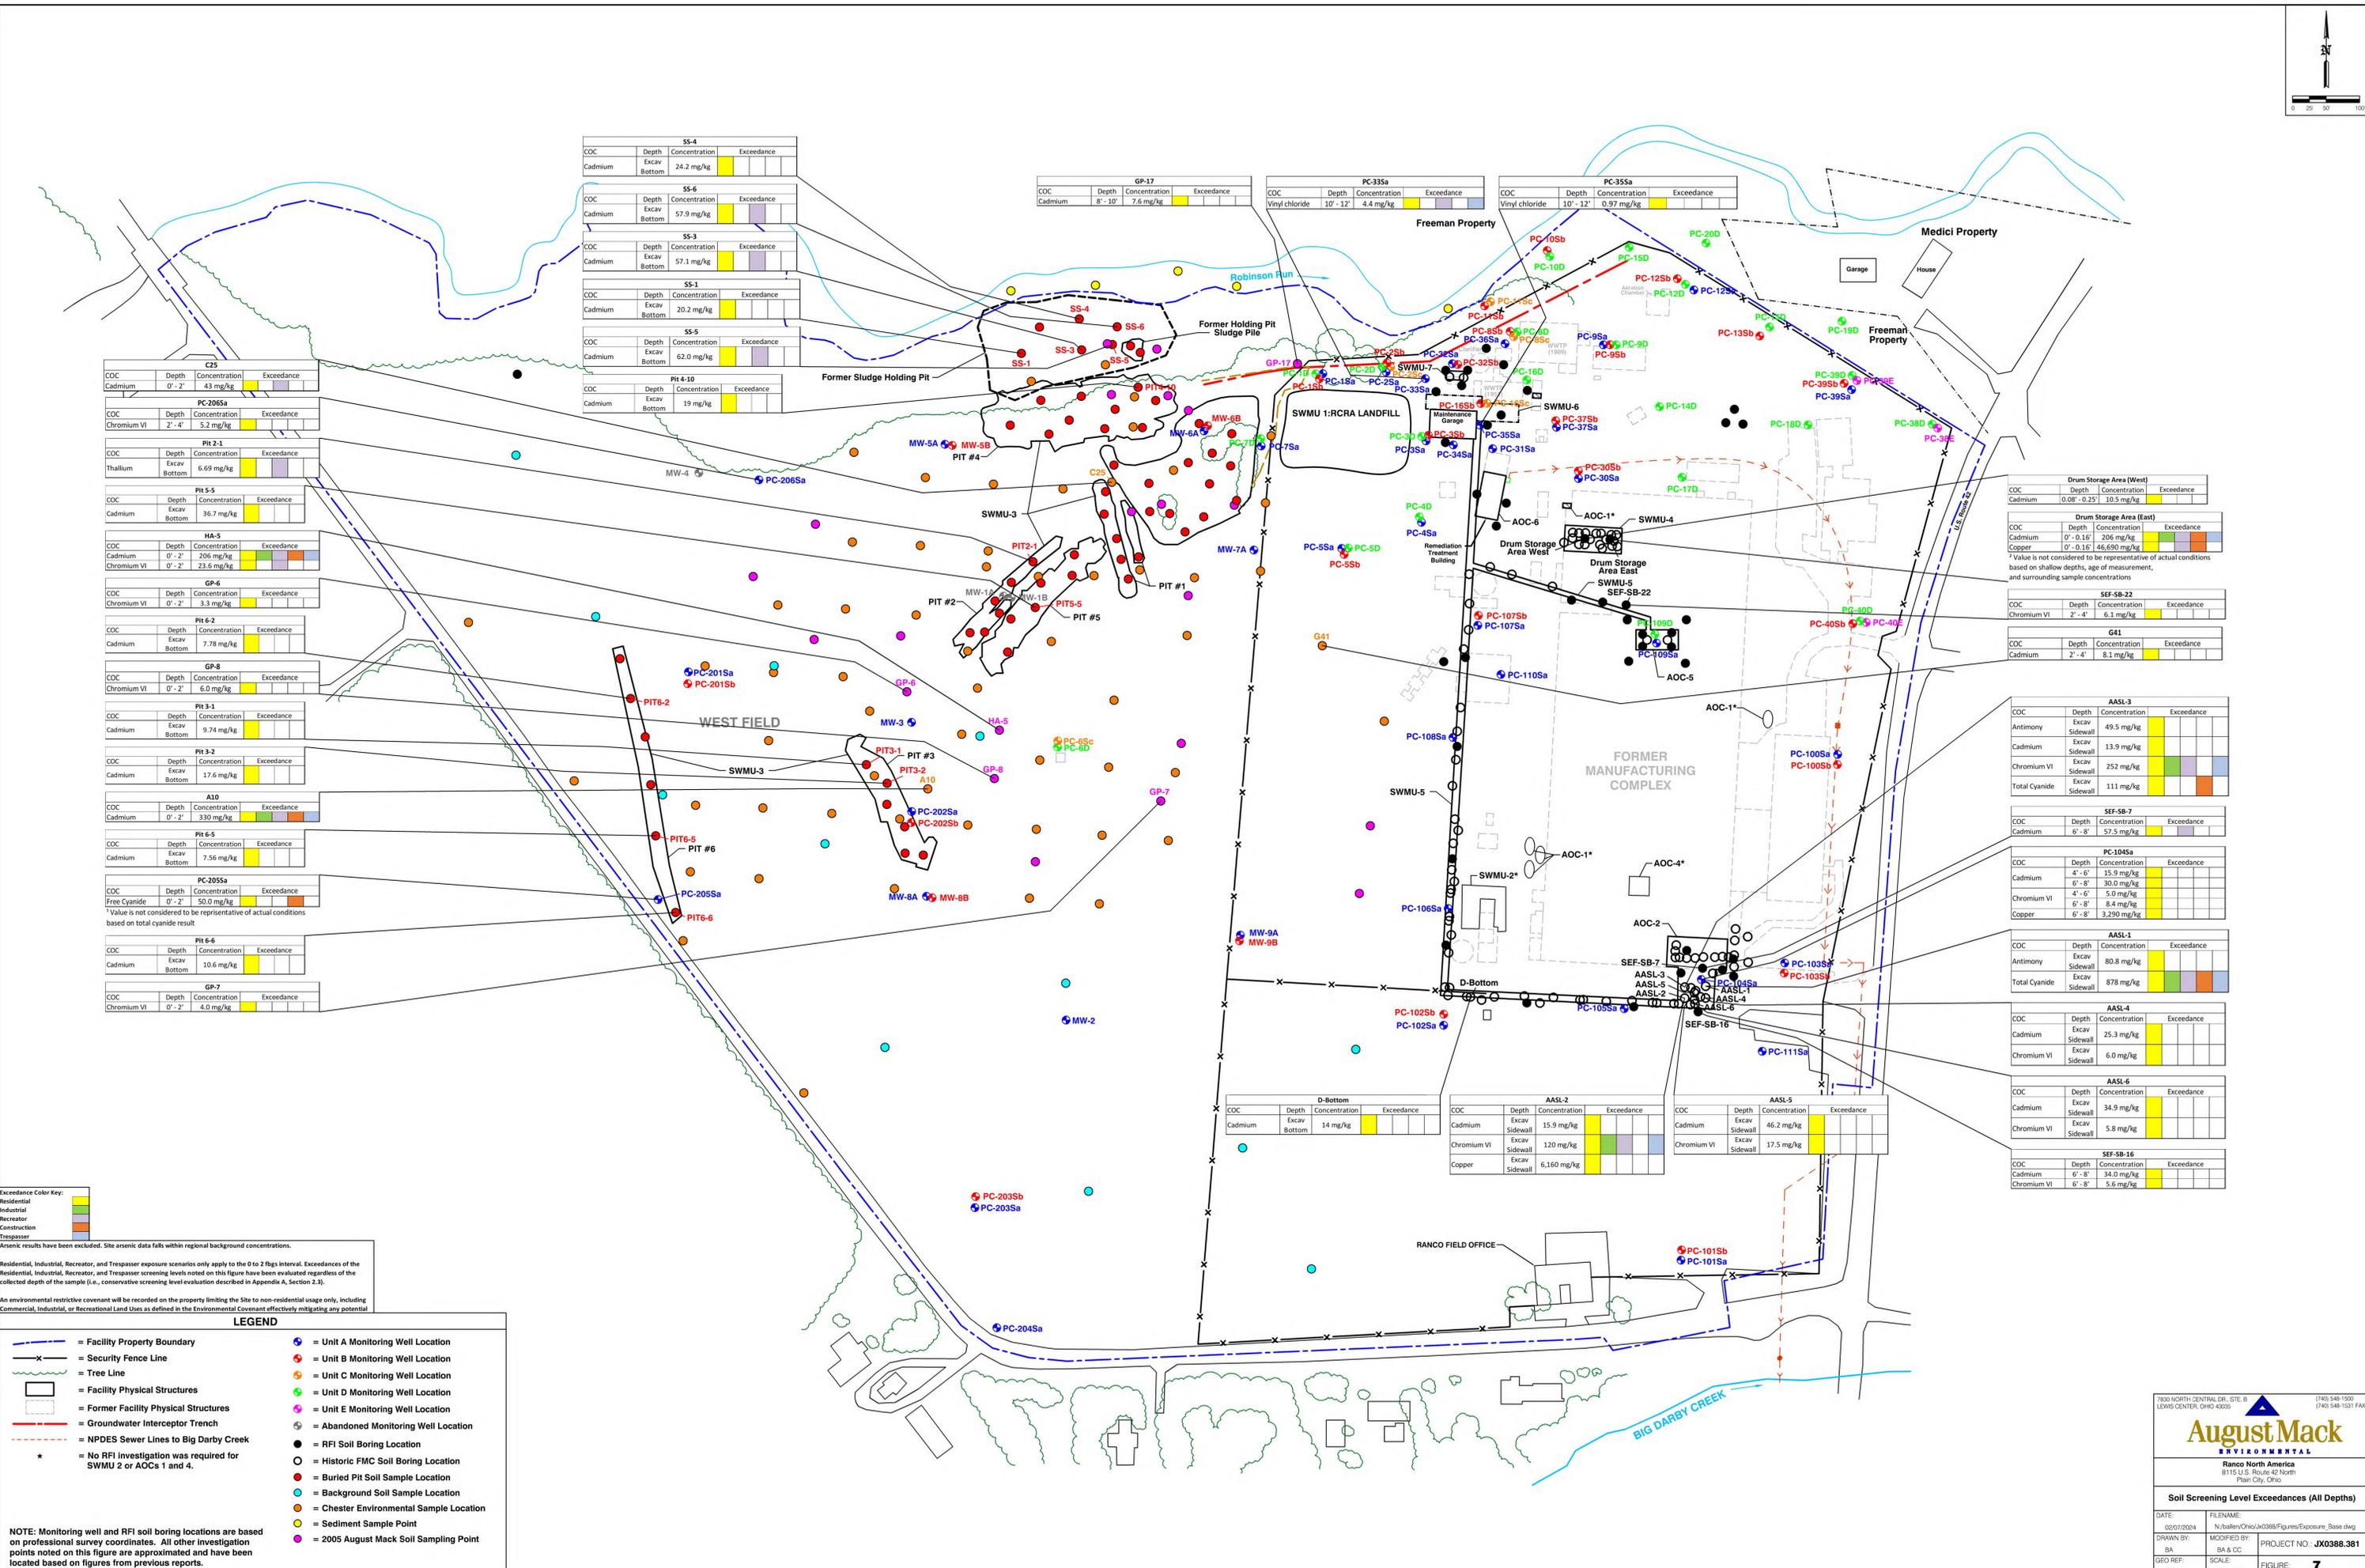
Residential, Industrial, Recreator, and Traveller exposure scenarios only apply to the 0 to 2 ft depth interval. Exceedances of the Residential, Industrial, Recreator, and Traveller screening levels noted on this figure have been evaluated regardless of the collected depth of the sample (i.e., conservative screening level evaluation described in Appendix A, Section 2.3).

Figure 4 shows the location of all monitoring wells and soil borings installed during the RFI. Figures 6a, 6b, and 6c show ground water impact for Units A, B/C and D, respectively. Figure 7 shows soil sample results for the screening level evaluation for all exposure pathways, including residential exposure. Figures 8a and 8b show non-residential soil impacts after remediation for the 0-to-30-foot soil interval and the 0-to-2-foot soil interval, respectively. Soil and ground water investigations have resulted in the delineation of contamination at the Site, and the nature and extent of on-Site impacts are delineated and/or well understood. The following overall conclusions can be made regarding constituents of concern (COCs) and the delineation effort of the RFI:

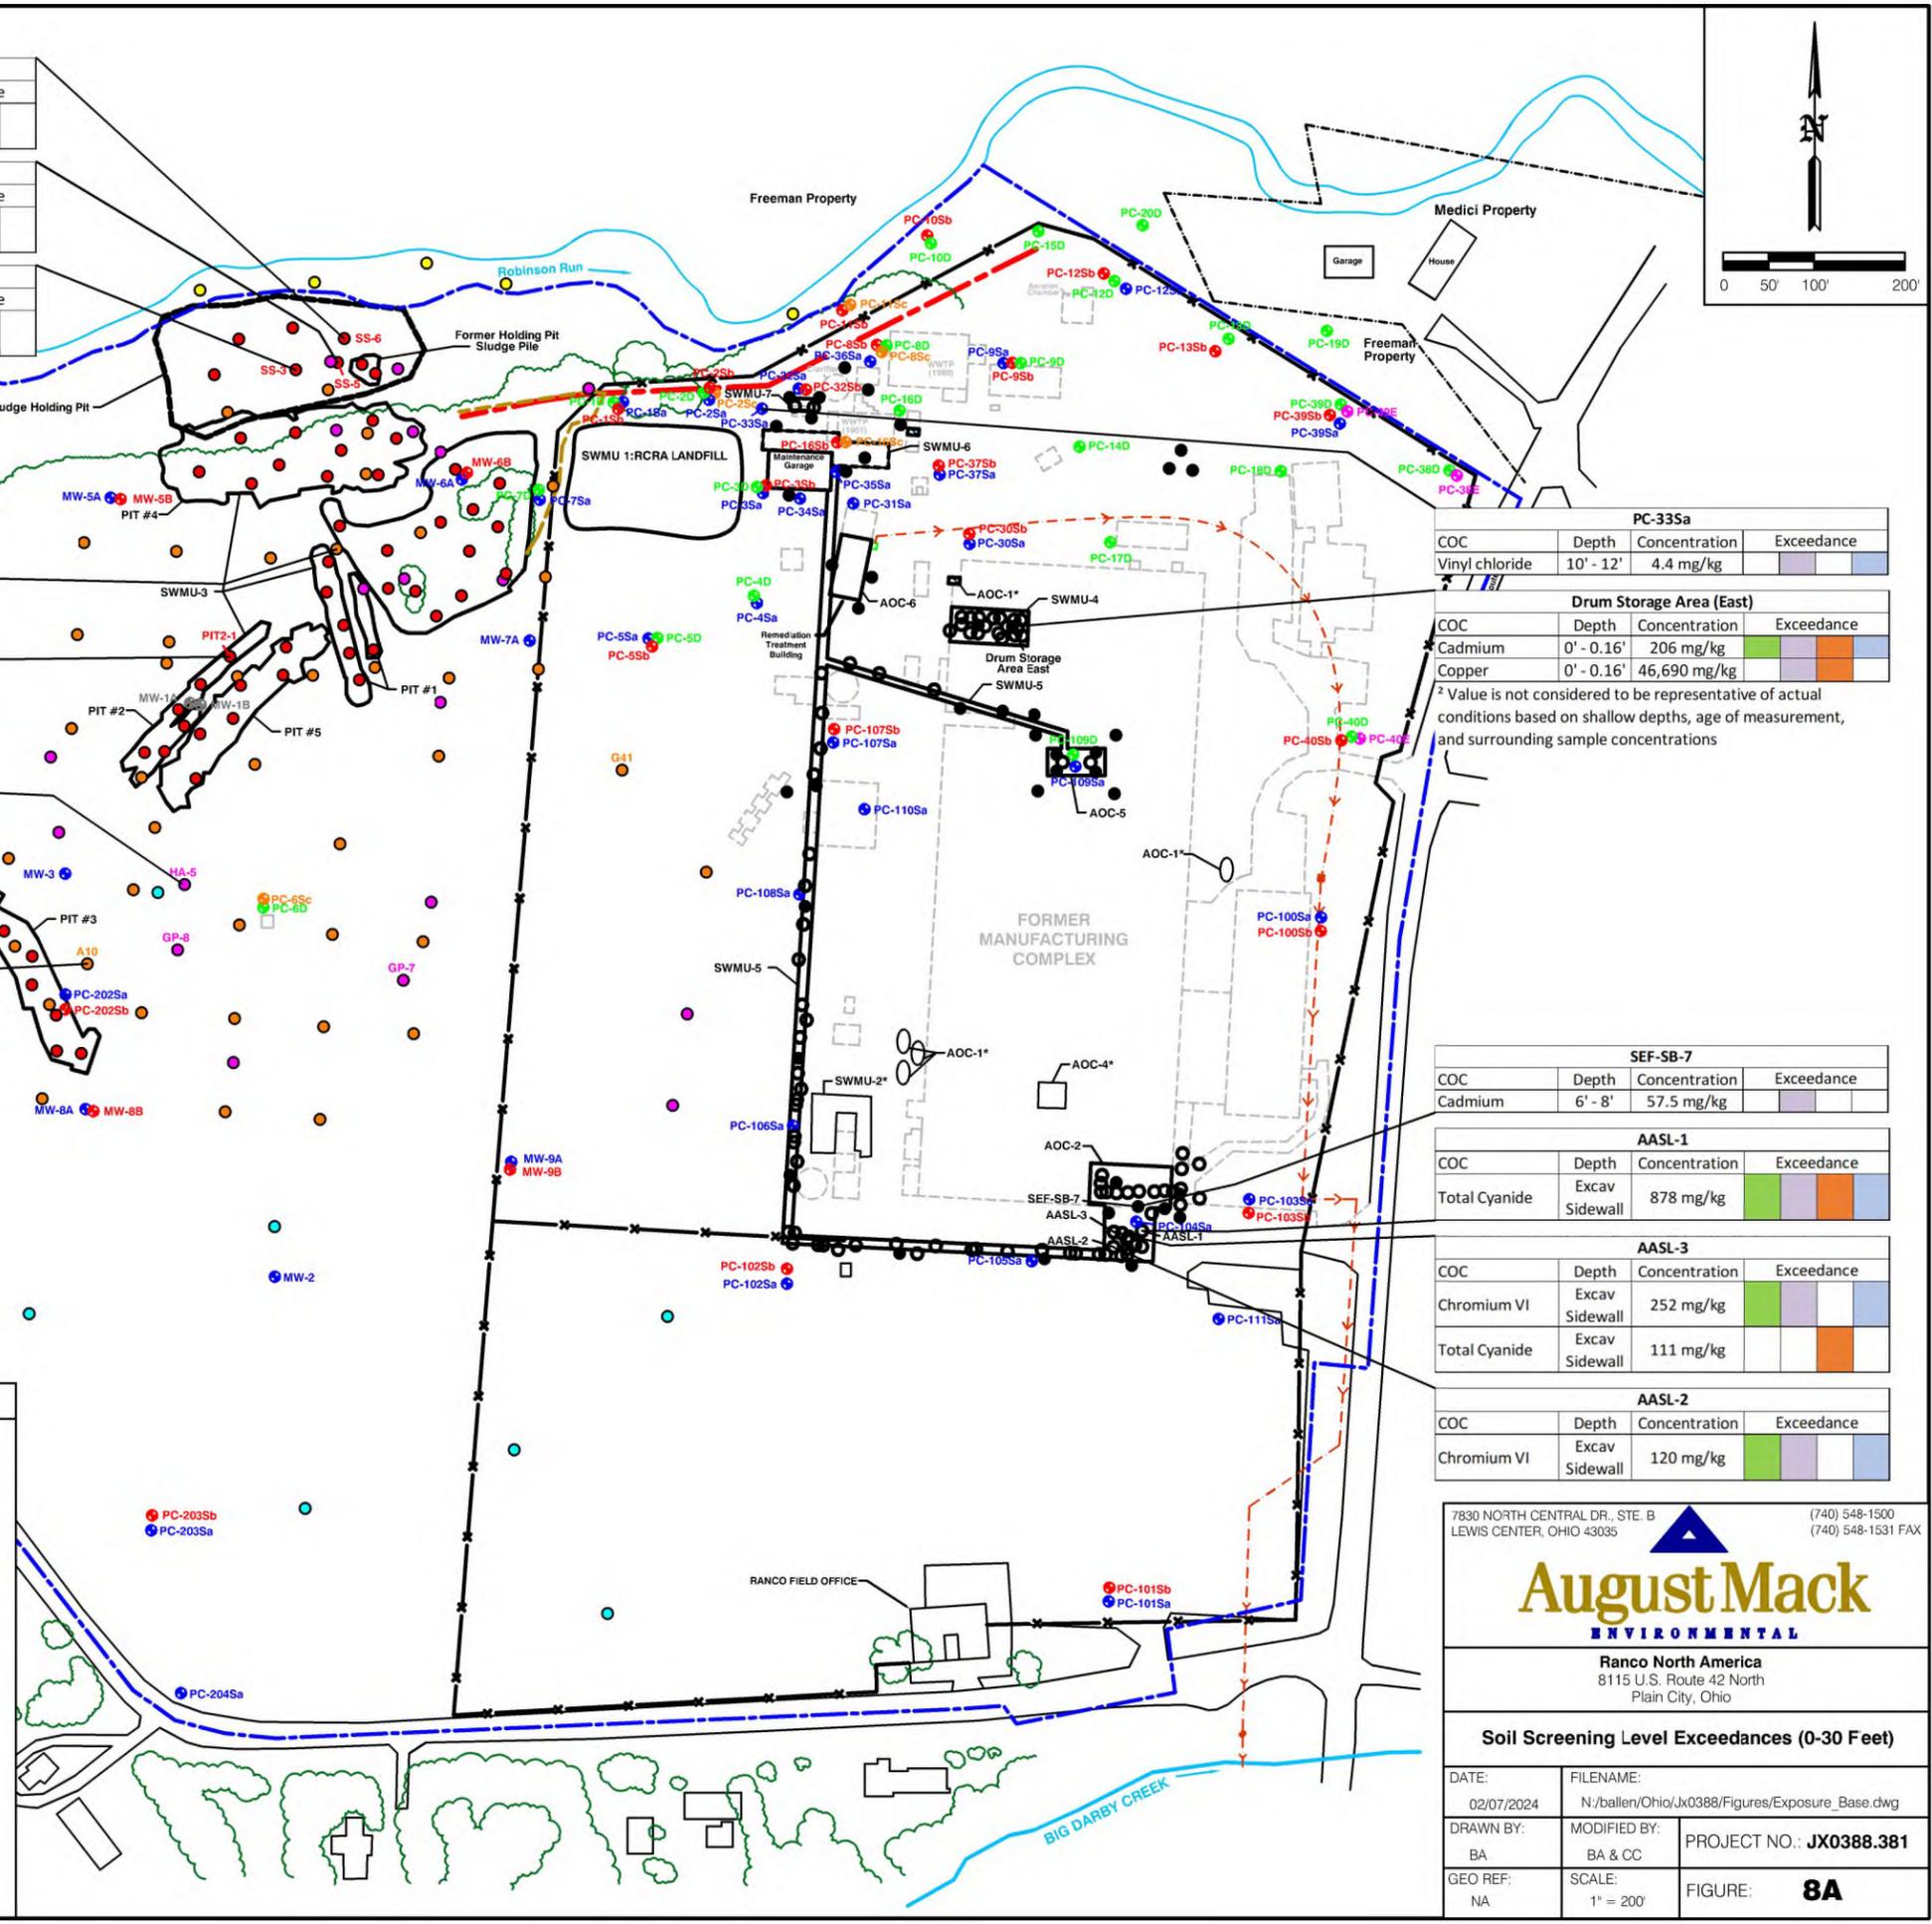
Soil Screening Level Exceedances (0-30 Feet)

Industrial, Recreator, and Trespasser exposure scenarios only apply to the 0 to 2 fbg interval. Exceedances of the Industrial, Recreator, and Trespasser screening levels noted on this figure have been evaluated regardless of the collected depth of the sample (i.e., conservative screening level evaluation described in Appendix A, Section 2.3).

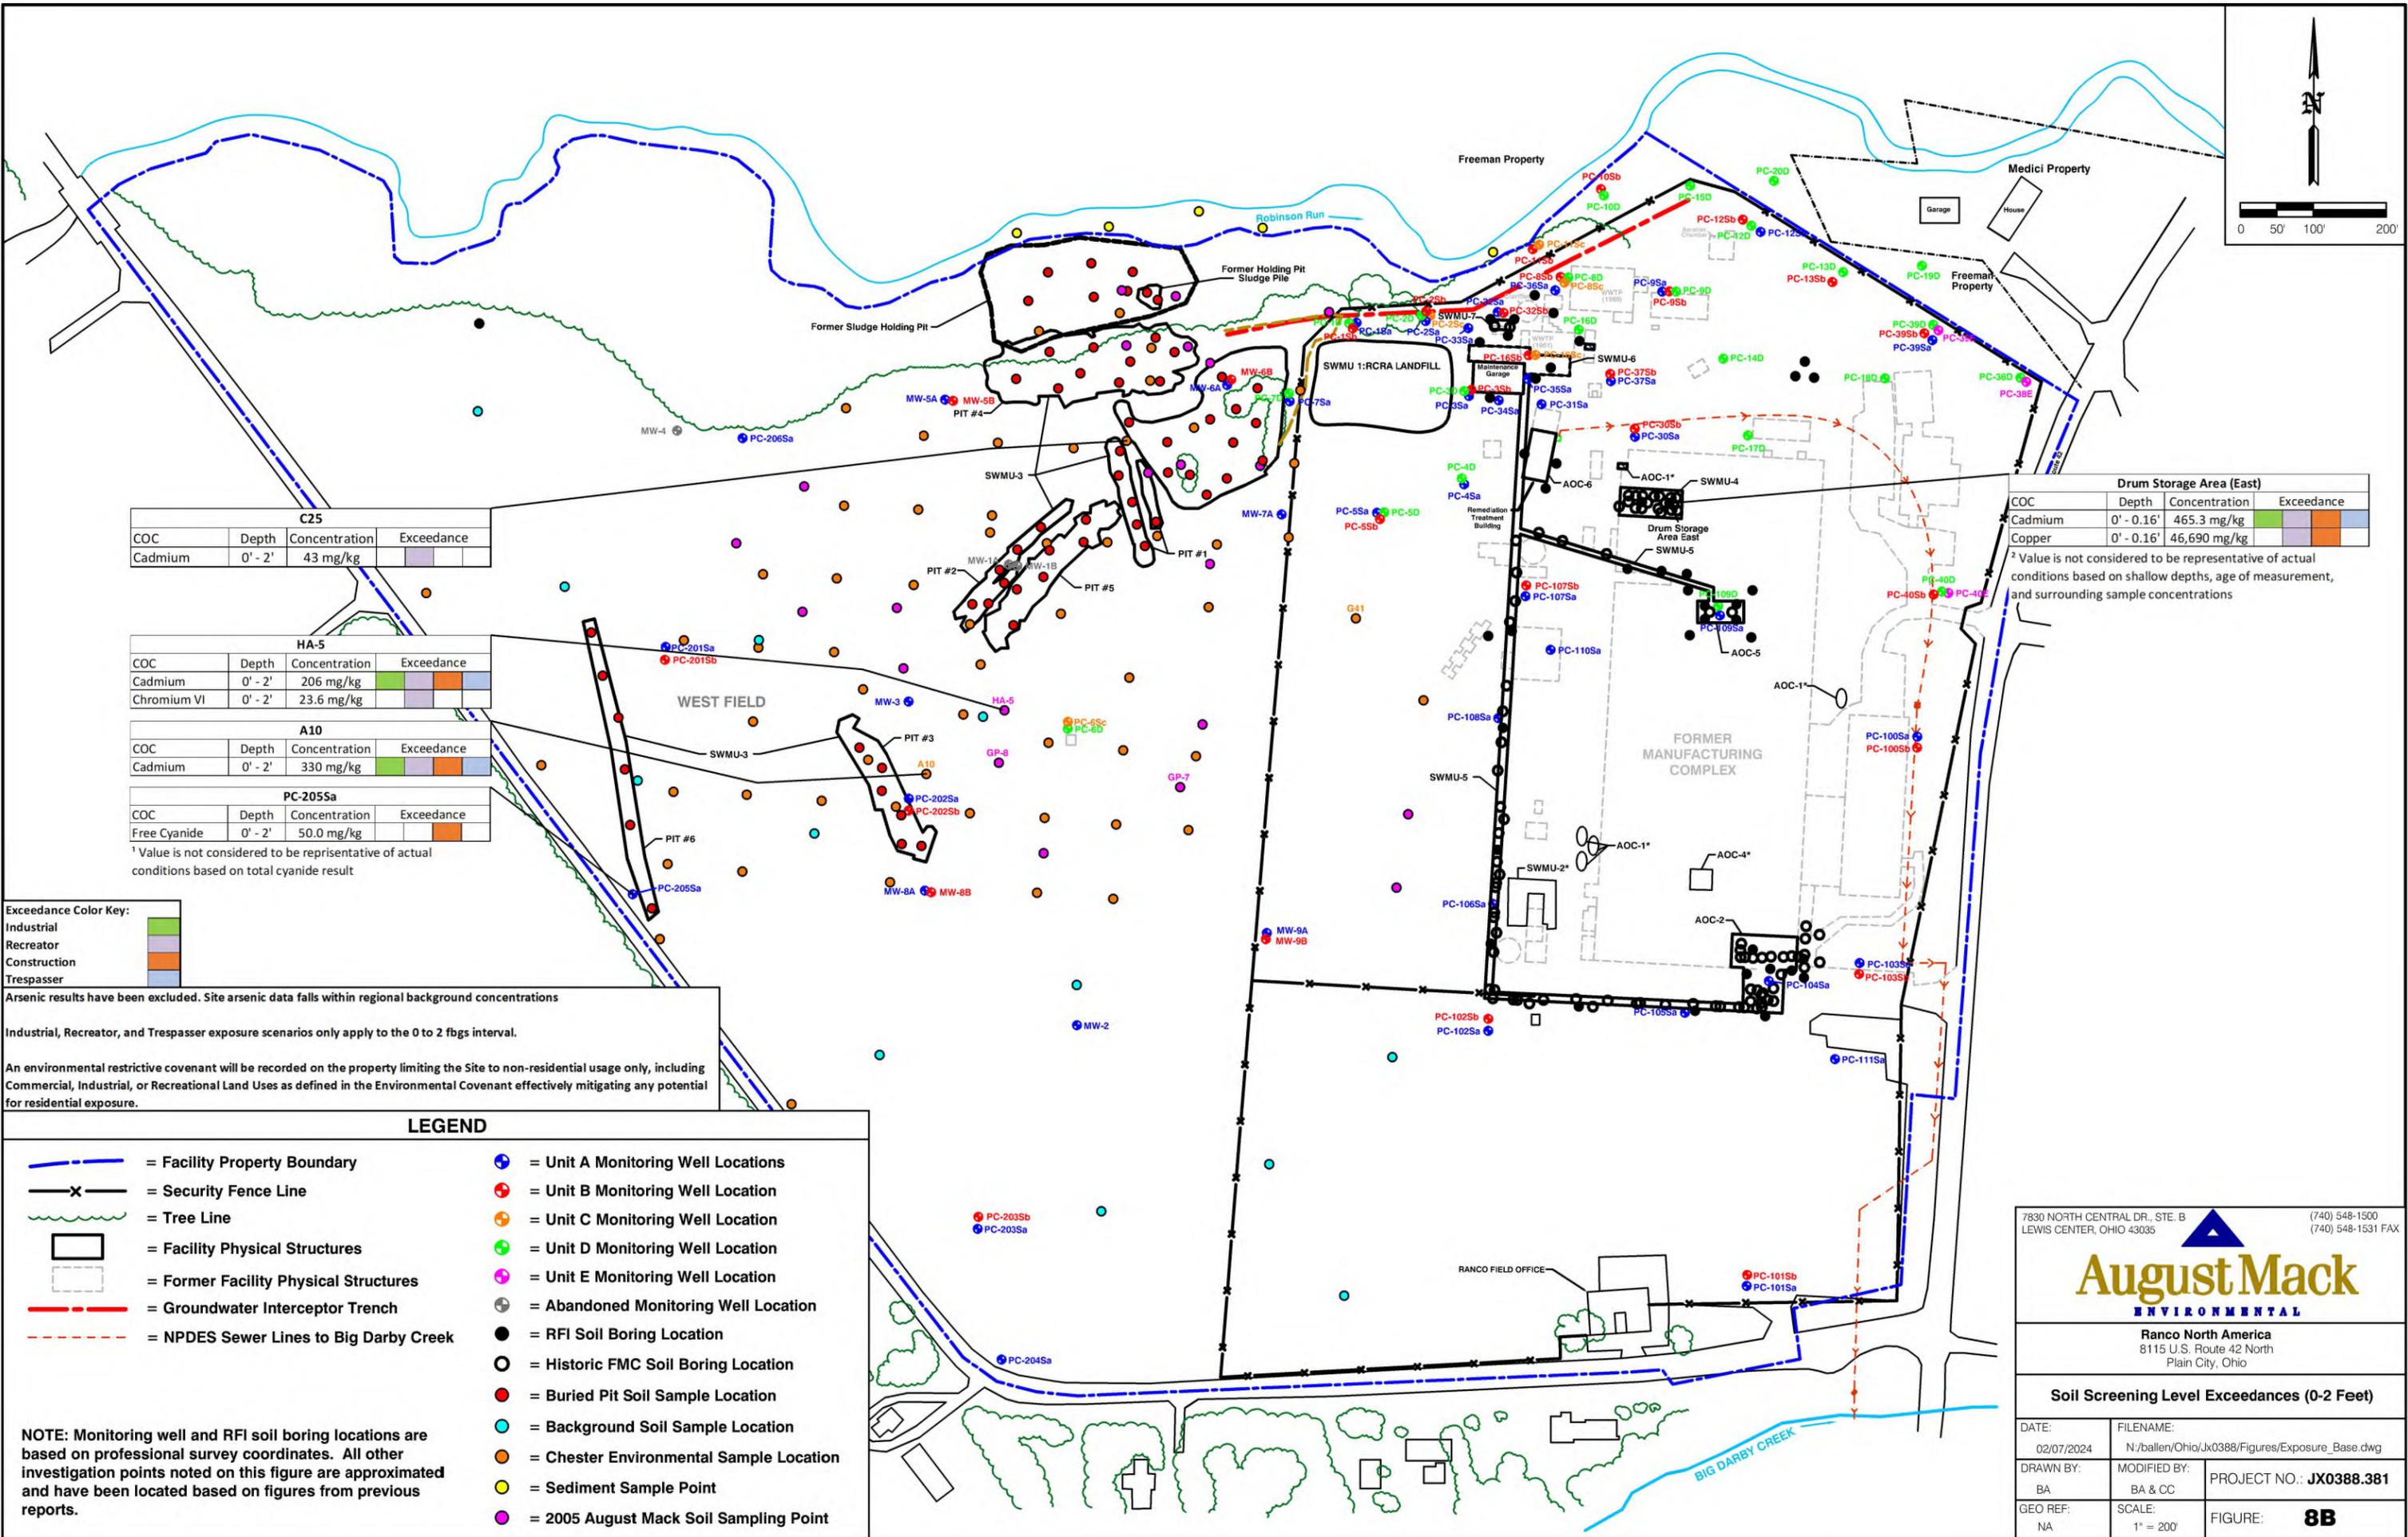
C25			
COC	Depth	Concentration	Exceedance
Cadmium	0' - 2'	43 mg/kg

HA-5			
COC	Depth	Concentration	Exceedance
Cadmium	0' - 2'	206 mg/kg	
Chromium VI	0' - 2'	23.6 mg/kg
