Village of Millersburg, Ohio Public Water System Lead (Pb) Components PWS# OH-3800912 Prepared March 2017

Village of Millersburg Public Water Distribution System Lead Components and Lead Service Lines Map

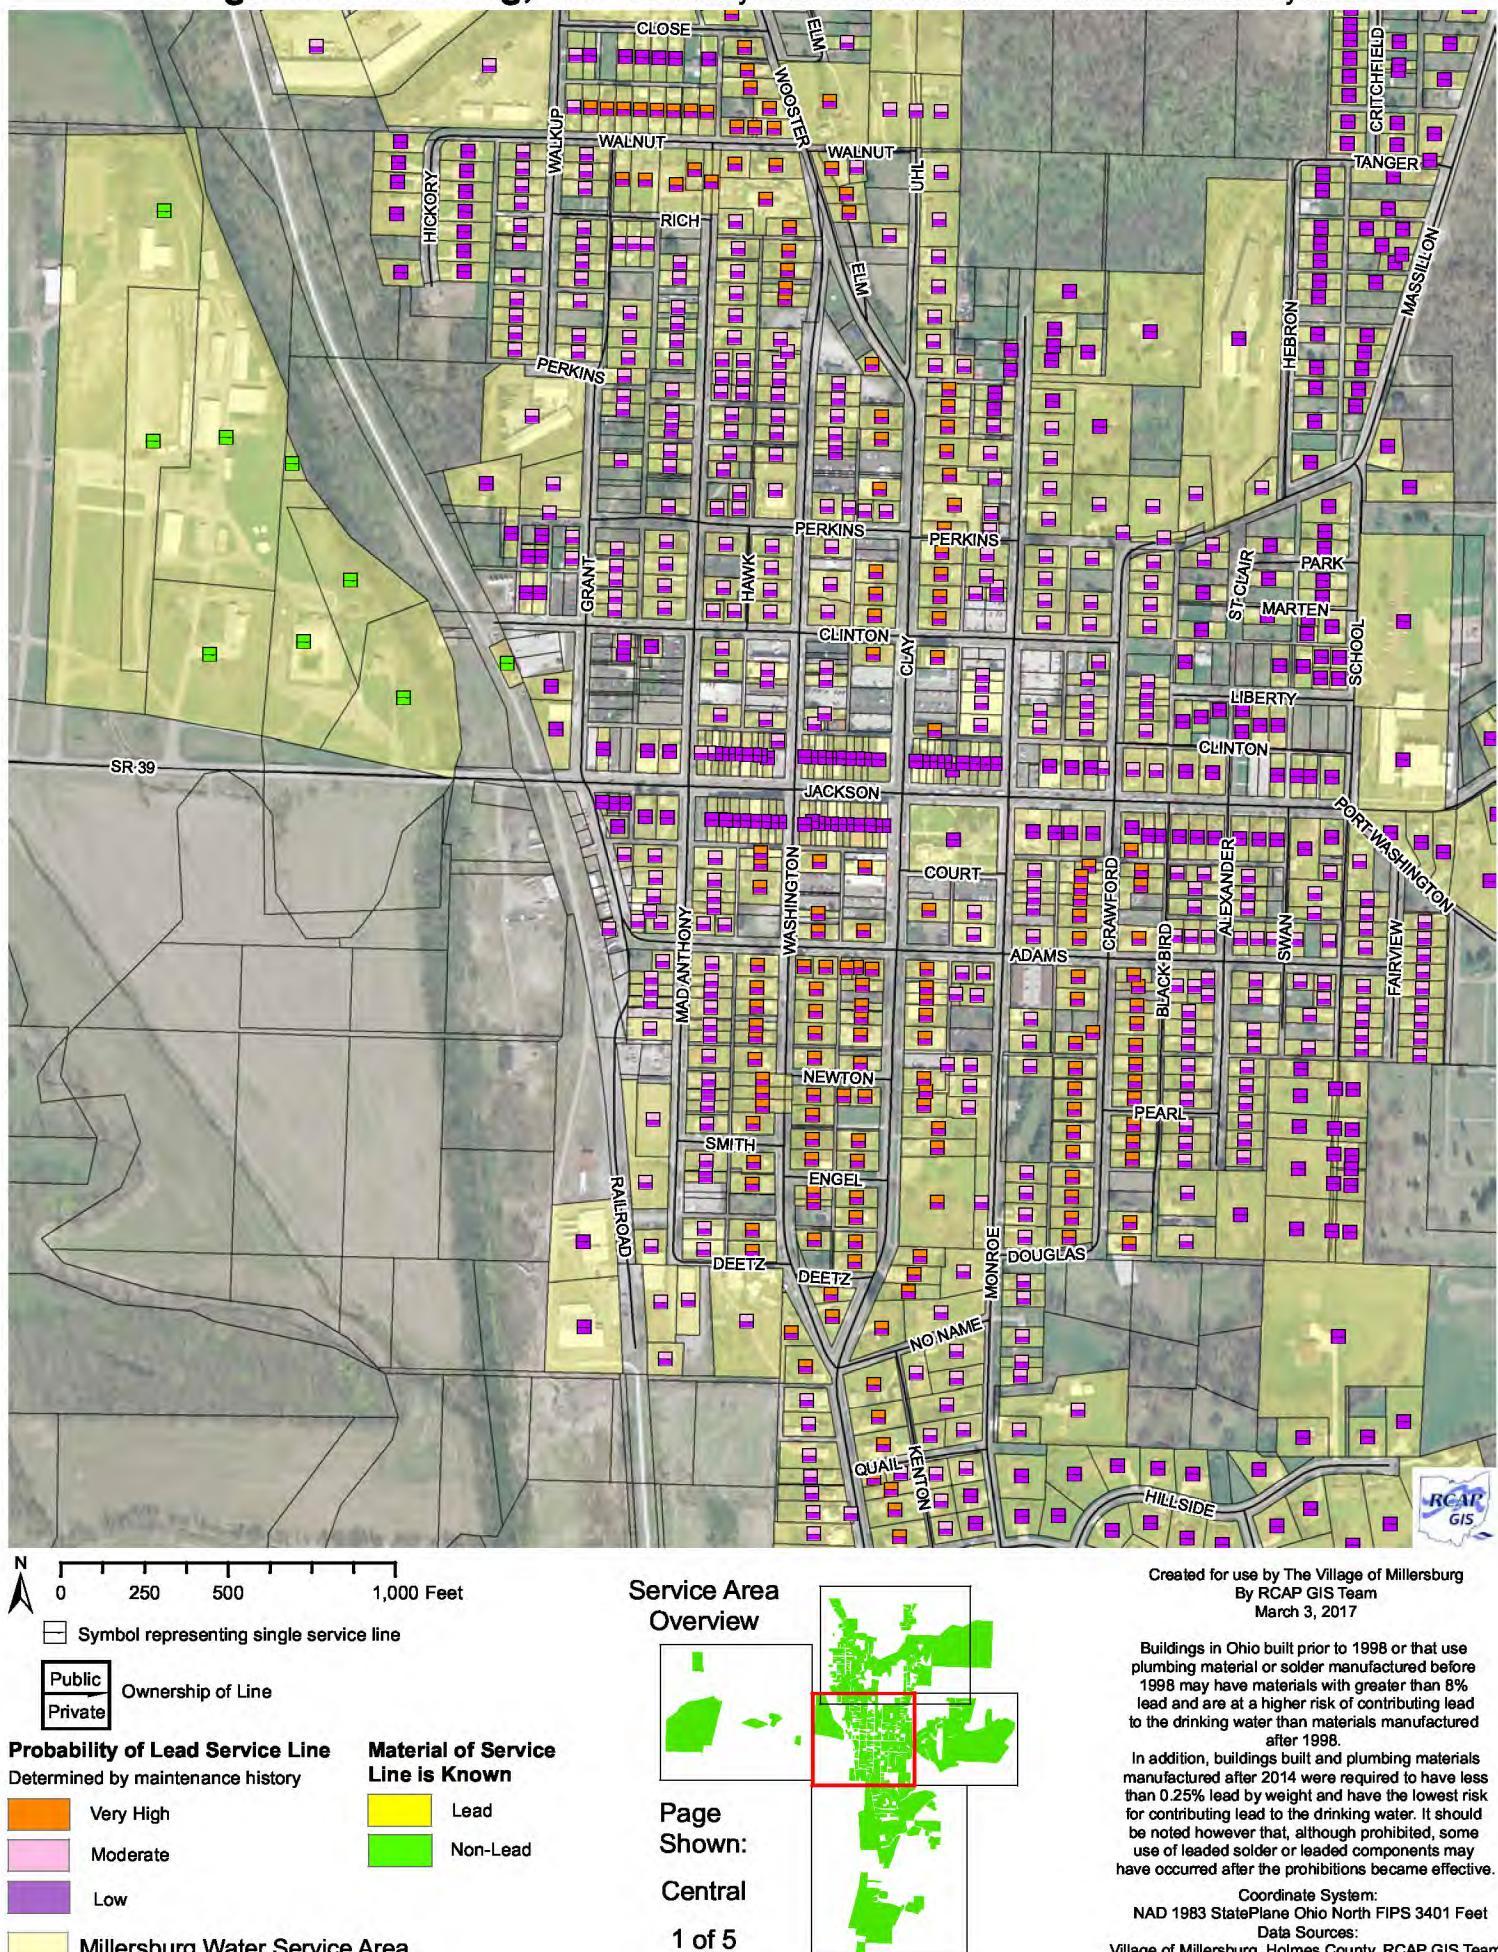
Millersburg Water Service Area

The following map(s) does not verify the presence of lead in any of the lines or structures shown. This map only shows the probable or possible locations based on the year that the structure was built, historical maintenance and operation records, and customer or utility staff verification.

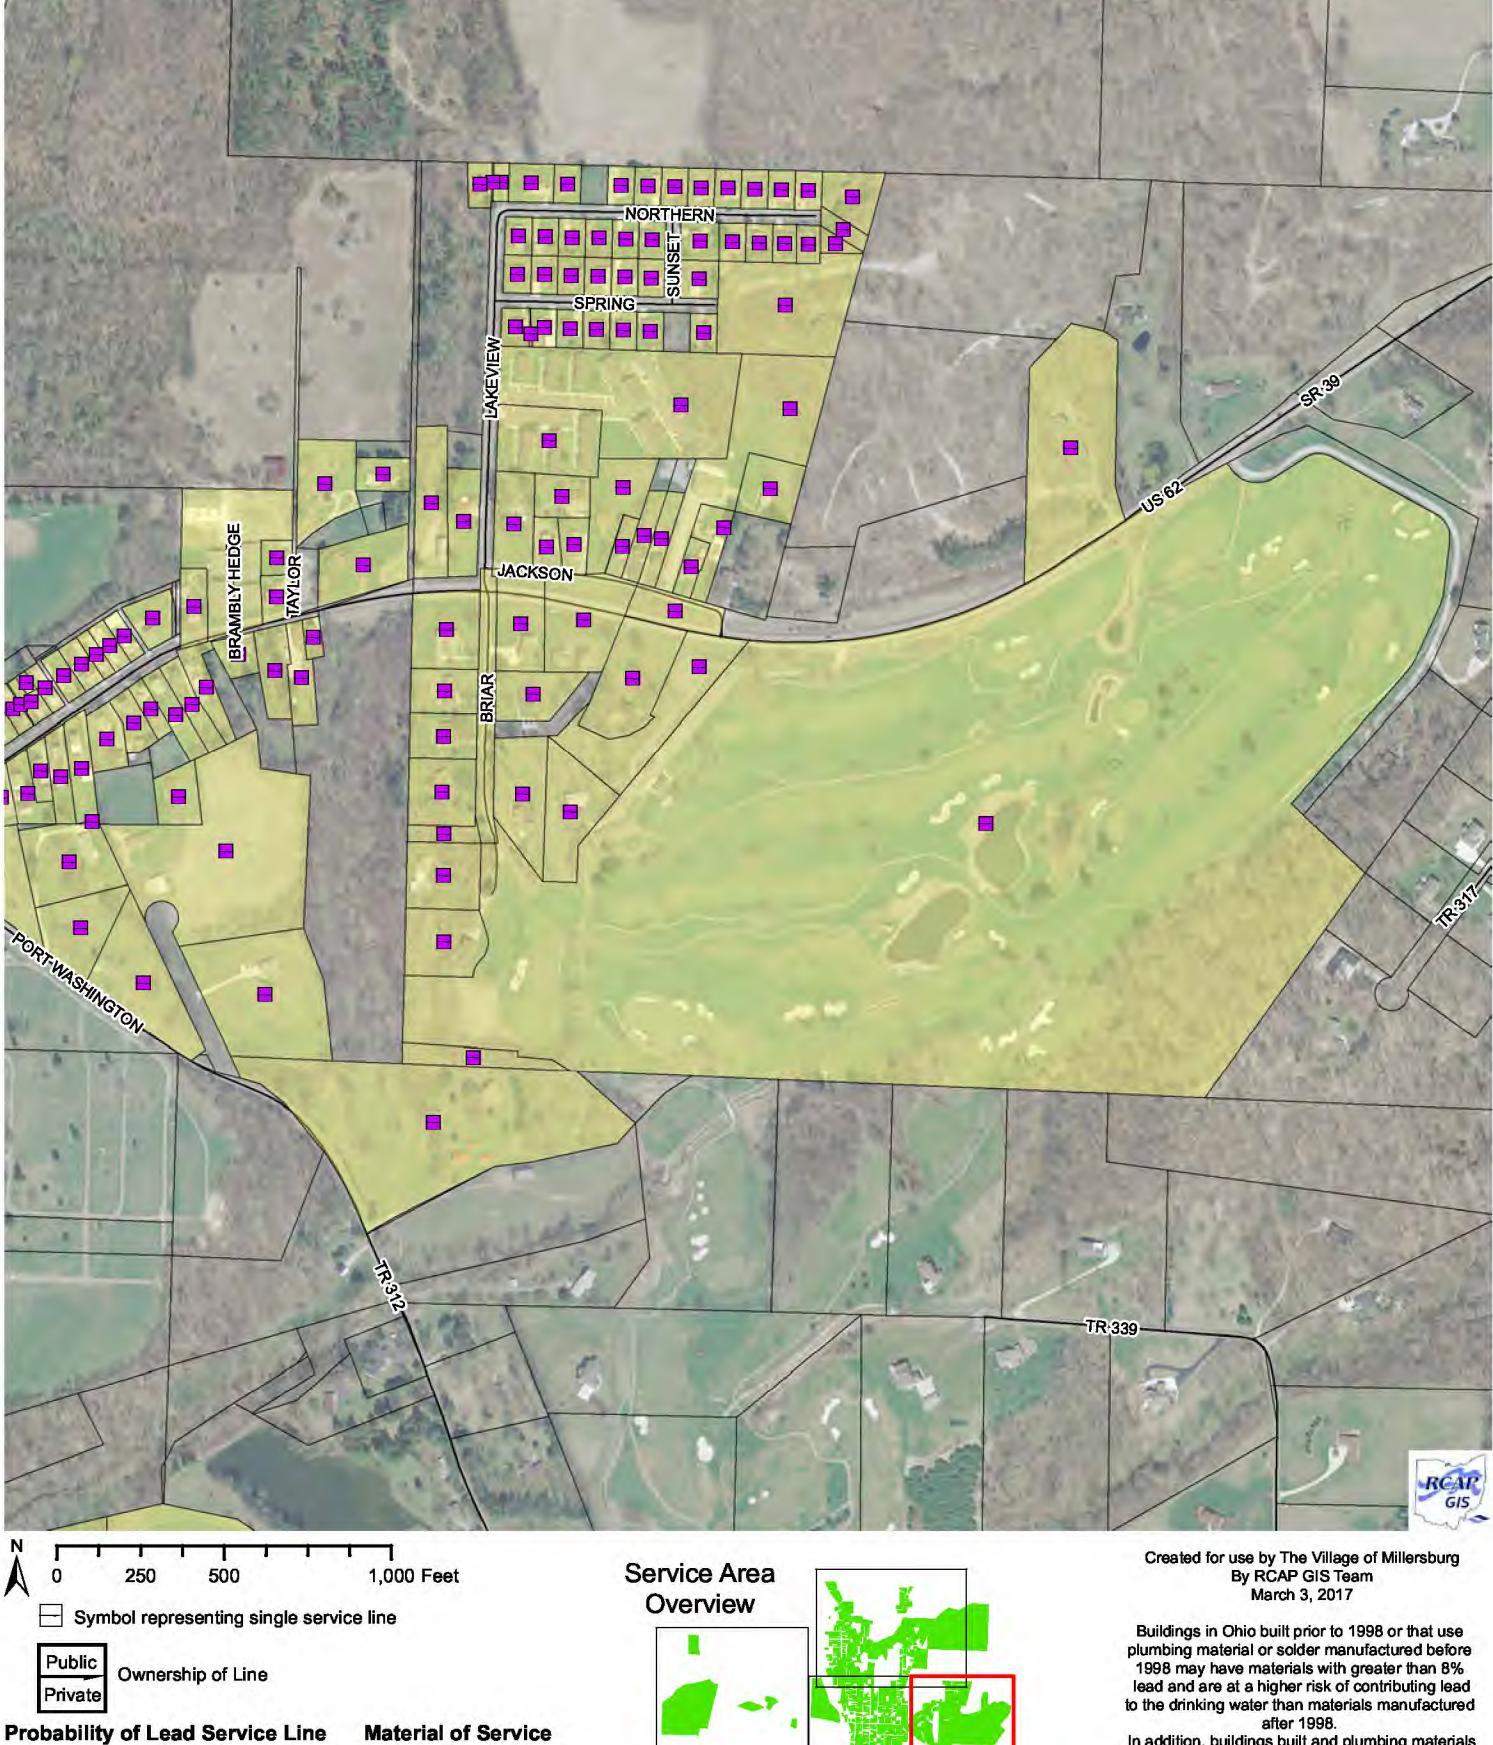
3 of 5

Determined by maintenance history
