Village of Roseville, Ohio Public Water System Lead (Pb) Components PWS# OH-6002112 Prepared March 2017

Village of Roseville Public Water Distribution System Lead Components and Lead Service Lines Map

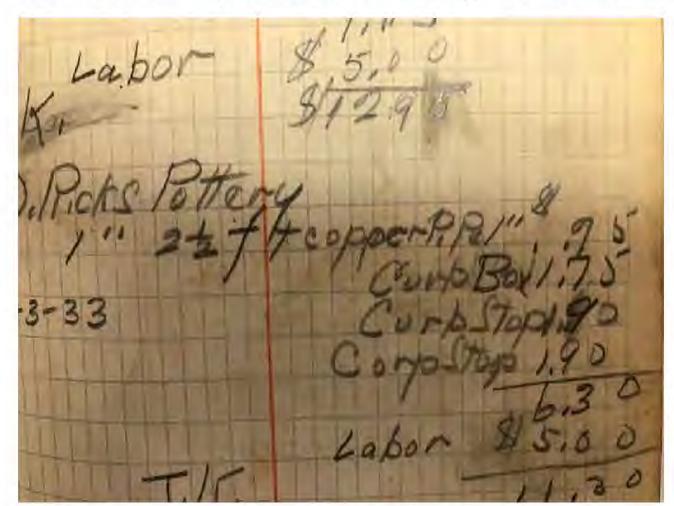
Inspection book from the 1930's documenting copper pipe was used for services.
