WinCup, Inc. Attn: Court Jones 150 Fourth Ave. Mt Sterling, Ohio 43143 *courtjones@wincup.com* Re: WinCup Notice of Violation (NOV) NOV NPDES Madison County 4GR00840*BG

Subject: Notice of Violation

Industrial Stormwater Inspection Checklist

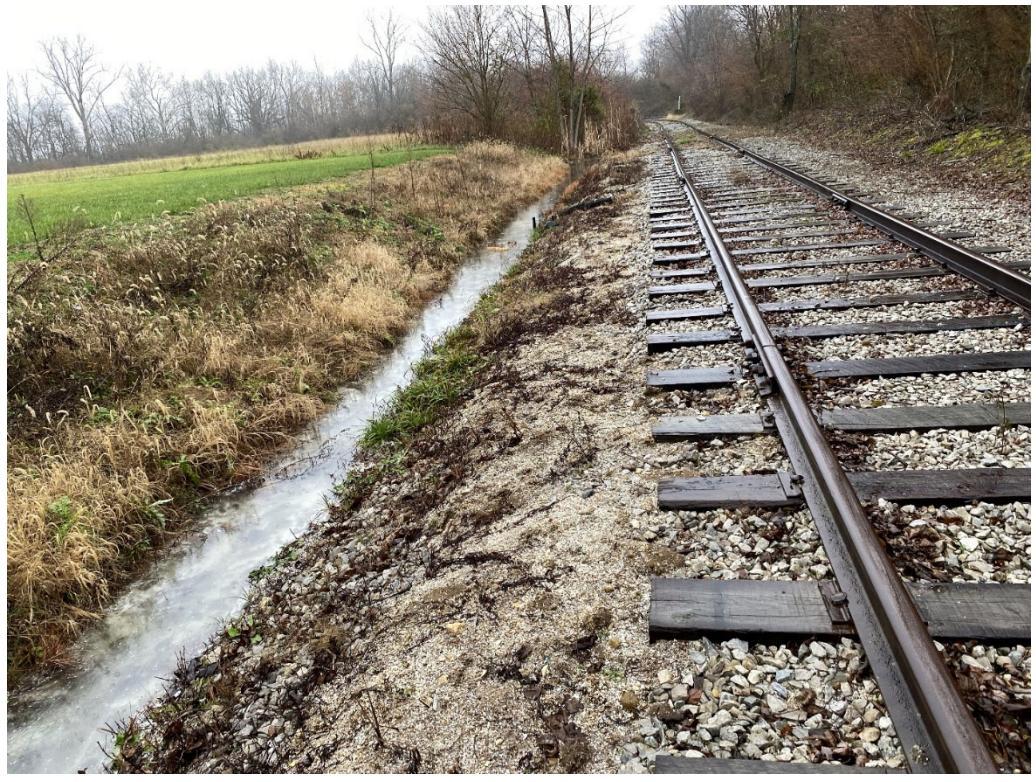
Additional Information: Ohio EPA staff observed plastic pellets and regrind material throughout the facility grounds. Plastic pellet waste was around the silos, in the parking lot, on the lawn and other grassed areas, and along the railroad. Plastic material was along the banks of and within the bed of the swale that discharges to a surface water of the state. At the time of the inspection it was raining, and plastic pellets were observed floating in the swale's flow.

Figure 1. Swale leading to discharge point.

<u>Requested Action</u>: Please implement corrective action procedures as described in Part 3 of the MSGP to thoroughly clean all areas where spills have occurred and where control measures are no longer functional. Document the following in a corrective action report and submit the report to Ohio EPA:

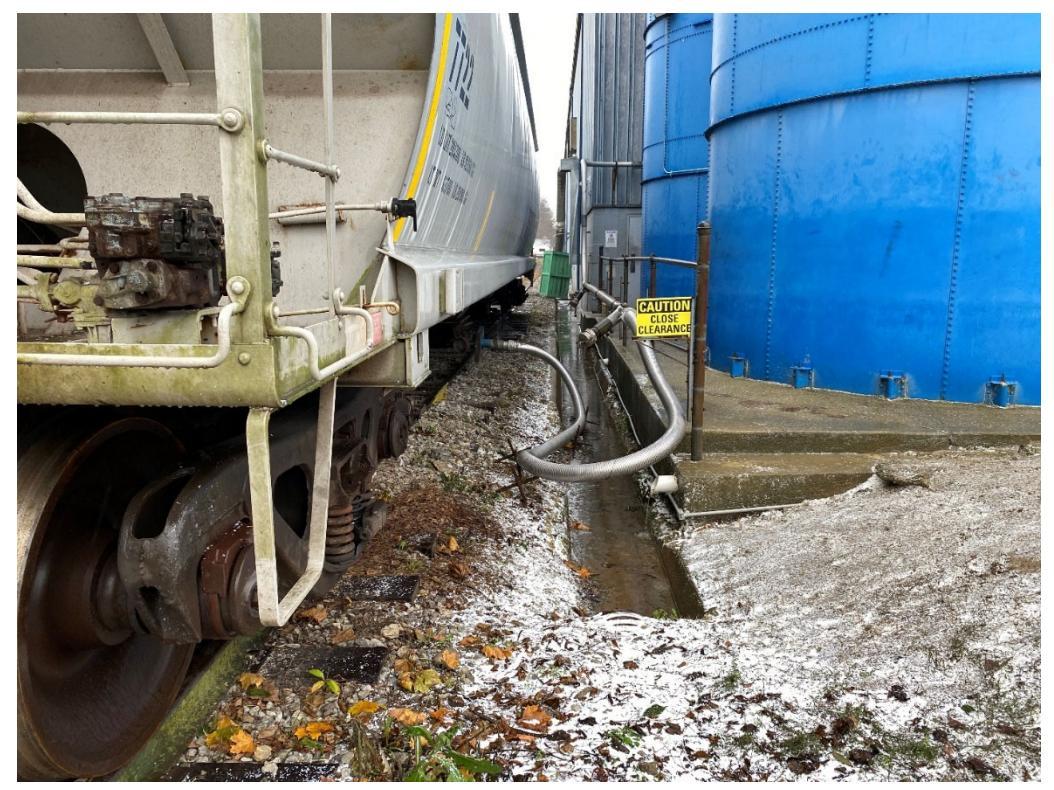
Figure 2. Concrete swale where material unloading occurs.

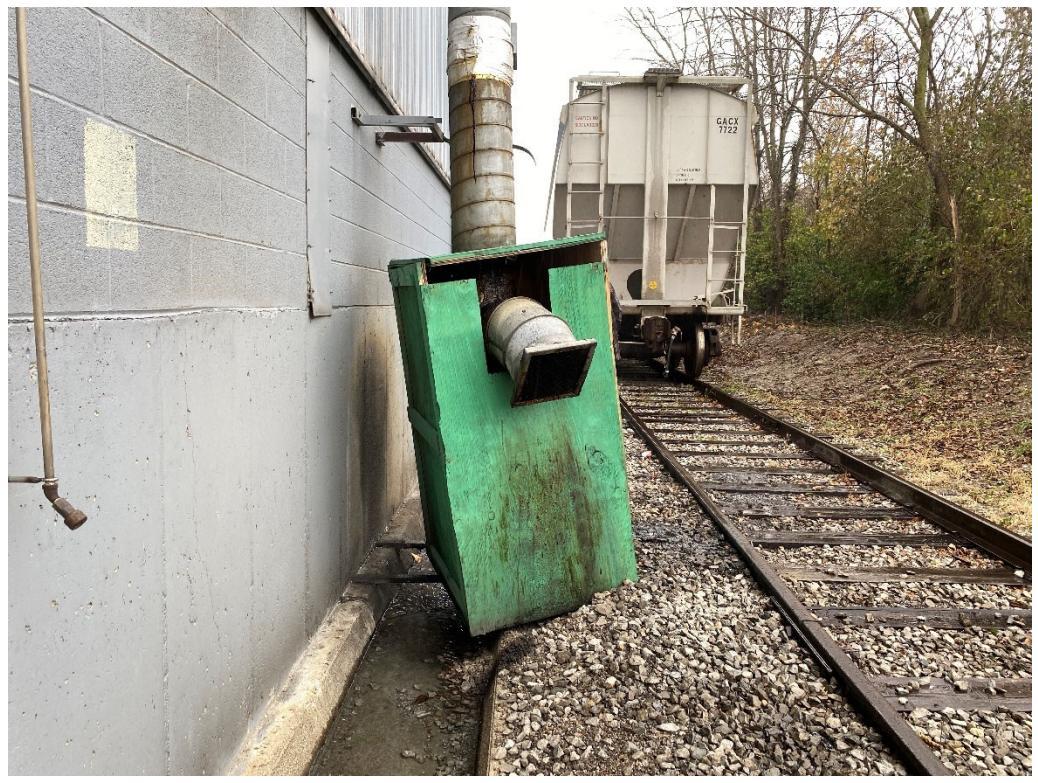
Additional Information: There is drum situated over the concrete portion of the swale along the south side of the building. The drum is used to capture particulate matter from an air filtration system. An oily substance was seen on the drum.

Figure 3. Air filtration particulate collection drum.

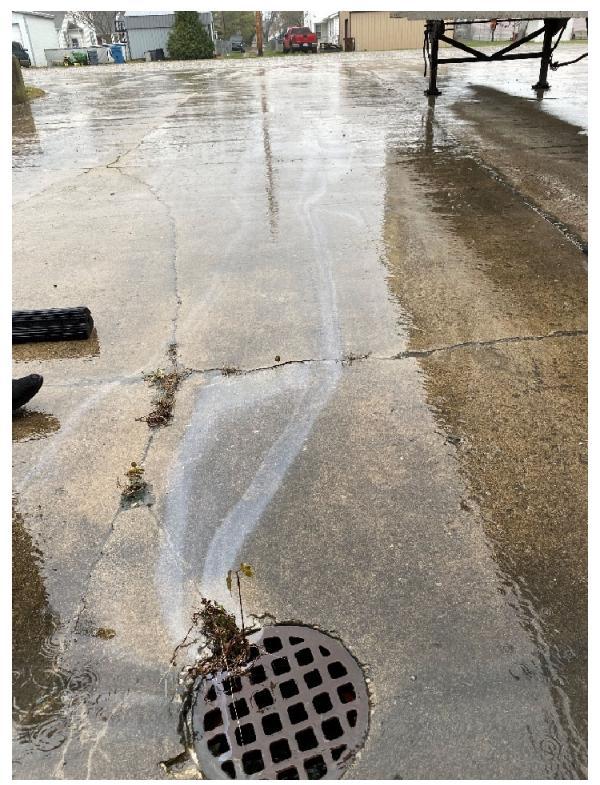
Additional Information: A sheen was evident in the stormwater flow within the swale that discharges to a surface water of the state. During the inspection a sheen was observed flowing into a stormwater catch basin at the loading docks on the west side of the building.

Figure 4. Sheen discharge into storm drain located in loading bay on west side of the facility.

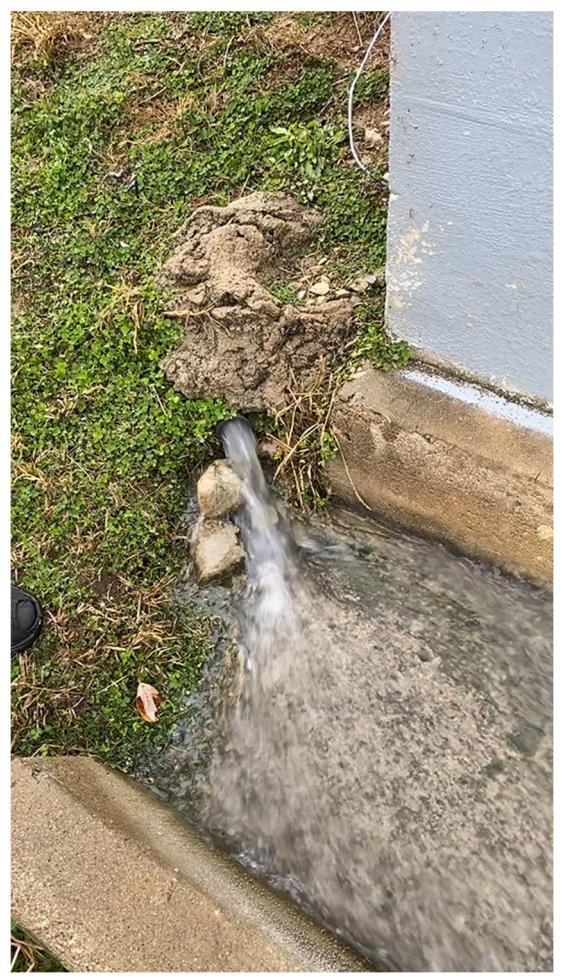
Additional Information: During the inspection, Ohio EPA observed water discharging from a pipe into the concrete swale located in the southwest corner of the building. The water was not flowing continuously, but rather was discharging in spurts indicating that it may not be a stormwater discharge.

Figure 5. Still from a video. Image shows water flowing from a pipe located in the southwest corner of the facility building. Discharge was not continuous and was occurring in spurts indicating this may be a non-stormwater discharge.

<u>Requested Action</u>: Please investigate the source of this discharge and report the results to Ohio EPA. Based on the results of the investigation, Ohio EPA will determine if additional action needs to occur.
