## Mt.Perry Commissary

#### PWS 6431712

# Mapping Lead Plumbing and Fixtures for Individual Buildings (nontransient noncommunity water system)

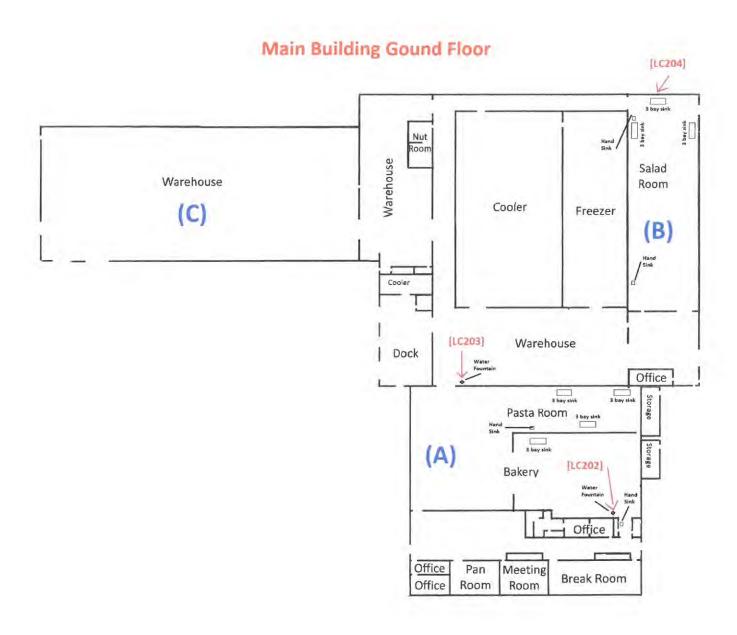
#### Main Building Ground Floor Map: This show main building witch is sectioned off three sections.

A: Shows offices and bakery witch consist of combination plumbing materials. (LC202 is located in this area) (Galvanized, Copper, and Plastic)

**B:** Shows warehouse storage, Kit Room, cooler and freezer witch was added in 1983. This area also consists of a combination of plumbing materials. (LC203andLC204 is located in this area) (Galvanized, Copper, and Plastic)

**C:** Shows warehouse storage and was built in 1984 only has one line running to the rear for water hose and is made only in one kind of plumbing material. (Copper)

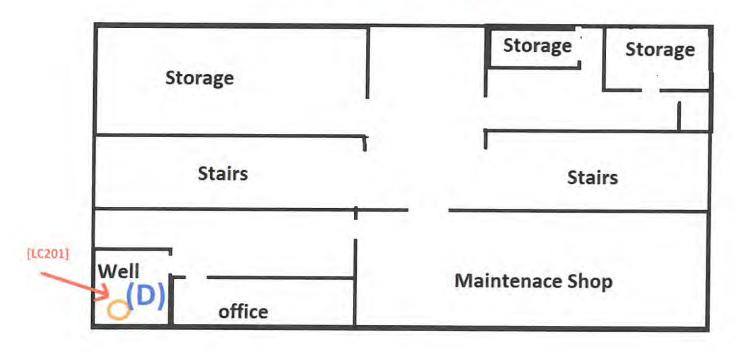
## **BASEMENT AREA**

Main Building Basement Area Map: This show main building basement where the well witch supplies water to Both buildings it also has combination of plumbing materials. (Galvanized, Copper, and Plastic)

D: (LC201is located in this area)

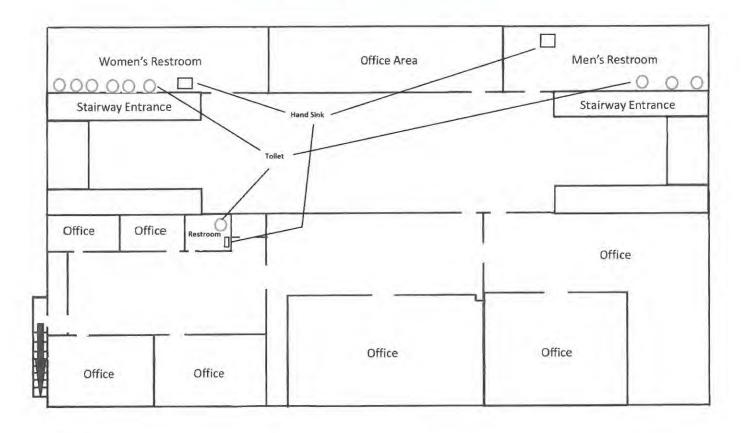
## **Top Floor Main Building**

Main Building Top Floor Map: This show main building top floor witch consist of office space and two employees restrooms and office restroom .lt also has a combination of plumbing materials.

(Galvanized, Copper, and Plastic)

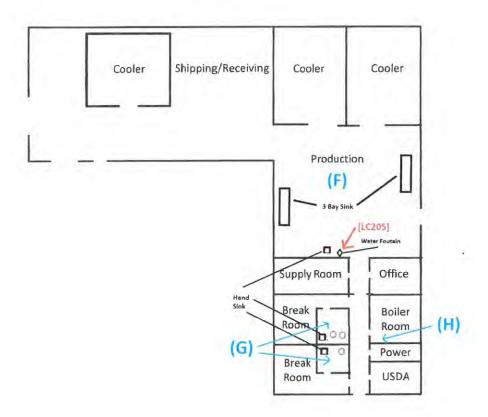
## Commissary

**Commissary Map:** This show a ground level building located north side of main building and was built in 1984. It has galvanized water main coming from main building basement where water well is located. All plumbing materials in building is of one material. (Galvanized, Copper, and Plastic)

- F: Shows production area (LC205 is located in this area)
- G: Shows two employee restrooms
- H: Shows where water main shut off is located.
