RE: Club Island Association
Report
Drinking Water Program
Mercer County
PWS ID: OH5402012

Lead Mapping - Club Island Association Public Water System OH5402012 - 2017

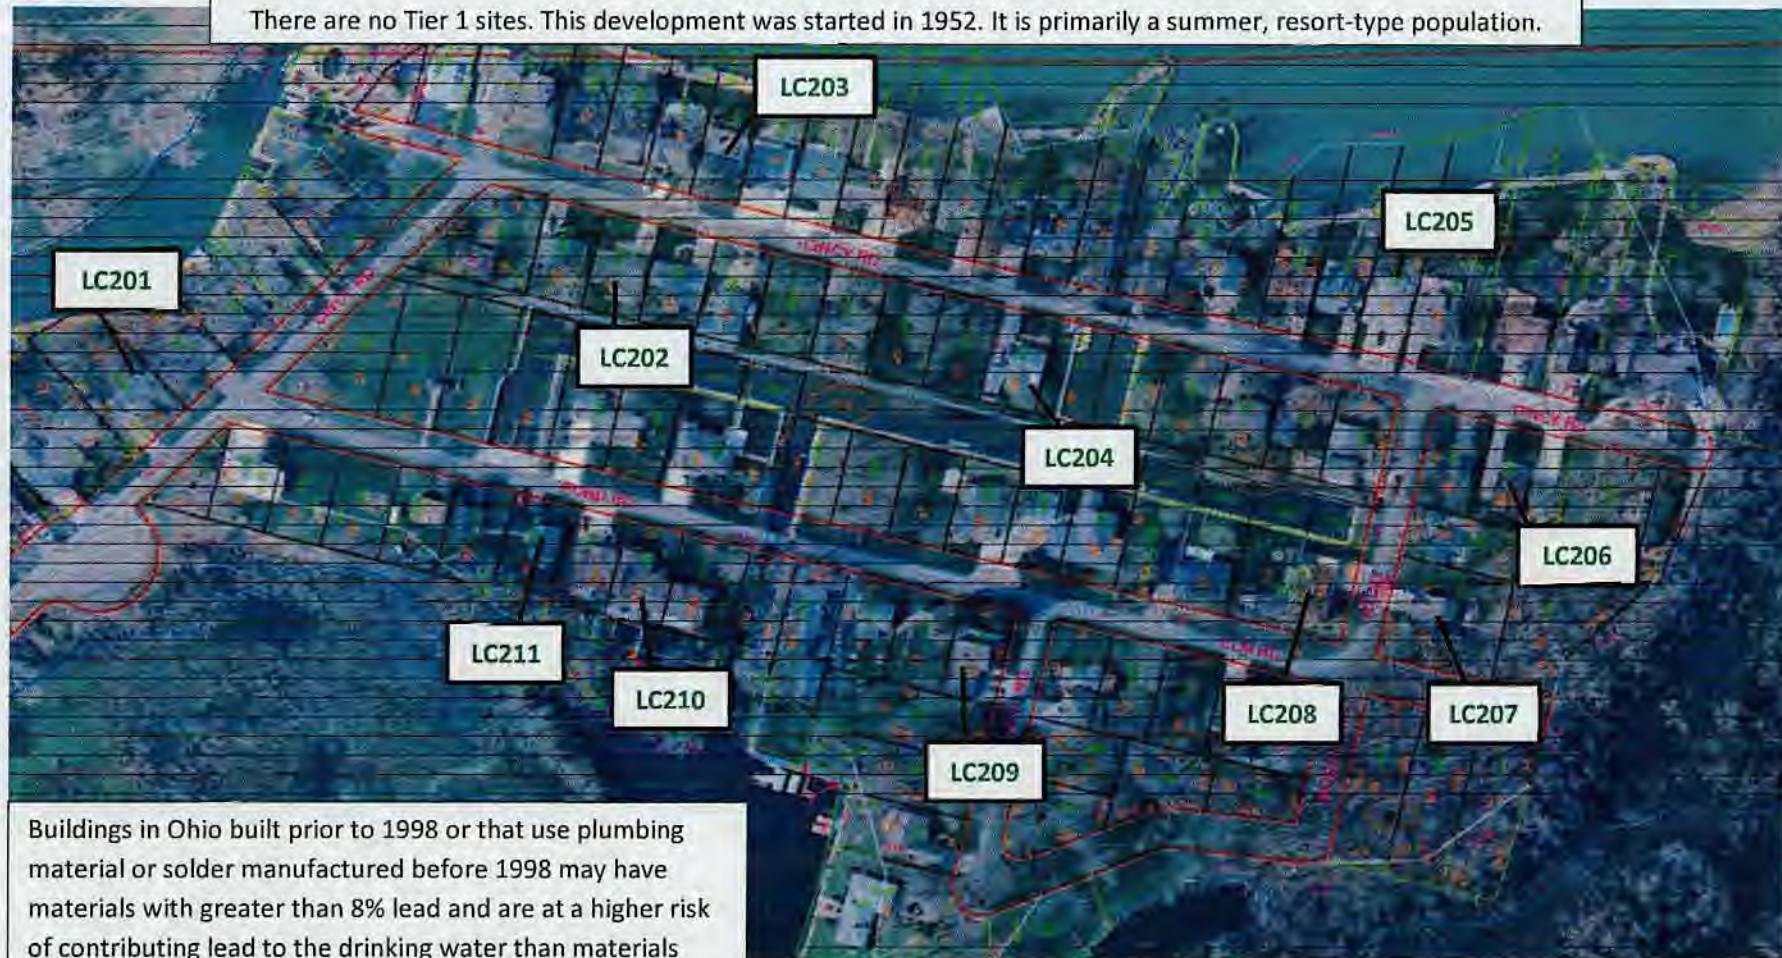
Water Sampling Locations for Year-round Residents. All are SFH
 There are no Tier 1 sites. This development was started in 1952. It is primarily a summer, resort-type population.

Club Island water mains are PVC. The public side service lines are Poly. There are 54 service connections.

Map legend, Private Side Identification, non-lead.
