# DEERSVILLE VILLAGE PWS PWS ID OH3400312

## Deersville Village PWS Lead Map of Distribution

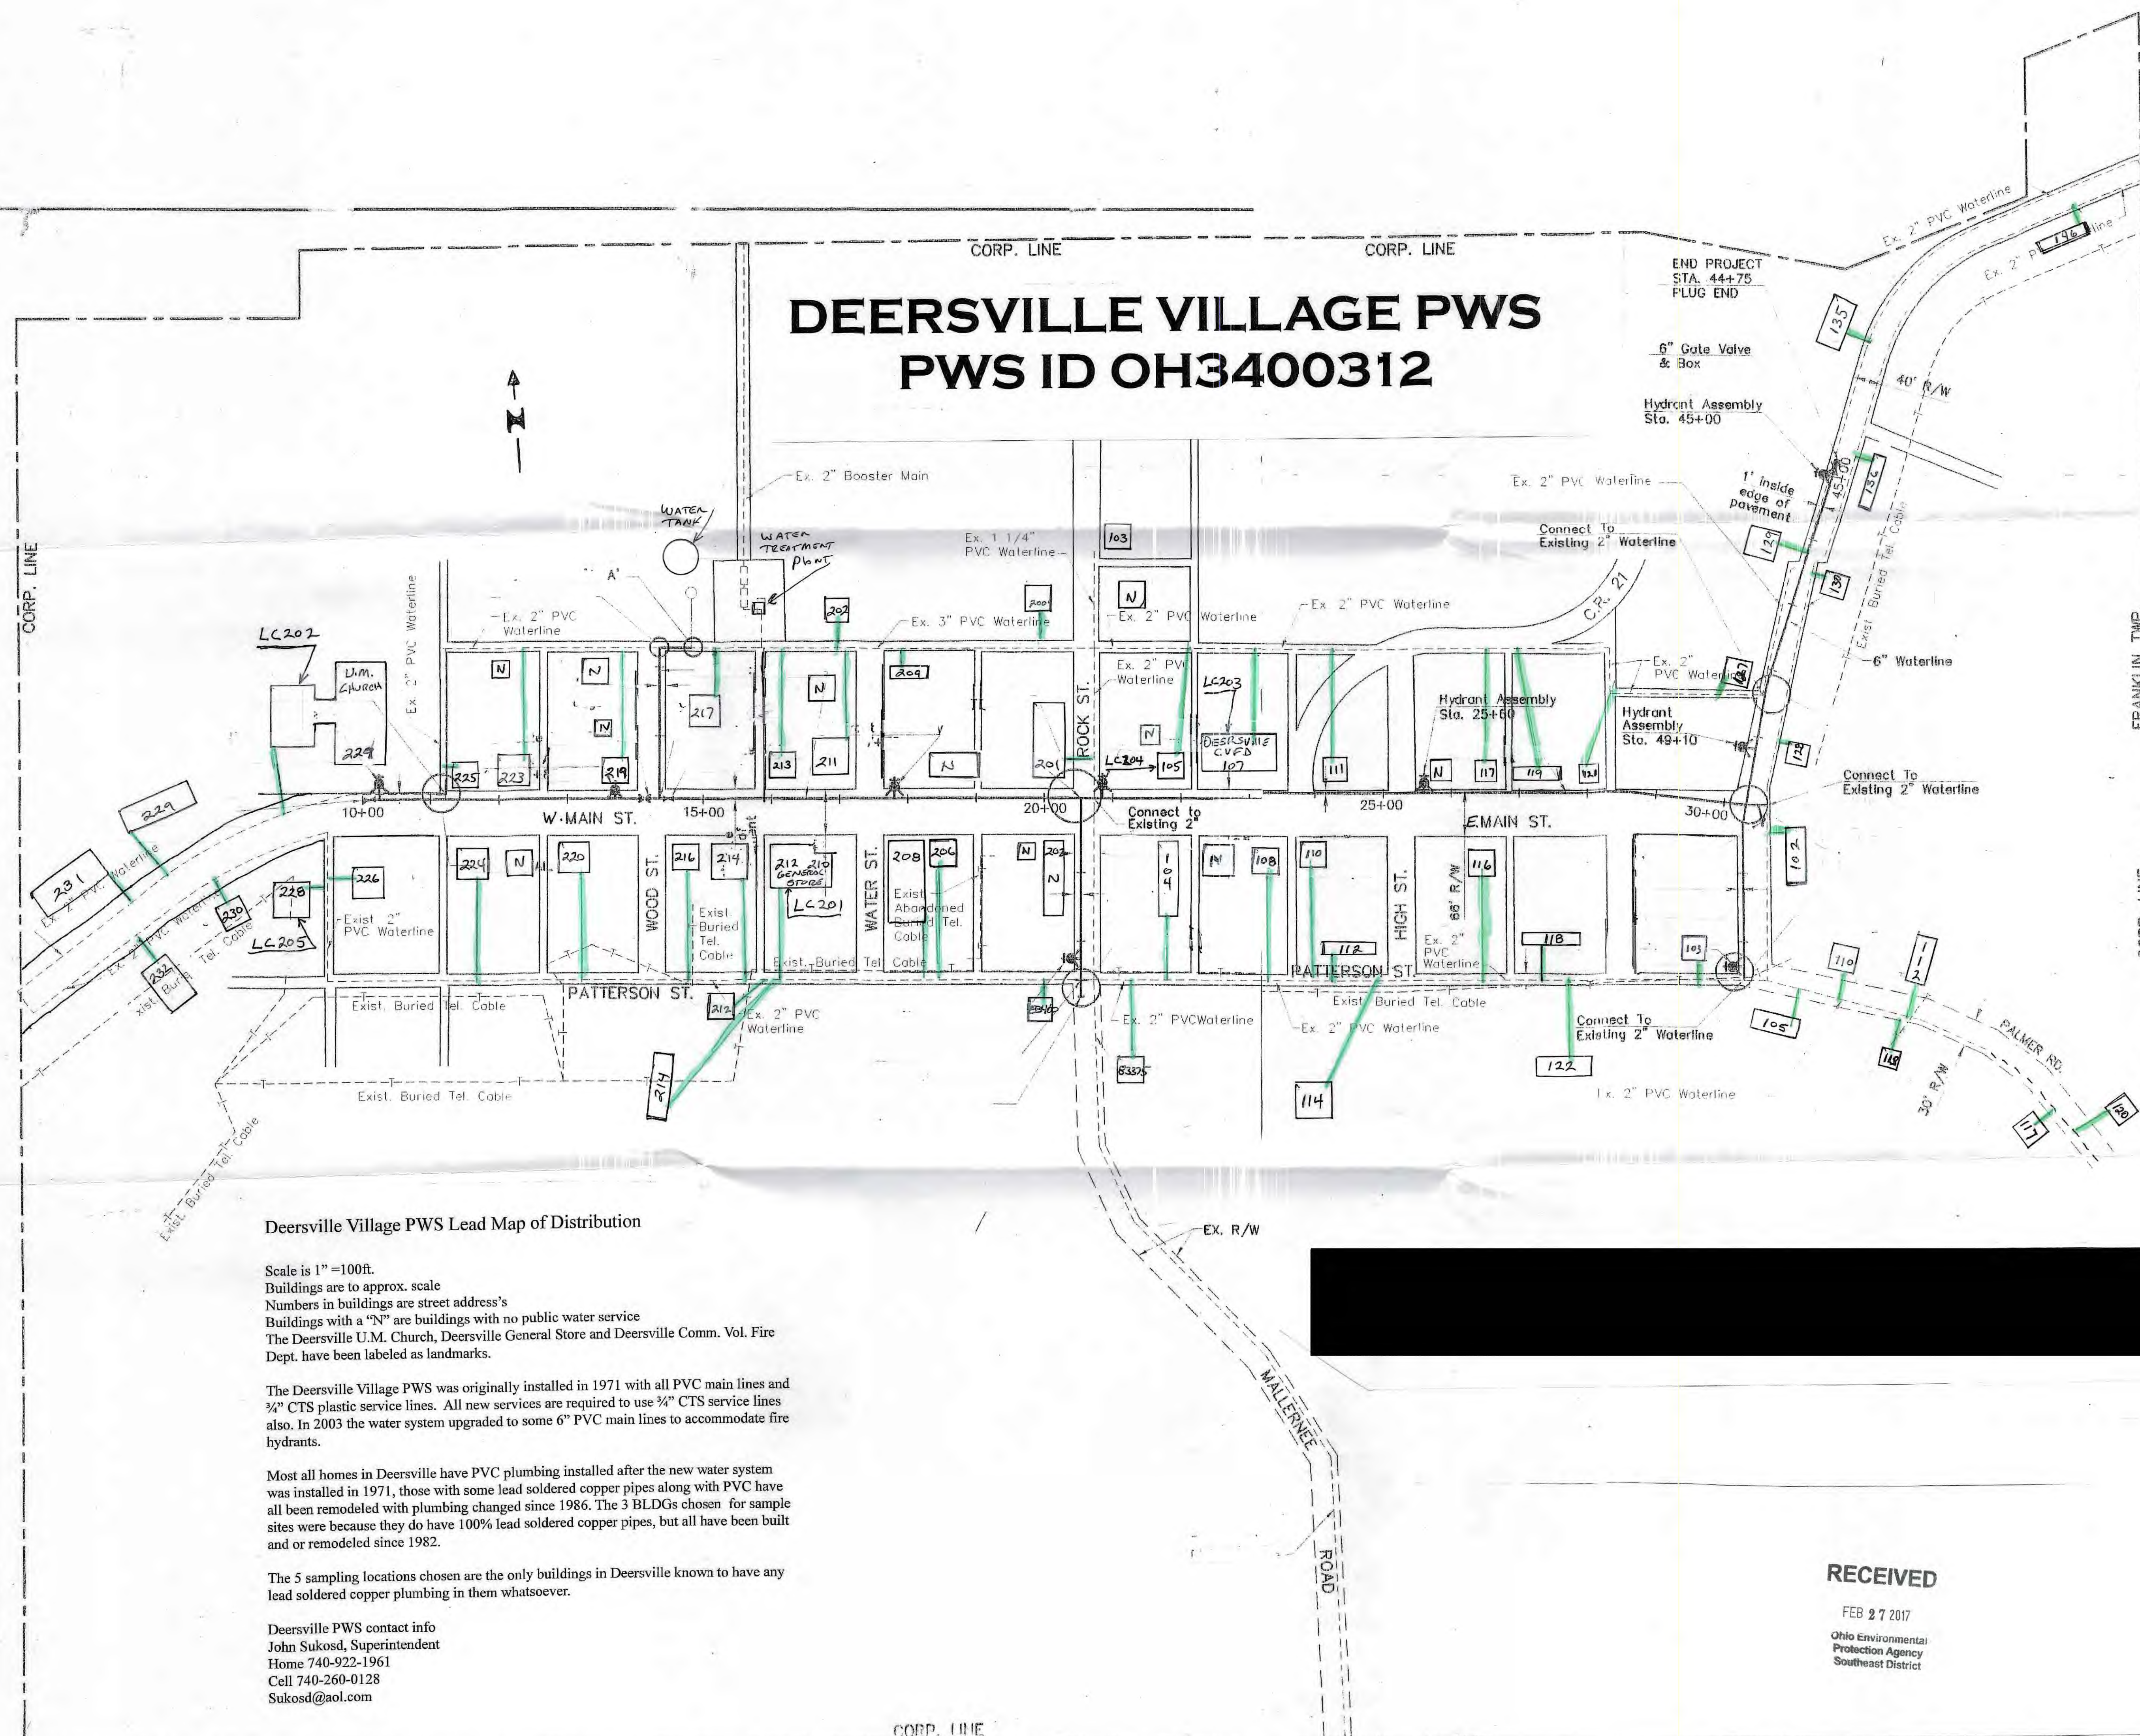
Scale is 1" = 100ft.  
 Buildings are to approx. scale  
 Numbers in buildings are street address's  
 Buildings with a "N" are buildings with no public water service  
 The Deersville U.M. Church, Deersville General Store and Deersville Comm. Vol. Fire Dept. have been labeled as landmarks.

The Deersville Village PWS was originally installed in 1971 with all PVC main lines and 3/4" CTS plastic service lines. All new services are required to use 3/4" CTS service lines also. In 2003 the water system upgraded to some 6" PVC main lines to accommodate fire hydrants.

Most all homes in Deersville have PVC plumbing installed after the new water system was installed in 1971, those with some lead soldered copper pipes along with PVC have all been remodeled with plumbing changed since 1986. The 3 BLDGs chosen for sample sites were because they do have 100% lead soldered copper pipes, but all have been built and or remodeled since 1982.

The 5 sampling locations chosen are the only buildings in Deersville known to have any lead soldered copper plumbing in them whatsoever.
