A Narrative Description of the Village of Granville, Ohio Water Distribution System, in regards to lead service lines

Village of Granville, PWS # 4500612

2/22/17

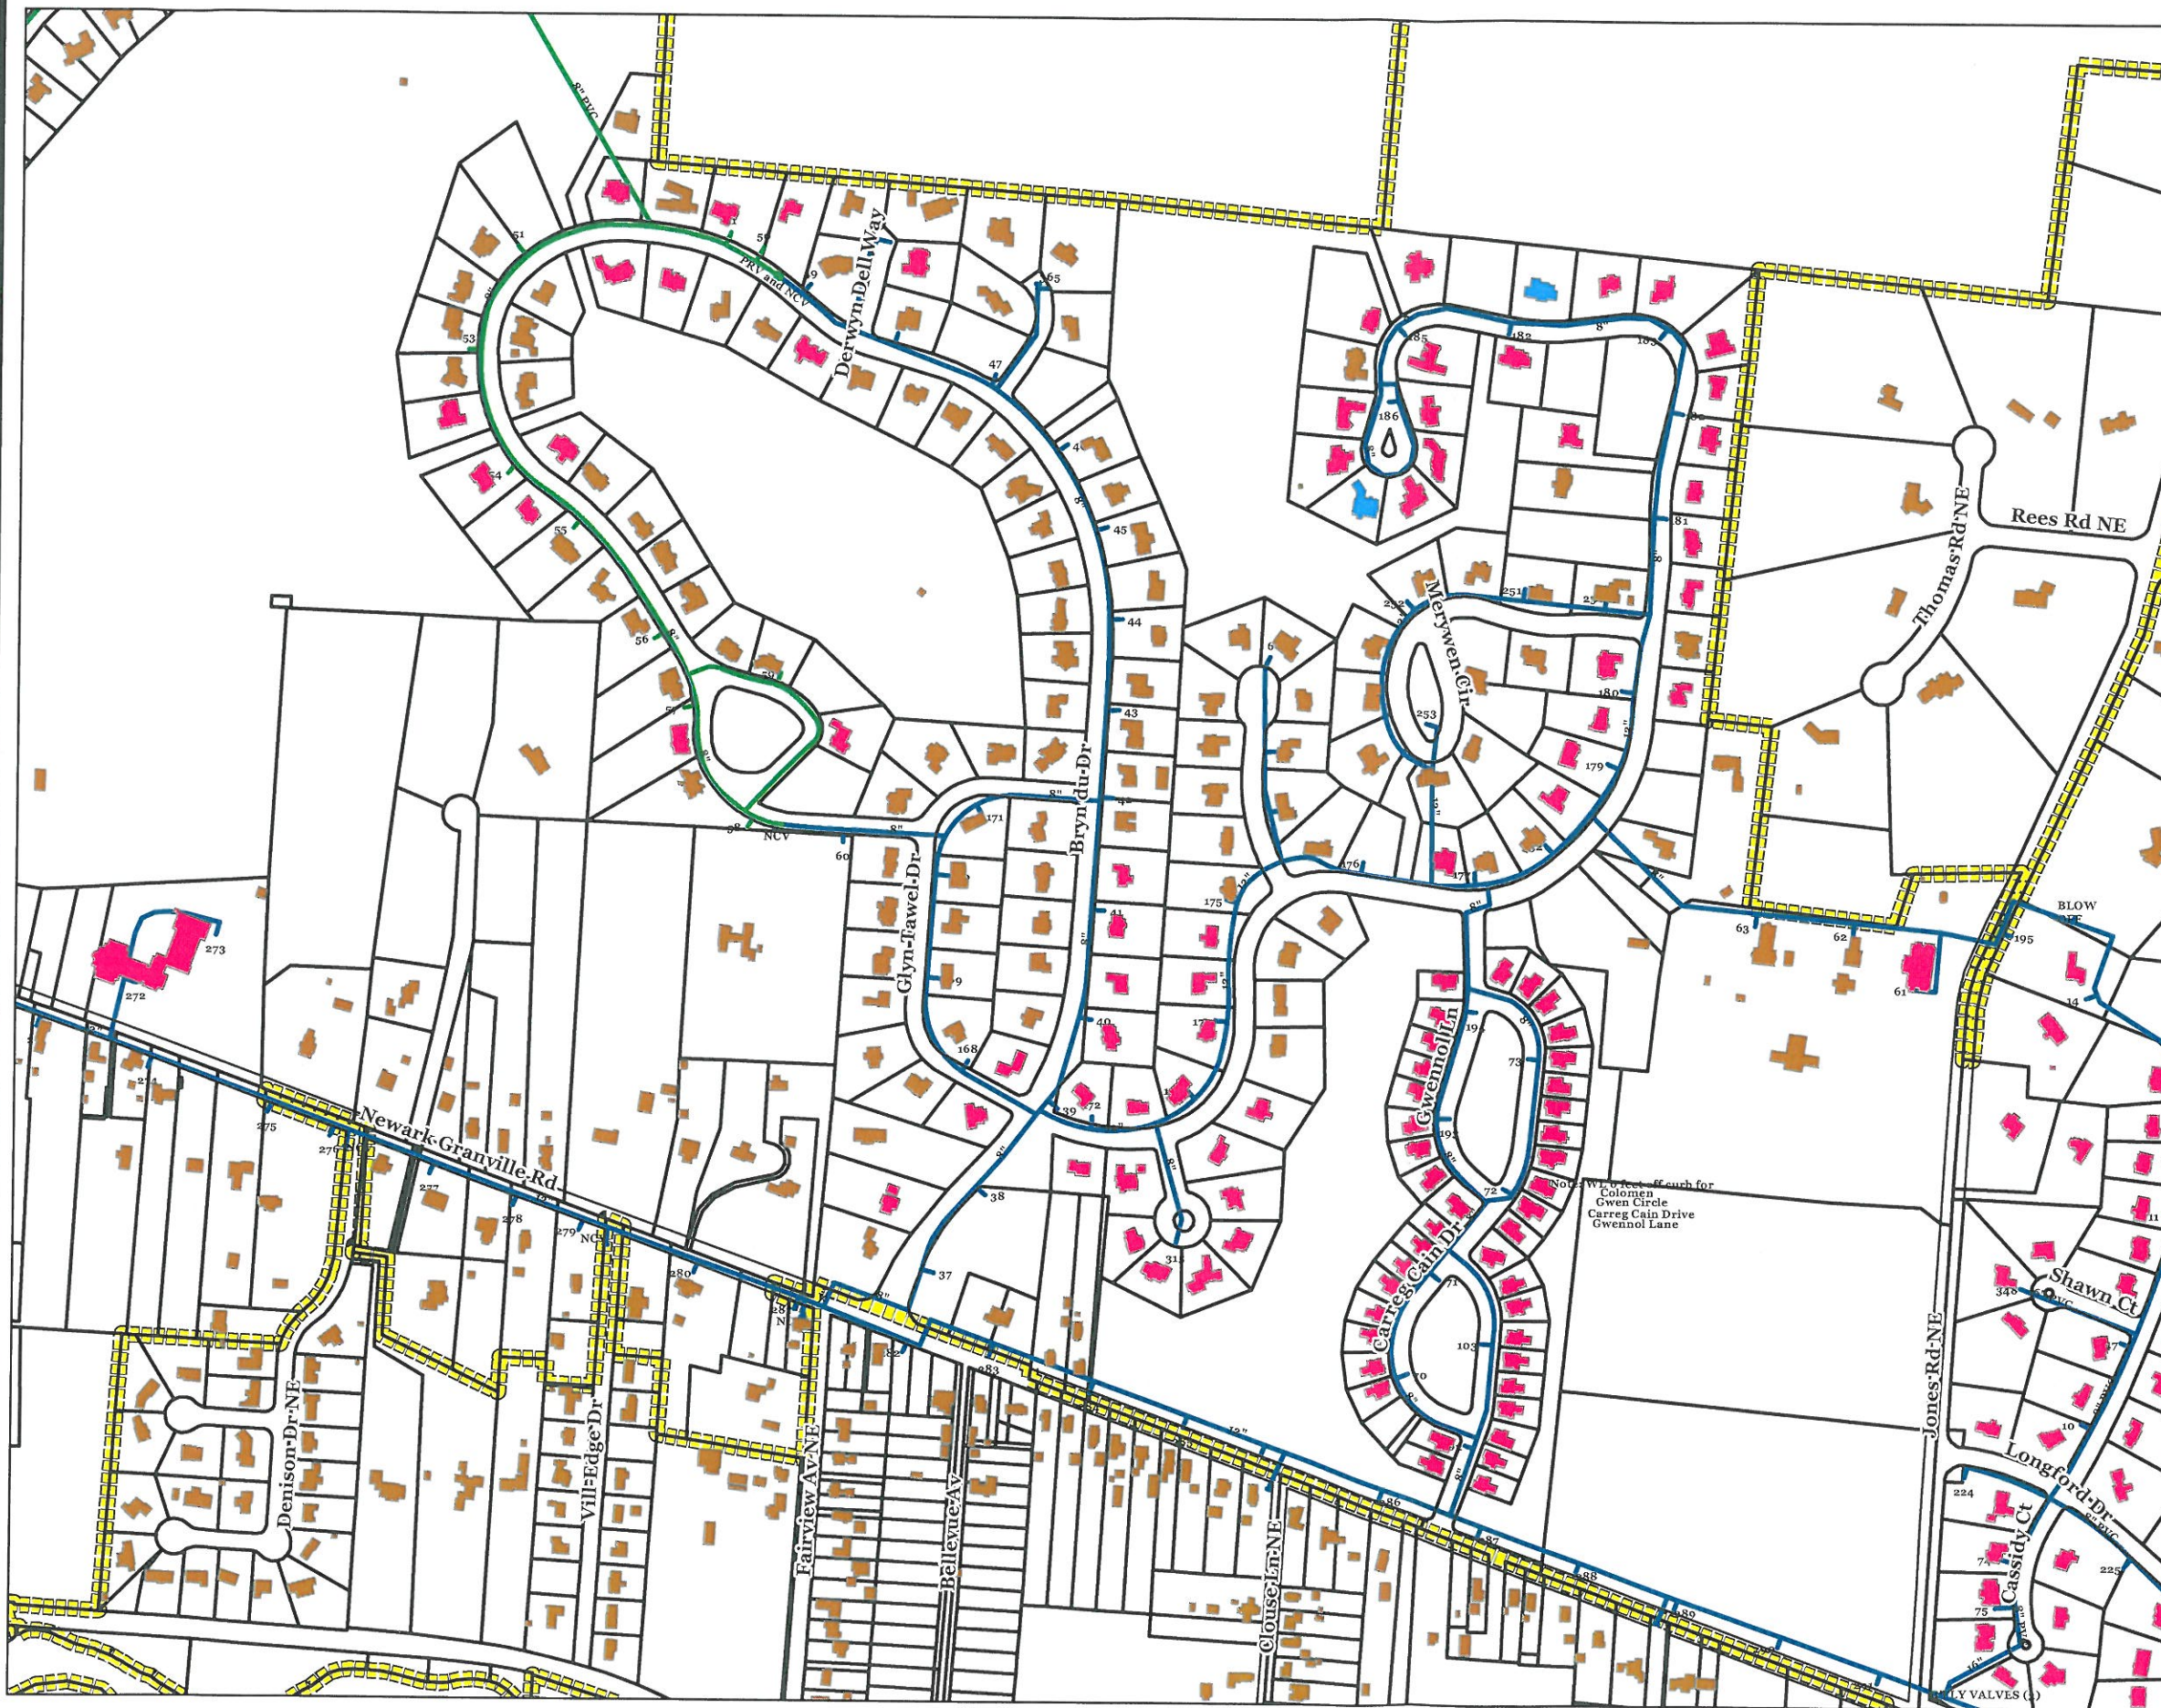
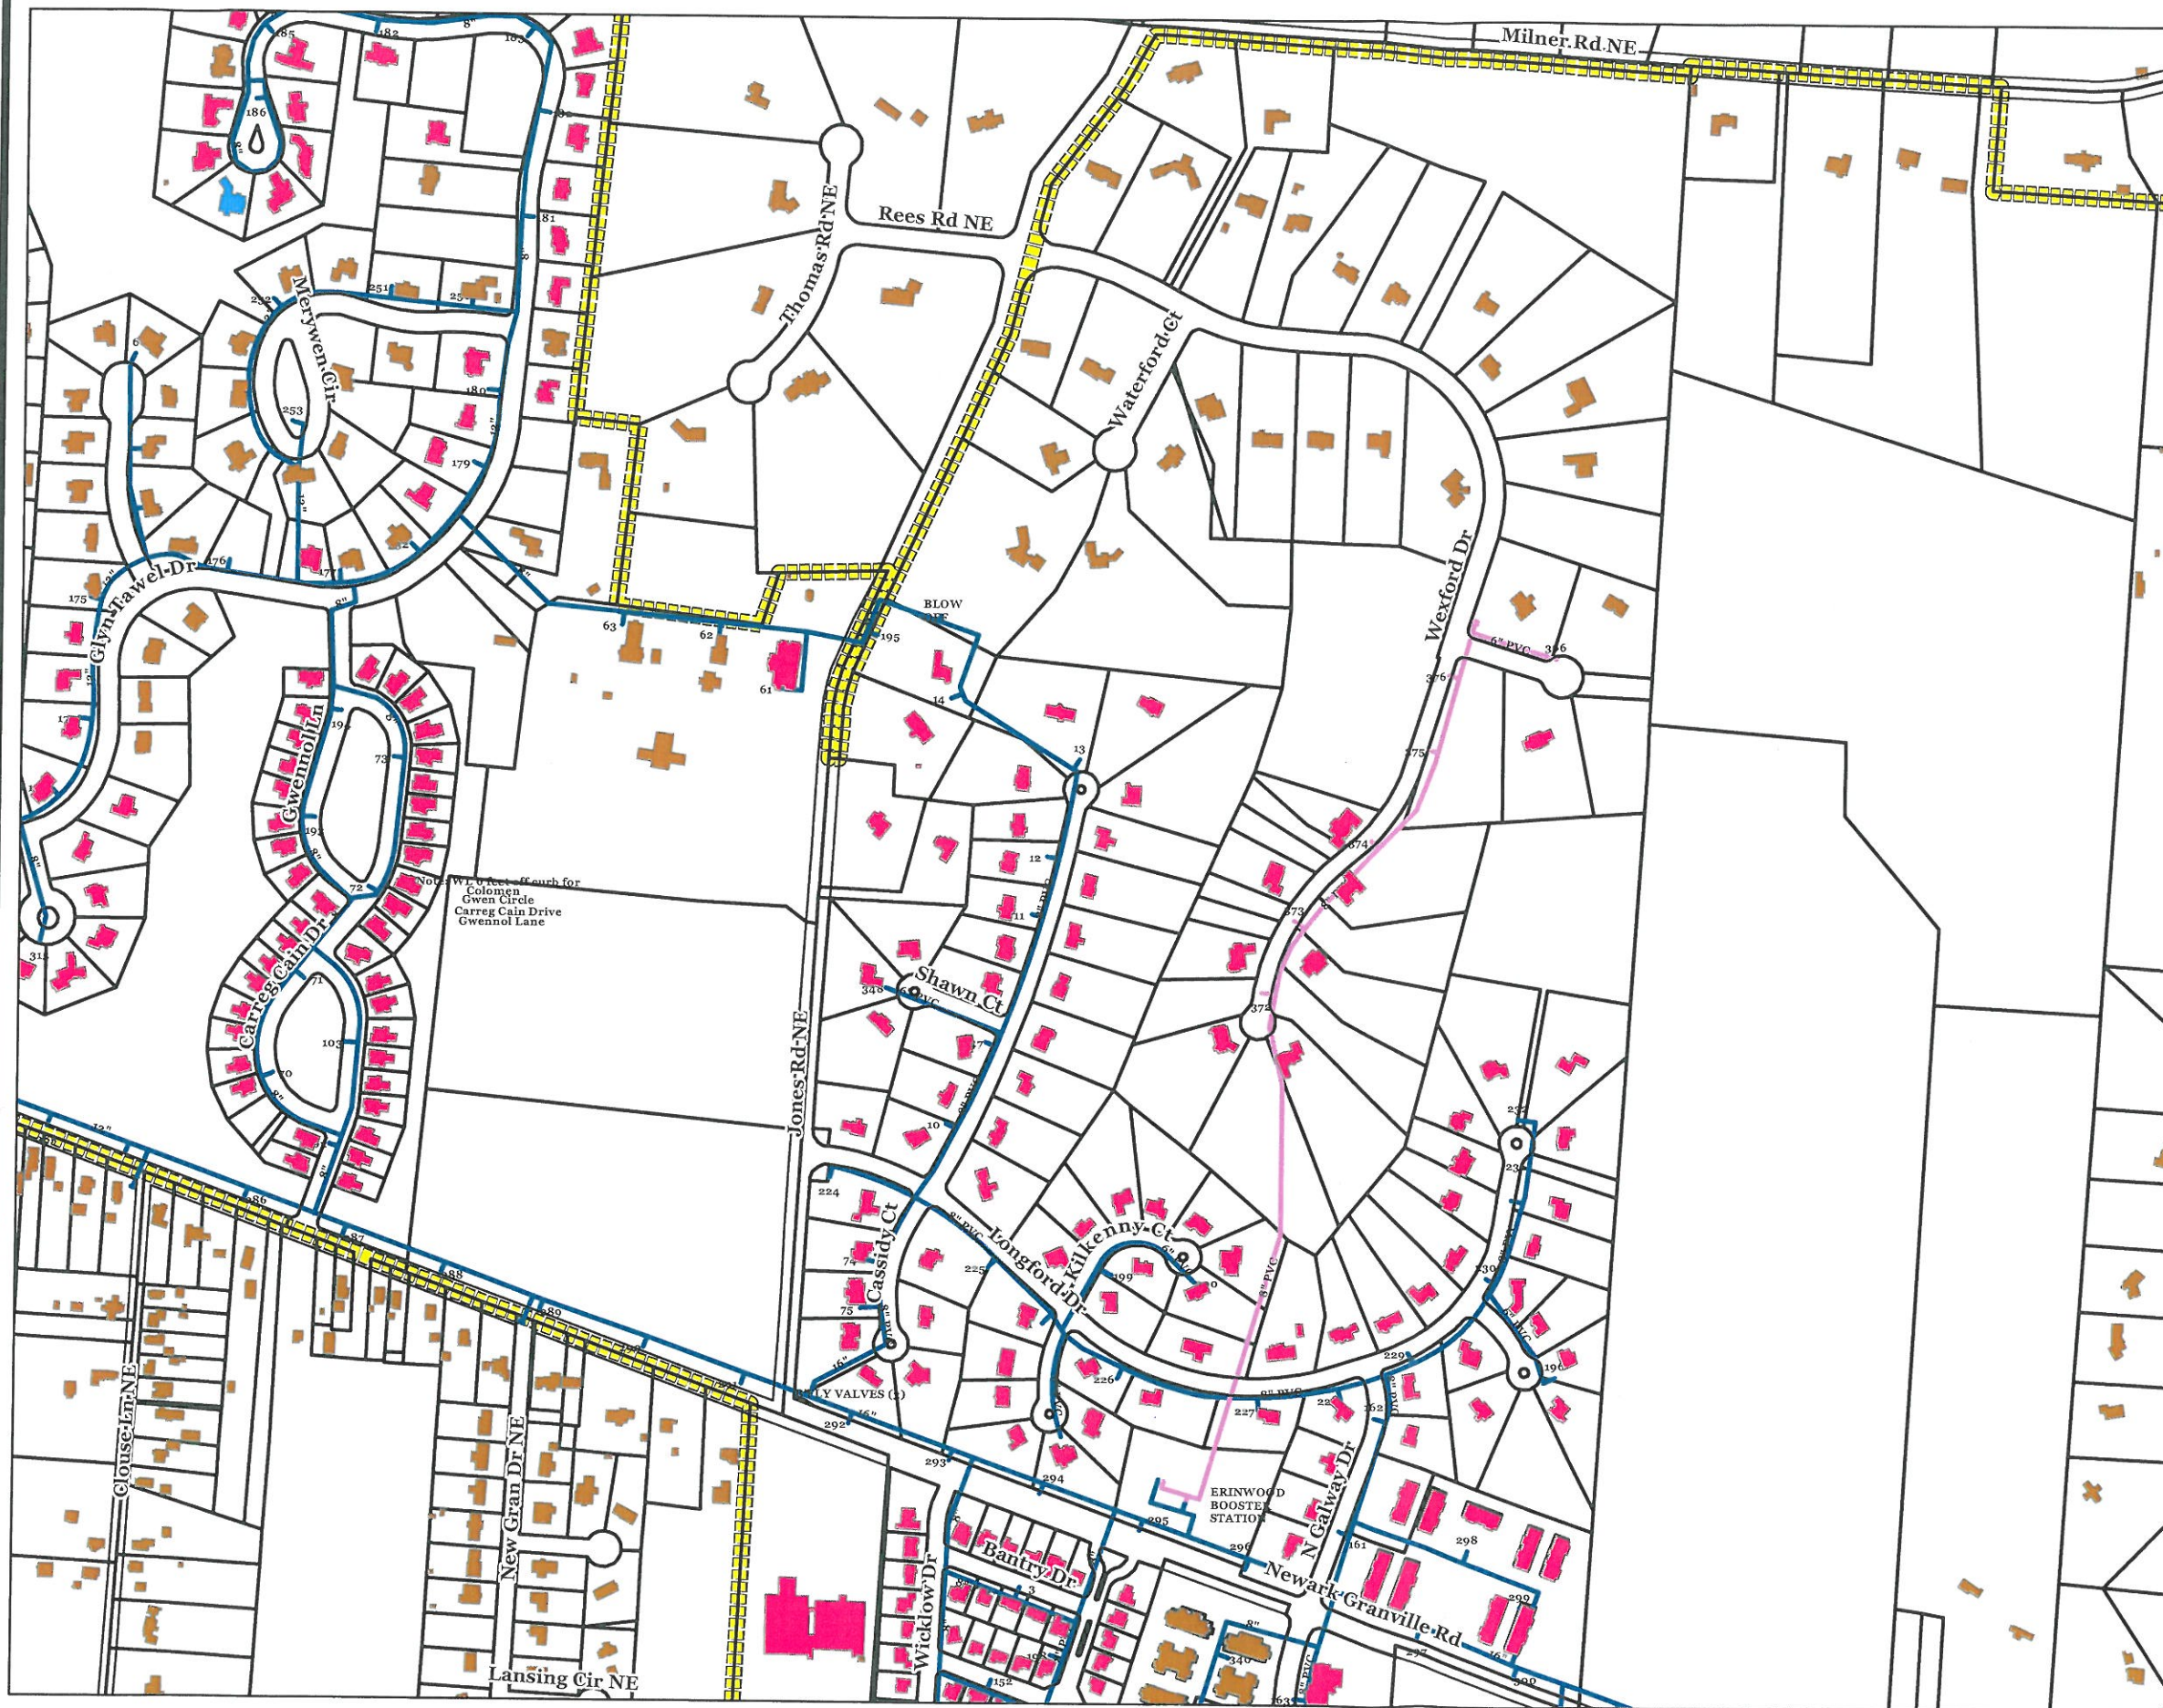
EPA Mapping - Central Area 1

- No lead piping is known to exist in the Village of Granville's Water Distribution System.
- Customers served by Granville's Distribution System are identified on the map of the distribution system.

- Customers with buildings built before 1998 are color-coded brown and are the most likely to have leaded solder or plumbing fixtures containing lead.
- Customers with buildings built between 1998 and 2014 are color coded red and are less likely to have lead solder or plumbing fixtures containing lead than houses built before 1998.

- Customer with buildings built after 2014 are color coded blue and are least likely to have leaded solder or plumbing fixtures containing lead.
