RE: St Matthew Lutheran Church
Report
Drinking Water Program
Allen County
PWS ID: OH0254712

St. Matthew Lutheran Church
5050 St. Mathews Dr.
Lima, OH 45806

St. Matthew Lutheran Church Lead Mapping additional information

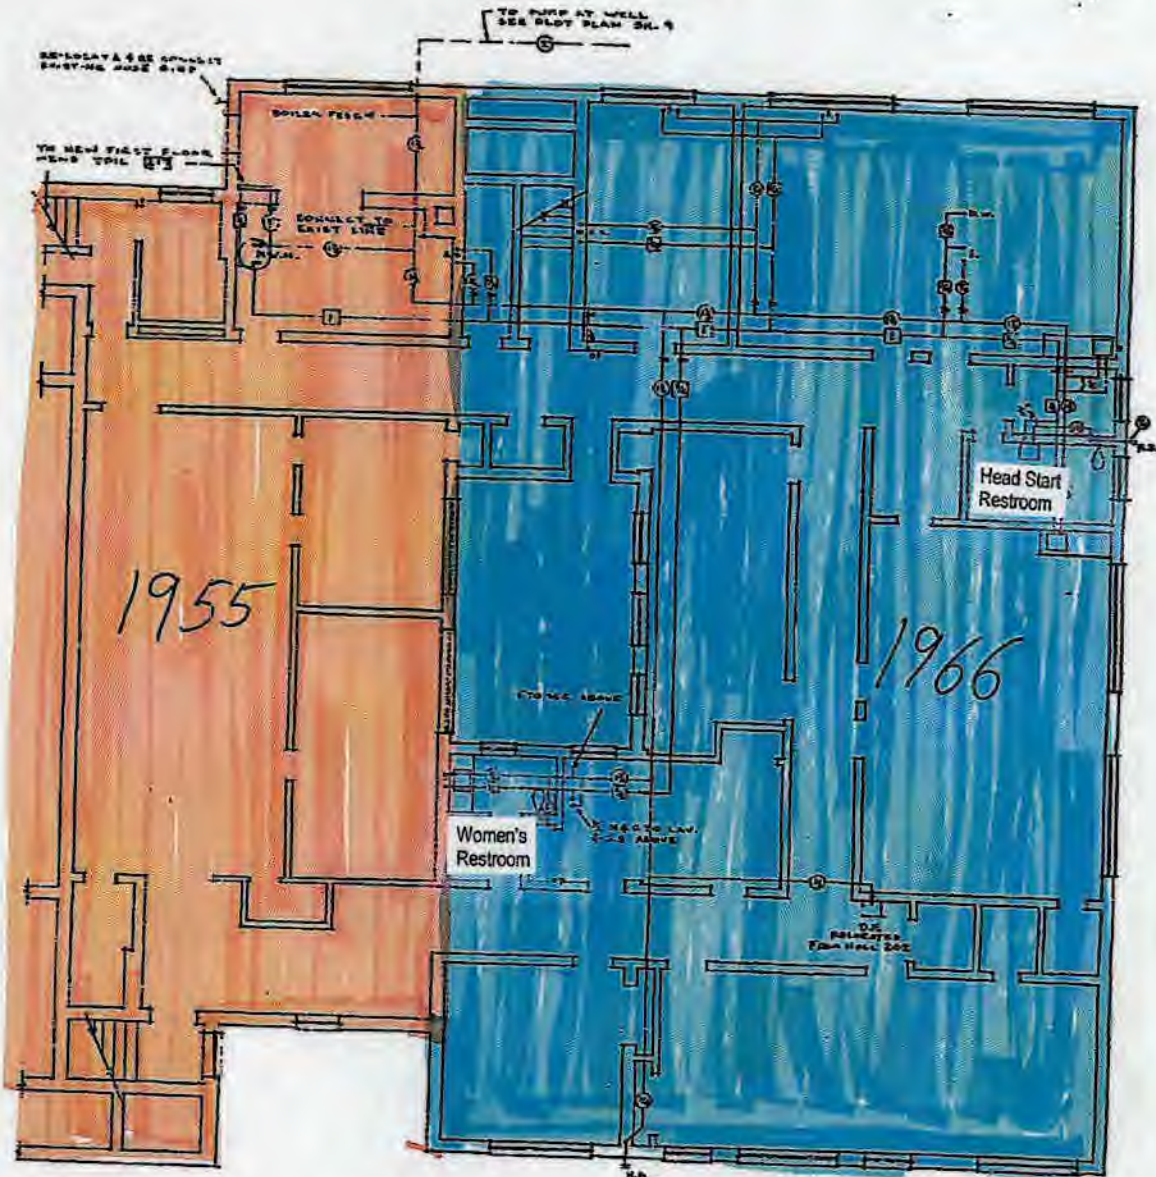
BASEMENT PLAN
 1/2" = 1'-0"

LEGEND
 ○ COLD WATER
 □ HOT WATER

PIPING Note: Plumbing Engineering Plans Check and Double Check with Water Governor. Sewer Water Lines Are Installed.

The waterline between the water well (Located on the South side of the building) and the entrance to the church basement is 2 inch PVC pipe as noted on map.

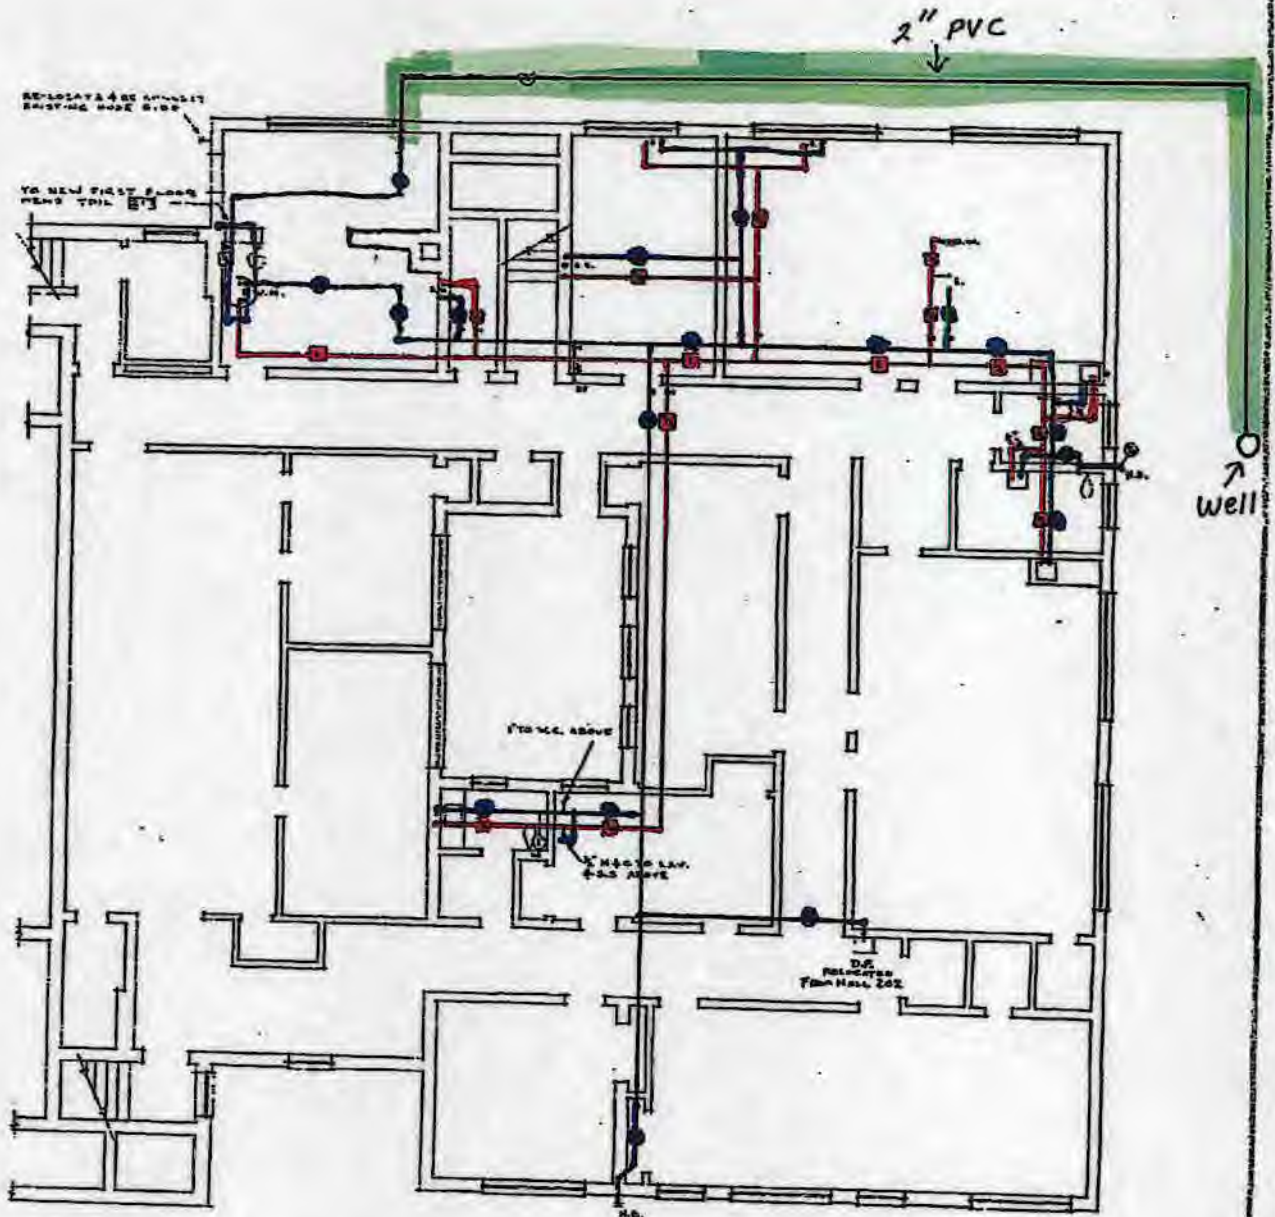
* BASEMENT PLAN *
 1/2" = 1'-0"

LEGEND
 ● COLD WATER
 ■ HOT WATER

NOTE: PLUMBING CONTRACTOR SHALL CHECK AND
 CORRECT CONCERNING WATER CONNECTIONS
 BEFORE WATER TEST AND INSTALLATION
