Rationale of Water Distribution System

Re: Licking County PWS ID OH4564812 Licking Valley Elementary School PWS Non Transient Non Community Public Water System Ground Water

This document includes interior, exterior water line mapping and color coded sampling locations for lead and copper.

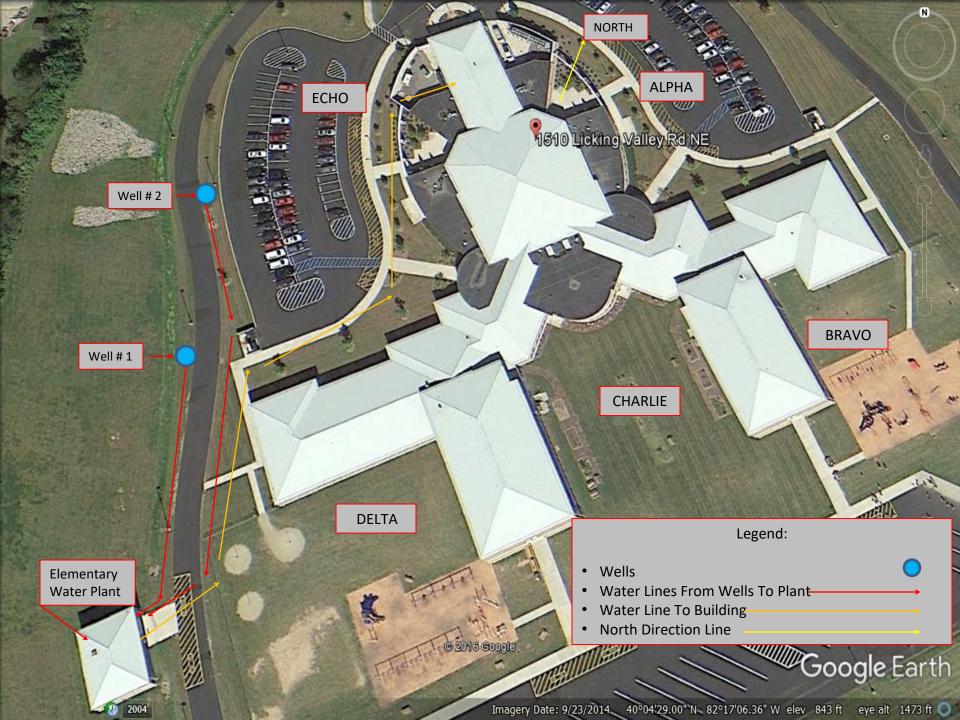
Licking Valley Local School District **Re: Licking County** 1379 Licking Valley Dr. N.E. PWS ID 0H4564812 Newark, Ohio 43055 Licking Valley Elementary School PWS Non Transient Non Community Public Water System Lead and Copper Color Coded Sample Locations Ground Water K-1 Prep Sink - Intermediate Side of Kitchen (Dishwasher Area) 🗢 • K-2 Hand Sink - Intermediate Side of Kitchen (Dishwasher Area) ٠ • K-3 Hand Sink - Intermediate Side Center of Kitchen (Right of Hood) K-4 Prep Sink - Intermediate Side Center of Kitchen (Across From Hood) 🧿 • K-5 Prep Sink - Intermediate Side Center of Kitchen (Across From K-4) ٠ K-6 Hand Sink - Primary Side Center of Kitchen (Left of Hood) • K-7 Prep Sink - Primary Side Center of Kitchen (Near Exterior Entrance) ٠ \bigcirc • K-8 Three Bowl Sink - Primary Side of Kitchen (Dishwasher Area) K-9 Hand Sink - Primary Side of Kitchen (Next to Three Bowl) • K-10 Prep Sink - Primary Side of Kitchen (Next to Hand Sink) ٠ K-11 Kitchen Sink - Intermediate Side of Building (Admin Office Kitchen) 🔴 • K-12 Kitchen Sink - Intermediate Side of Building (Staff Breakroom) • ٠ K-13 Kitchen Sink - Primary Side of Building (Admin Office Kitchen) ٠ STR-1 Lavatory Sink - Kitchen Restroom (Located in Kitchen) 🥏 STR-2 Lavatory Sink - Intermediate Side of Building (Admin Restroom) ٠ STR-3 Lavatory Sink - Intermediate Side of Building (Staff Restroom) 🗢 ٠ ٠ STR-4 Lavatory Sink - Primary Side of Building (Clinic Restroom) 🥏 D-1 Water Cooler - Intermediate Side of Building (South Corridor Near Restrooms) ٠ D-2 Water Cooler - Intermediate Side of Building (North Corridor Near Gym and Restrooms) ٠ D-3 Water Cooler - Primary Side of Building (South Corridor Near Restrooms) ٠

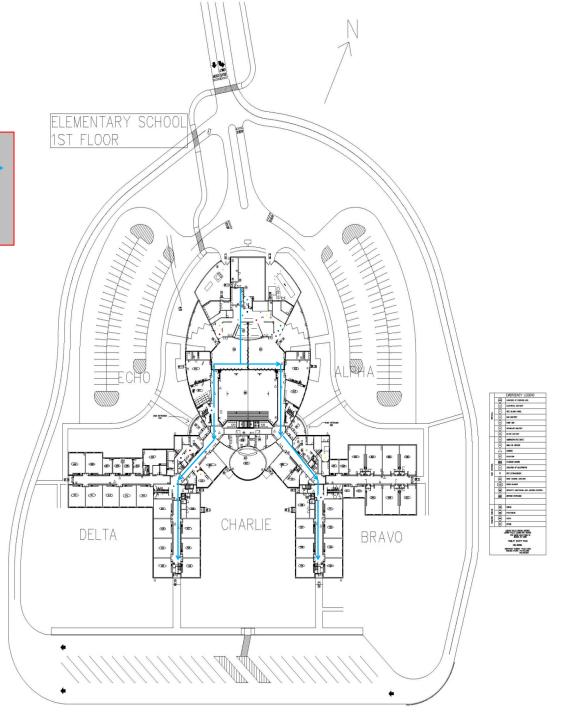
Zoom to view map: Interior Water Lines: Lead and Copper Sample Locations: All Lead-Free Type L Copper Water Lines Installed Within Building 95/5% Used On All Solder Joints
