East Palestine, Ohio Public Water System Lead (Pb) Components PWSID# OH1500912 Prepared February 2017

East Palestine Water Distribution PWS 1500912 Probability of Lead Services

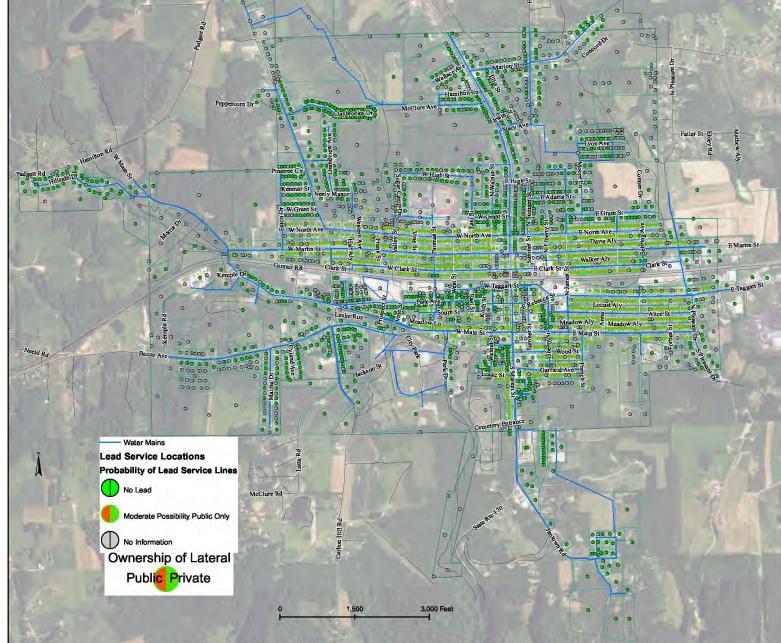
This map does not verify the presence of lead in any of the lines or structures shown. This map only shows the probable or possible locations based on the year that the structure was built, historical maintenance and operation records, and customer or utility staff verification. This map is not intended for design engineering, surveying, or construction purposes. Information and data contained or accessed within this map emanates from various public and private sources and may contain errors and omissions. This map remains under development and is subject to change with or without notice. All data, information and documentation within this map are provided "as is" without warranty of any kind, either expressed or implied. The suitability of the data and information contained in this map is not guaranteed, and the user assumes all risk for such uses. WSOS, Community Action and its employees, affiliates, agents and licensors cannot and do not warrant the accuracy, completeness, non-infingement, merchantability or fitness of any information contained within this map. Sources: OGRIP, Columbiana County Auditor, RCAP GIS. Datum/Projection: NAD 1983 Ohio State Plane North (ff) Date: 2/2017

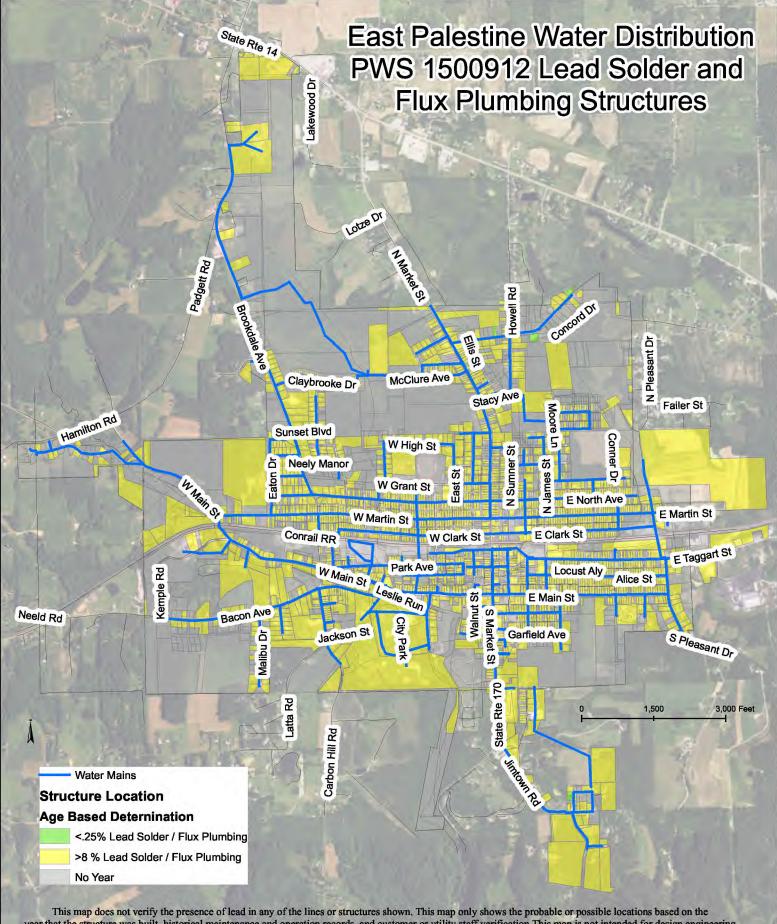
This map does not verify the presence of lead in any of the lines or structures shown. This map only shows the probable or possible locations based on the year that the structure was built, historical maintenance and operation records, and customer or utility staff verification. This map is not intended for design engineering, surveying, or construction purposes. Information and data contained or accessed within this map emanates from various public and private sources and may contain errors and omissions. This map remains under development and is subject to change with or without notice. All data, information and documentation within this map are provided "as is" without warranty of any kind, either expressed or implied. The suitability of the data and information contained in this map is not guaranteed, and the user assumes all risk for such uses. WSOS, Community Action and its employees, affiliates, agents and licensors cannot and do not warrant the accuracy, completeness, non-infringement, merchantability or fitness of any information contained within this map. Sources: OGRIP, Columbiana County Auditor, RCAP GIS. Datum/Projection: NAIP 1993 Other states and the GIS User Community USDA, USGS, AeroGRID, IGN, and the GIS User Community
