RE: Franklin Elem Sch / Mercer Co Head Start
Report
Drinking Water Program
Mercer County
PWS ID: OH5432412

FRANKLIN ELEMENTARY / MERCER COUNTY HEAD START

PWS ID# OH 5432412

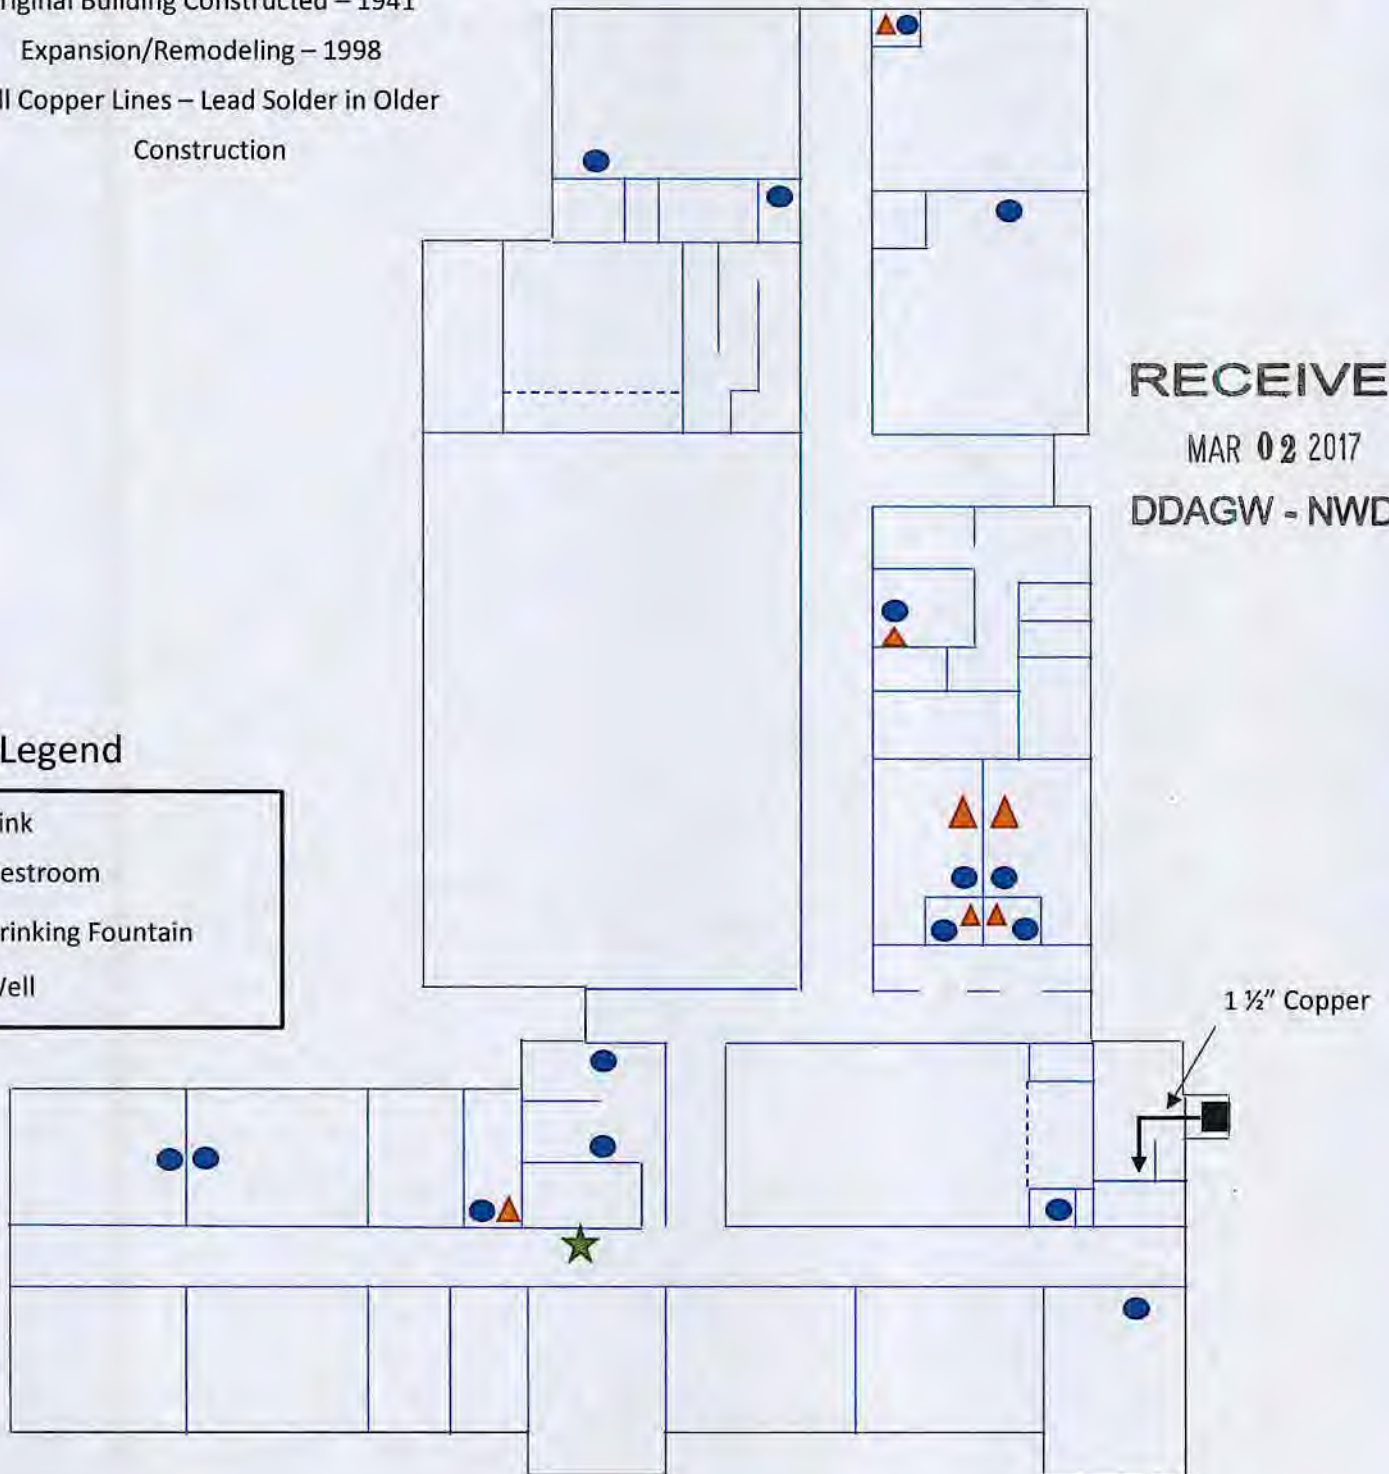
Well and Service Line into Building

Original Building Constructed – 1941

Expansion/Remodeling – 1998

All Copper Lines – Lead Solder in Older
Construction

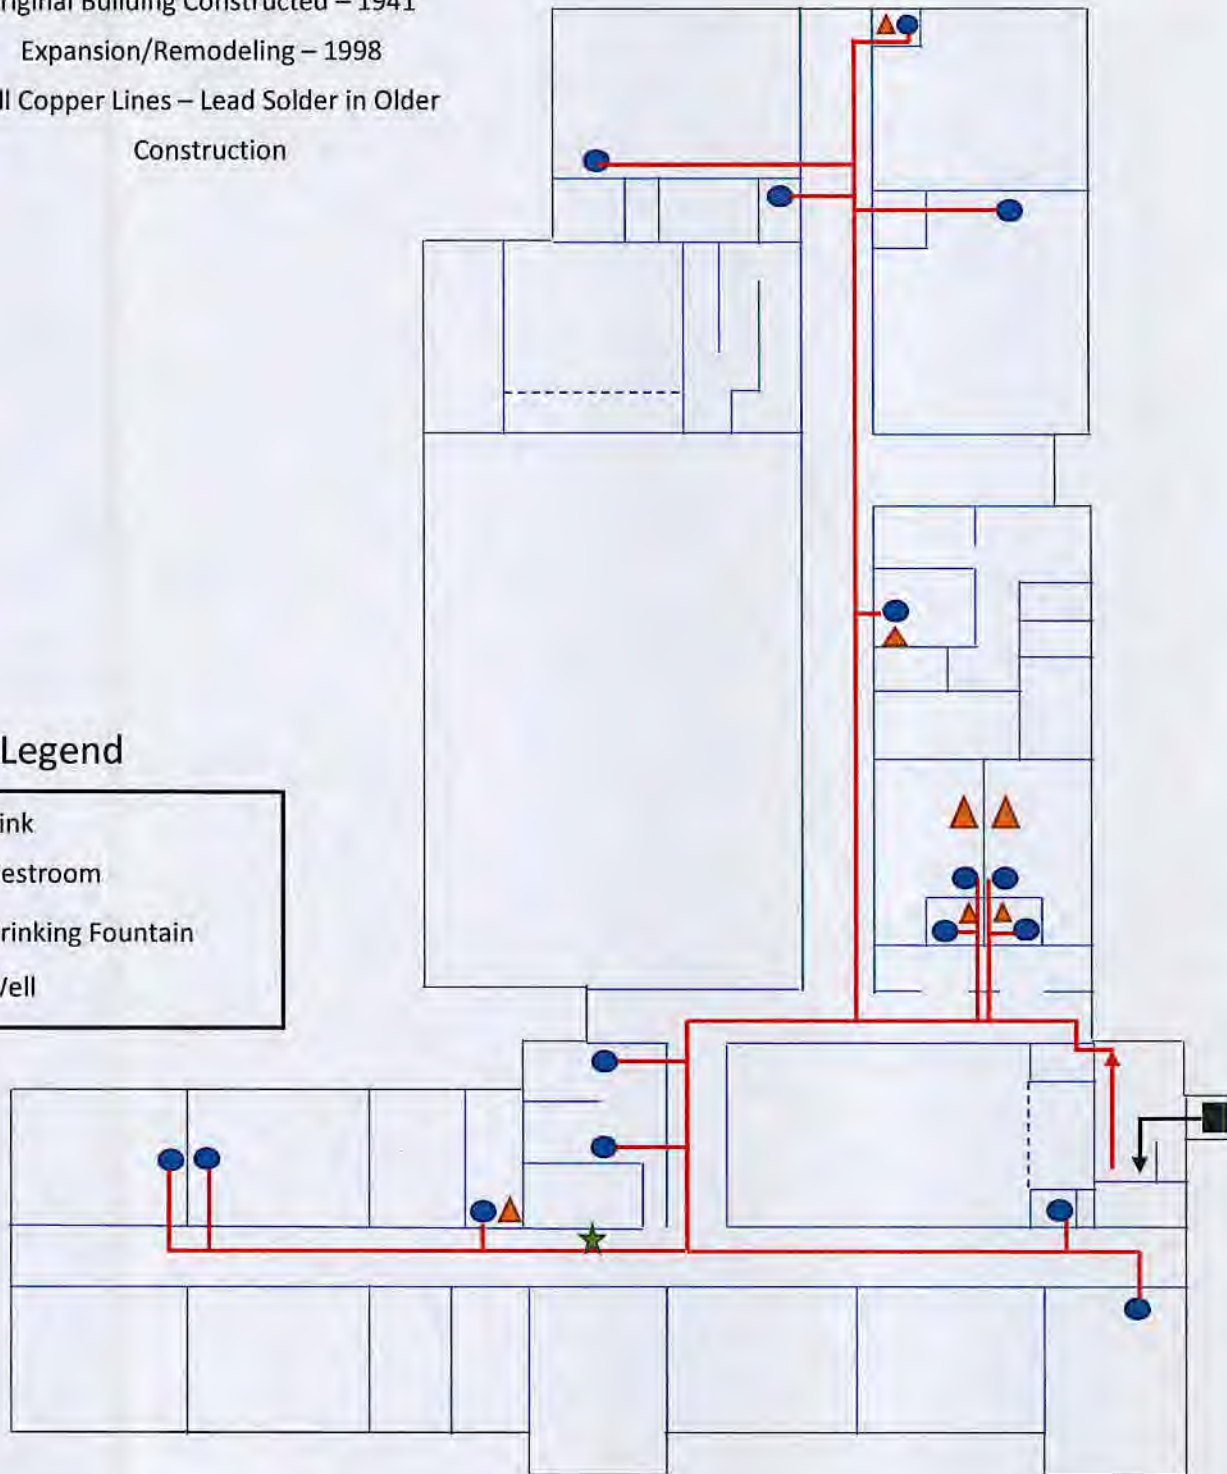
Hot Water Service Lines

Original Building Constructed – 1941

Expansion/Remodeling – 1998

All Copper Lines – Lead Solder in Older
Construction

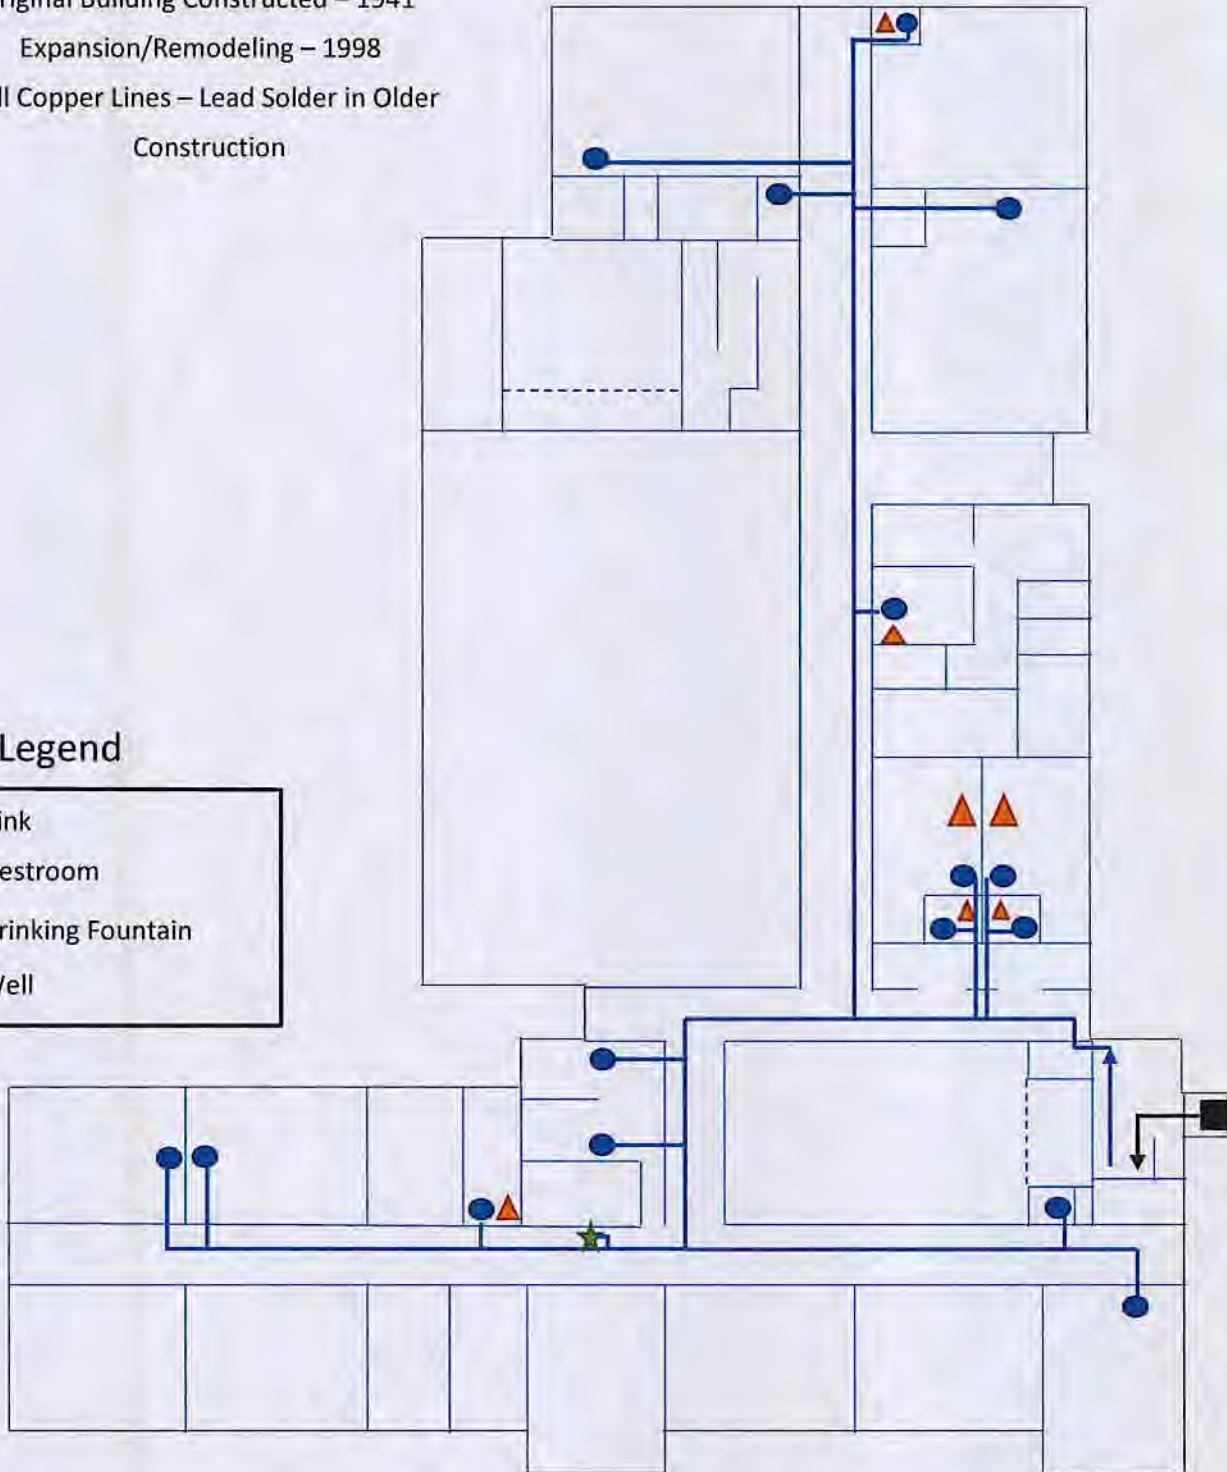
Cold Water Service Lines

Original Building Constructed – 1941
Expansion/Remodeling – 1998
All Copper Lines – Lead Solder in Older
Construction

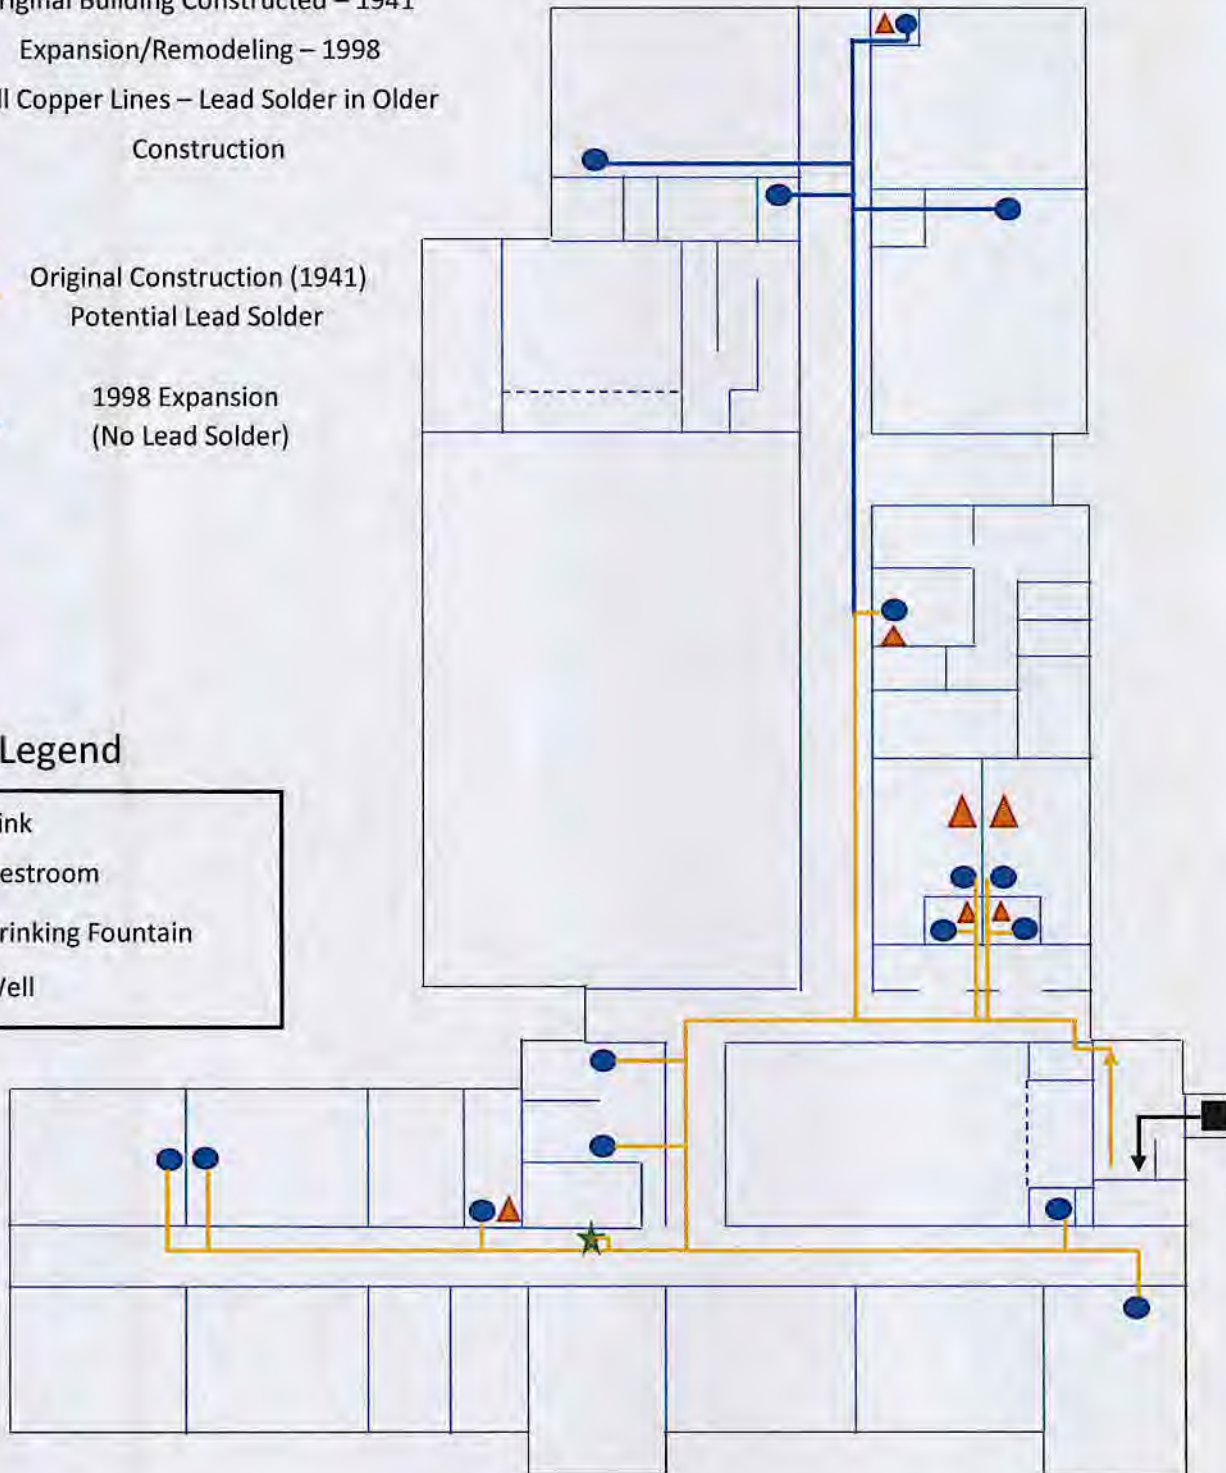
Lines/Fixtures with Potential Lead Solder

Original Building Constructed – 1941
Expansion/Remodeling – 1998
All Copper Lines – Lead Solder in Older
Construction

Original Construction (1941)
Potential Lead Solder

1998 Expansion
(No Lead Solder)

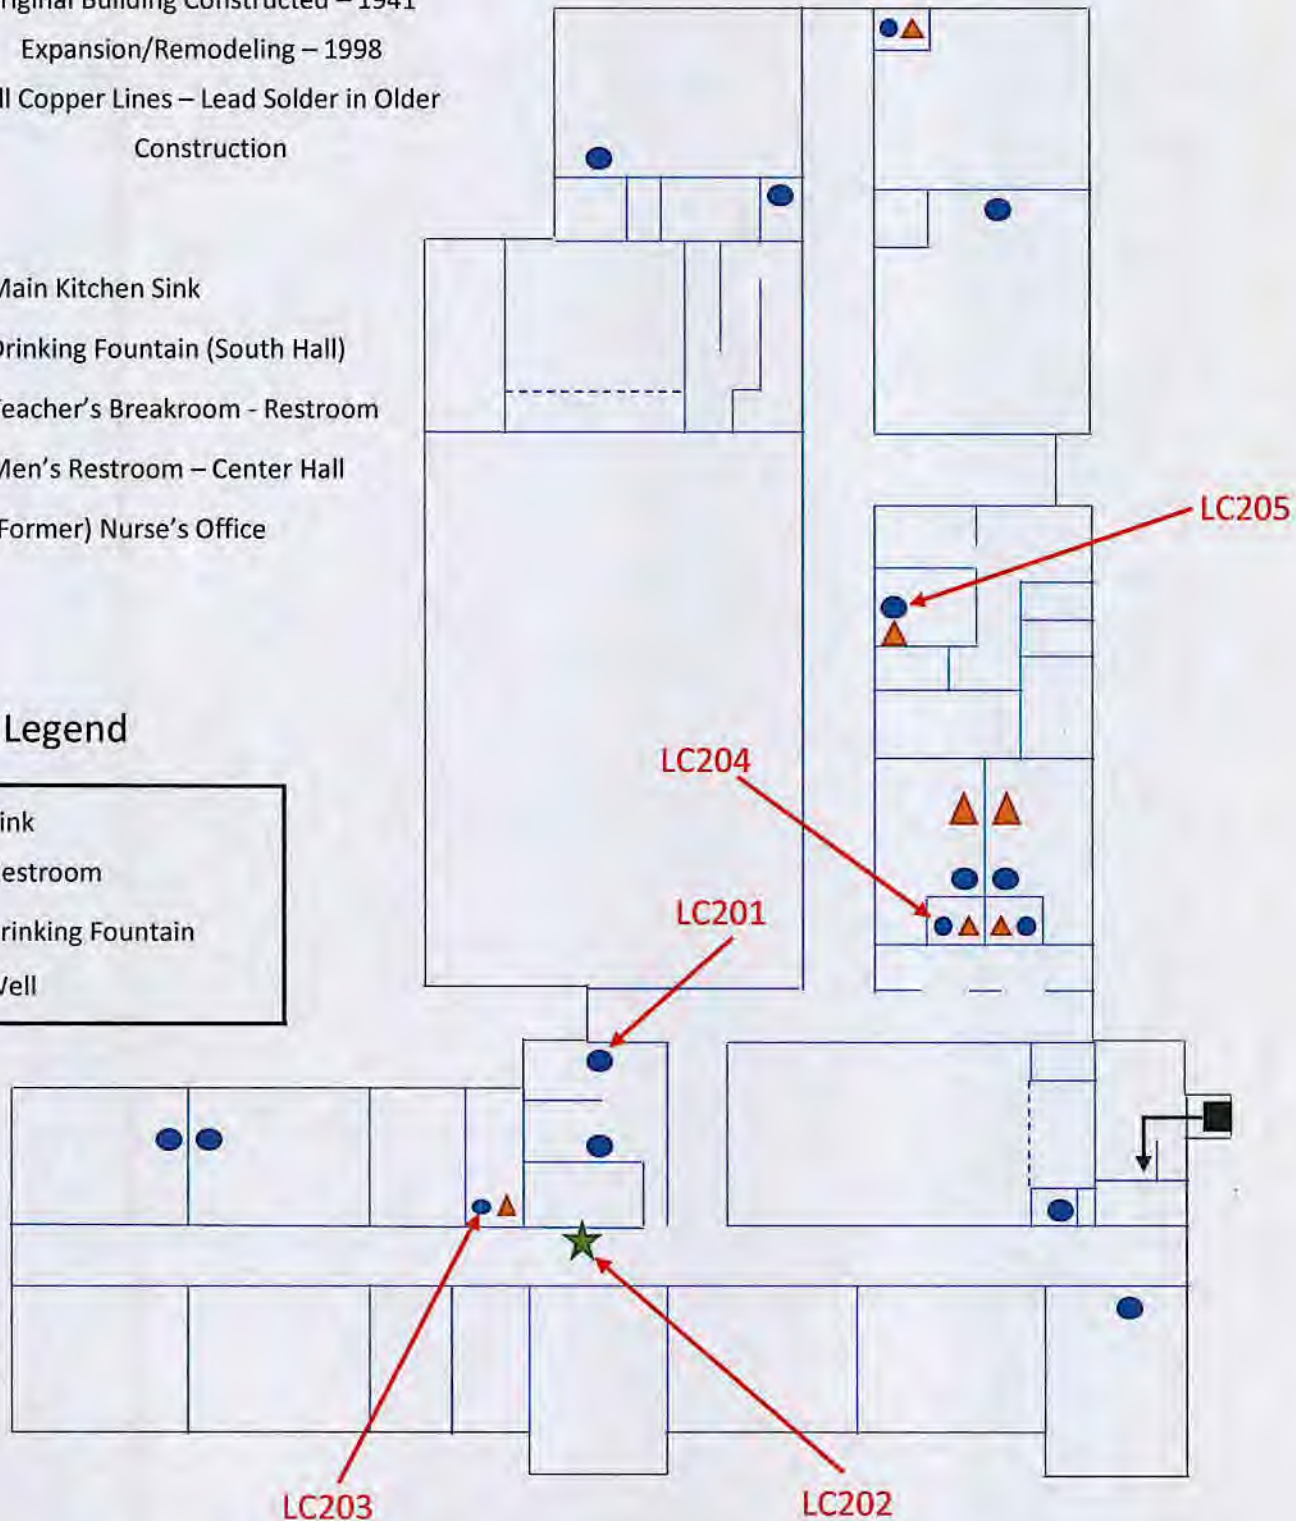
Lead/Copper Sampling Locations

Original Building Constructed – 1941
Expansion/Remodeling – 1998
All Copper Lines – Lead Solder in Older Construction

- LC201 – Main Kitchen Sink
- LC202 – Drinking Fountain (South Hall)
- LC203 – Teacher's Breakroom - Restroom
- LC204 – Men's Restroom – Center Hall
- LC205 – (Former) Nurse's Office
