# OHIO EPA NEDO Manchester United Methodist Church

## FAX COVER SHEET

• ATTACHED IS LAYOUT OF CHURCH WITH INFO  
RELATED TO YOUR 1-10-17 LETTER & MR BAKER'S 1/17  
LETTER.

**MANCHESTER UNITED METHODIST CHURCH**  
**5625 Manchester Road**  
**Akron, Ohio 44319**

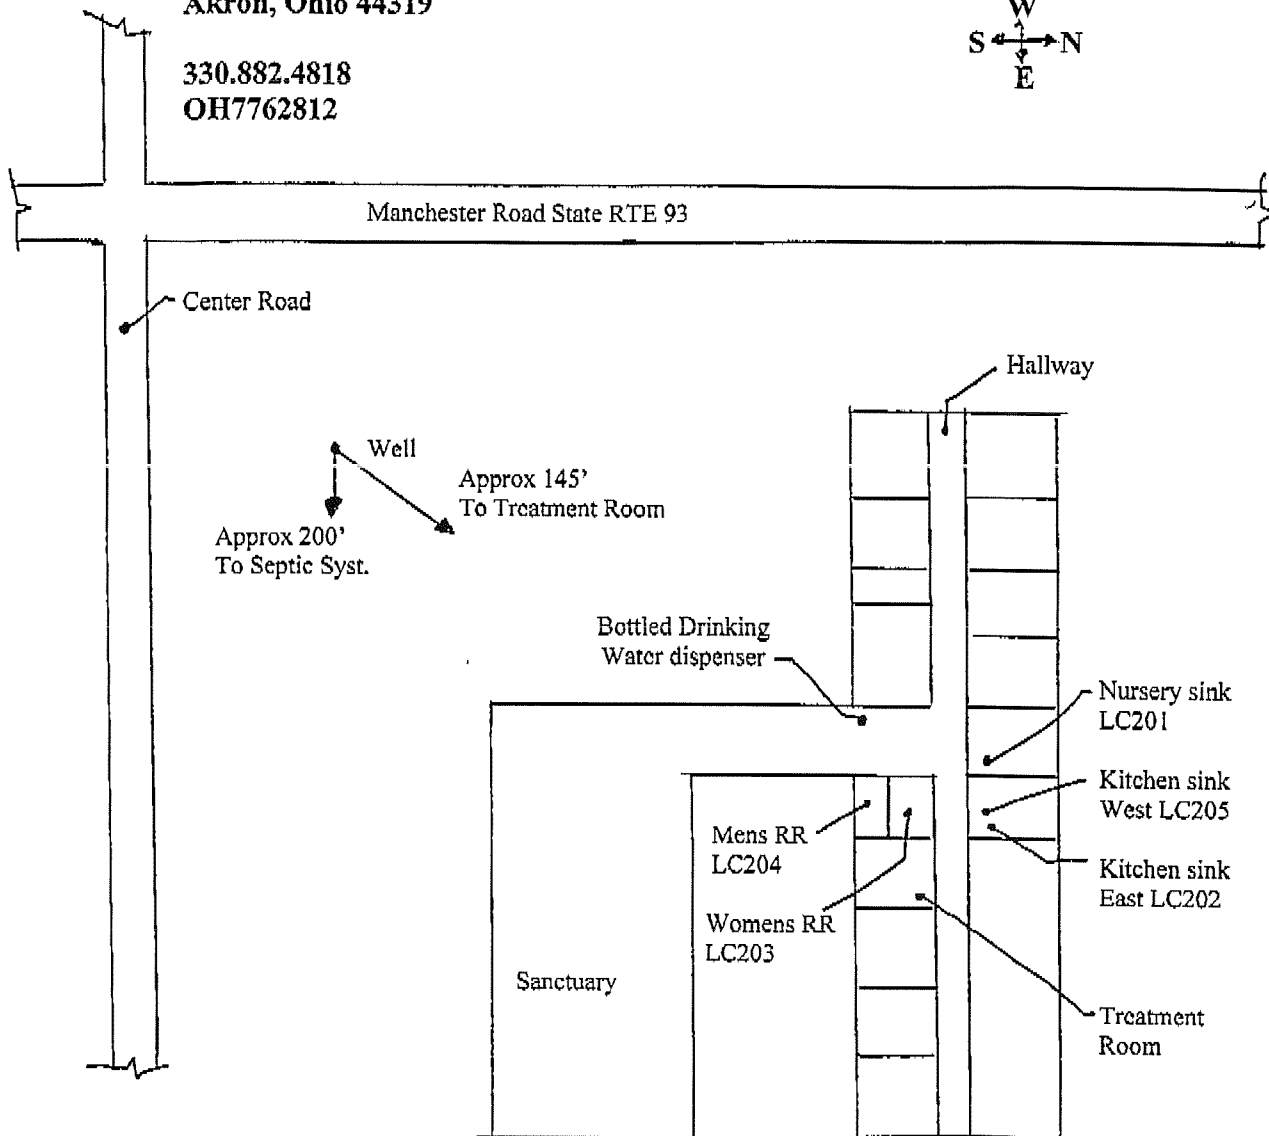
• I HAVE NOTED TEST LOCATIONS FOR LEAD & COPPER

1. Treatment room contains Pressure tank, Softener, Water heater, Janitor sink and Boiler for facility hot water heat.
2. Hot and Cold water piping North of Hallway is PEX, installed 2/13/16.
3. Interior water piping south of Hallway is copper. Church was built around 1960.
4. Well piping material is Polypropylene.
5. Service line from well to Treatment room is Polypropylene.
