Lead Line Mapping Narrative

TRIMBLE TOWNSHIP, ATHENS COUNTY, OHIO
VILLAGE OF TRIMBLE
WATER SYSTEM IMPROVEMENTS
2016

LEAD LINE MAP

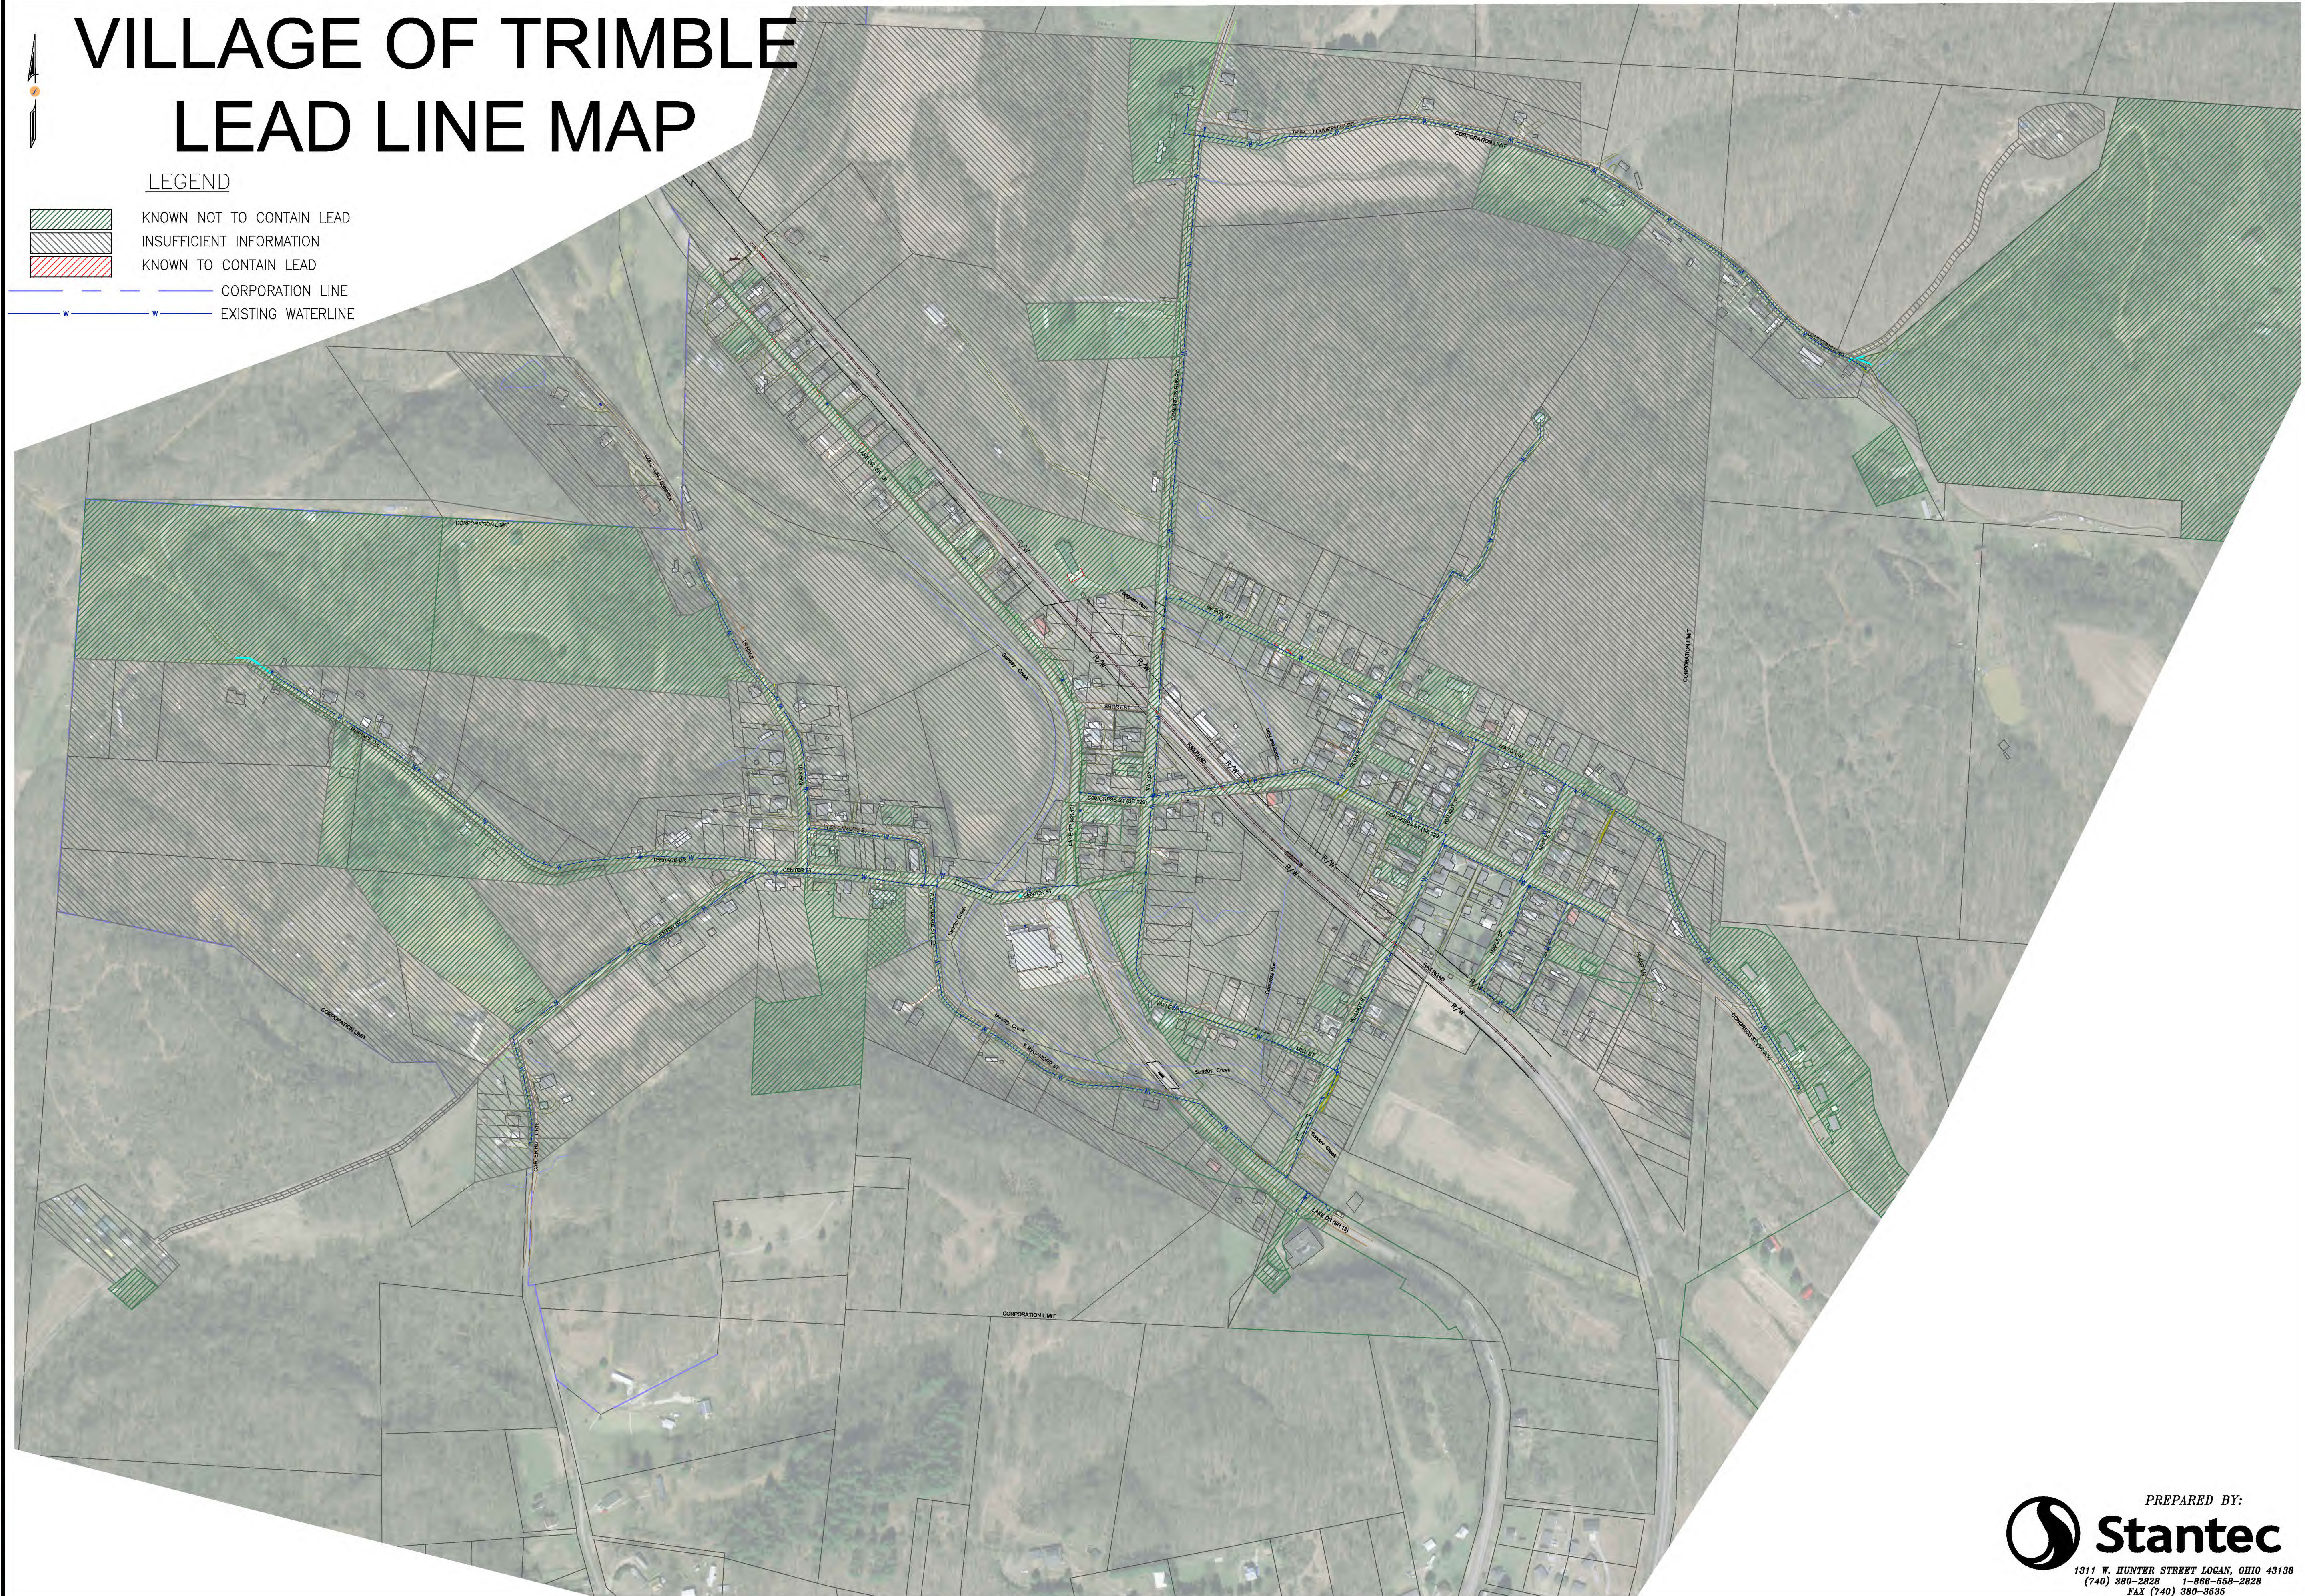
For the mapping purposes, any buildings or areas constructed prior to 1998 were classified as “no information available”, while buildings or areas constructed in 1998 or after were classified as “no lead”. The age of the building was obtained from the knowledge of Village staff and the self-reporting forms. In addition, the self-reporting was used to identify “no lead” for customers that reported that their service line material and building plumbing area all plastic.

The Village is not aware of the presence of any lead service lines within the system, but cannot rule out the possibility due to the lack of information.

The Village of Trimble owns and maintains a public water system that serves approximately 200 customers. The water mains and public portion of the service lines were all replaced in 2015 and are PVC and PE pipe materials. Therefore, the entire public portion of the system can be classified as not containing lead.

The Village lacks sufficient records to accurately determine areas within the system containing lead service lines on private property. They do not have a building department or permit records. There are no as-built drawings for the original system that may identify material utilized for service line installation. Their existing operation and maintenance records do not contain information about the material of existing lines that were repaired. The Village does not use tap cards for new installations nor do they have any historic tap card records. The Village has implemented a customer self-reporting program to identify lead lines within the distribution system, but has received a low response rate of about 10%. Due to the lack of adequate record information, the only basis of determination for preparation of the lead line map for private service lines is the age of the building and the 10% self-reporting responses.
