2603 State Route 59

AAA Plaza No permanent residents

2641 State Route 59

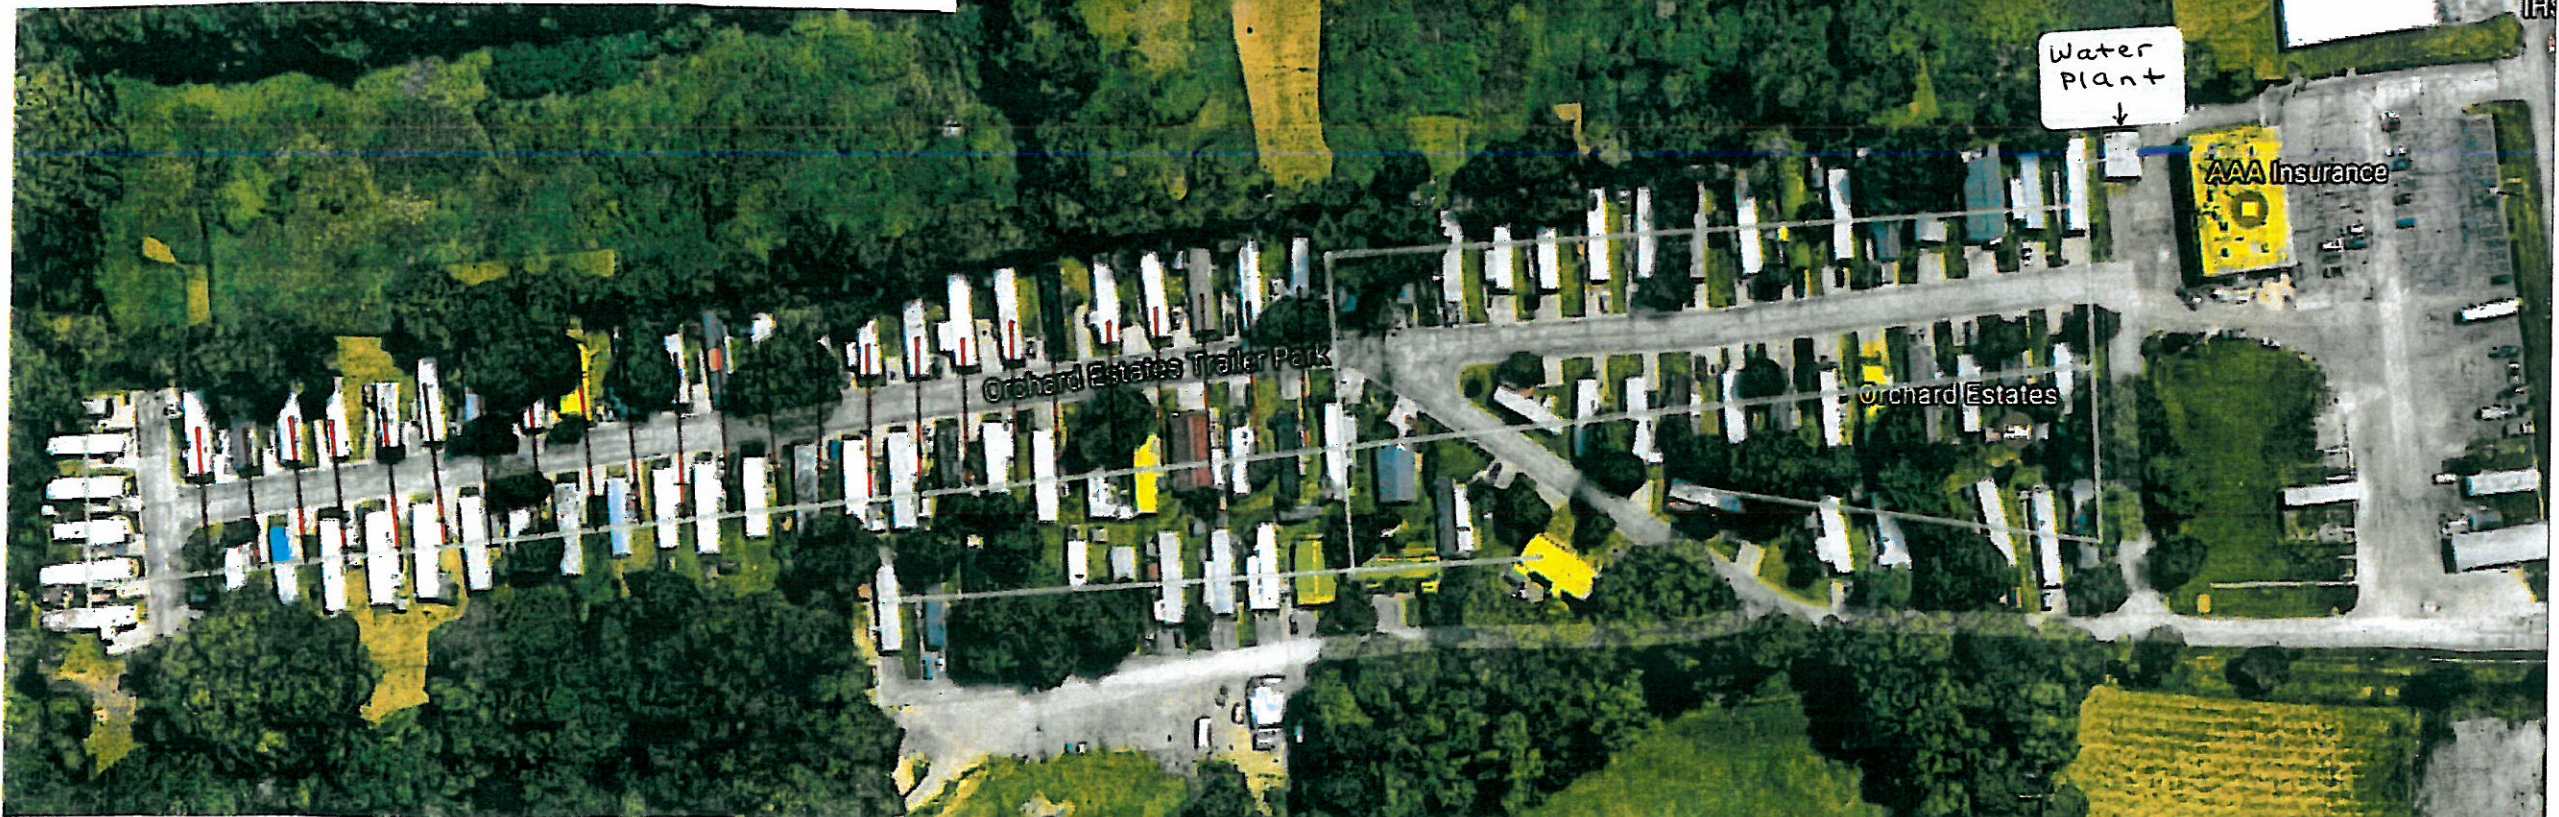
Water main consist of 1.5" to 3" galvanized pipe

Service line to homes is 1" galvanized

Main to plaza is 2" PVC, internal plumbing is copper & plastic

Water main to residents 1.5" to 3" galvanized pipe

Service to residents 1" galvanized pipe

Water bmain to AAA Plaza 2" PVC
