RE: Forest Village  
Report  
Drinking Water Program  
Hardin County  
PWS ID: OH3300312

**WATER DISTRIBUTION SYSTEM  
LEAD MAPPING SUBMITTAL**

PREPARED FOR:  
**VILLAGE OF FOREST**  
**PUBLIC WATER SYSTEM ID: OH3300312**  
**211 W. LIMA STREET**  
**FOREST, OH 45843**

**Lead Mapping Narrative 2017**

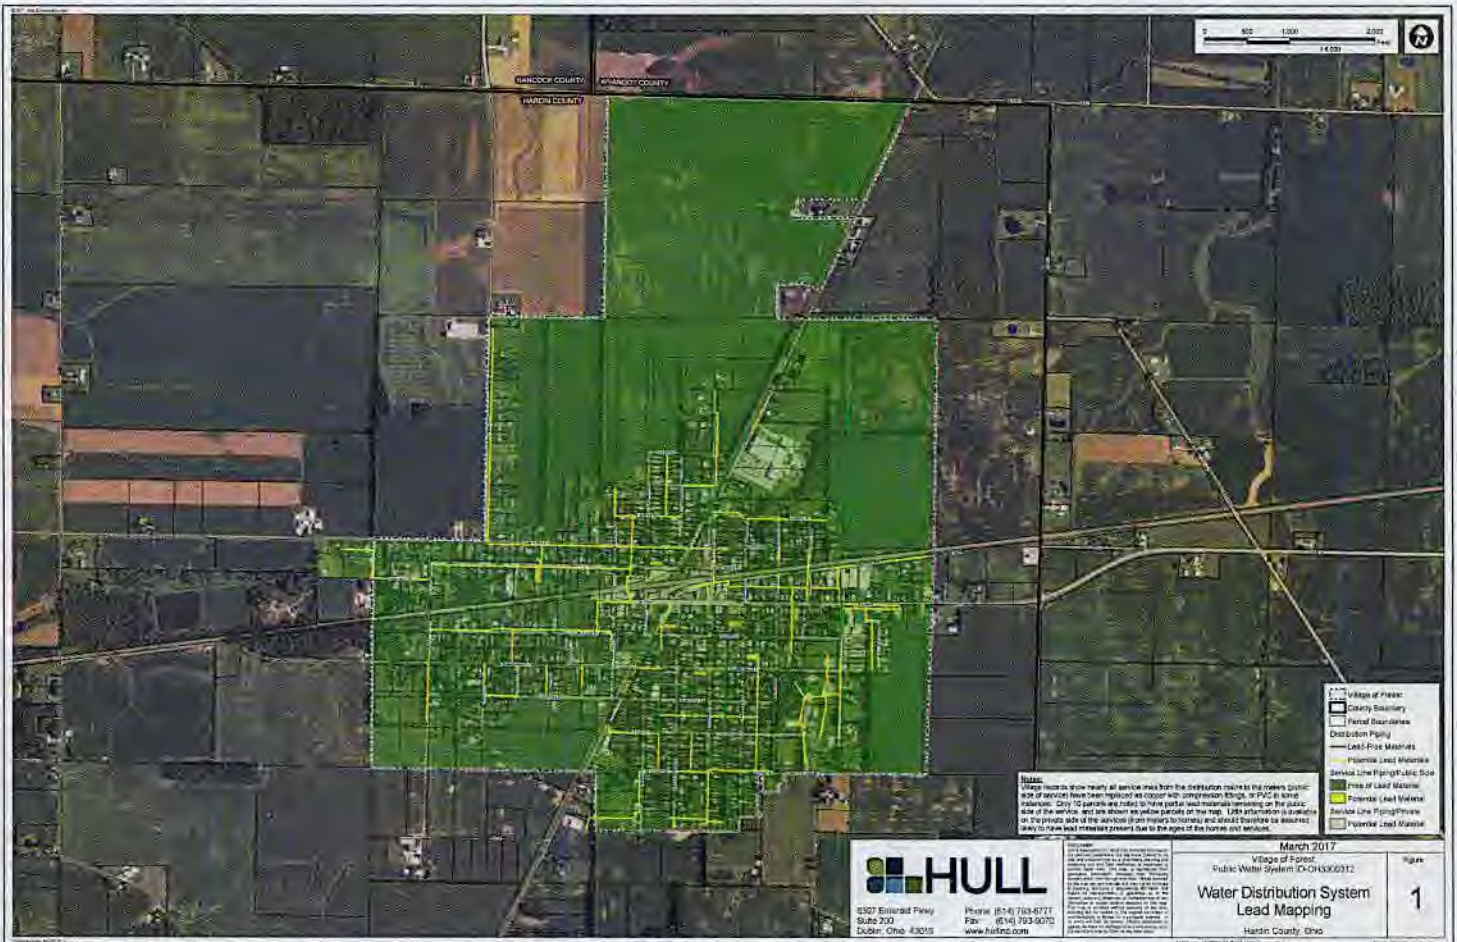
In accordance with HB 512, the Village of Forest (Village), Public Water System ID# OH3300312, worked with engineering consultant, Hull & Associates (Hull), to produce an overall water system map. The map shows the approximate location of the distribution system and identifies areas of the City that are known or likely to contain lead service lines. For this submittal, the map depicts areas of general service line information and only indicates the likelihood of lead in the publicly owned portion of the service lines (the portion from the water main to the water meter). At this time, information on the lead content of the private side of the service lines are generally unknown.

The materials of water main pipe installed in the Village appear to have originally been of cast iron or galvanized pipe. Cast iron water main pipes may contain lead-oakum joints. Since 1992, the Village has replaced several water main sections with C900 PVC plastic pipe which is lead-free material. The map shows the PVC piping as green lines, and all other mains shown yellow as potential lead material. The Village has a master plan to replace more of the older piping with C900 PVC pipe over the next 9 years in four phases of construction: 2017, 2020, 2022, and 2025.

To develop the map, Hull interviewed Village officials knowledgeable of the water distribution system, reviewed the available water distribution map which also identifies service line locations, reviewed the service line log books which describe all service line work and replacements from 1939 to present, and determined approximate dates of construction for developed areas. The wells that supply the water system were installed in 1930 and 1932. It appears from review of the log books that the Village began an effort in 1939 to replace any lead service lines with copper pipe/tube with compression or flared type fittings, either as routine repairs were needed or as a pro-active effort on an individual parcel basis. Of the approximate 580 services, only 10 are reported in these log books to have portions of lead materials remaining in the public side of the service lines. The log book records do not typically describe the private side of the services, and therefore it is assumed that all private sides of the services lines have the potential to contain lead materials.
