# Village of Lisbon Lead Mapping for 2017

Village of Lisbon PWS 1501512

## Lead and Copper Sample Sites

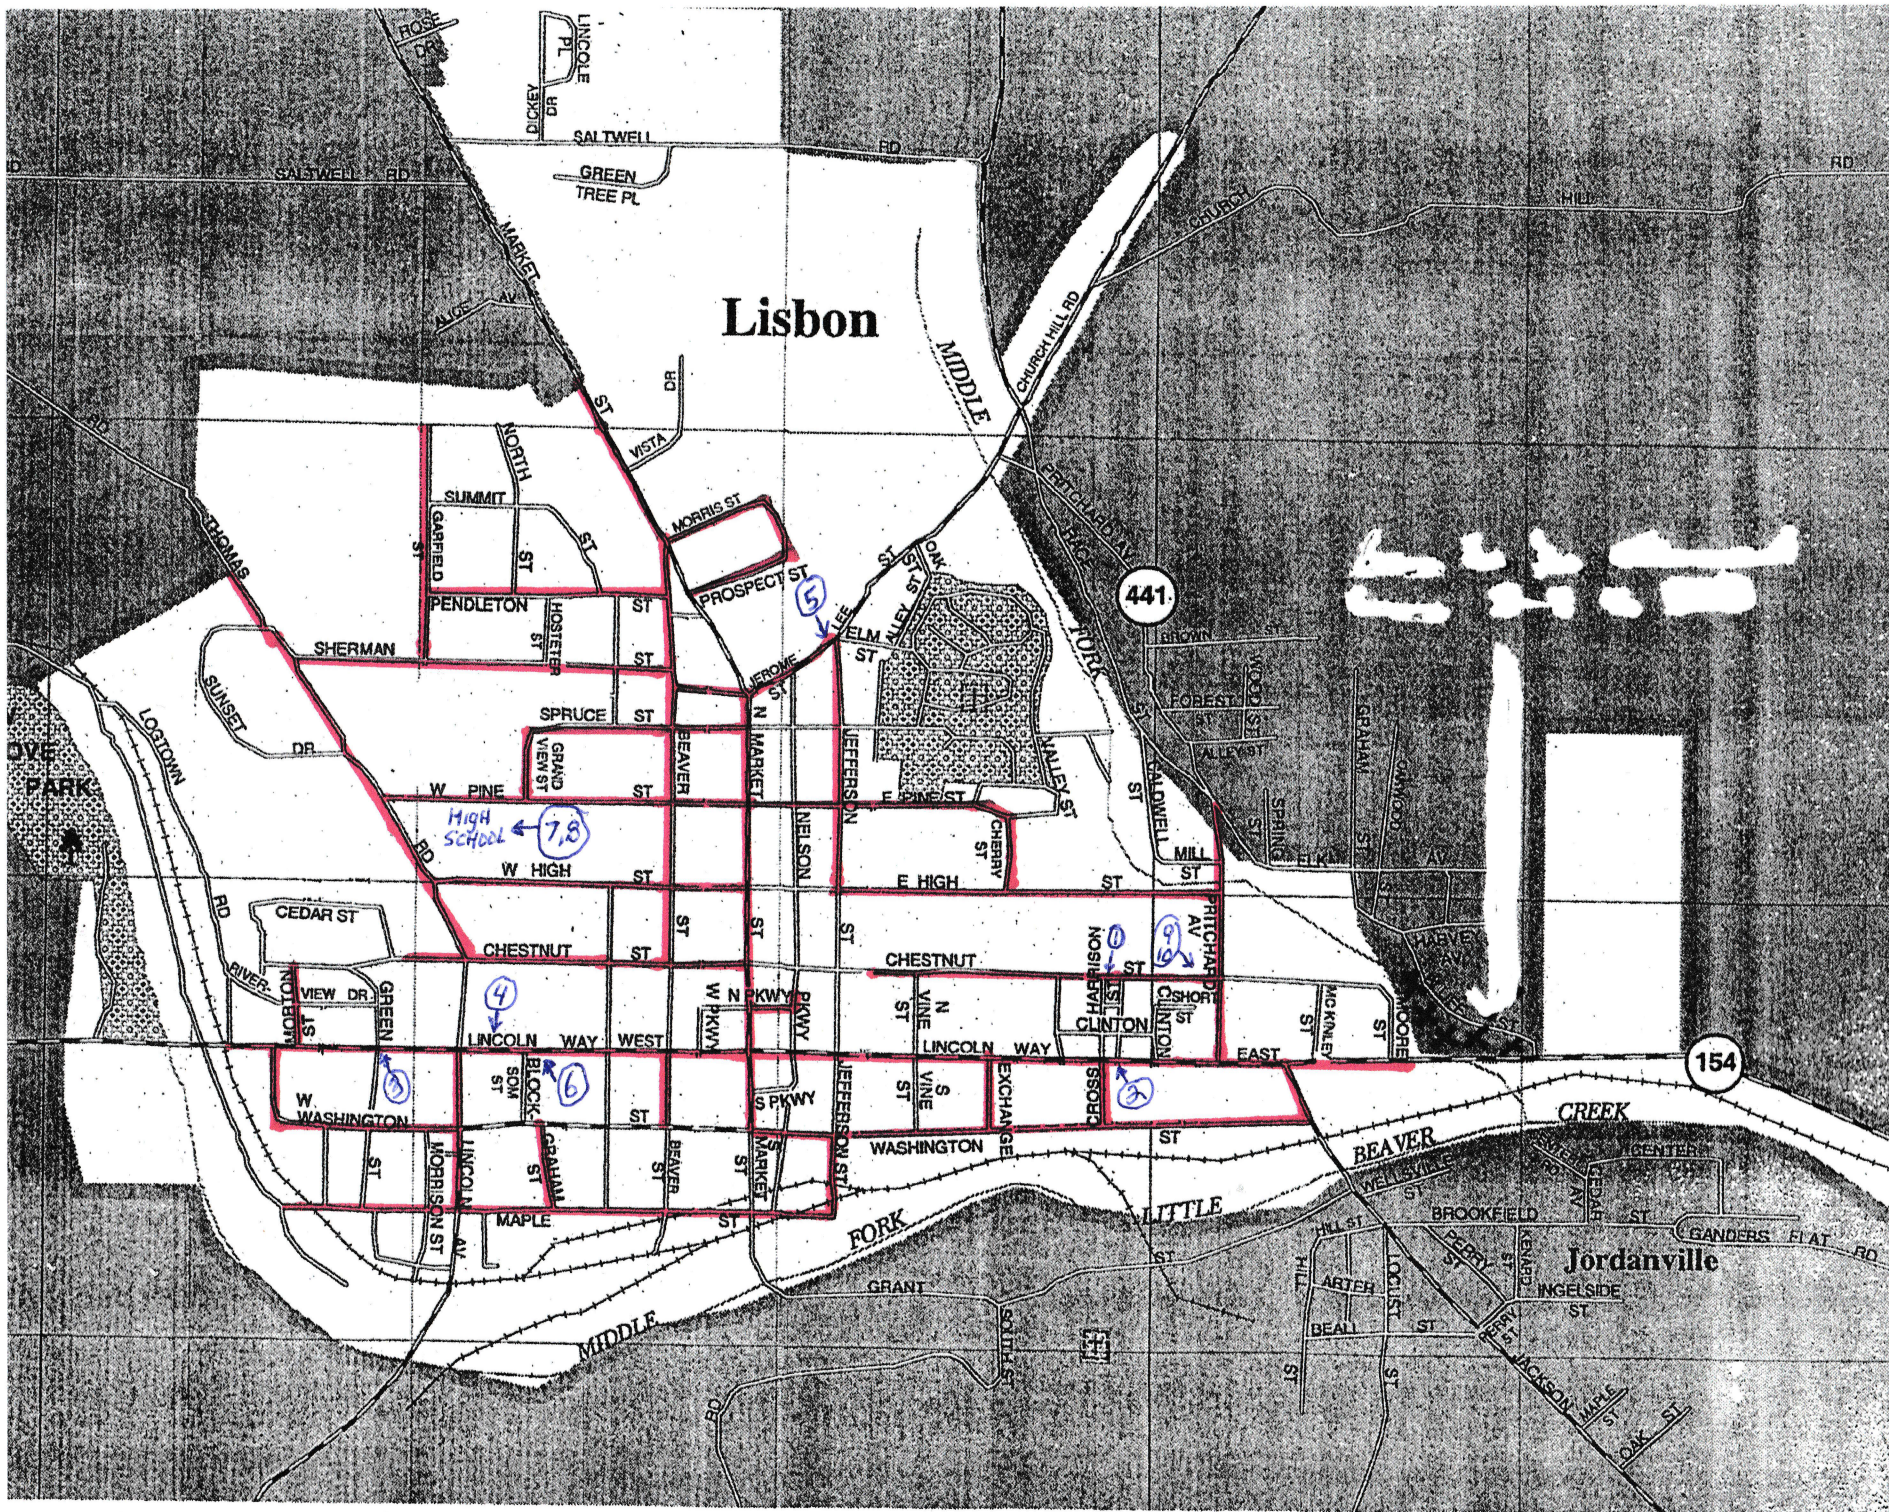
The areas that we have identified as possibly containing lead lines are identified on map with red. These distribution lines are the oldest active distribution lines. They are 4 and 6 inch cast iron pipe with Lead packed seals. Over the years we have discovered many service
