RE: PRINCIPLE BUSINESS
ENTERPRISES

Report
Drinking Water Program
Wood County
PWS ID: OH8741612

PBE FACILITY OVERVIEW w/ MAIN WATER DISTRIBUTION LINES – MARCH 2017

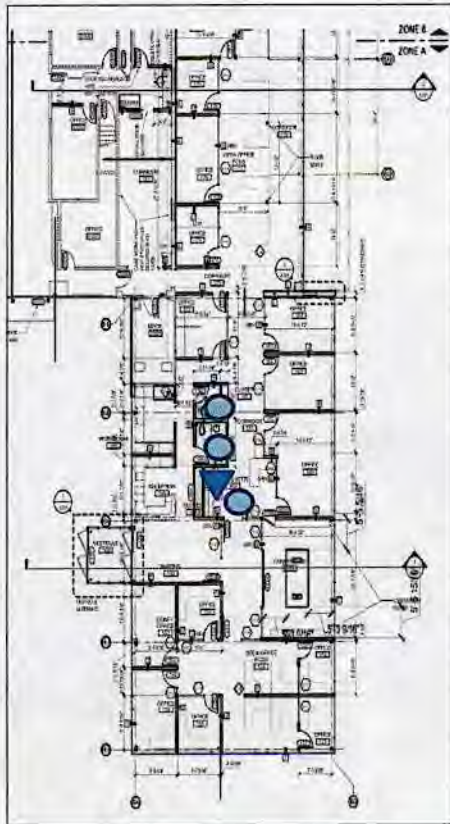
Drawing A1: First Floor 'Lakeside' Offices (East)

NOTE: 'Building A and B' 1st Floor Hot and Cold Water Supplied from 2nd Floor Lines within the Wall Cavities

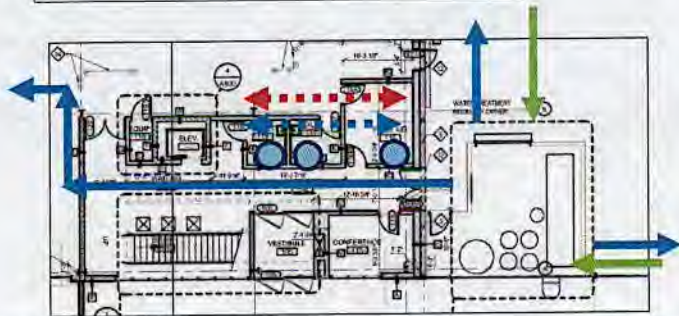
Drawing F1: 'Building F' 'Courtyard' 1st Floor Restrooms / First Aid Room
 NOTE: Hot and Cold Water Supplied from 2nd Floor Supply Lines
