# LEAD MAPPING

Stimmel Properties PWS

OH2549412

Re: 1316 - 1340 Stimmel Road—Site Map

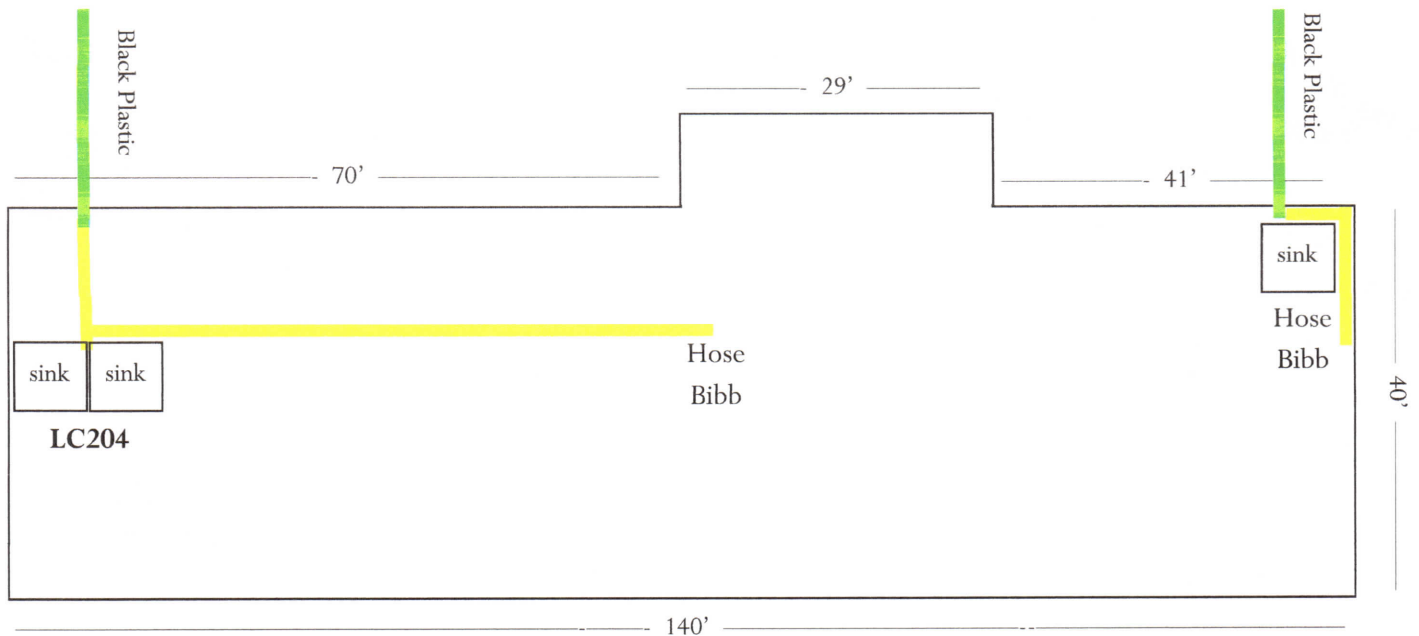
Re: 1340 Stimmel Road

\*This building has two (2) service line entrances (black plastic ) into the building. It was built in 1975, so we have to assume that the solder used on the copper piping inside the building is NOT lead free.

Built In 1975

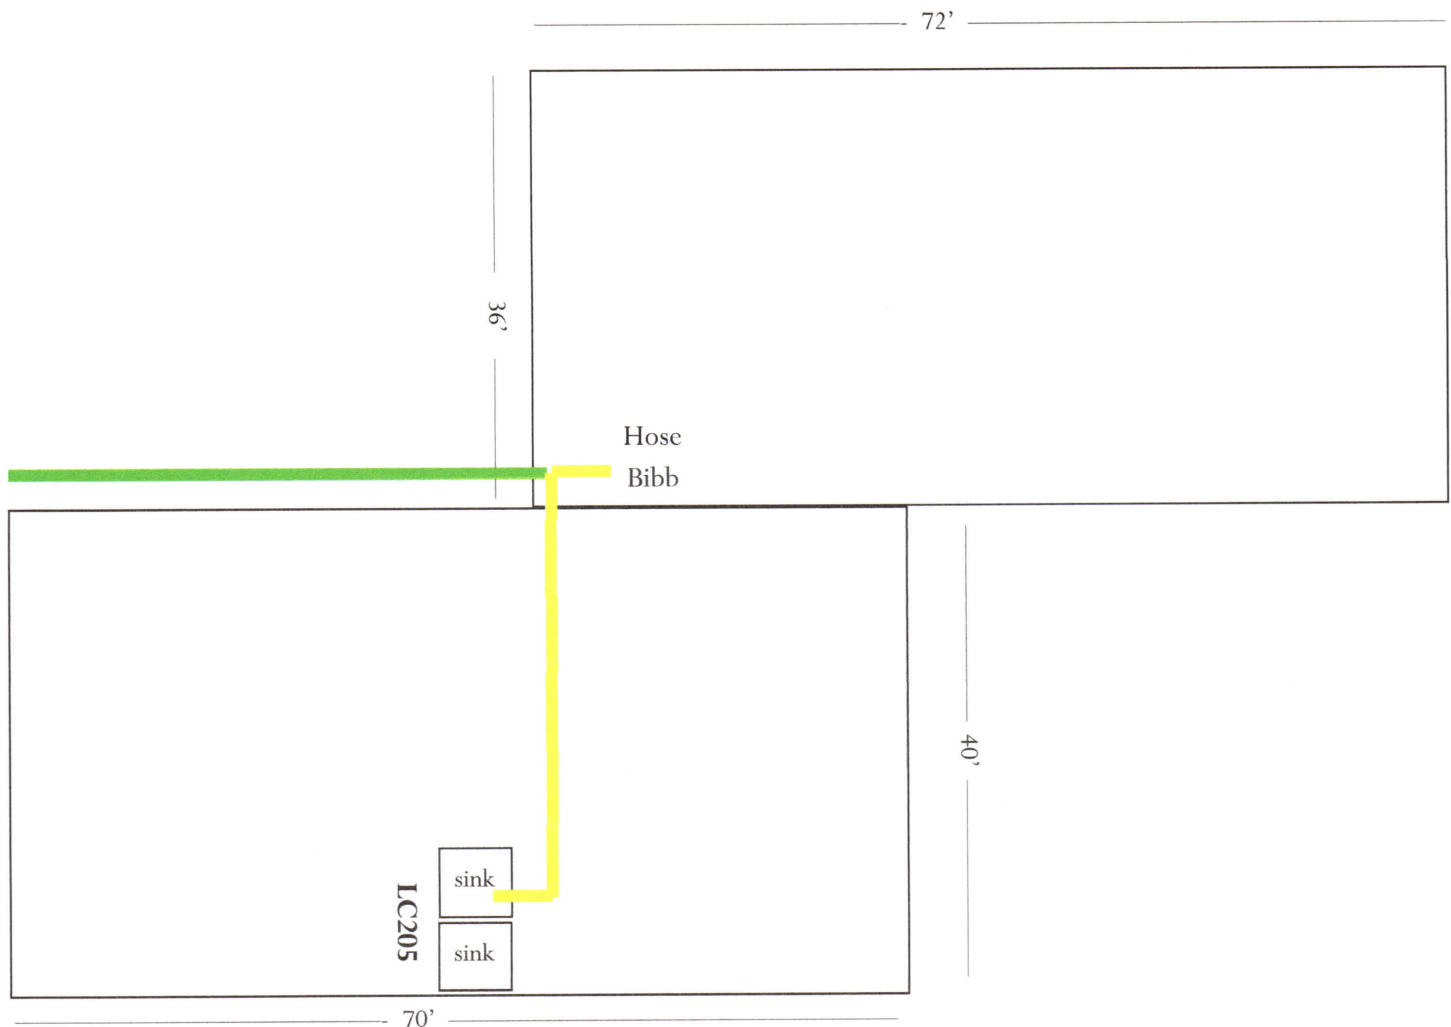
Re: 1336 Stimmel Road

\*This building has a black plastic service line into the building. It was built in 1978, so we have to assume that the solder used on the copper piping inside the building is NOT lead free.

Built In 1978

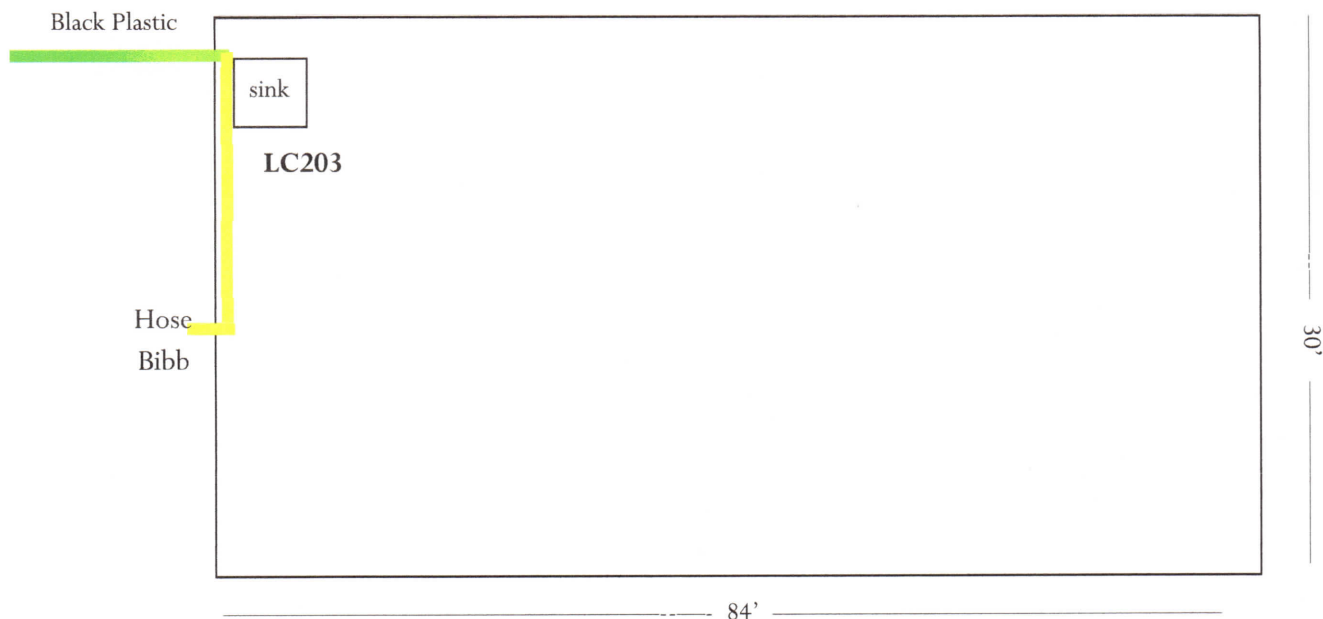
Re: 1338 Stimmel Road

\*This building has a black plastic service line into the building. It was built in 1976, so we have to assume that the solder used on the copper piping inside the building is NOT lead free.

Built In 1976

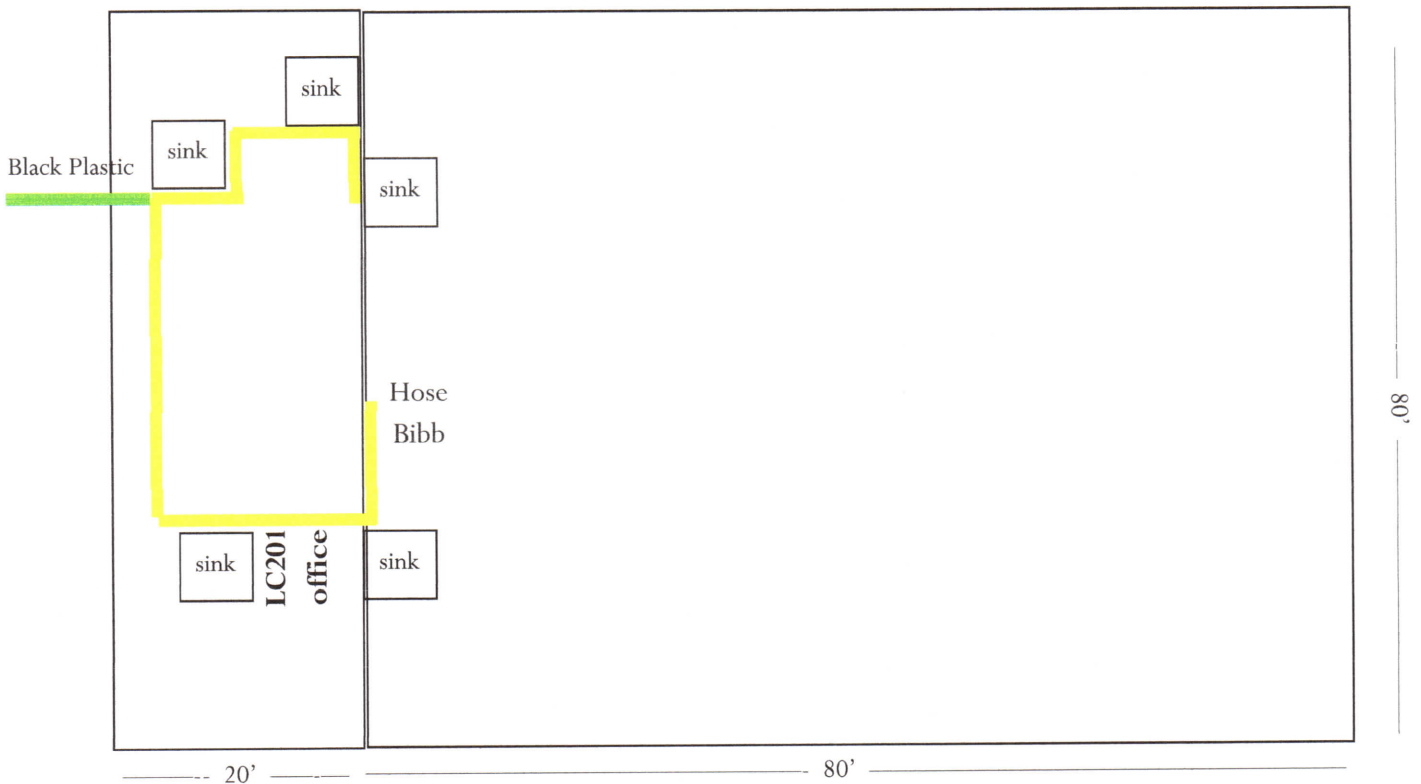
Re: 1330 Stimmel Road

\*This building has a black plastic service line into the building. It was built in 1980, so we have to assume that the solder used on the copper piping inside the building is NOT lead free.

Built In 1980

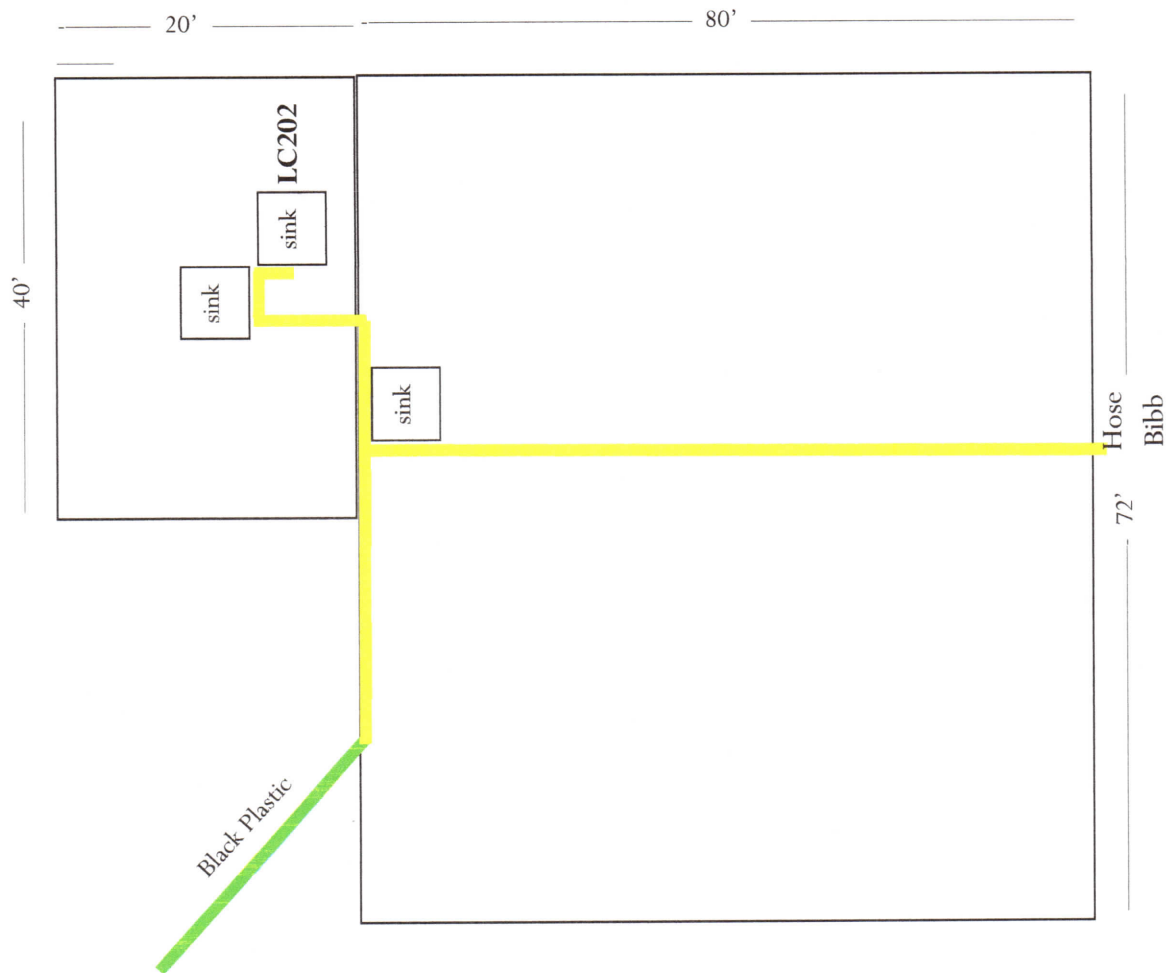
Re: 1316 Stimmel Road

\*This building has a black plastic service line into the building. It was built in 1982, so we have to assume that the solder used on the copper piping inside the building is NOT lead free.

Built In 1982
