Creekside Child Care  
 OH 2570716  
 Nontransient Non-Community  
 Contact  
 Jeff Hickman  
 614-576-9807  
 jhickm7@columbus.rr.com

Creekside Child Care  
 2225 Rohr Rd.  
 Lockbourne, Ohio 43147  
 Phone - 614-491-4906

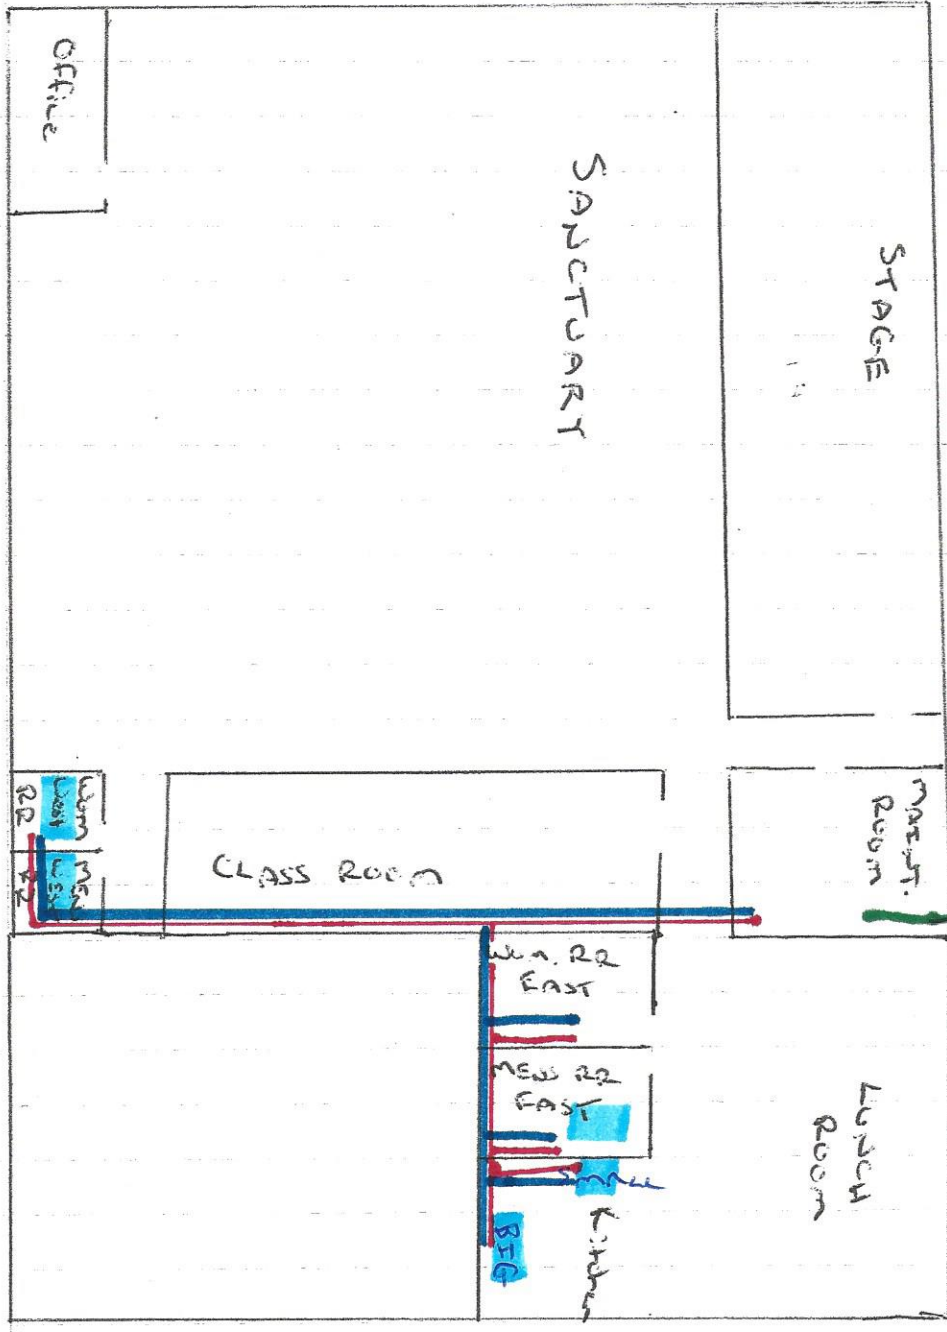
Service Line - PVC  
 Interior Lines - Copper 7/8"

SAMPLE SITES -

- LC 201 Women's RR West
- LC 202 Mens RR West
- LC 203 Mens RR East
- LC 204 Kitchen Sink - Small
- LC 205 Kitchen Sink - Big

Hot water lines - Red  
 Cold water lines - Blue  
 Service line - Green

Building was constructed in 1986 per the  
 Franklin Cty. Auditor website.  
 1986-2014 lead solder was banned and  
 there was lower content of lead in brass
