# INDUSTRIAL FLUID MANAGEMENT, INC.

Re: Travel Centers of America 11 PWS  
PWS ID: OH6832712  
Eaton Ohio  
Preble County

Enclosed you will find, as per House Bill 512, lead mapping and SMP ID for Travel Centers of America 11 PWS in Eaton, Ohio.

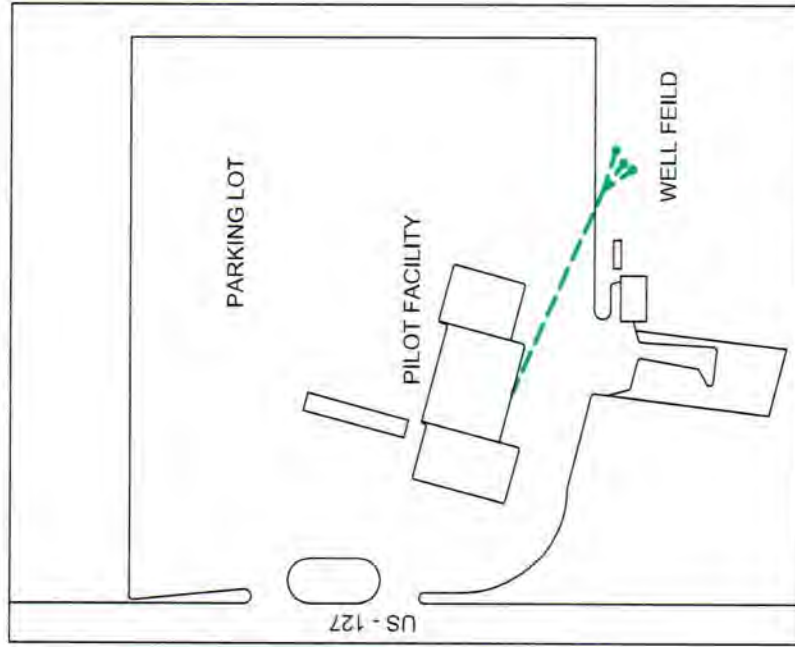
PWS ID: OH6832712

VISUAL INSPECTION IN FEBRUARY OF 2017 REVEALED THE LINES FROM THE WELLS ARE PLASTIC AND ALL INTERIOR PLUMBING IS SOLDERED COPPER. DUE TO THE AGE OF THE ORIGINAL BUILDING AND LACK OF DOCUMENTATION, WE HAVE LISTED THE INTERIOR PLUMBING AS COPPER INSTALLED BEFORE 1983 (COPPER <83).

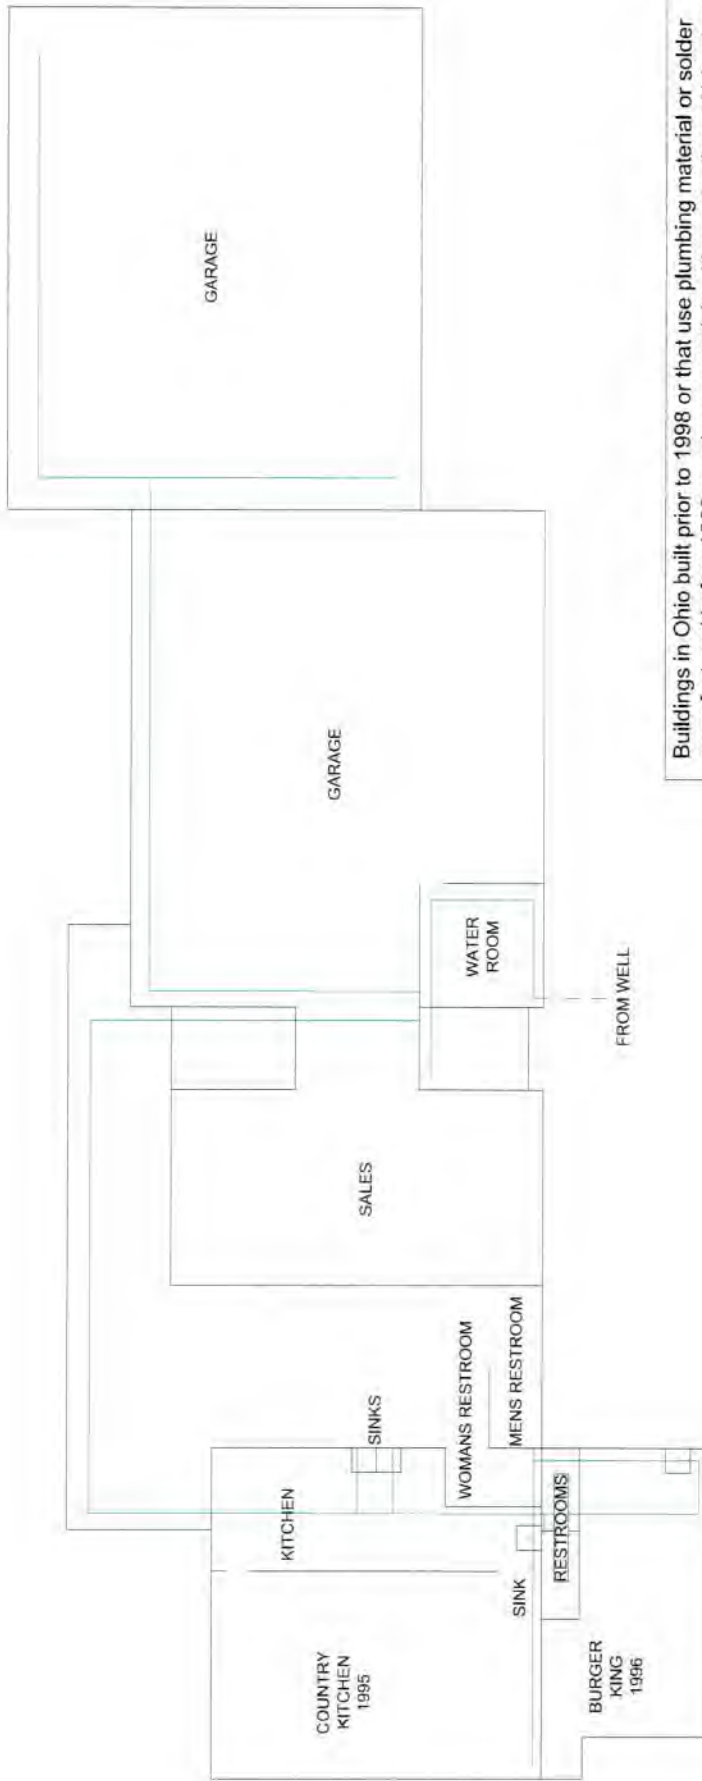
LEGEND: PWS ID: OH6832712

VISUAL INSPECTION IN FEBRUARY OF 2017 REVEALED THE LINES FROM THE WELLS ARE PLASTIC AND ALL INTERIOR PLUMBING IS SOLDERED COPPER. DUE TO THE AGE OF THE ORIGINAL BUILDING AND LACK OF DOCUMENTATION, WE HAVE LISTED THE INTERIOR PLUMBING AS COPPER INSTALLED BEFORE 1983 (COPPER <83).

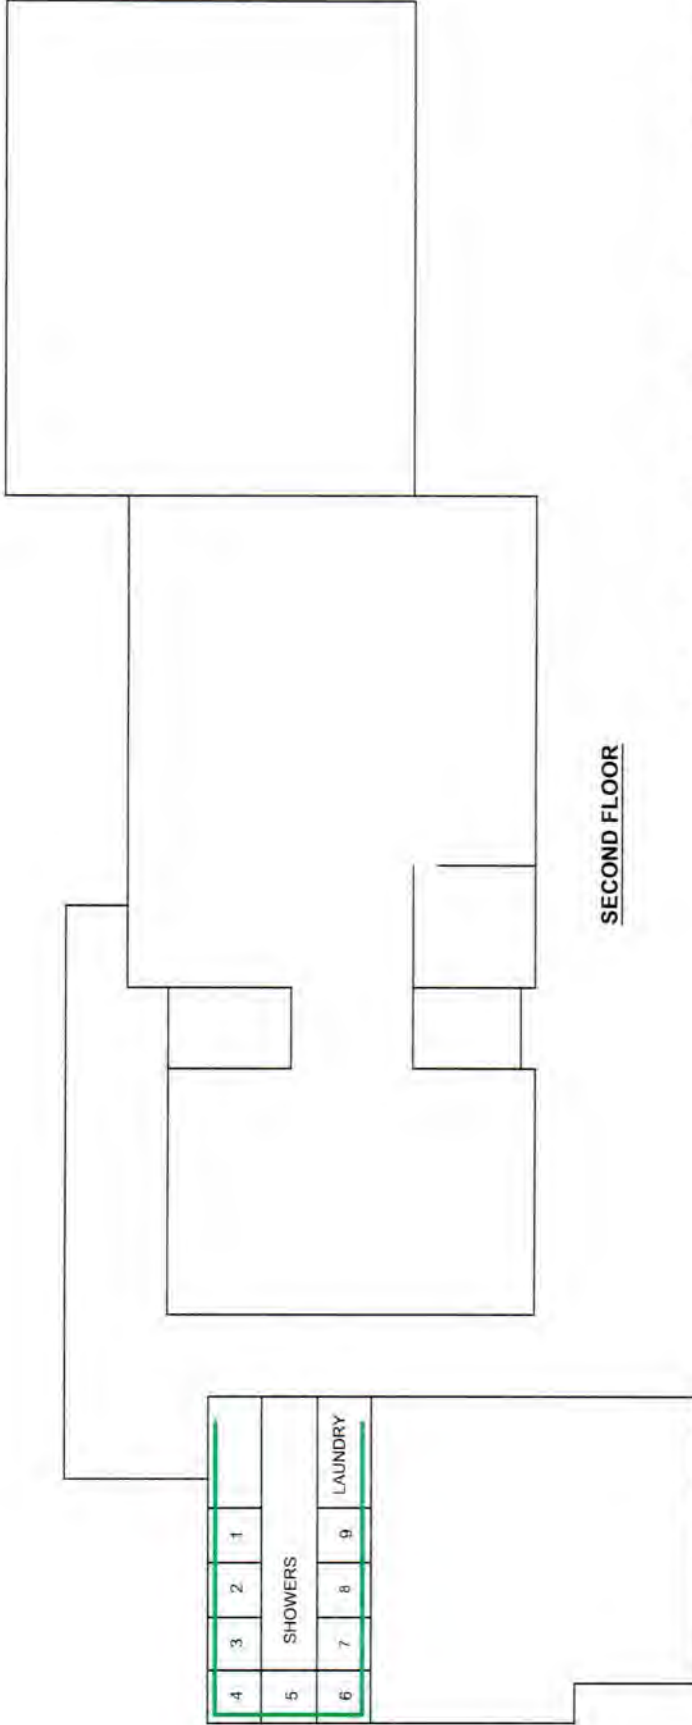
**SECOND FLOOR**

VISUAL INSPECTION IN FEBRUARY OF 2017 REVEALED THE LINES FROM THE WELLS ARE PLASTIC AND ALL INTERIOR PLUMBING IS SOLDERED COPPER. DUE TO THE AGE OF THE ORIGINAL BUILDING AND LACK OF DOCUMENTATION, WE HAVE LISTED THE INTERIOR PLUMBING AS COPPER INSTALLED BEFORE 1983 (COPPER <83).
